**Improvement Dredging for  
Lamma Power Station Navigation Channel  
Quarterly Environmental Monitoring & Audit Report**

**May – July 2021**

**ENVIRONMENTAL PERMIT NO. EP-535/2017**

Report Title	Quarterly EM&A Summary Report (May 2021 to July 2021)
Date	14 September 2021
Certified by

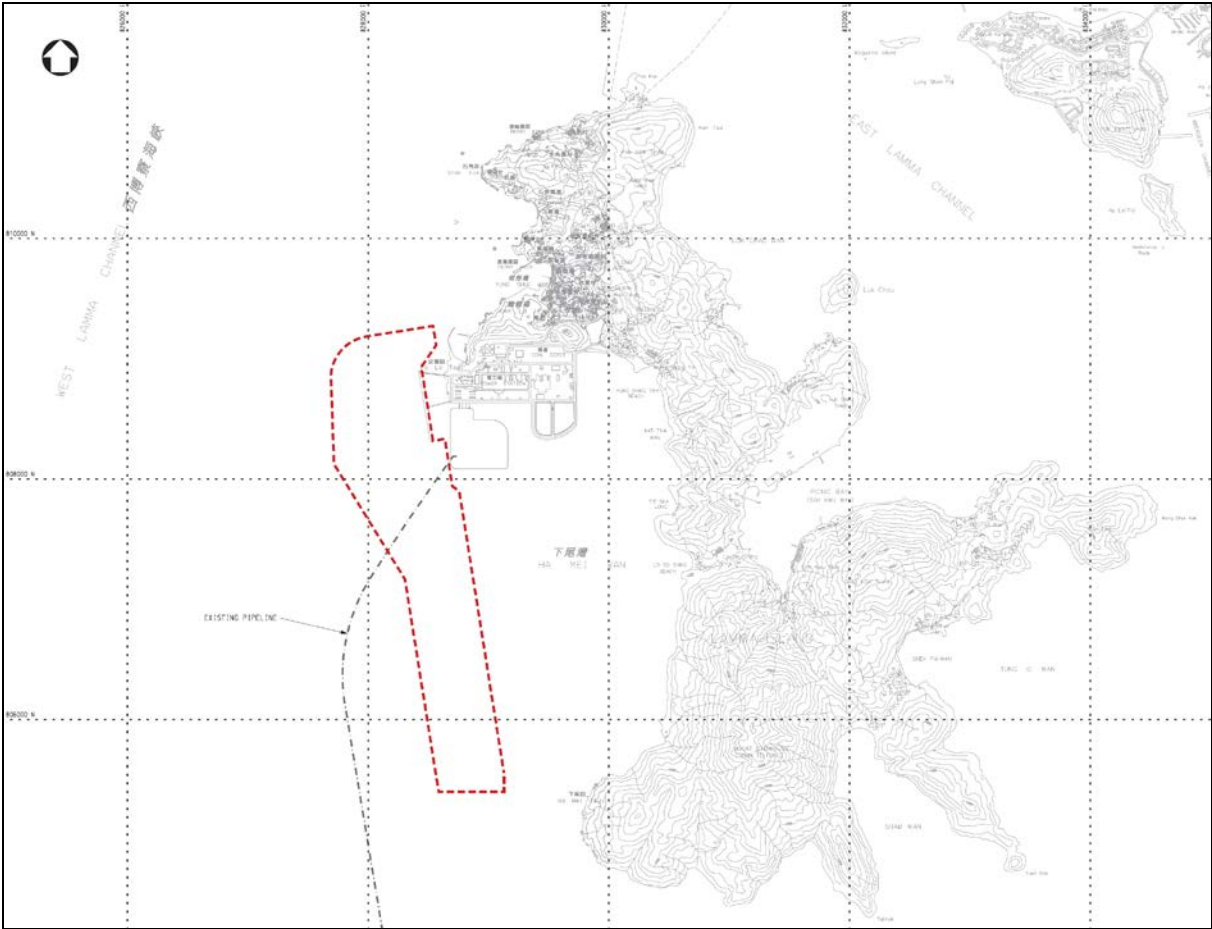
Figure 1.1 Project Area

The Project involves re-profiling the Lamma Power Station Navigation Channel (the “Channel”) to a target depth of -16.5 mPD with an estimated sediment quantity up to approx. 3.2 million m<sup>3</sup>, subject to fine-tuning against the actual existing seabed profile. The Project Area is shown in [Figure 1.1](#).

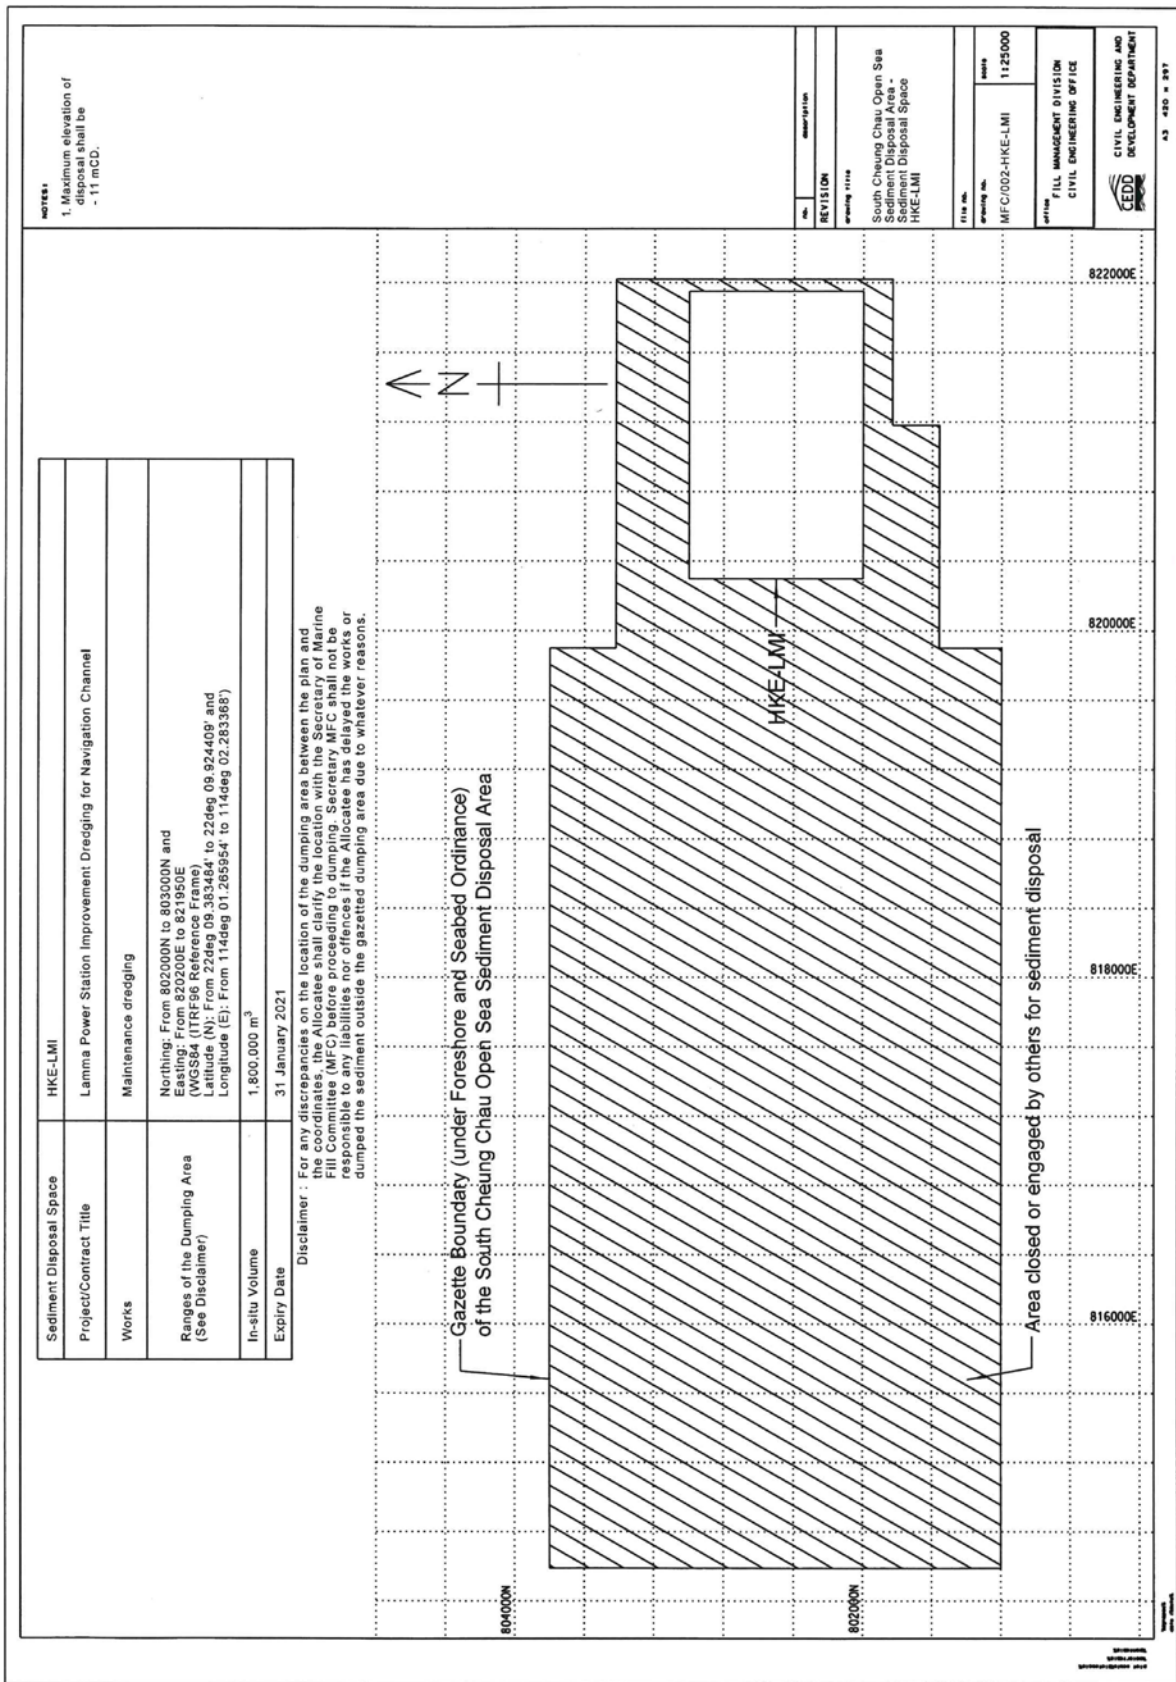
Figure 1.2 Location of Dumping Site (South Cheung Chau Open Sea Sediment Disposal Area)

Construction activities undertaken during the reporting report for this Project were dredging and dumping of dredged mud. One to two grab dredgers were deployed and operated within the Project Area. The total volume of dredged materials from 1 May to 31 July 2021 was 24,600 m<sup>3</sup>. Uncontaminated materials were dumped at the designated location within the South Cheung Chau Open Sea Sediment Disposal Area and the total dumped volume in reporting period was 24,600 m<sup>3</sup>. The location of dumping site is shown in [Figure 1.2](#).

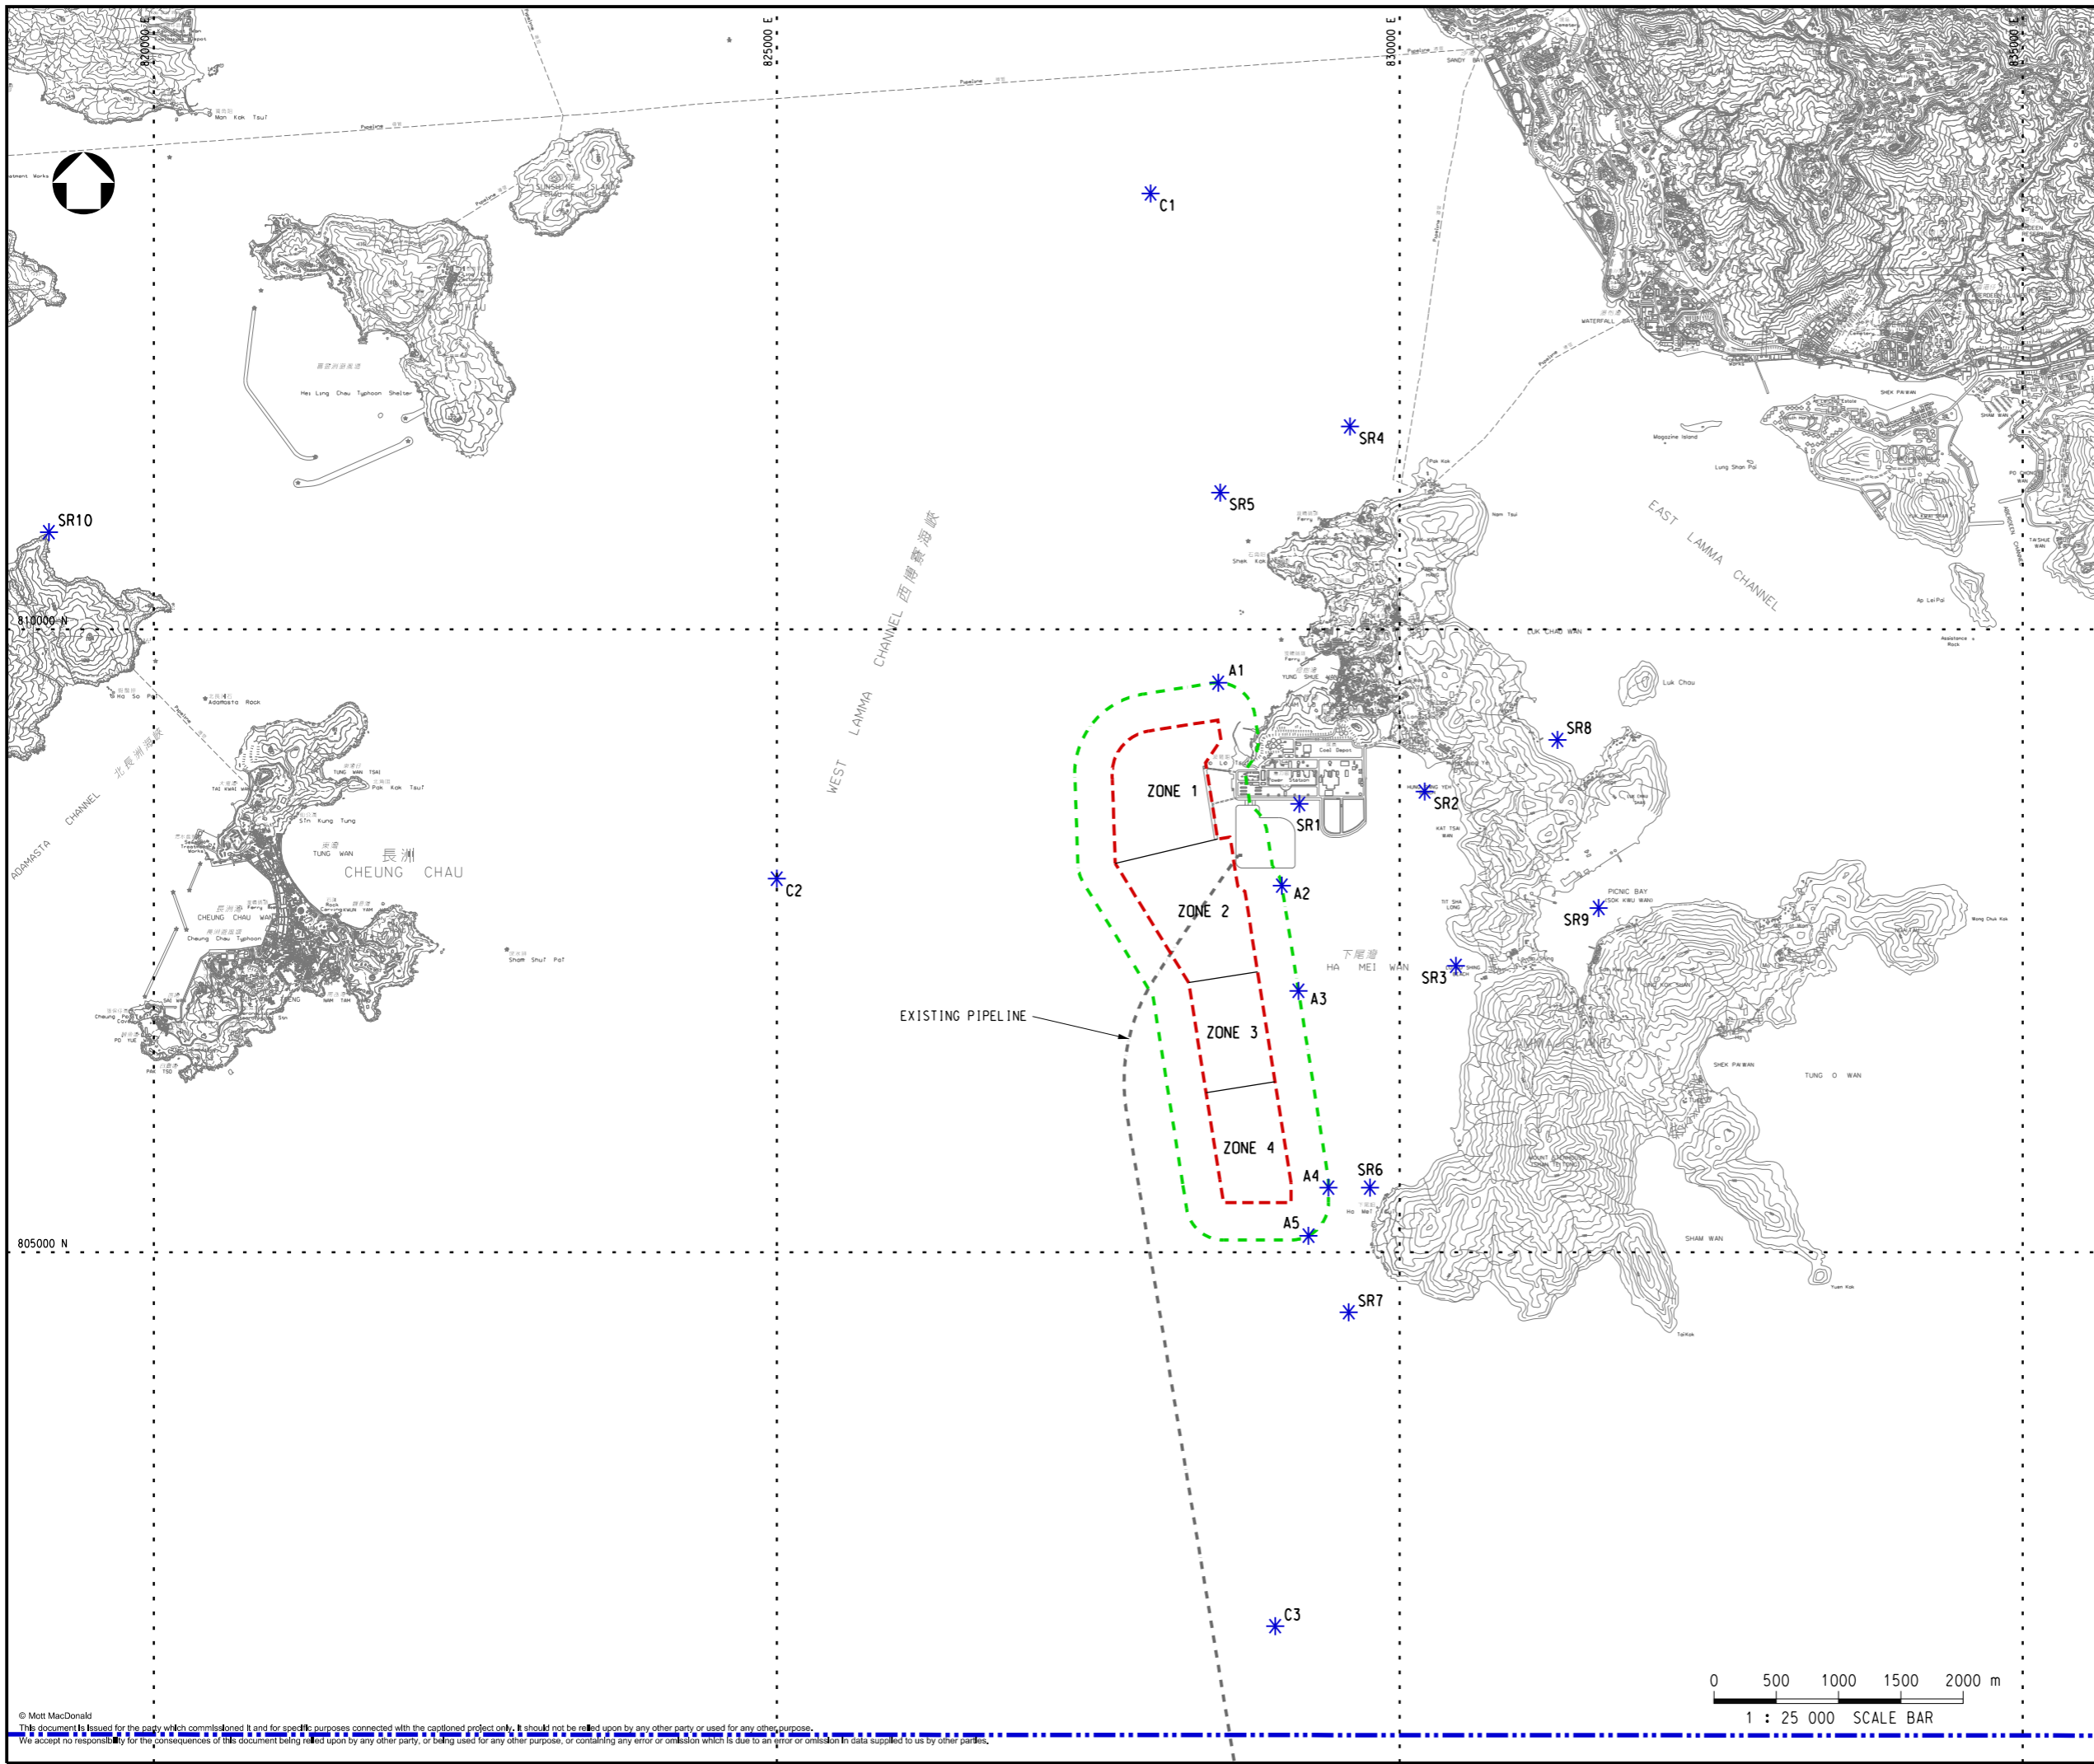
The water quality monitoring was conducted three days per week during the reporting period at mid-flood and mid-ebb tides. The monitoring was conducted at a total of 18 water quality monitoring stations, comprising ten SR stations, five near stations and three control stations. Details of the monitoring locations are shown in **Figure 2.1** and **Table 2.1**. It should be noted that the location of SR8 provided in **Table 2.1** is approximate due to changing location of fish rafts under different tidal and wind condition. Water quality monitoring at SR8 was conducted at the nearest safely accessible location to the Fish Culture Zone.

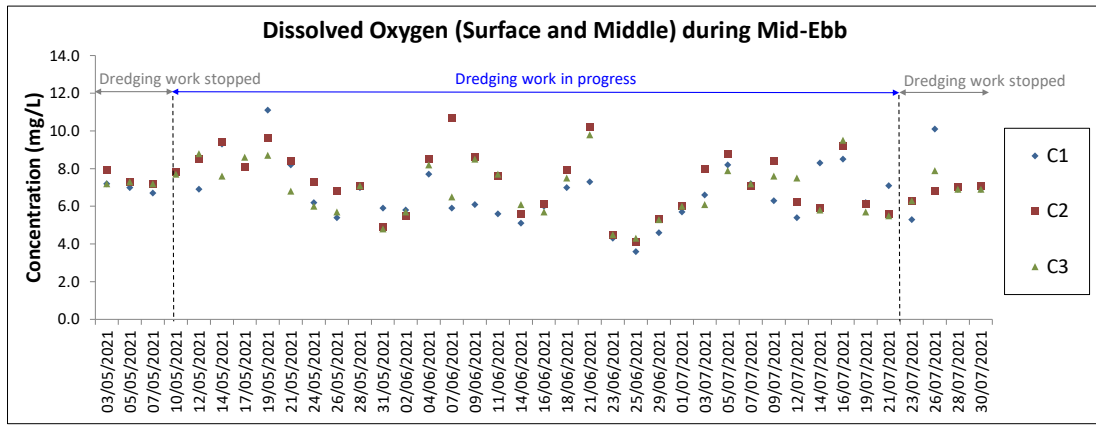
## **A. Graphical Presentations of Water Quality Monitoring Results**

1. General weather condition during monitoring ranged from sunny to rainy, with sea condition ranged from calm to rough. Detailed meteorological conditions can be referred to the corresponding Monthly Water Quality Monitoring Reports.
2. As specified in the Updated EM&A Manual, SR2 and SR3 were monitored during bathing season only (March to October inclusive).
