Contract No. 18/8005
Lamma Power Station
Navigation Channel Improvement 2019
Silt Curtain Deployment Plan for Dredging Works

Lamma Power Station Navigation Channel Improvement 2019

Silt Curtain Deployment Plan

November 2019 (Revised)

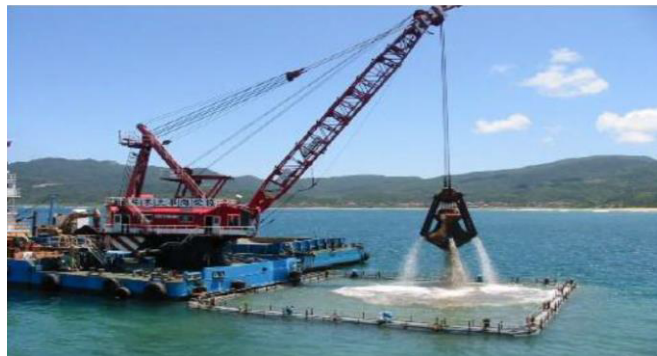
As the first measure to mitigate water pollution nuisance, the cage type silt curtain is designed to enclose local pollution caused by the grab dredger. This frame type silt curtain is made by a steel frame with floating buoy fixed on the top frame such that it is floating on water. A silt curtain membrane is mounted on the four sides of the steel frame so as to cover the entire water column.

The dredging works by the grab dredger would then be carried out within the frame type silt curtain. The position of this frame type silt curtain would be maintained by a chain fixed between the frame structure of silt curtain and the dredger.

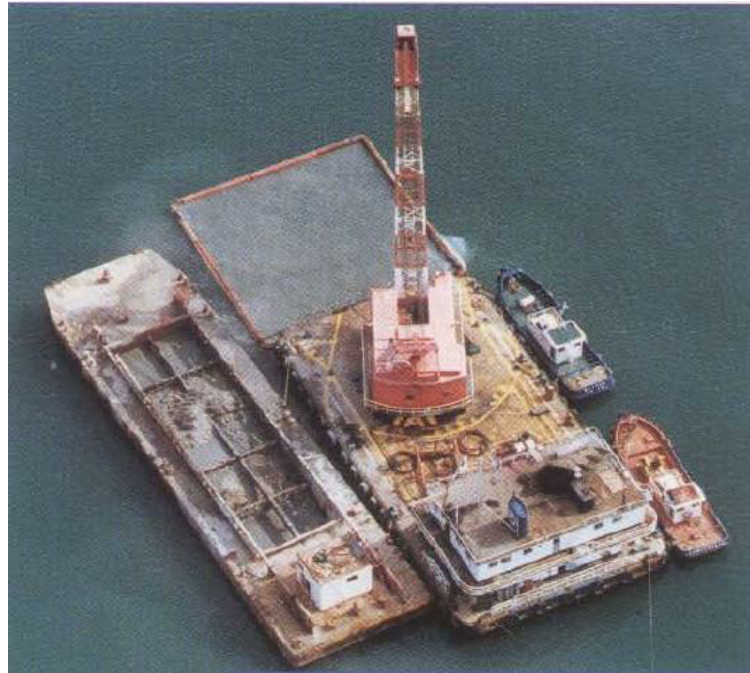
The silt curtains will be installed at the bow of the dredger with connection by using steel chains. Work boat will be engaged to assist the connection works.

sizing and installation position of silt curtain frame to be carefully decided and adjusted so as not to affect hopper barges berthing

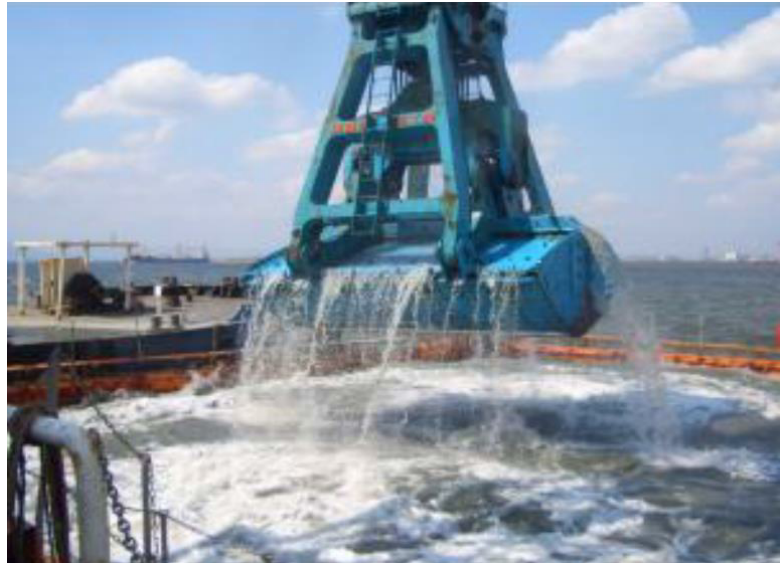
The silt curtain separates the dredging zone from the nearby waters to minimize water pollution nuisance

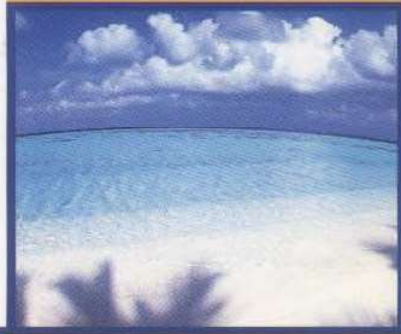
SILT PROTECTOR®

PREVENT DIFFUSION
OF SILT IN WATER

This type has been designed to enclose local pollution caused by the grab dredging. It consists of floats (usually discharge pipes are used), curtain and ballast at the bottom. Mid-ballast may be added as necessary. Many of this type is made so that the length of the curtain can be changed according to the depth by using a winch and wire rope. The length of the curtain is made ~~less than 1.5m for use with the grab dredger~~ so that the ballast at the bottom of silt curtain shall be placed 30cm - 50cm above the seabed.

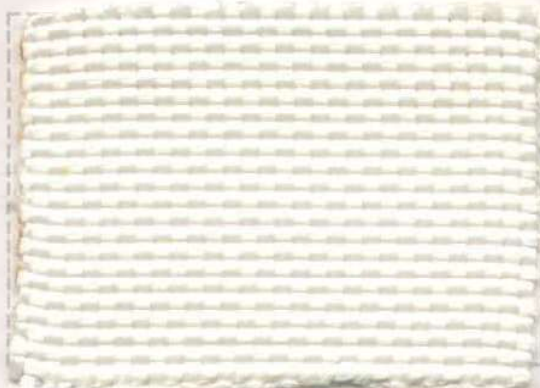
SPO-#800

Tensile strength 800kgf/3cm

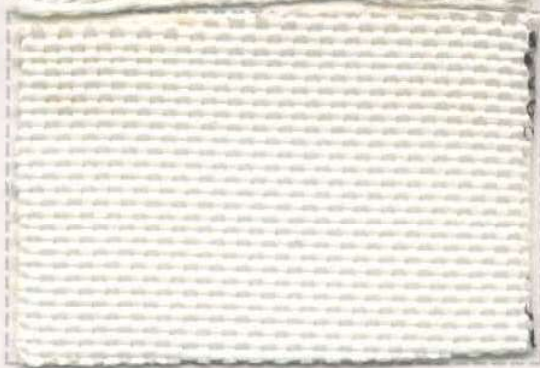
SPO-#500

Tensile strength 500kgf/3cm

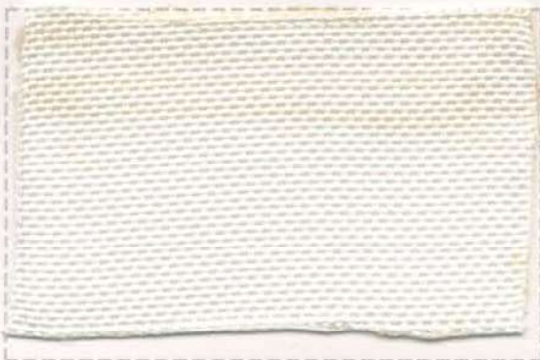
SPO-#300

Tensile strength 300kgf/3cm

Ballast Chain

Seabed

30cm - 50cm

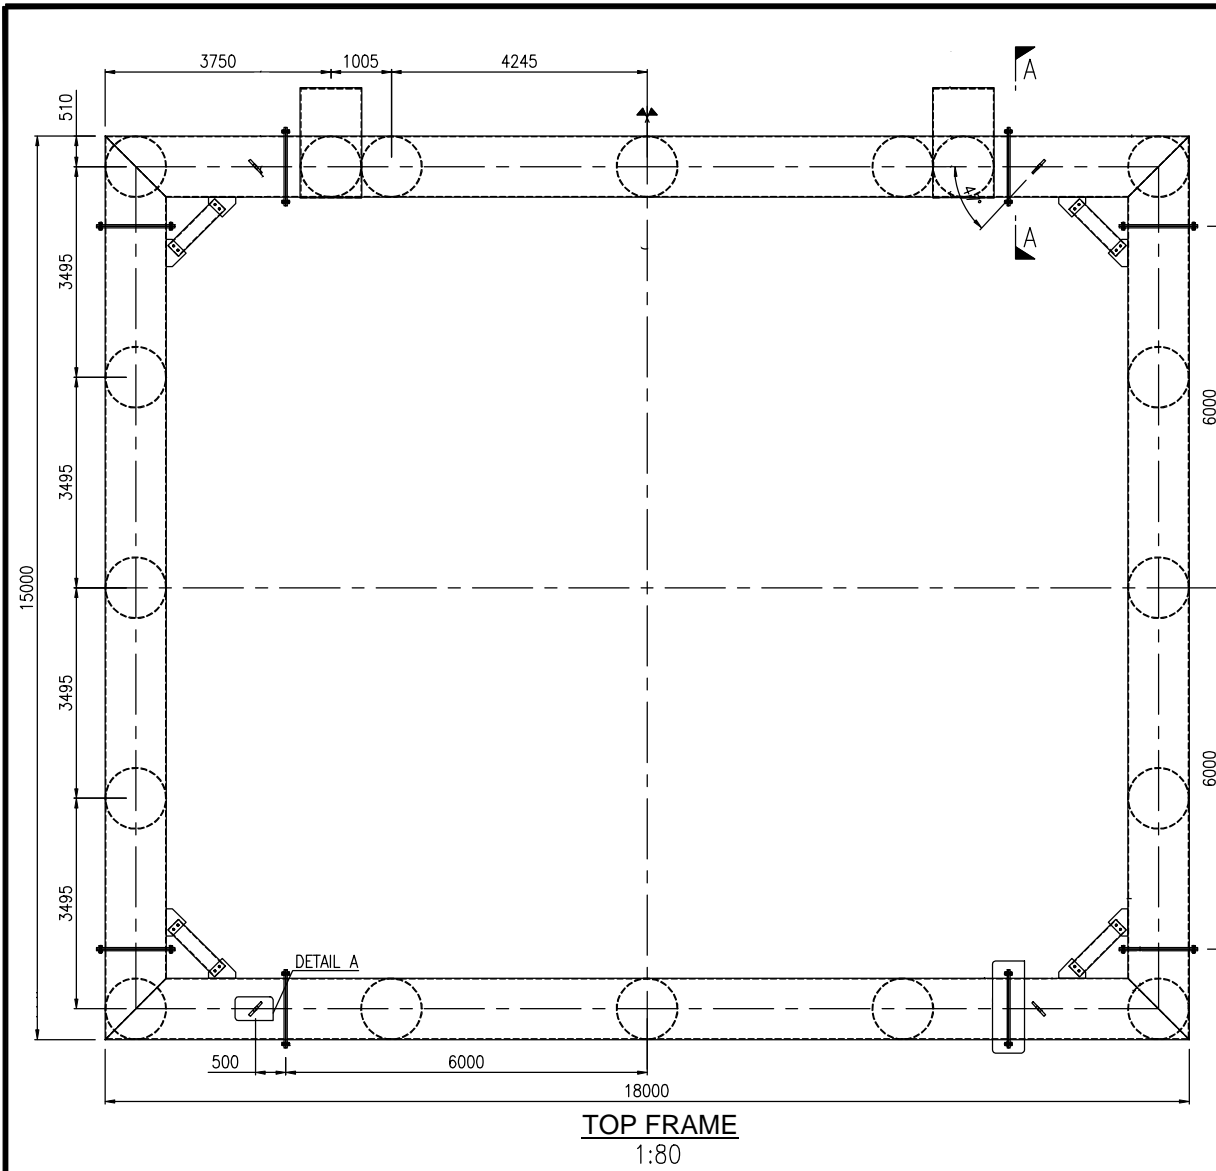
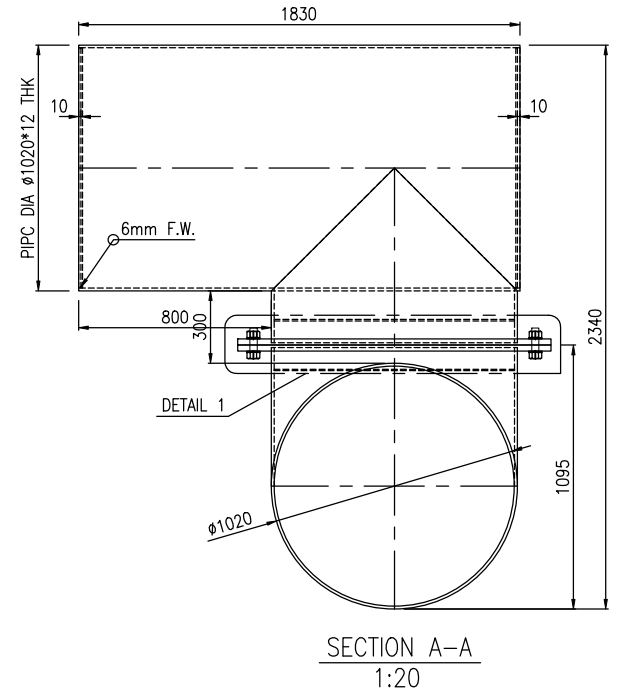
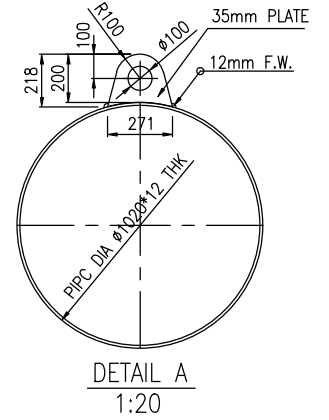
APPENDIX C – DRAWING / SKETCH FOR SILT CURTAIN FRAME

Floating Frame 15X18M								For Information only

The upper part of each of the silt curtains consists of a floating hollow frame from 4 tubular floats. The silt curtain frame is of 18m x 15m fabricated with member size of approx. 1m diameter 12mm thick pipe section. The silt curtain design is attached in Appendix C.

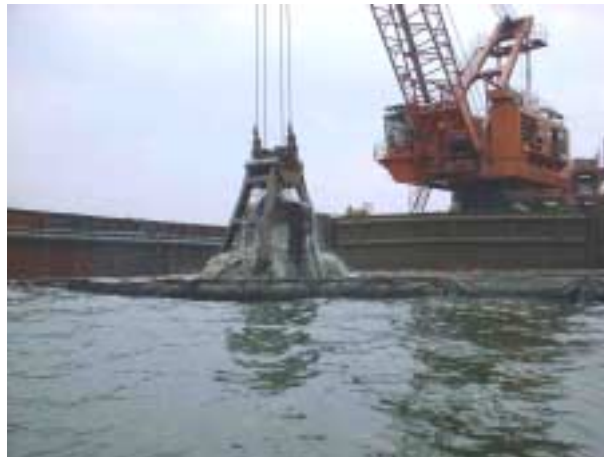
Figure 1.1 Silt curtain around the dredger

- 1.2 In order to minimize environmental impact to seawater during the period of dredging works, HEC has employed a silt curtain around the dredger to screen the dredged sediments such as shown in Figure 1.1.

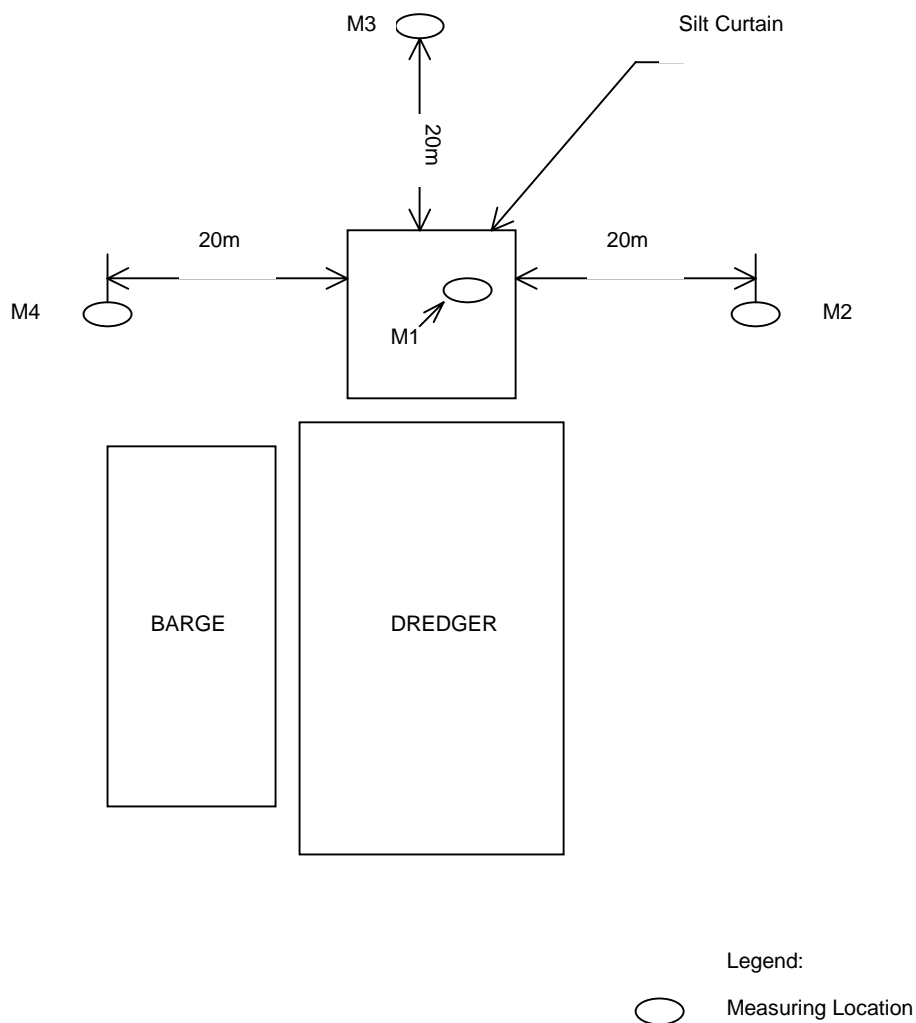
Figure 2.1 Plan for Seawater Measurement Location

- 2.1 Seawater quality was measured at four measurement locations, for which one of them is inside the silt curtain (M1) and the remaining three are outside the silt curtain (M2, M3 & M4) as given in Figure 2.1.

2.2 Measurements at Station M1 would give the water quality within the dredging area, while those at stations M2, M3 & M4, the water quality at the distance approximately 20 metres from the edge of the silt curtain. These three locations are situated outside the silt curtain.

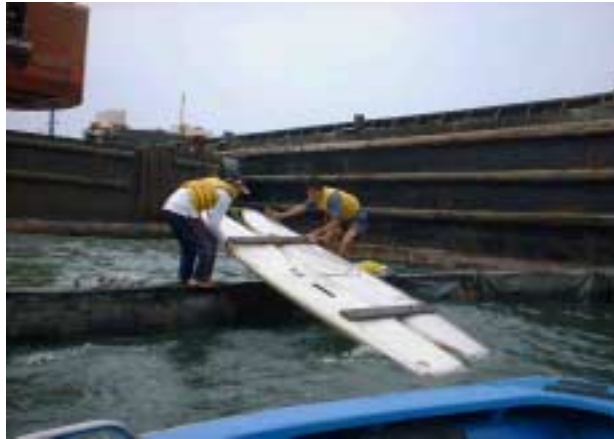
(a) maneuvering the wind-surfer boards over the silt curtain

- 2.9 For sampling at M1 (within the dredging area), it was originally proposed to install a platform on the top of the silt curtain to allow sampling personnel to gain access to the region enclosed by the silt curtain. However, such platform was not available, and after a few trials with other means, it was decided that to employ two wind-surfer boards ganged together. The surfer boards were carried in the usual sampling boat. When the boat arrived the silt curtain, the wind-surfer boards with two sampling personnel were lowered onto the sea. The sampling personnel then moved to the silt curtain with the wind-surfer boards, carried the boards over the silt curtain and continued to move to the M1 location to perform sampling. This was finally done on 18 April 2001, and is illustrated in Figure 2.1.

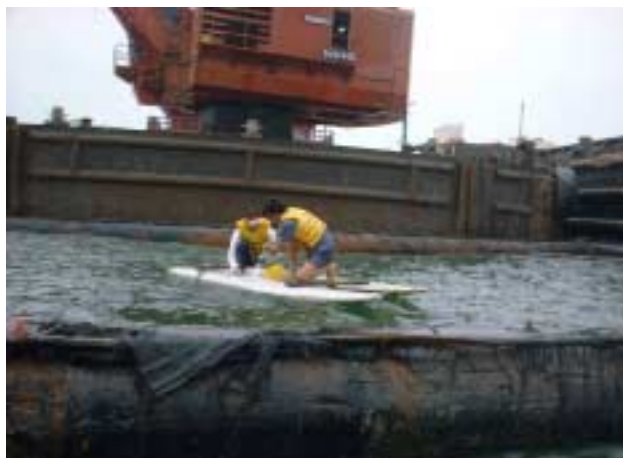
(b) Sampling personnel moved the wind-surfer boards to M1 position

Figure 2.1 Sampling at M1 using wind-surfer boards

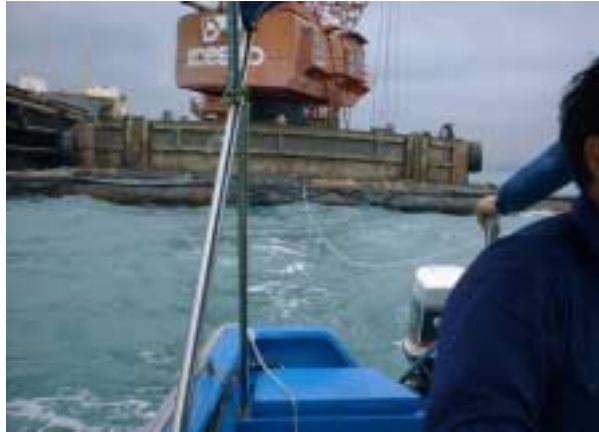
Figure 2.2 Hooking the rope to the edge of silt curtain

- 2.10 It is worth to mention that, as it was not practicable to take sample inside the silt curtain while dredging was in progress, dredging work was temporary halted for 15 minutes during sampling at M1.
- 2.11 For sampling at M2, M3 and M4 locations outside the dredging area, a 20-metre long rope with a hook was used to locate the sampling locations. This was done by hooking the rope to the edge of the silt curtain, and maneuvering the sampling boat away from the silt curtain until the rope was slightly tight. Figure 2.2 shows the above method in locating M2 to M4. The actual grid references of M2 to M4 for each measurement were recorded by the GPS and converted into Northing and Easting coordinates.

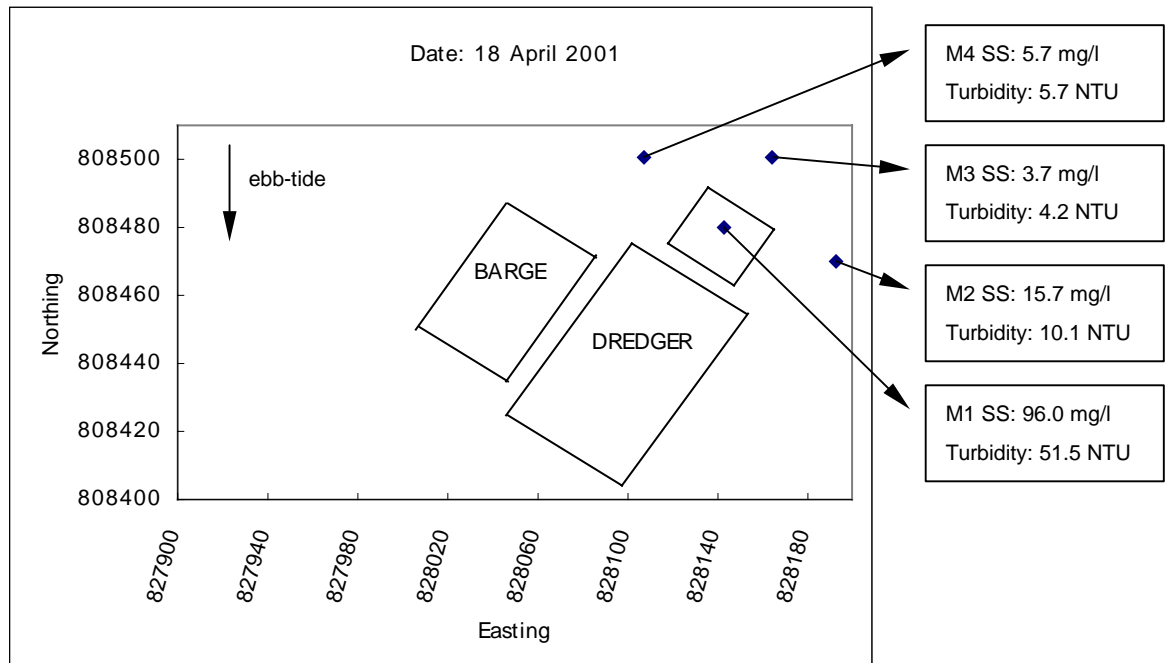
Figure 3.1 SS & Turbidity results at various locations

3.3 The averaged turbidity levels outside the silt curtain measured at M2 to M4 ranges from 4.2 to 10.1 NTU (10.1 NTU downstream at M2, 5.7 NTU upstream at M4 and 4.2 NTU along side at M3) while 51.5 NTU was recorded at M1. The corresponding SS concentrations measured at M2 to M4 ranges from 3.7 to 15.7 mg/l (15.7 mg/l downstream at M2, 5.7 mg/l upstream at M4 and 3.7 mg/l along side at M3) while 96.0 mg/l was recorded at M1. This is illustrated in Figure 3.1.

Remark: The sketch of silt curtain, barge and dredger is not-to-scale

3.4 Very high turbidity and SS levels were found inside the silt curtain compared to the sampling location outside the silt curtain on 18 April 2001 when sampling was made immediately after the completion of the dredging activities. The measurement results clearly demonstrate that the silt curtain was very effective in preventing silt from spreading during dredging. With the silt curtain around the dredger, pollution caused by the dredging process, mainly turbidity and SS, were localized inside the silt curtain, where the silt will settle. Neighbouring areas as close as 20 m away downstream, were not noticeably affected.
