**Expansion of Research and Residential Facilities for
The Swire Institute of Marine Science, Faculty of Science,
The University of Hong Kong at Cape d' Aguilar, Shek O, Hong Kong
Submission of Monthly Environmental Monitoring and Audit Report No.15**

MONTHLY ENVIRONMENTAL MONITORING AND AUDIT (EM&A) REPORT (NO. 15)

**Expansion of Research and Residential Facilities for the Swire Institute of
Marine Science, The University of Hong Kong at Cape D'Aguilar, Shek O**

Table 2-3: Site Observations

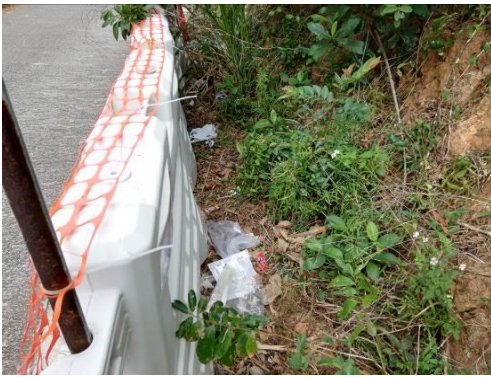
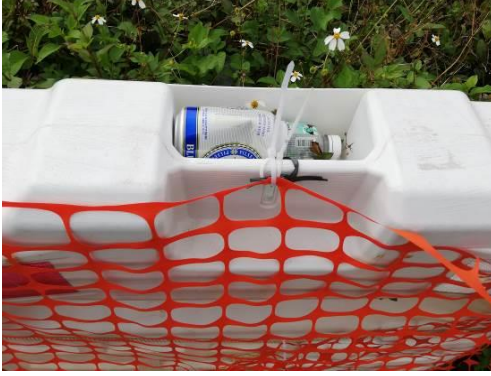
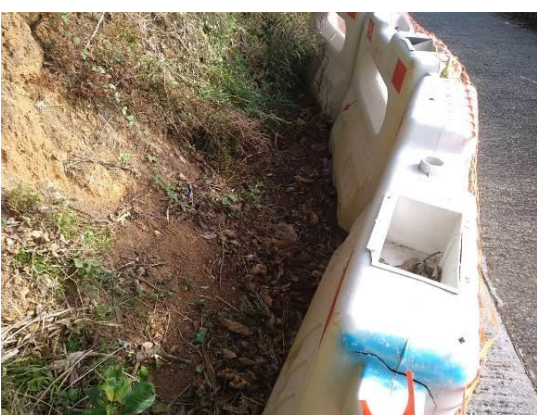
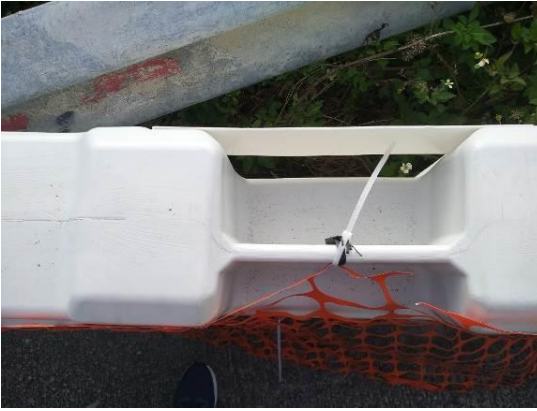
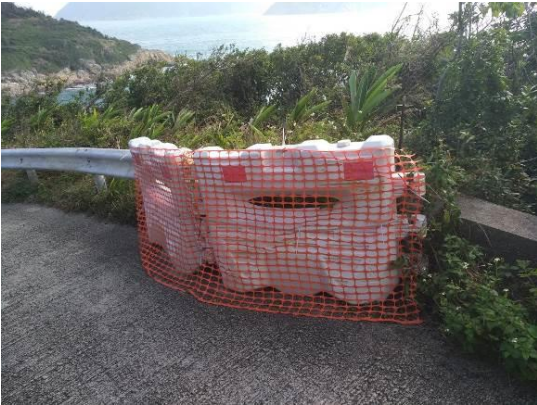
Date	Environmental Observations	Follow-up Status
21-Dec-2018	General waste was found in the protection zone	Rectified by HKU site contractor on 4 Jan 2019 General waste was removed from the protection zone
	<p data-bbox="392 524 539 551"><i>Millettia ovaria</i></p>

<p data-bbox="392 958 544 985"><i>Vitis Bryoniifolia</i></p>

<p data-bbox="919 524 1066 551"><i>Millettia ovaria</i></p>

<p data-bbox="919 1003 1070 1030"><i>Vitis Bryoniifolia</i></p>

- 2.4.3. HKU has rectified most of the observations identified during environmental site inspection in the reporting period.
- 2.4.4. Ecology and landscape and visual monitoring had been conducted on 27 December, 2018. As reported by Qualified Ecologist, observations and recommendation are summarised as below.

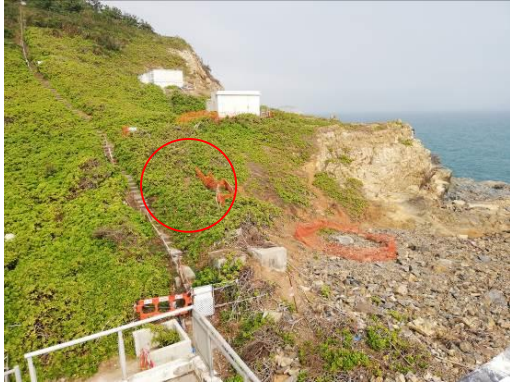
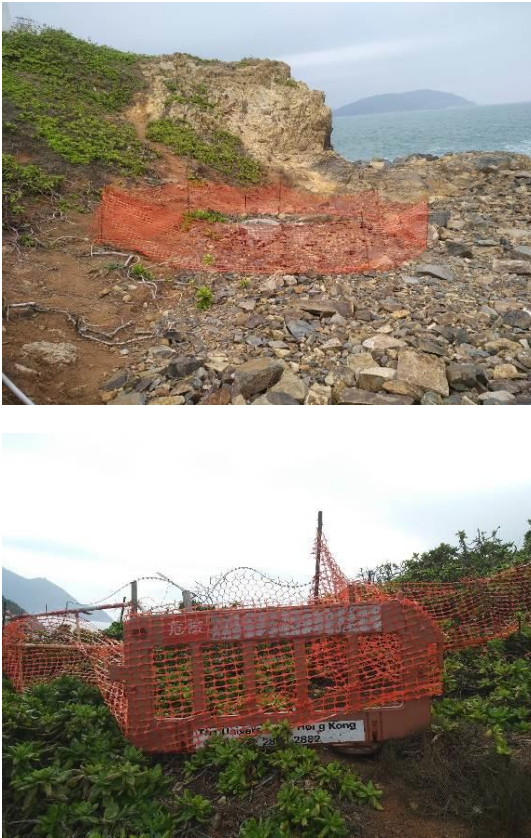
<p>21-Dec-2018</p>	<p>Orange barrier was broken and not erected at 1.0m height for the protection zone.</p>	<p>Rectified by HKU site contractor on 4 Jan 2019 Orange barrier was replaced and erected at 1.0m height for the protection zone.</p>
	<p><i>Lysimachia mauritiana</i></p>

<p><i>Lysimachia mauritiana</i></p>

- 2.4.5. Damages by the Typhoon Mangkhut remained, especially on *Lysimachia mauritiana*. (濱海珍珠菜) and the retained tree TA.
- 2.4.6. Coastal vegetation had been wholly destroyed and removed by the typhoon, including most *Lysimachia mauritiana* (濱海珍珠菜). Another young *Lysimachia mauritiana* (濱海珍珠菜) with living green leaves was discovered since the first one detected during last monitoring. Seed-bearing individual in poor condition without leaves still existed.

- 2.4.7. The coastal area where *Lysimachia mauritiana* (濱海珍珠菜) was growing should still be fenced off and free from any construction works and human disturbance. Next few monitoring would be important to confirm the re-establishment of this plant species of conservation importance from seed bank in the area. Building up additional assurance colonies of *Lysimachia mauritiana* (濱海珍珠菜) by collecting seeds may still be feasible.
