MONTHLY ENVIRONMENTAL MONITORING AND AUDIT (EM&A) REPORT (NO. 17)

**Expansion of Research and Residential Facilities for the Swire Institute of
Marine Science, The University of Hong Kong at Cape D'Aguilar, Shek O**

**MONTHLY ENVIRONMENTAL
MONITORING AND AUDIT
(EM&A) REPORT (NO.17) -**

**EXPANSION OF RESEARCH AND RESIDENTIAL
FACILITIES FOR THE SWIRE INSTITUTE OF
MARINE SCIENCE**

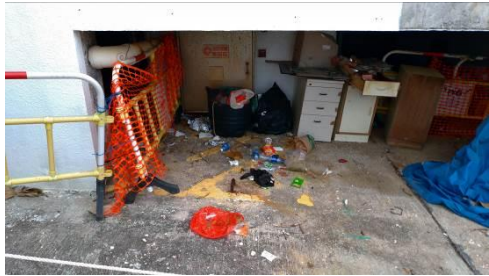
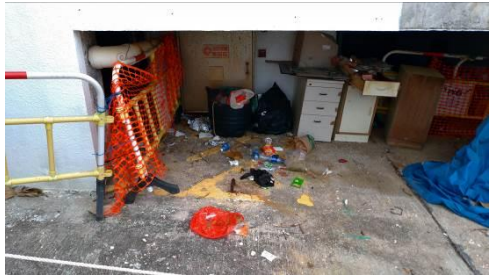
Date	Environmental Observations	Follow-up Status
26-Feb-2019	General refuse was found in the academic block and in the drums.	Rectified by HKU site contractor on 5 March 2019 General refuse was removed from the Academic Block and the drums.

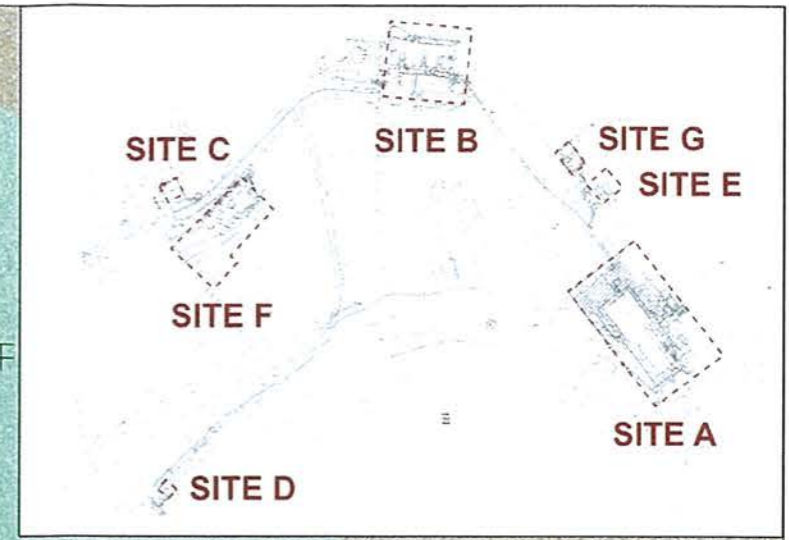
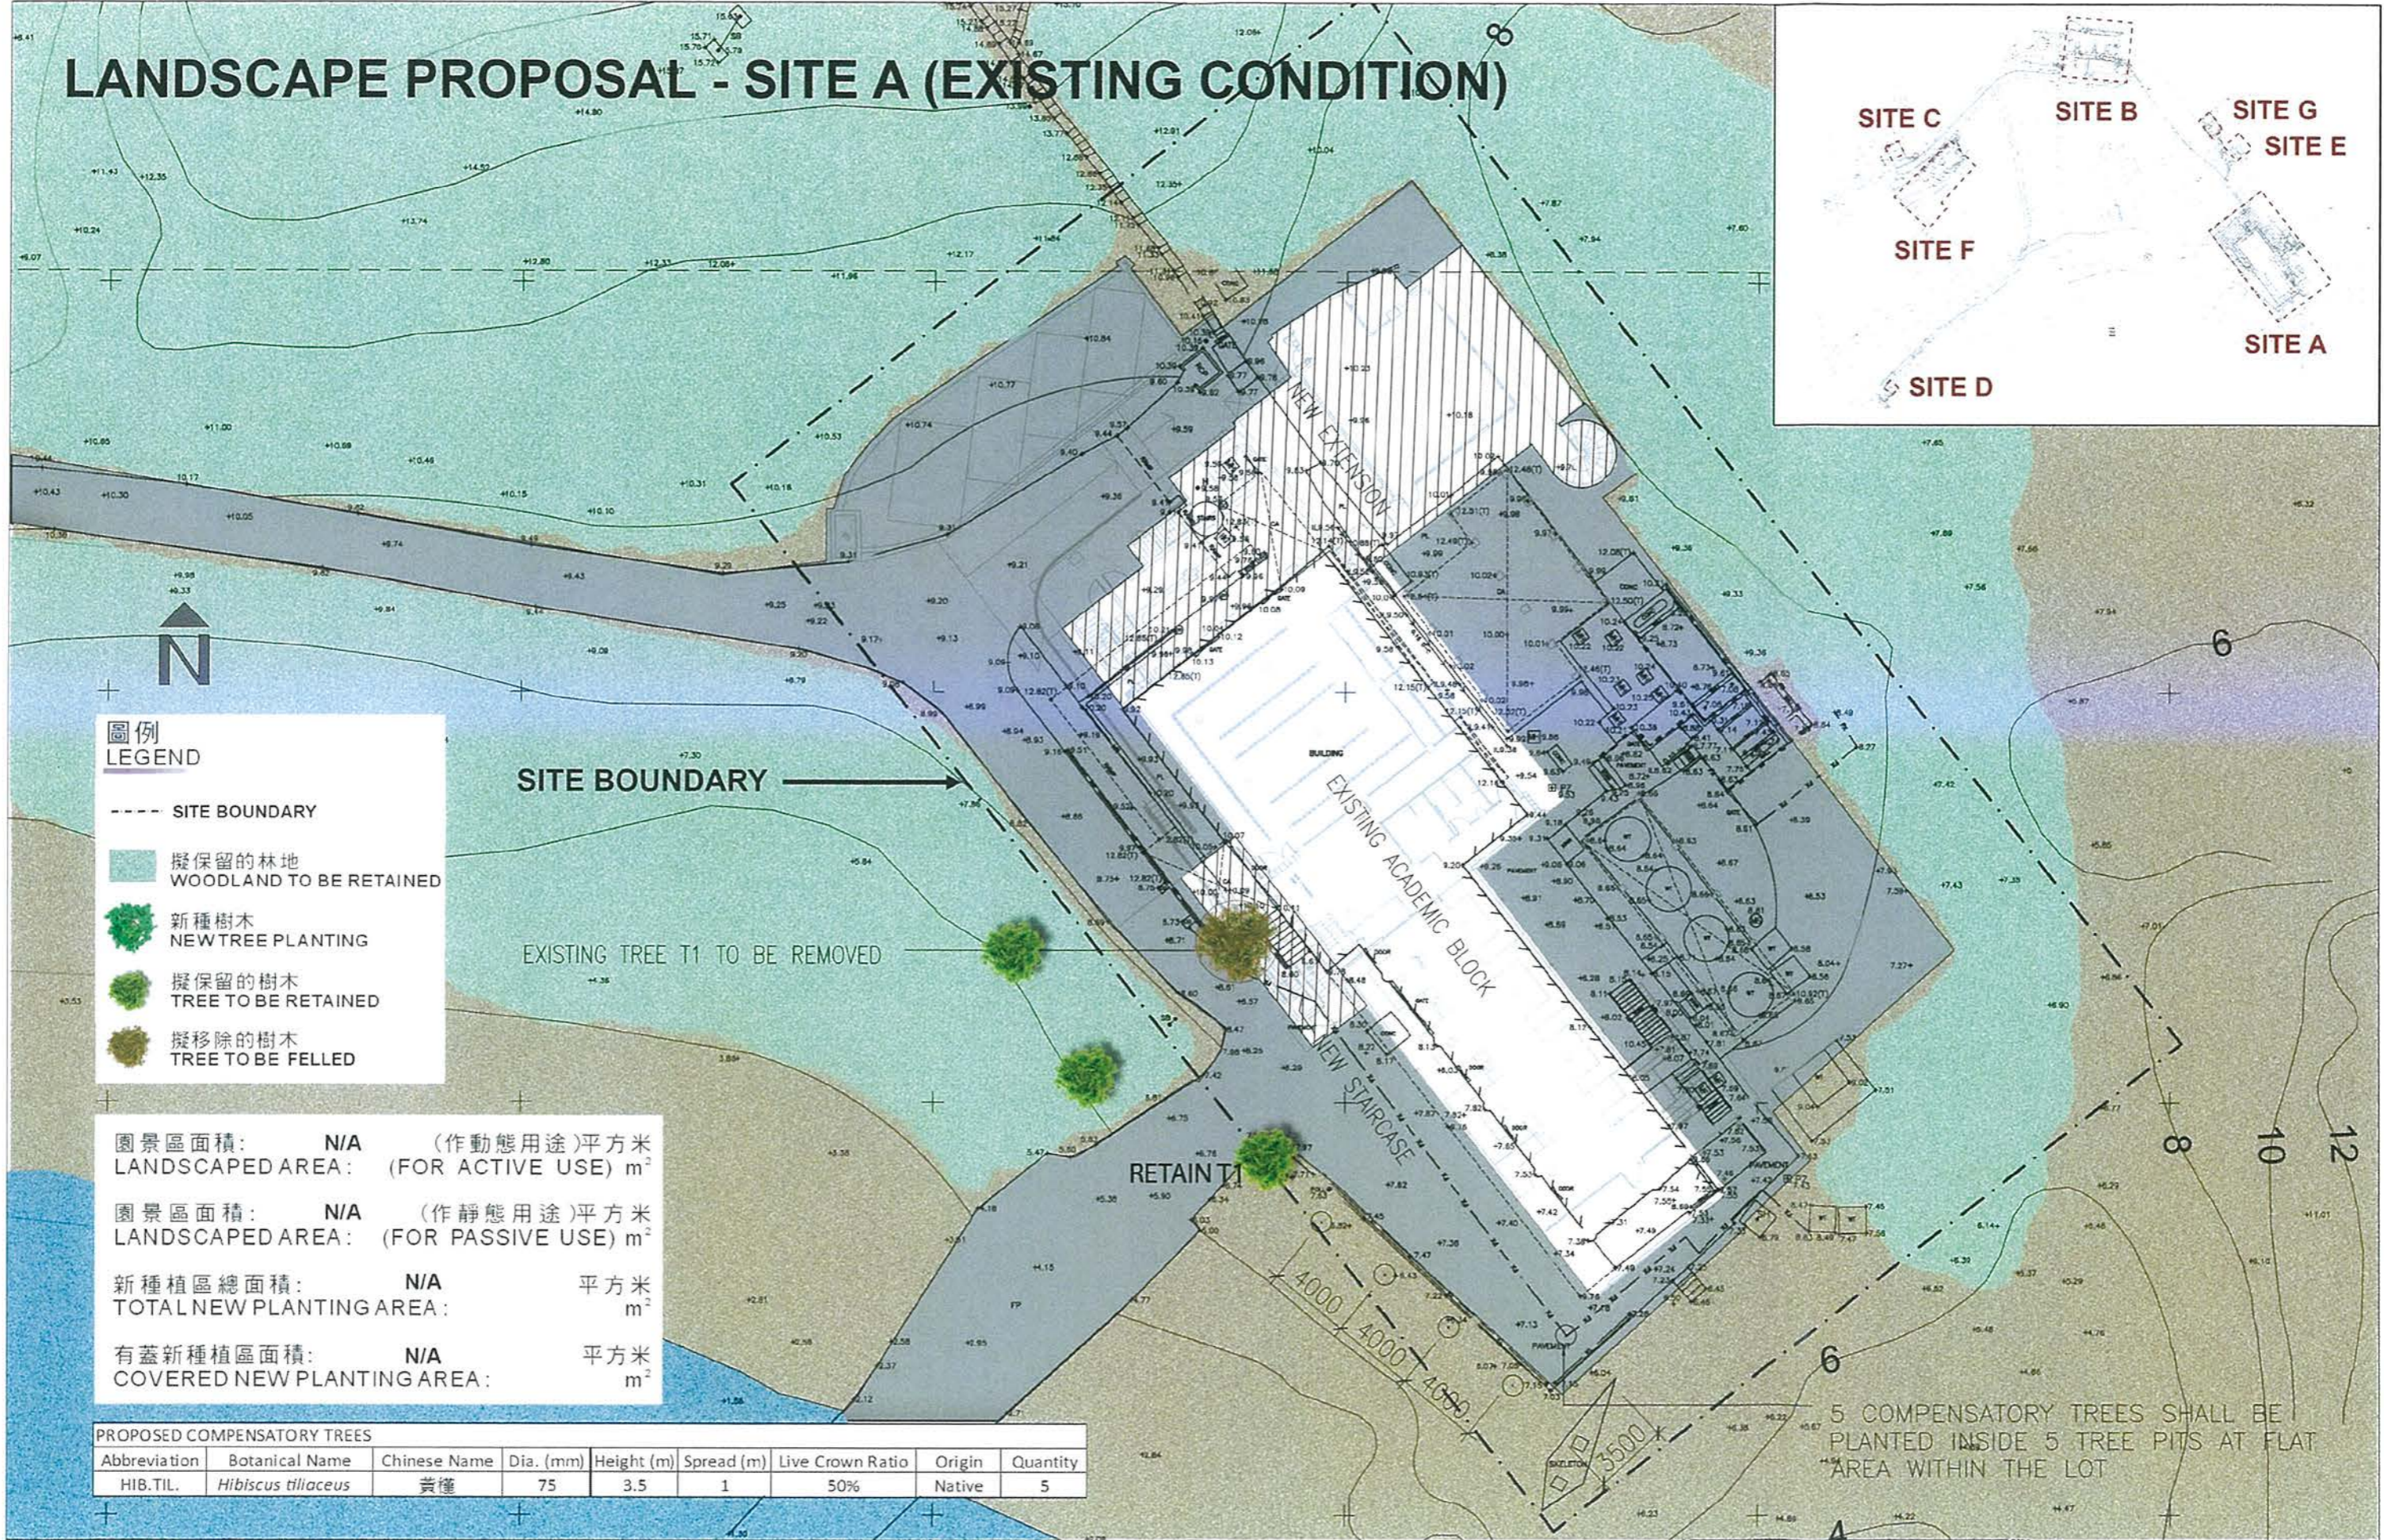
LANDSCAPE PROPOSAL - SITE A (EXISTING CONDITION)

5 COMPENSATORY TREES SHALL BE PLANTED INSIDE 5 TREE PITS AT FLAT AREA WITHIN THE LOT

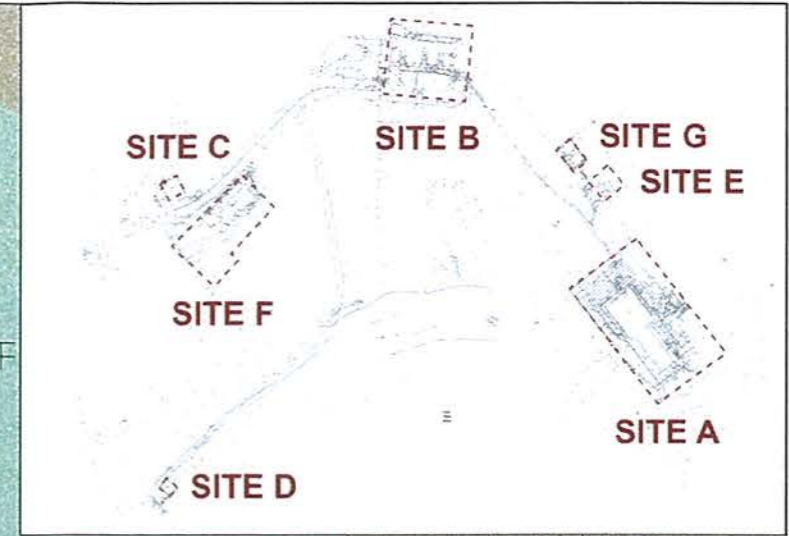
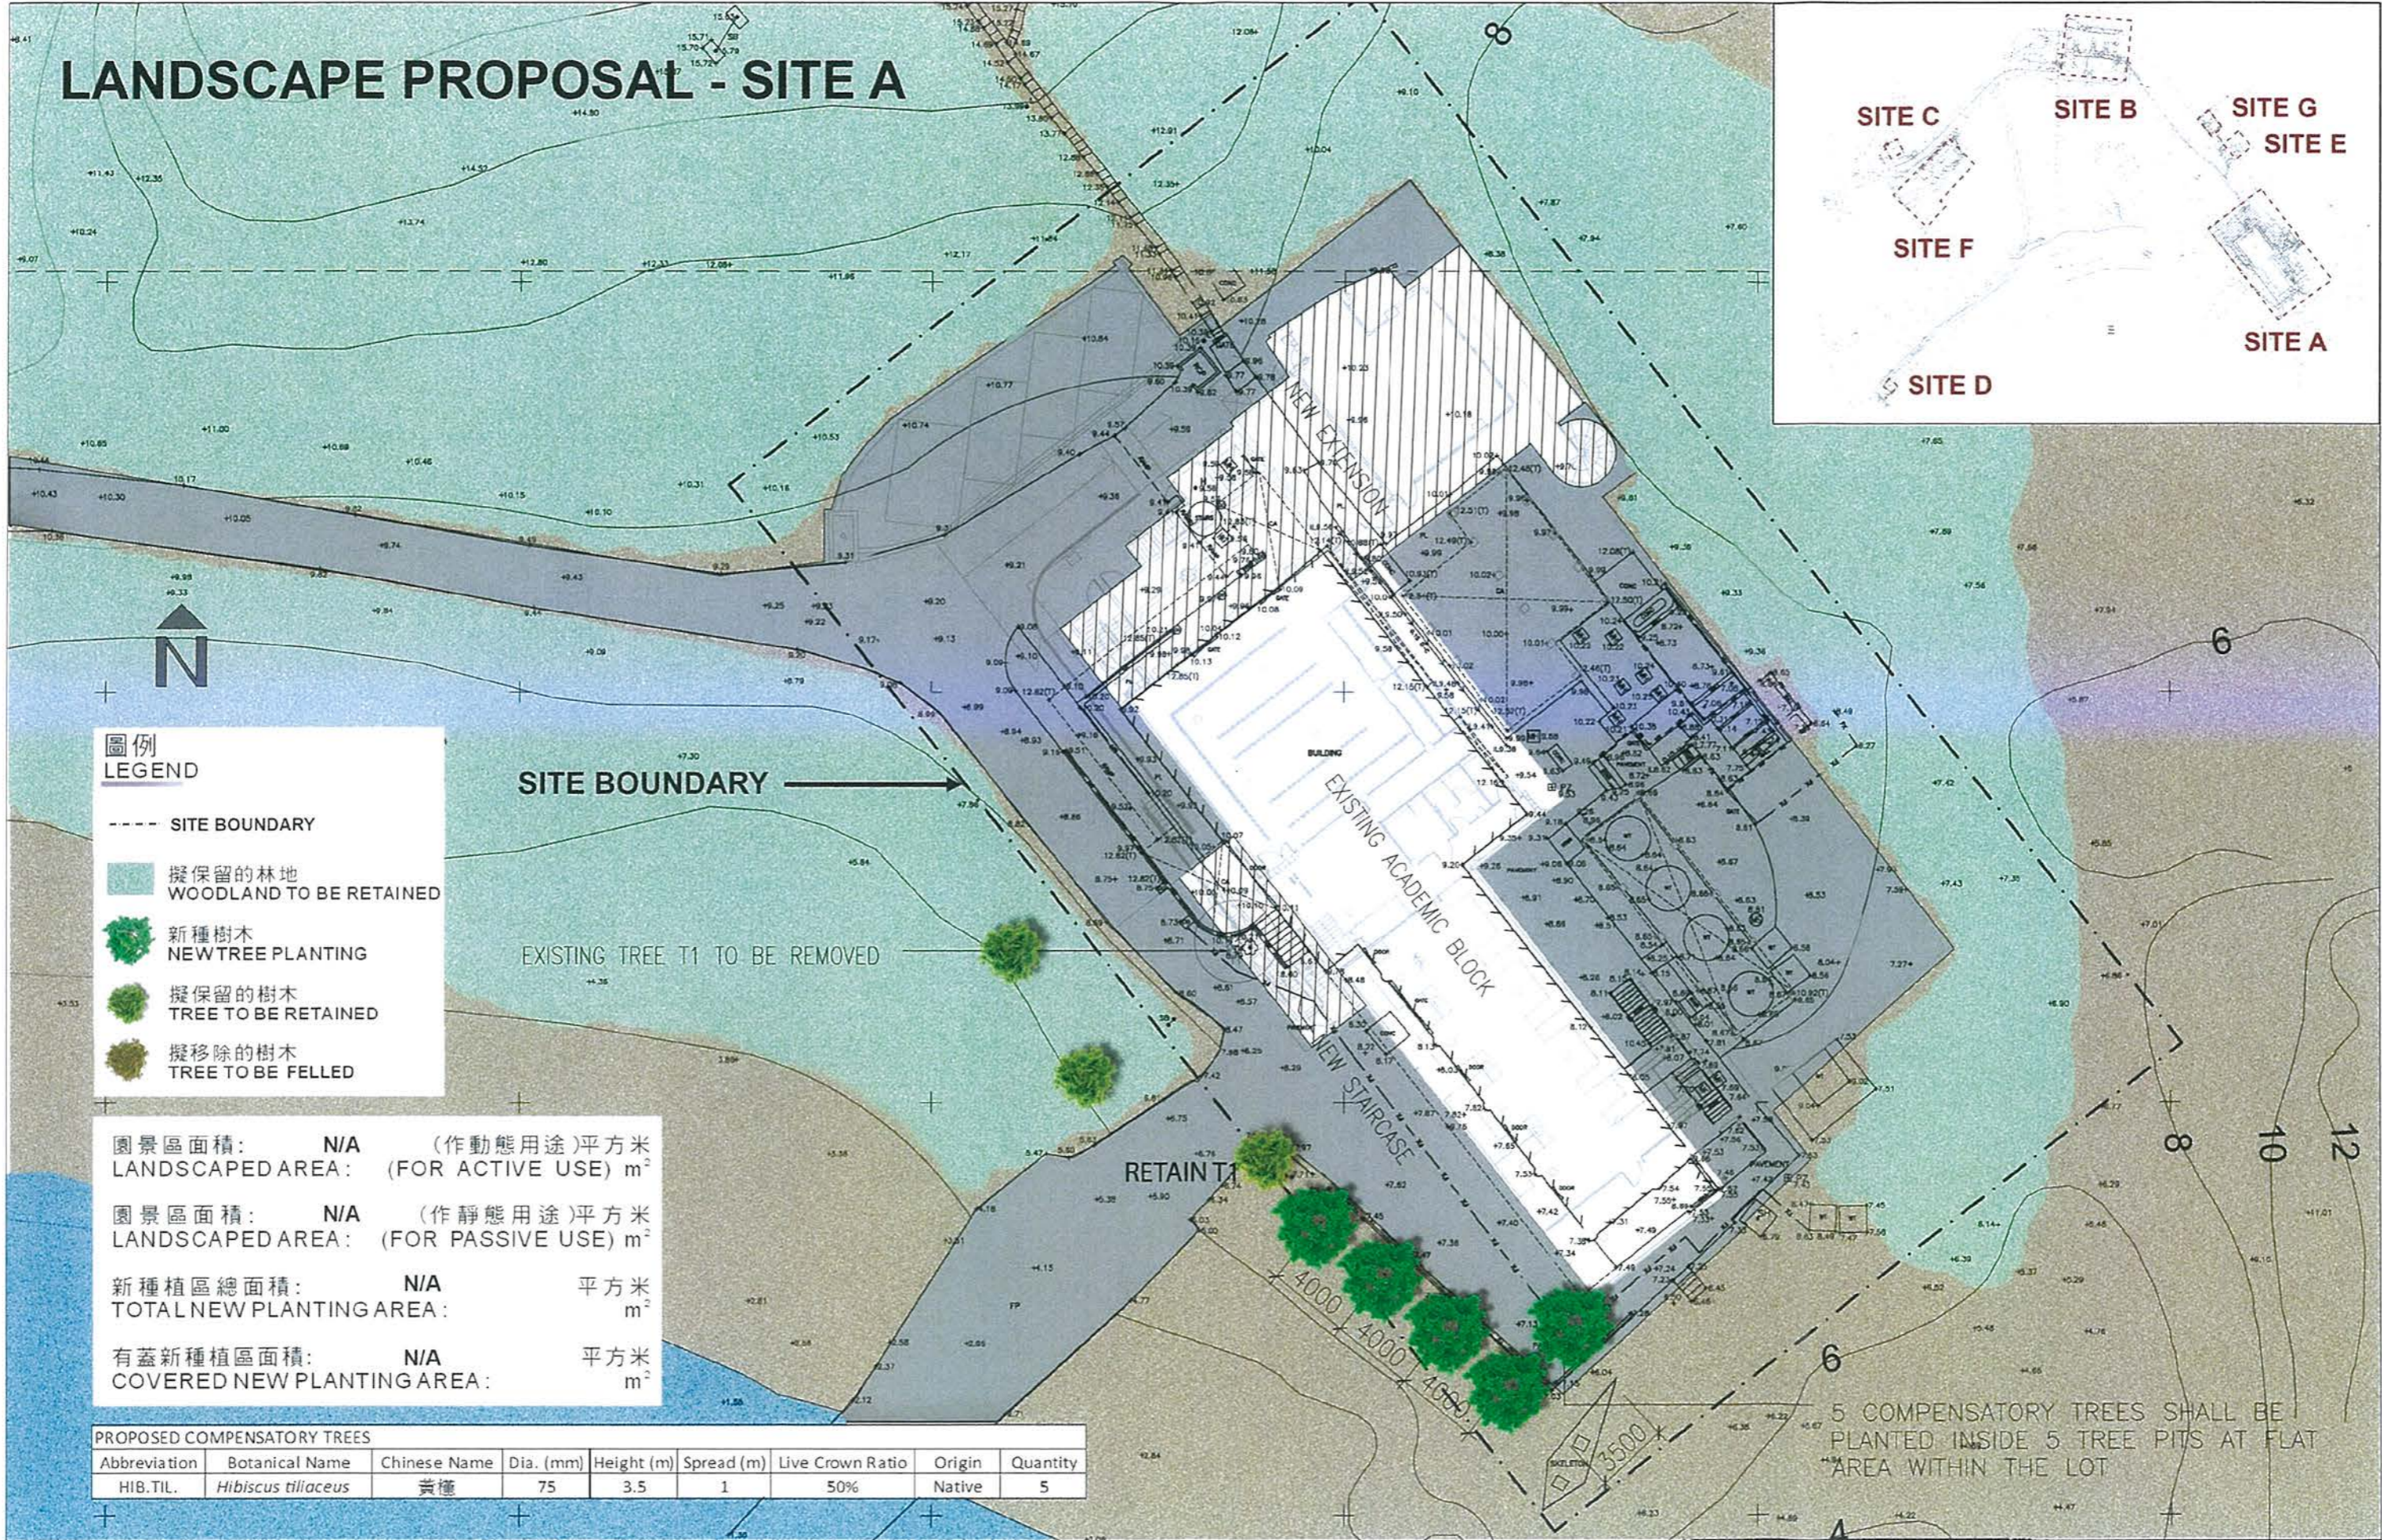
LANDSCAPE PROPOSAL - SITE A

5 COMPENSATORY TREES SHALL BE PLANTED INSIDE 5 TREE PITS AT FLAT AREA WITHIN THE LOT

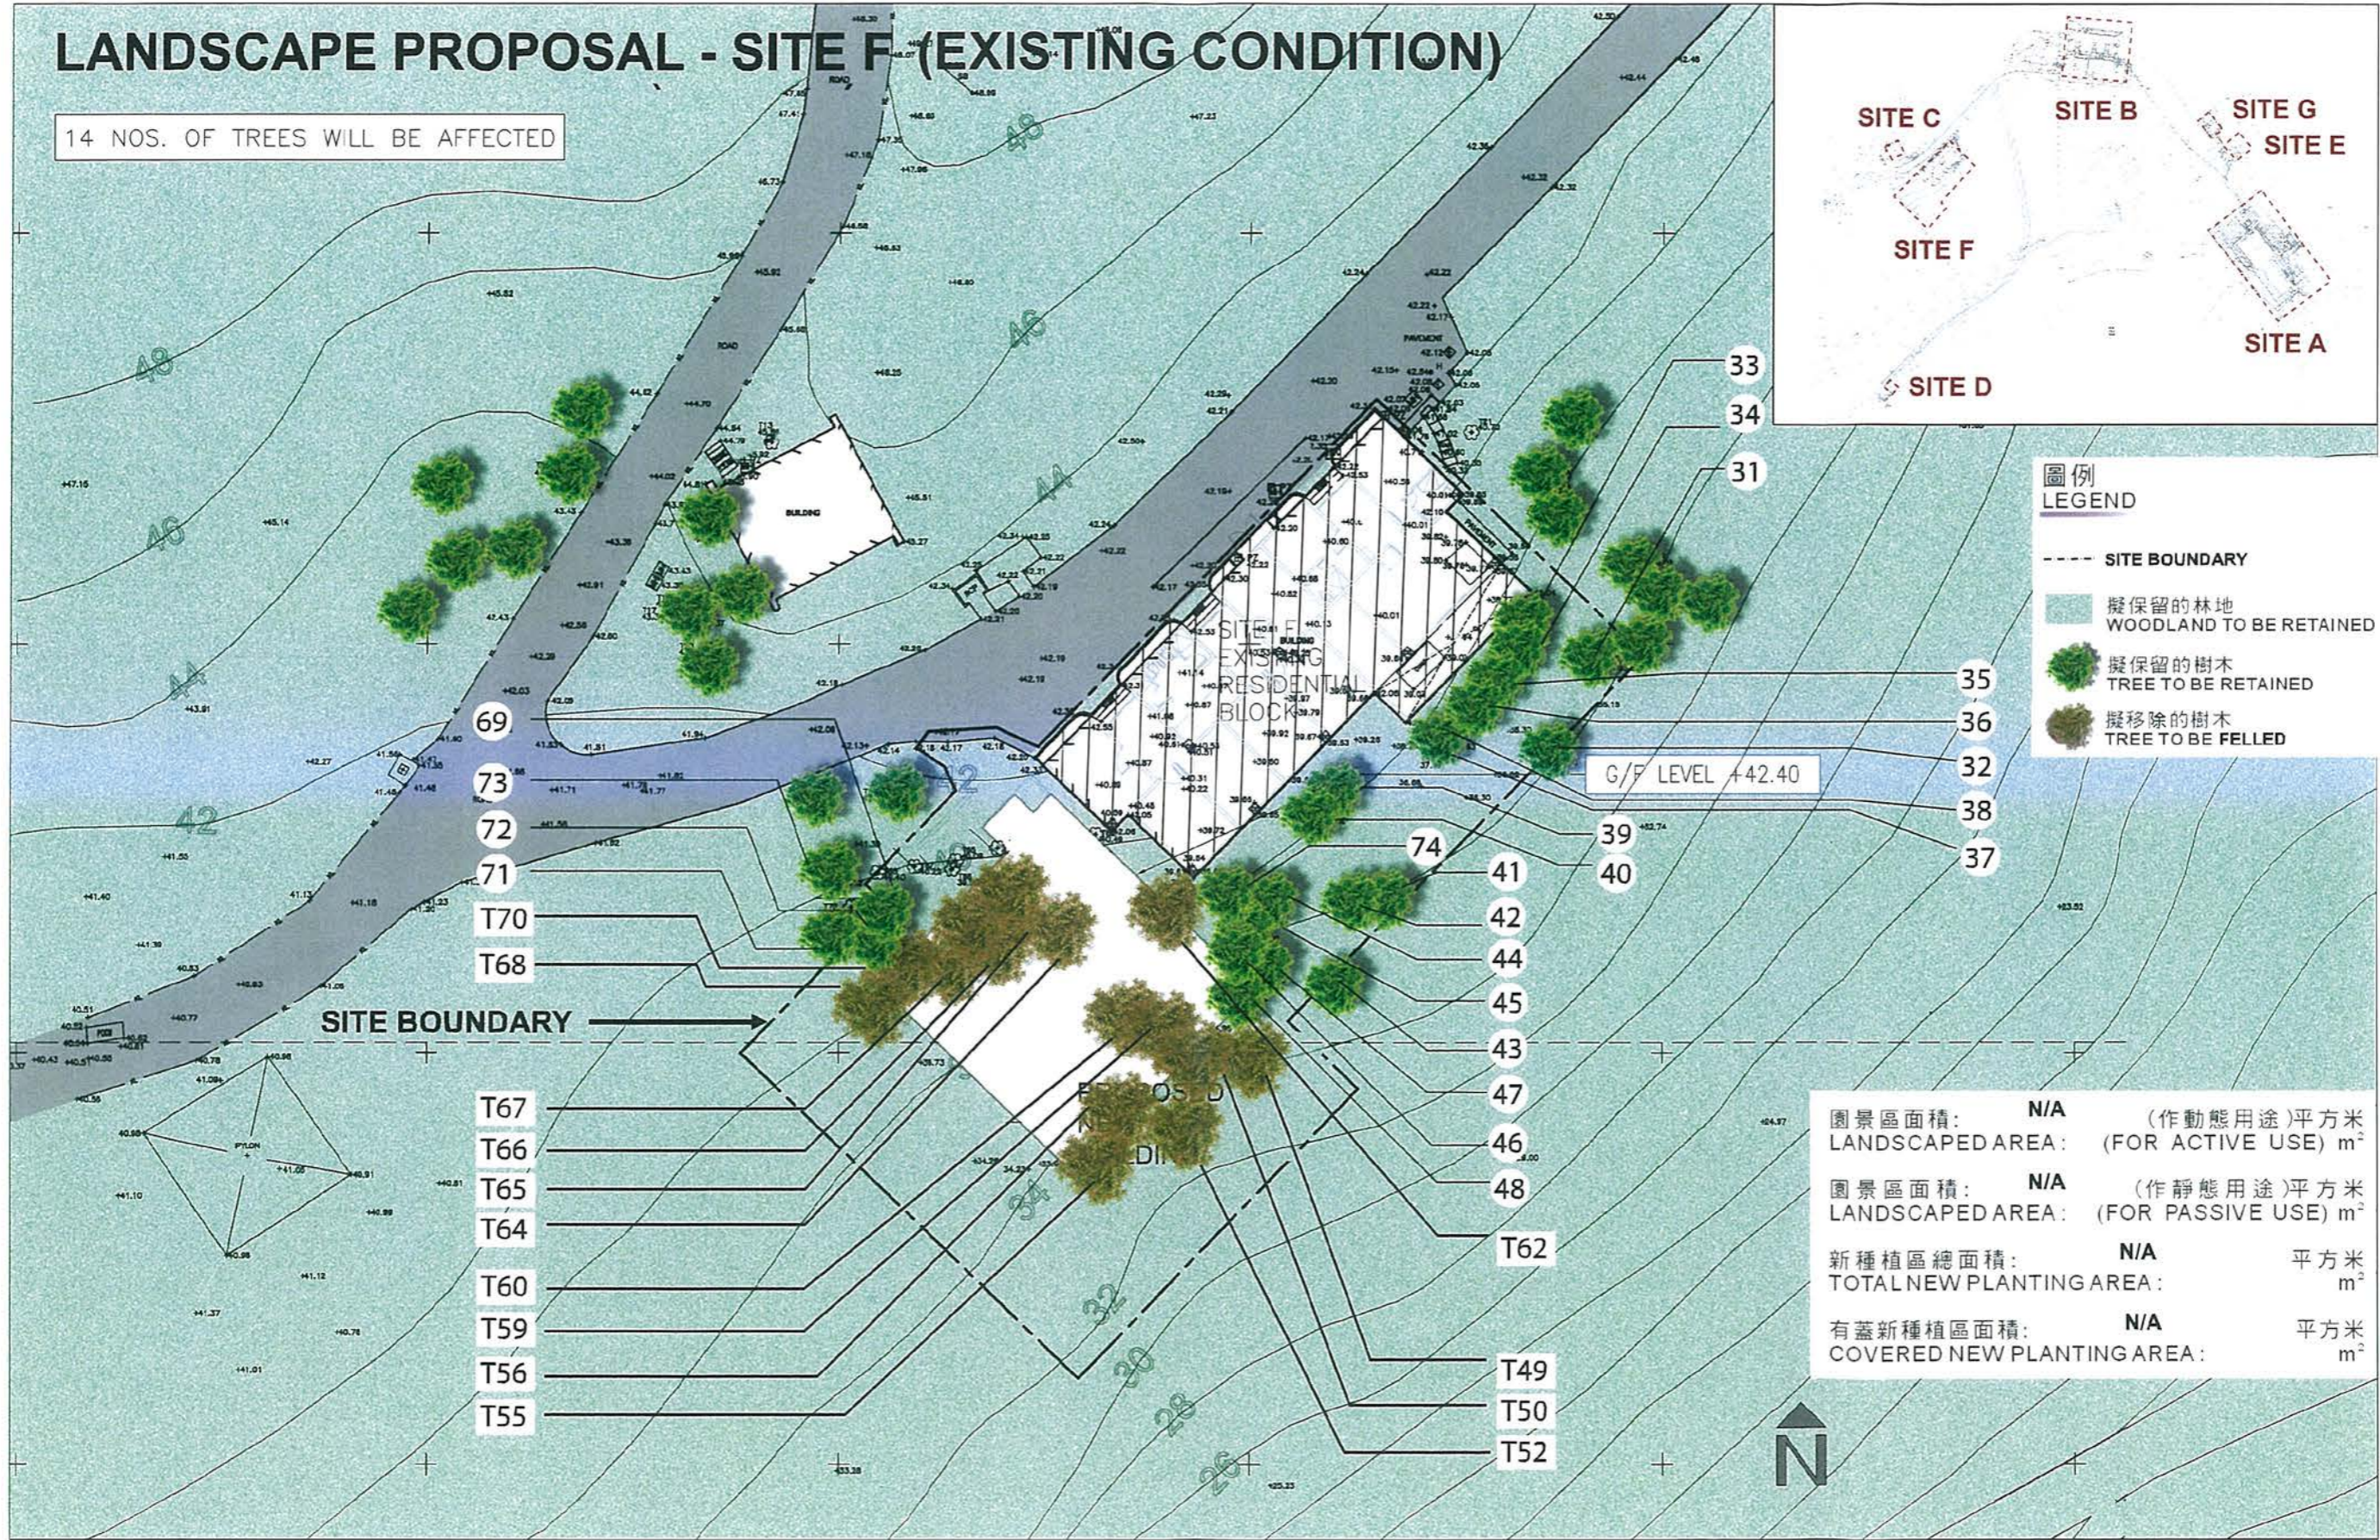
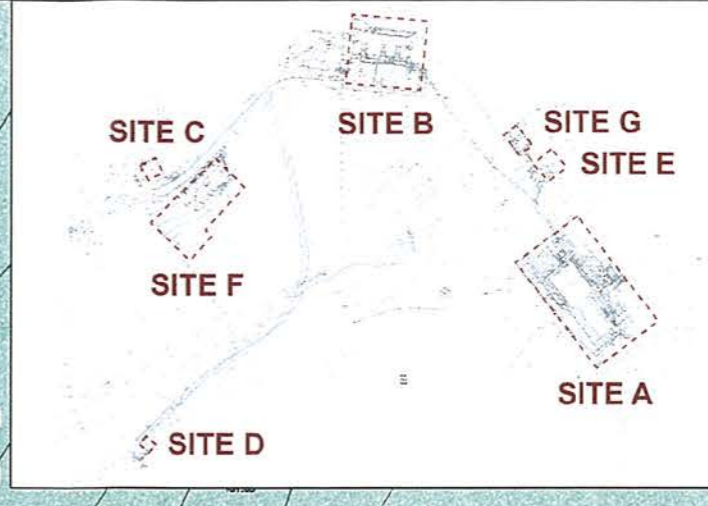
LANDSCAPE PROPOSAL - SITE F (EXISTING CONDITION)

14 NOS. OF TREES WILL BE AFFECTED
