**Expansion of Research and Residential Facilities for
The Swire Institute of Marine Science, Faculty of Science,
The University of Hong Kong at Cape d' Aguilar, Shek O, Hong Kong
Submission of Monthly Environmental Monitoring and Audit Report No.18**

MONTHLY ENVIRONMENTAL MONITORING AND AUDIT (EM&A) REPORT (NO. 18)

**Expansion of Research and Residential Facilities for the Swire Institute of
Marine Science, The University of Hong Kong at Cape D'Aguilar, Shek O**

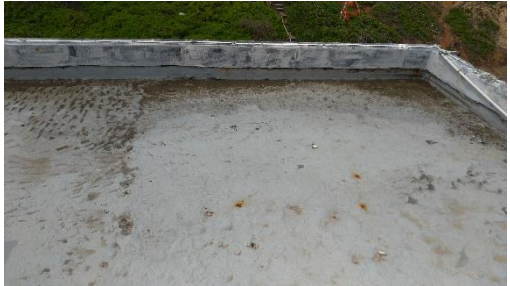
Date	Environmental Observations	Follow-up Status
28-Mar-2019	Site should be cleaned on a regular basis.	Rectified by HKU site contractor on 4 April 2019 General refuse was removed from the Academic Block and the drums.

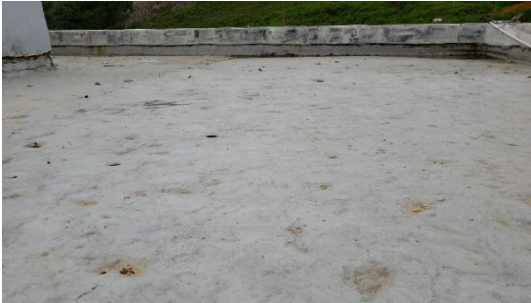
28-Mar-2019	Stagnant water was found on roof of the academic building.	Rectified by HKU site contractor on 4 April 2019 Dusty material was covered three-sided by tarpaulin sheet in the Academic Block.

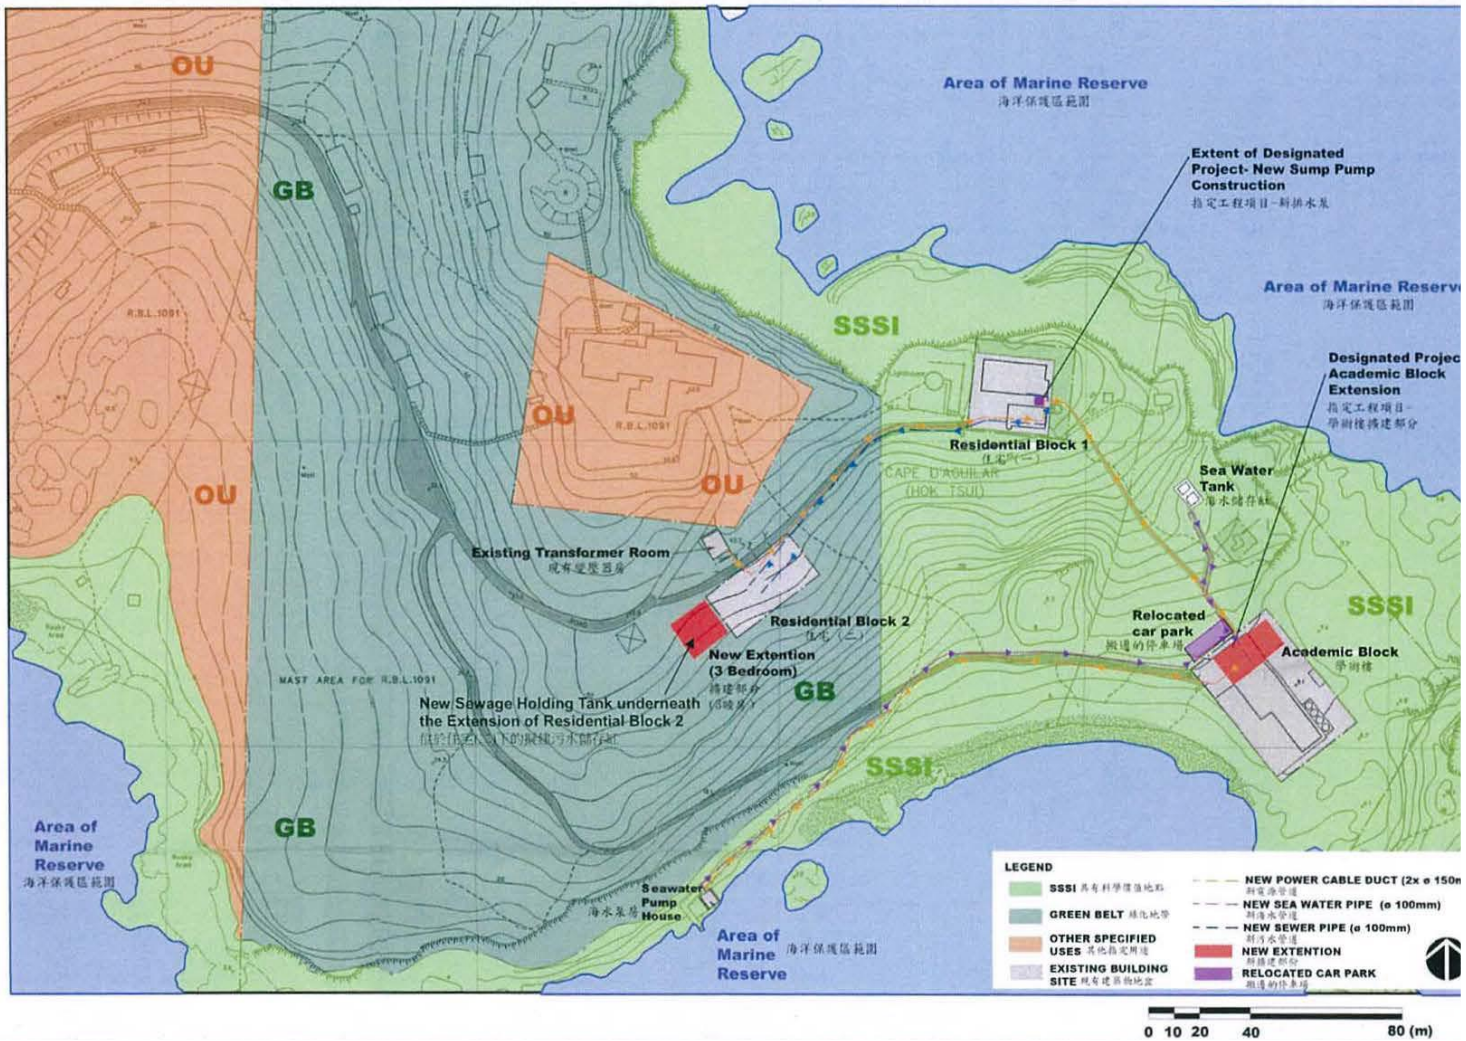
Appendix A: Location of Construction

- 1.4.1. The construction phase of the Contract commenced on 6 October 2017.
- 1.4.2. The contract was terminated on 9 February 2018, thus no construction activities was conducted in the reporting period.
- 1.4.3. The locations of the construction activities are shown in Appendix A.
