**Expansion of Research and Residential Facilities for
The Swire Institute of Marine Science, Faculty of Science,
The University of Hong Kong at Cape d' Aguilar, Shek O, Hong Kong
Submission of Monthly Environmental Monitoring and Audit Report No.20**

MONTHLY ENVIRONMENTAL MONITORING AND AUDIT (EM&A) REPORT (NO. 20)

**Expansion of Research and Residential Facilities for the Swire Institute of
Marine Science, The University of Hong Kong at Cape D'Aguilar, Shek O**

Table 2-3: Site Observations

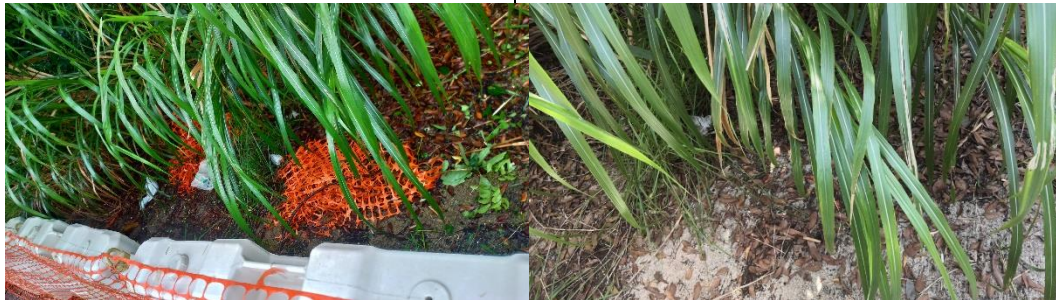
Date	Environmental Observations	Follow-up Status
31-May-2019	Waste was found in the protection zone.	Rectified by HKU site contractor on 10 June 2019 Waste was removed.
	<p data-bbox="389 477 539 504"><i>Millettia ovaria</i></p>

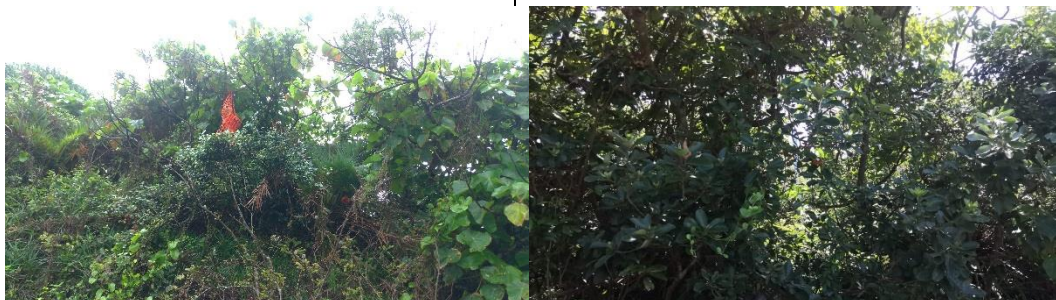
<p data-bbox="389 857 584 884"><i>Pittosporum tobiral</i></p>
