## **MONTHLY ENVIRONMENTAL MONITORING AND AUDIT (EM&A) REPORT (NO. 1)**

**Expansion of Research and Residential Facilities for the Swire Institute of  
Marine Science, The University of Hong Kong at Cape D'Aguilar, Shek O**

**EXPANSION OF RESEARCH AND RESIDENTIAL  
FACILITIES FOR THE SWIRE INSTITUTE OF  
MARINE SCIENCE**

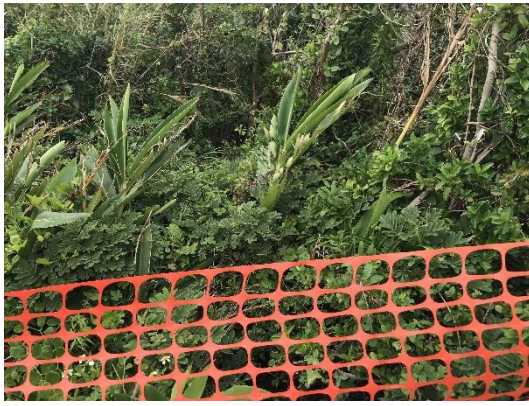
Date	Environmental Observations	Follow-up Status
19-Oct-2017	<p>The protection zone was not setback with at least 1.5m from the <i>Vitis bryoniifolia</i></p>

<p>Rectified by contractor on 20-Oct-2017                      Extra water barriers with orange net were added and the orange net was repaired for the protection zone of <i>Pittosporum tobira</i>.</p>  
19-Oct-2017	<p>Gas tank, plastic bottles were found in the protection zone of <i>Pavetta hongkongensis</i></p>

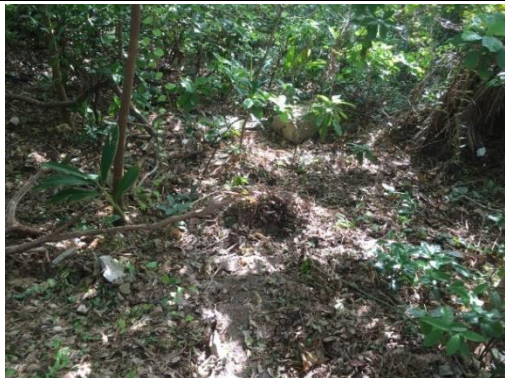
<p>Rectified by contractor on 20-Oct-2017                      Gas tank, plastic bottles and rubbish were removed.</p>

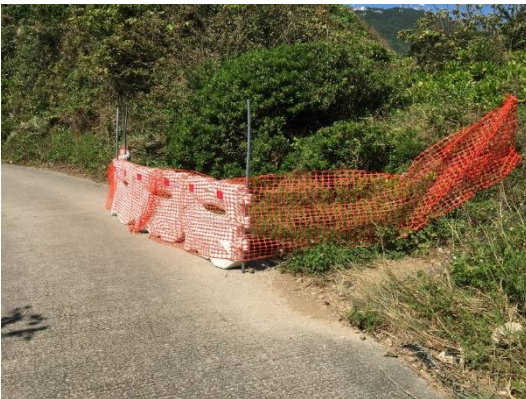
Date	Environmental Observations	Follow-up Status
	<p>The orange net was found not rigidly fixed for the protection zone of <i>Pittosporum tobira</i></p>	<p>Rectified by contractor on 20-Oct-2017                      Extra water barriers with orange net were added and the orange net was repaired for the protection zone of <i>Pittosporum tobira</i>.</p>
<p>19-Oct-2017</p>
