**Expansion of Research and Residential Facilities for  
The Swire Institute of Marine Science, Faculty of Science,  
The University of Hong Kong at Cape d' Aguilar, Shek O, Hong Kong  
Submission of Monthly Environmental Monitoring and Audit Report No.22**

## **MONTHLY ENVIRONMENTAL MONITORING AND AUDIT (EM&A) REPORT (NO. 22)**

**Expansion of Research and Residential Facilities for the Swire Institute of  
Marine Science, The University of Hong Kong at Cape D'Aguilar, Shek O**

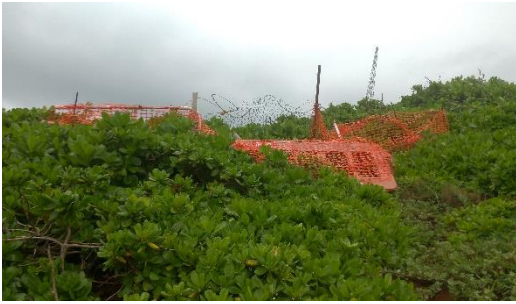
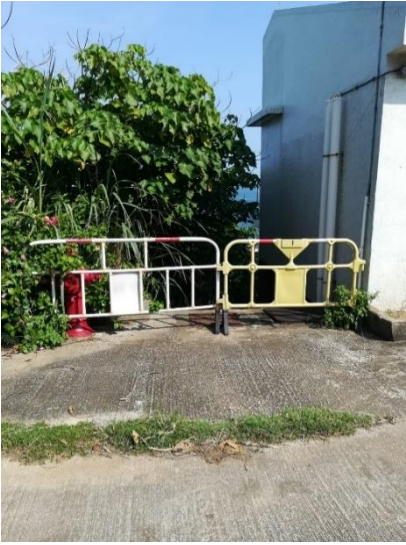
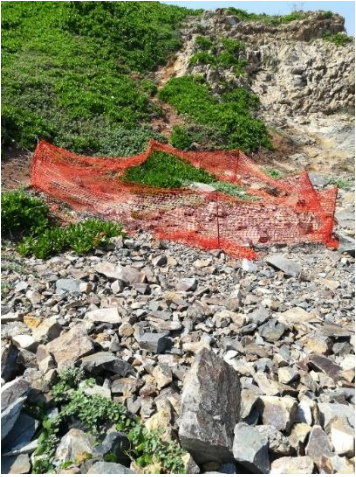
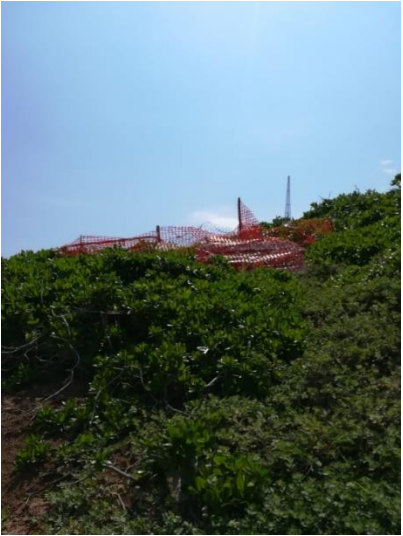
Date	Environmental Observations	Follow-up Status
2-Aug-2019	Orange nets were damaged.	Rectified by HKU site contractor on 6 Aug 2019 Orange nets replaced.
	<p><i>T5 and T6</i></p>  	 
	<p><i>Pittosporum tobiral</i></p>  	
	<p><i>Elaeagnus tutcheri</i></p>  	 
	<p><i>Lysimachia mauritiana</i></p>

2-Aug-2019	Water barrier was collapsed.	Rectified by HKU site contractor on 6 Aug 2019

Date	Environmental Observations	Follow-up Status
	 	<p>Stagnant water was cleaned up.</p>  
2-Aug-2019	<p>Sand bags were not placed along the site boundary.</p>    	<p>Rectified by HKU site contractor on 6 Aug 2019                  Sand bags replaced.</p>

- 2.4.3. HKU has rectified most of the observations identified during environmental site inspection in the reporting period.
- 2.4.4. Ecology and landscape and visual monitoring had been conducted on 3 August 2019. As reported by Qualified Ecologist, observations and recommendation are summarised as below.
