**Expansion of Research and Residential Facilities for  
The Swire Institute of Marine Science, Faculty of Science,  
The University of Hong Kong at Cape d' Aguilar, Shek O, Hong Kong  
Submission of Monthly Environmental Monitoring and Audit Report No.24**

## **MONTHLY ENVIRONMENTAL MONITORING AND AUDIT (EM&A) REPORT (NO. 24)**

**Expansion of Research and Residential Facilities for the Swire Institute of  
Marine Science, The University of Hong Kong at Cape D'Aguilar, Shek O**

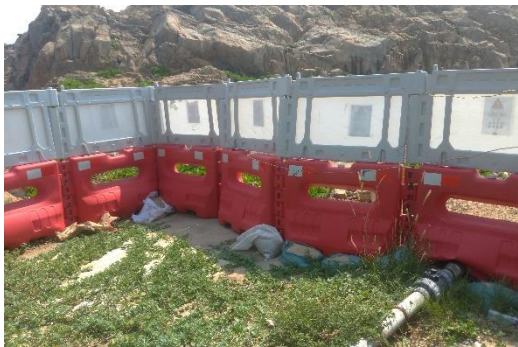
Date	Environmental Observations	Follow-up Status
27-Sep-2019	Damaged orange nets were observed.	Rectified by HKU site contractor on 9 Oct 2019 Damaged orange nets were replaced.
	<p>T5 and T6</p>  	 
	<p><i>Pittosporum tobiral</i></p>  	 
	<p>TA</p>  	 
27-Sep-2019	Damaged sand bags were observed in academic building.	Rectified by HKU site contractor on 9 Oct 2019 Damaged sand bags were replaced with new sand bags.

- 2.4.3. HKU has rectified most of the observations identified during environmental site inspection in the reporting period.
- 2.4.4. Ecology and landscape and visual monitoring had been conducted on 30 September 2019. As reported by Qualified Ecologist, observations and recommendation are summarised as below.
