**Expansion of Research and Residential Facilities for  
The Swire Institute of Marine Science, Faculty of Science,  
The University of Hong Kong at Cape d' Aguilar, Shek O, Hong Kong  
Submission of Monthly Environmental Monitoring and Audit Report No.36**

**MONTHLY ENVIRONMENTAL MONITORING AND AUDIT  
(EM&A) REPORT (NO. 36)**

**Expansion of Research and Residential Facilities for the Swire Institute of  
Marine Science, The University of Hong Kong at Cape D'Aguiar, Shek O**

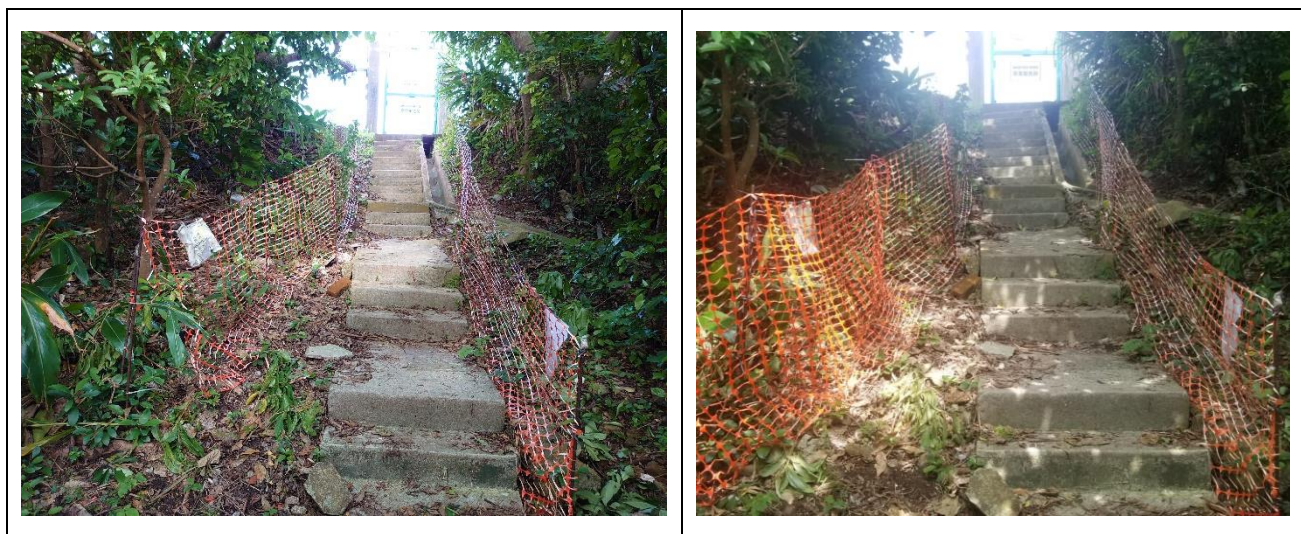
Table 2-3: Site Observations

| <b>Observation - Item 1</b> | |
|---|--|
| <i>At Location A, mud was overflowing into the drip tray and should be cleaned and treated as chemical waste.</i> | <i>At Location A, the mud is removed from the drip tray</i> |
| <i>The orange nets at the lighthouse and PCCW need to be maintained.</i> | <i>The orange nets at the lighthouse and PCCW are fixed / replaced by new net.</i> |

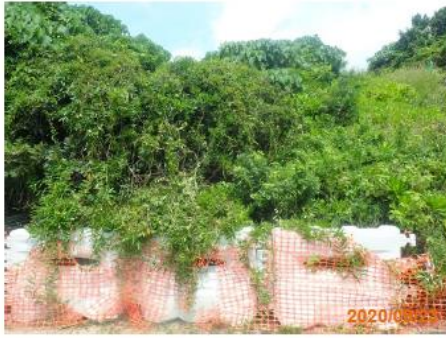
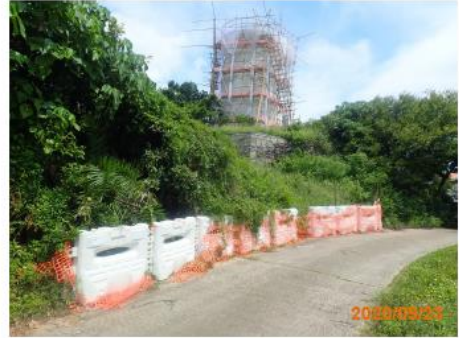
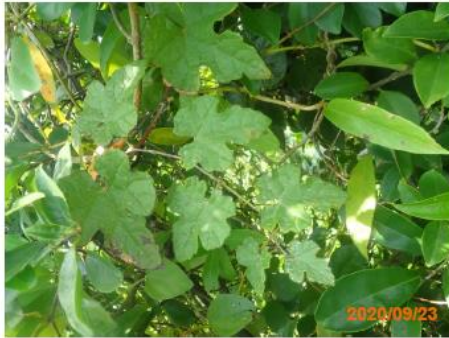
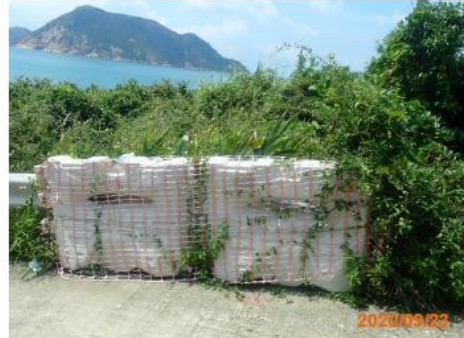
**Plate 1.** Photographic records of the six recorded plants species of conservation importance.

- 2.4.4. There is no change in form, health & structural condition and amenity value for all six recorded plant species of conservation importance.
- 2.4.5. Severe damage caused by Typhoon Mangkhut in September 2018 to the coastal vegetation remained. No *Lysimachia mauritiana* (濱海珍珠菜) could be observed in one of the protection zone near Academic Block (Site A) over 24 months. The original plants in this zone have certified as dead. The two rediscovered individuals kept growing in other protection zones, with some seedlings observed in vicinity (Plate 1).

- 2.4.6. *Pittosporum tobira* (海桐) has shown slight dieback of twigs, with regeneration of young leaves; while surrounding invasive species (*Leucaena leucocephala* and *Lantana camara*) still existed. Invasive species shall be cleared together with other overgrown climbers within in close vicinity of the protection zone

- 2.4.7. Another invasivespecies *Bidens alba* has also rapidly grown and covering the protection zone of *Elaeagnus tutcheri* (香港胡頹子). Invasive species shall be cleared together with other overgrown climbers within/in close vicinity of the protection zone. Leaves were not observed for this deciduous climber during this monitoring.

| <p><i>Elaeagnus tutcheri</i> 香港胡頹子</p> | <p>Overgrown weeds shall be cleaned</p> |

*Pittosporum tobira* 海桐; overgrown climbers shall be cleaned

*Vitis bryoniifolia* 蔓莢

- 4.1.11. To avoid/ reduce potential negative impacts to local native plant community and survival of plant species of conservation important, exotic and highly invasive tree *Leucaena leucocephala* (銀合歡), shrub *Lantana camara* (馬櫻丹), herb *Bidens alba* (白花鬼針草) and climber *Mikania micrantha* (薇甘菊) should be cleared and removed in whole, including the roots, whenever encountered throughout the construction phase, and packed properly before disposed as waste to prevent regrowth and dispersal of pollens and seeds. Invasive species and other overgrown climbers were observed within the protection zone of *Pittosporum tobira* (海桐) and *Vitis bryoniifolia* (蔓莢).

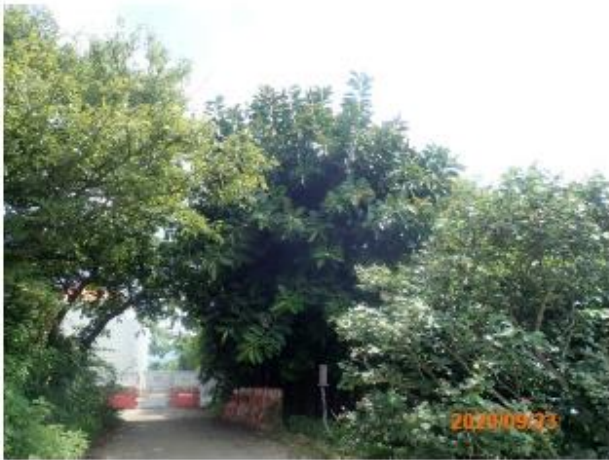
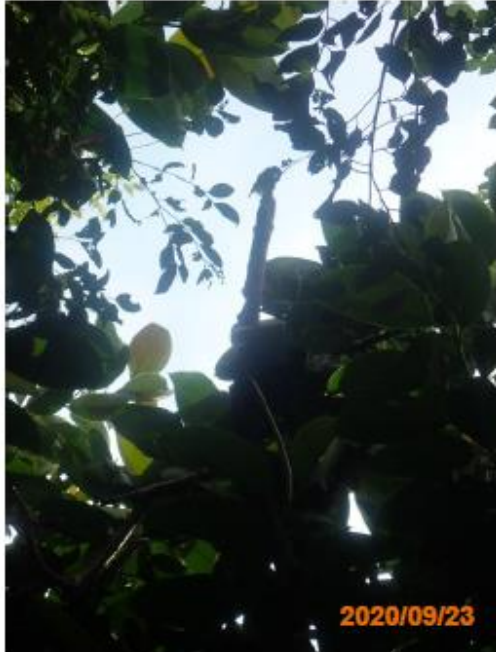
Plate 2: Photographic updates of the three retained trees that close to construction activities .

- 2.4.8. For the three retained trees, there is no change in overall condition of T5; while regeneration of new foliage made tree health of T6, as well as tree form of TA to be assessed from poor to fair. Broken branches in TA due to the typhoon damage should receive appropriate assessment and treatment. Corresponding photographic records of T5, T6 and TA are illustrated in **Plate 2**.

| <p>No change in condition of T5 from previous monitoring.</p> | <p>No change in condition of T6 from previous monitoring.</p> |
| <p>No change in condition of TA from previous monitoring.</p> | <p>Decaying branch hanger on TA.</p> |

- 4.1.8. Broken branches in the retained tree TA due to the typhoon damage remained. Relevant authority shall be contacted for appointing a Certified Arborist or equivalent to conduct a Tree Risk Assessment (TRA) on this tree in order to get Lands Department's approval on taking corresponding actions (e.g. pruning). Once the TRA appointment is confirmed, good written

and photographic records (e.g. personal, date and time, actions, etc.) should be made before, during and after any actions of treatment for the assessed tree (i.e. TA)
