MONTHLY ENVIRONMENTAL MONITORING AND AUDIT (EM&A) REPORT (NO. 4)

**Expansion of Research and Residential Facilities for the Swire Institute of
Marine Science, The University of Hong Kong at Cape D'Aguiar, Shek O**

**MONTHLY ENVIRONMENTAL
MONITORING AND AUDIT
(EM&A) REPORT (NO.4) -**

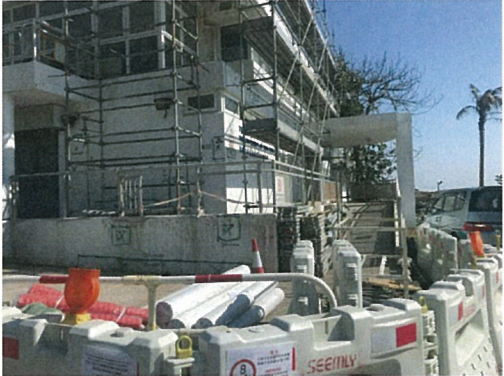
| Date | Environmental Observations | Follow-up Status |
|---|---|---|
| 18-Jan-2018 | Gap between noise curtain was spotted, which it might affect the noise reduction | Rectified by contractor on 20-Jan-2018 Ties were installed between the noise curtains to link up the curtains. |

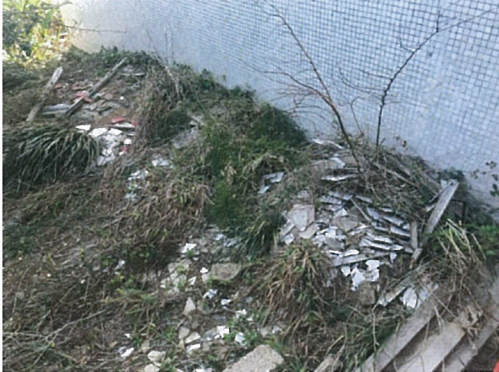
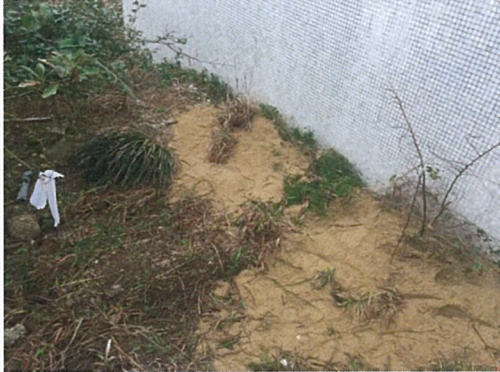
| Date | Environmental Observations | Follow-up Status |
|---|---|---|
| 18-Jan-2018 | Waste was found inside the orange net in Site C | Rectified by contractor on 20-Jan-2018 Waste was removed. |

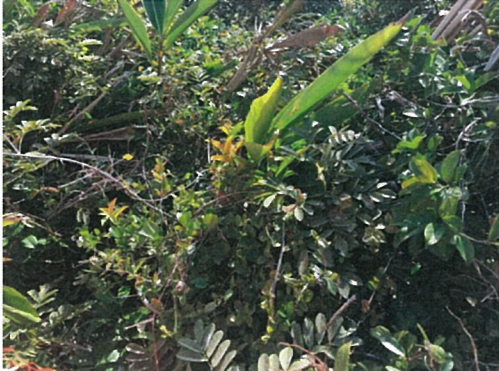
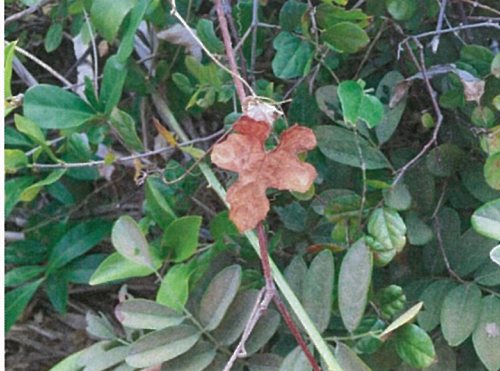
| Date | Environmental Observations | Follow-up Status |
|---|---|---|
| 18-Jan-2018 | Dried <i>Vitis bryoniifolia</i> was found | Rectified by Contractor on 22 January 2018 Inspection was carried out with Qualified Ecologist on 22-Jan-2018. Dried leaf of <i>Vitis bryoniifolia</i> was found and no green leaf was observed. |

- 4.1.3. During the joint site inspection, *Vitis bryoniifolia* was found dried. The condition of *Vitis bryoniifolia* is being concerned and contractor is reminded to inspect the condition more frequent.
