**Expansion of Research and Residential Facilities for
The Swire Institute of Marine Science, Faculty of Science,
The University of Hong Kong at Cape d' Aguilar, Shek O, Hong Kong
Submission of Monthly Environmental Monitoring and Audit Report No.41**

**MONTHLY ENVIRONMENTAL MONITORING AND AUDIT
(EM&A) REPORT (NO. 41)**

**Expansion of Research and Residential Facilities for the Swire Institute of
Marine Science, The University of Hong Kong at Cape D'Aguiar, Shek O**

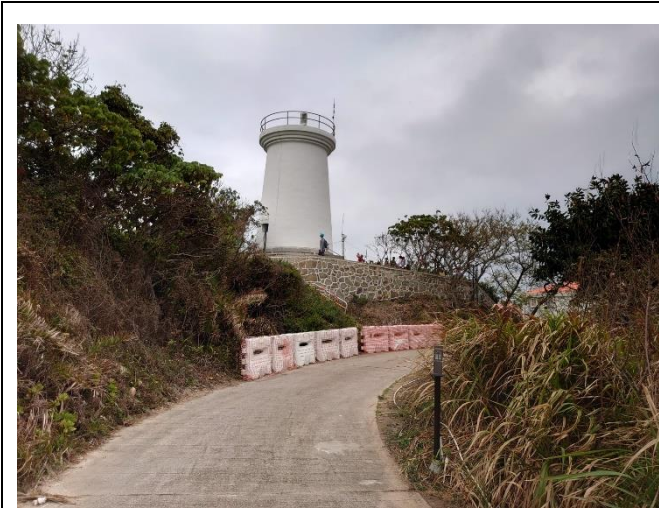
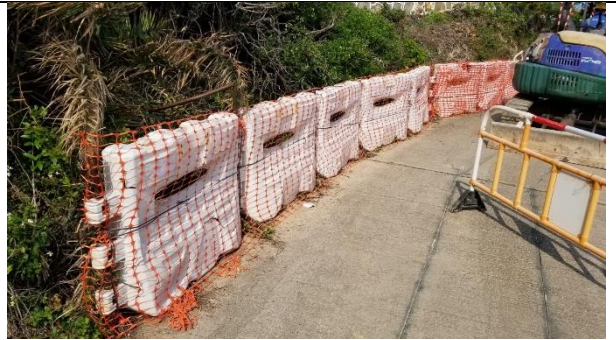
Observation - Item 1	
Observed 24 February 2021	Rectified by the Contractor on 08 March 2021
<i>At Site F, retaining trees should be well protected.</i>	<i>Retaining trees are fenced off with orange nets.</i>

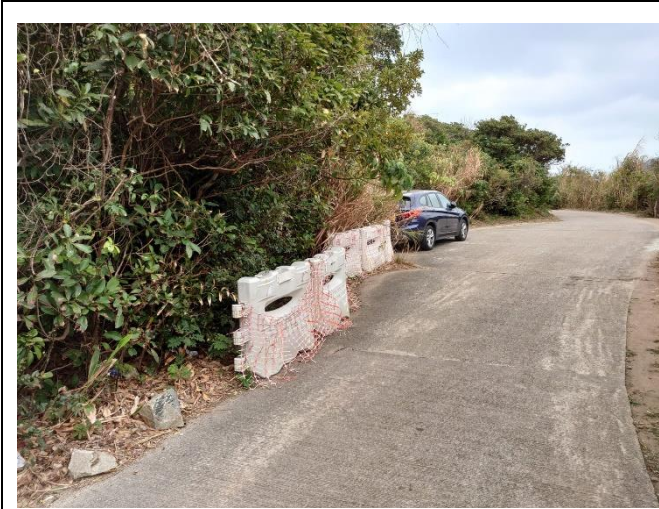
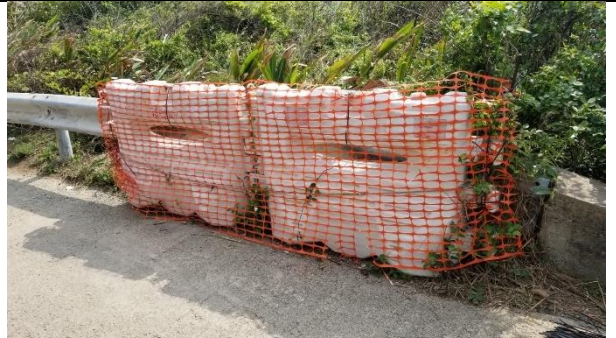
Observation - Item 3	
Observed 24 February 2021	Rectified by the Contractor on
<i>At Site B and Site G, orange nets should be enhanced and housekeeping standard should be raised.</i>	<i>Orange net is replaced and garbage is cleared.</i>

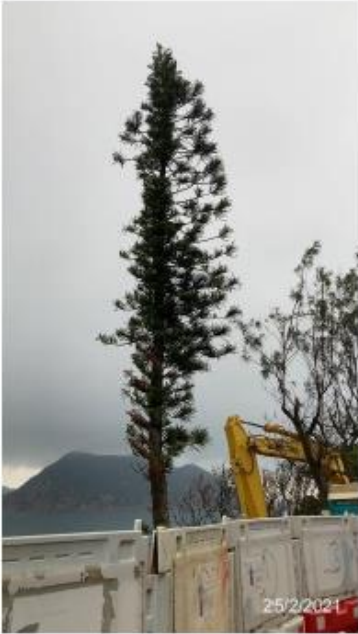
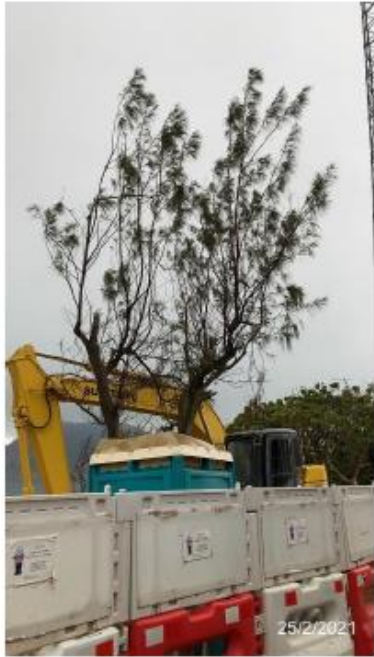
Plate 2: Photographic updates of the three retained trees that close to construction activities .

- 2.4.8. Young leaves of the deciduous *Vitis bryoniifolia* (蔓蘗) has emerged.
- 2.4.9. For the three retained trees, there is no change in overall condition of T5; while regeneration of new foliage made tree health of T6, as well as tree form of TA to be assessed from poor to fair. Broken branches in TA due to the typhoon damage should receive appropriate assessment and treatment. Corresponding photographic records of T5, T6 and TA are illustrated in Plate 2.

<p>No change in condition of T5 from previous monitoring.</p>	<p>No change in condition of T6 from previous monitoring.</p>

- 4.1.9. Construction works should be optimized to avoid encroaching into the protection zones as far as possible. Any works inevitably conducted in the protection zone of the three retained trees (e.g. removing man made concrete surface of a path) shall be minimized its impact to the root system and avoid any damage to the anchor roots.

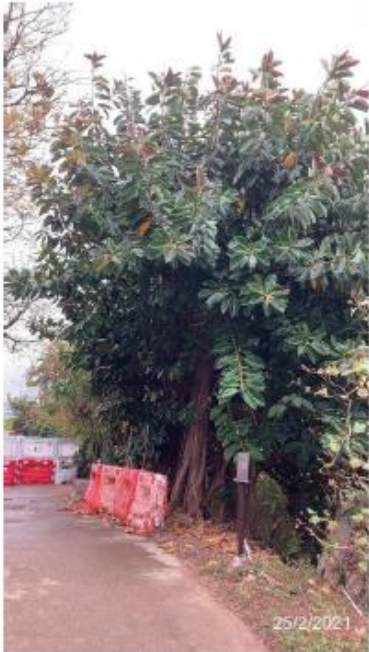
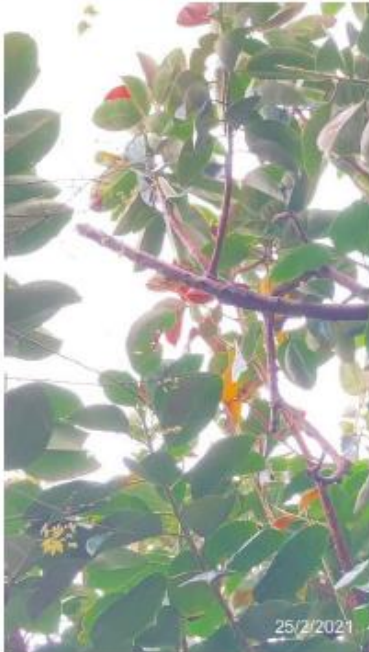
<p>No change in condition of TA from previous monitoring.</p>	<p>Decaying branch hanger on TA.</p>

- 4.1.8. Broken branches in the retained tree TA due to the typhoon damage remained. Relevant authority shall be contacted for appointing a Certified Arborist or equivalent to conduct a Tree Risk Assessment (TRA) on this tree in order to get Lands Department's approval on taking corresponding actions (e.g. pruning). Once the TRA appointment is confirmed, good written

and photographic records (e.g. personal, date and time, actions, etc.) should be made before, during and after any actions of treatment for the assessed tree (i.e. TA)
