**Expansion of Research and Residential Facilities for
The Swire Institute of Marine Science, Faculty of Science,
The University of Hong Kong at Cape d' Aguilar, Shek O, Hong Kong
Submission of Monthly Environmental Monitoring and Audit Report No.42**

MONTHLY ENVIRONMENTAL MONITORING AND AUDIT (EM&A) REPORT (NO. 42)

**Expansion of Research and Residential Facilities for the Swire Institute of
Marine Science, The University of Hong Kong at Cape D'Aguiar, Shek O**

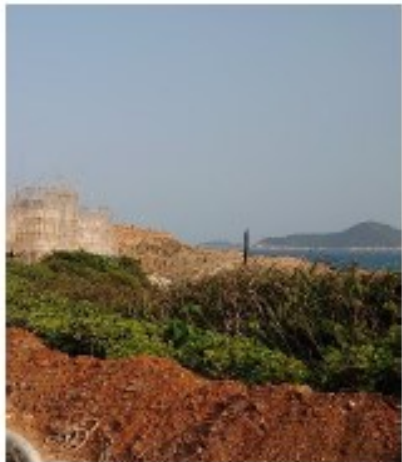
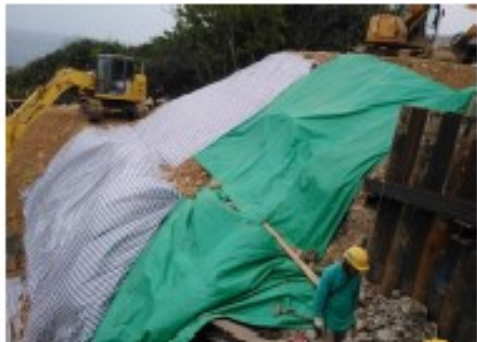
Observation - Item 4	
Observed 25 March 2021	Rectified by the Contractor on 01 Apr 2021
Stockpiles should be covered at Zone A and mitigation measures should be implemented to prevent run off from going out of the site boundary.	Stockpiles are covered.

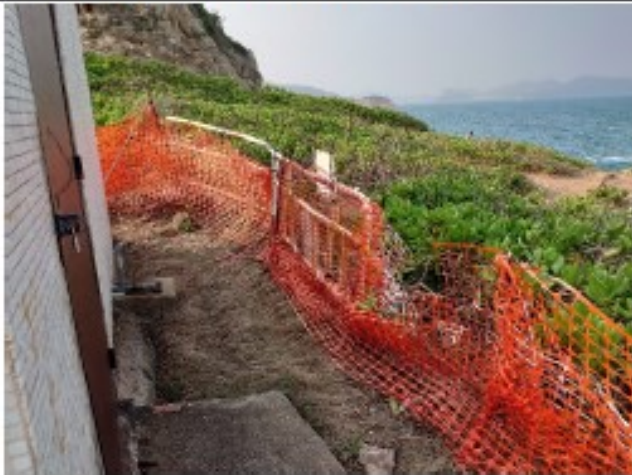
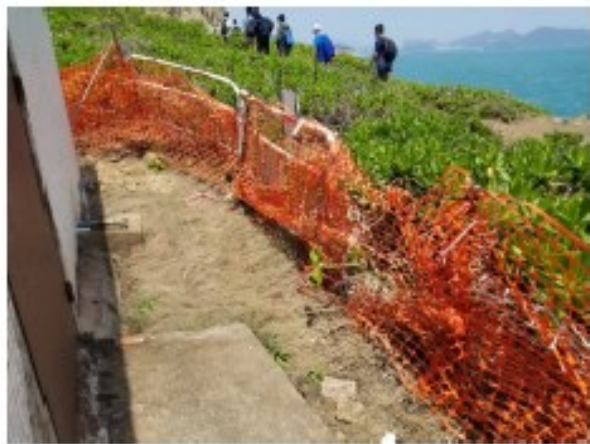
Observation - Item 5	
Observed 25 March 2021	Rectified by the Contractor on 01 Apr 2021
At Zone G, orange nets need to be repaired.	Orange net is repaired.

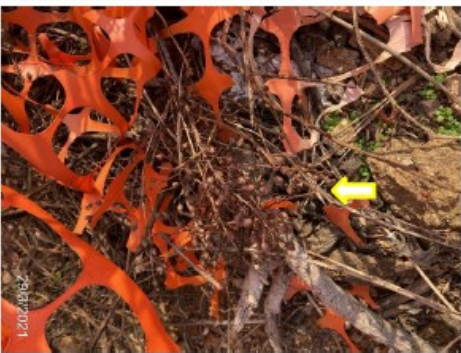
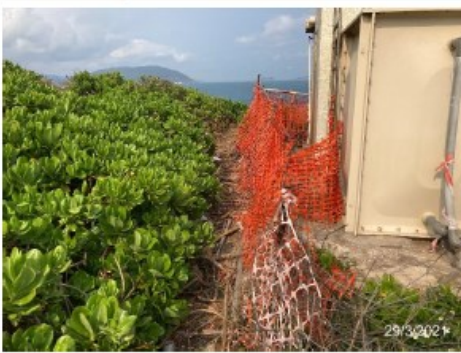
2.4.5. Severe damage caused by Typhoon Mangkhut in September 2018 to the coastal vegetation remained. No *Lysimachia mauritiana* (濱海珍珠菜) could be observed in one of the protection zone near Academic Block (Site A) over 30 months. The original plants in this zone have

certified as dead. The two rediscovered individuals and seedlings observed in vicinity have fruited during their end of biennial life cycle (Plate 1).

<p><i>Lysimachia mauritiana</i> 濱海珍珠菜 (biennial)</p>

- 4.1.5. However re-establishment of *Lysimachia mauritiana* (濱海珍珠菜) is ongoing. The two rediscovered individuals and seedlings observed in vicinity have fruited during their end of biennial life cycle. Building up additional assurance colonies by collecting seeds may still be feasible.

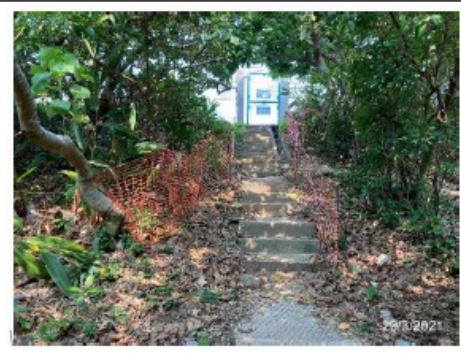
<p><i>Pavetta hongkongensis</i> 香港大沙葉</p>

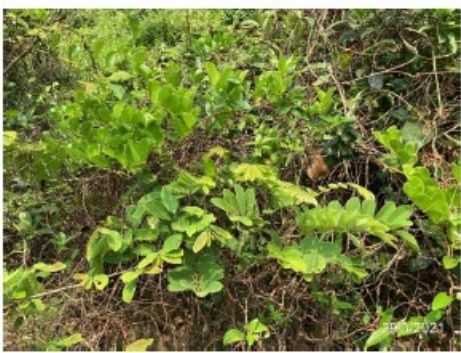
<p><i>Millettia oraria</i> 香港崖豆藤</p>

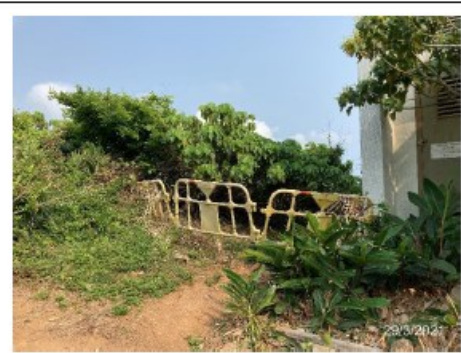
- 2.4.7. Invasive species *Bidens alba* within protection zone of *Elaeagnus tutcheri* (香港胡頹子) has been cleared together with other overgrown climbers.

<p><i>Elaeagnus titcheri</i> 香港胡頹子</p>

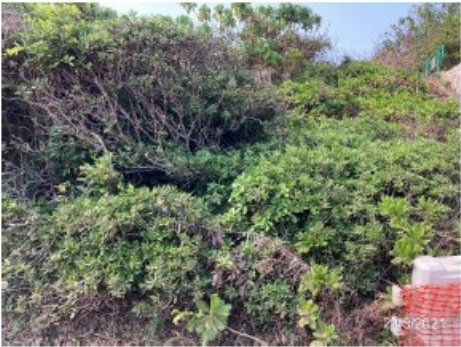
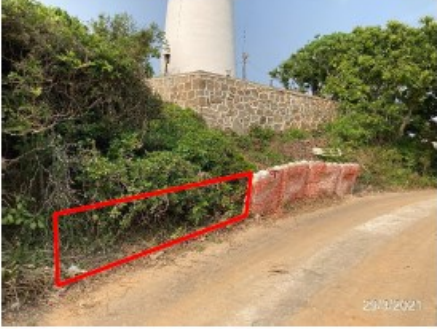
- 2.4.6. *Pittosporum tobira* (海桐) has shown slight dieback of twigs, with regeneration of young leaves. Invasive *Leucaena leucocephala* and *Lantana camara* within protection zone have been cleared together with other overgrown climbers.

<p><i>Pittosporum tobira</i> 海桐</p>	<p>Collapsed fencing to be rectified</p>

- 4.1.7. Protection zone has been provided in accordance with Condition 2.6 of the Environmental Permit. Any damage of the protection zone (e.g. due to coastal weather condition or disturbance of hikers and visitors) should be repaired promptly. Warning sign should be maintained at prominent positions within the works area to encourage hikers and visitors keeping away from any no-entry area or protection zone.

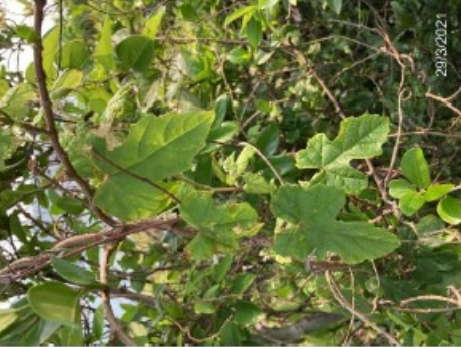
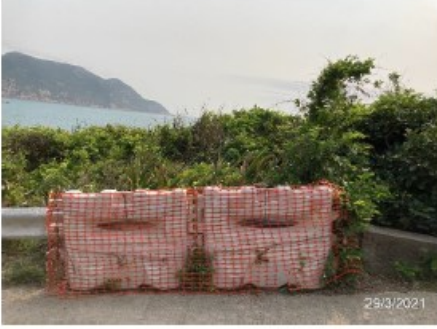
- 2.4.8. Young leaves of the deciduous *Vitis bryoniifolia* (蔓蘘) has emerged.
- 2.4.9. For the three retained trees, there is no change in overall condition of T5; while regeneration of new foliage made tree health of T6, as well as tree form of TA to be assessed from poor to fair. Broken branches in TA due to the typhoon damage should receive appropriate assessment and treatment. Corresponding photographic records of T5, T6 and TA are illustrated in Plate 2.

<p><i>Vitis bryoniifolia</i> 蔓莢 (deciduous)</p>

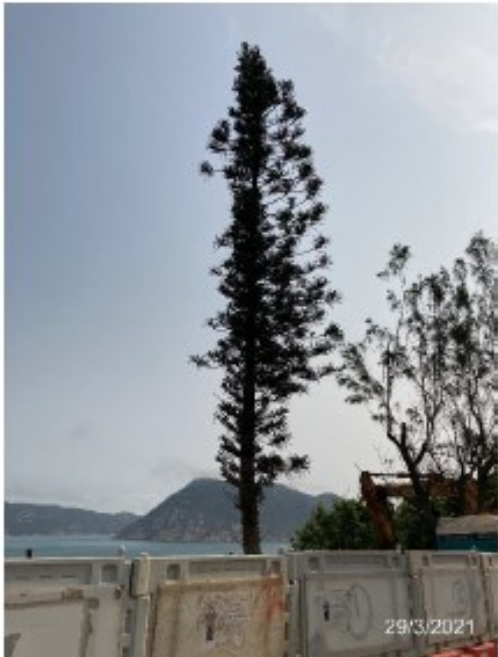
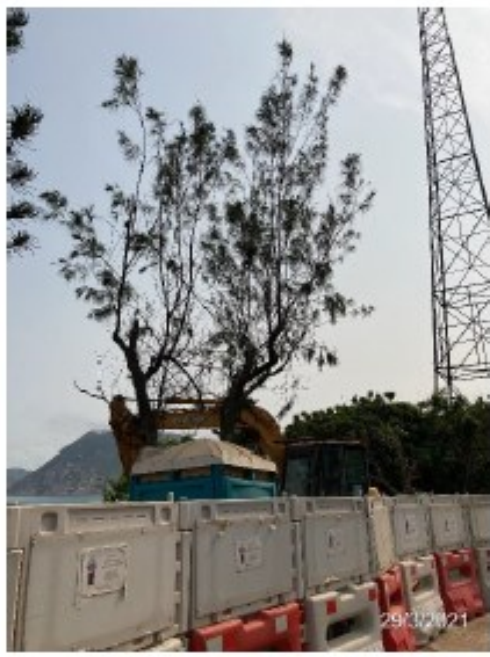
<p>No change in condition of T5 from previous monitoring.</p>	<p>No change in condition of T6 from previous monitoring.</p>

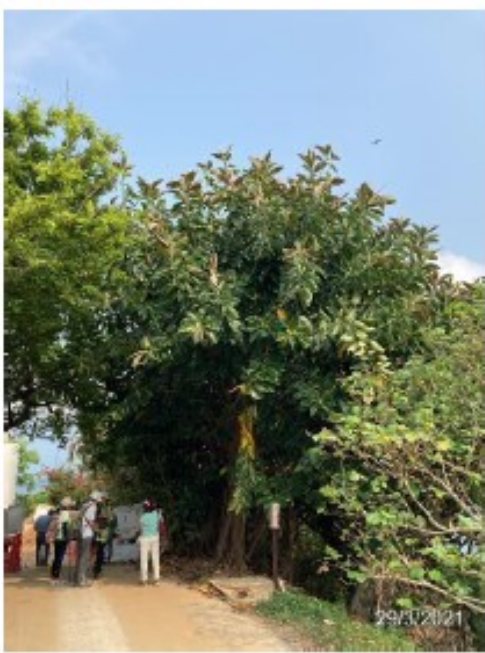
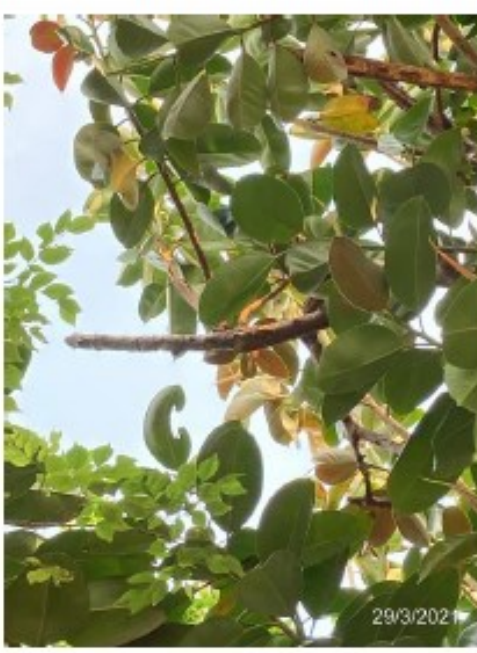
<p>No change in condition of TA from previous monitoring.</p>	<p>Decaying branch hanger on TA.</p>

- 4.1.8. Broken branches in the retained tree TA due to the typhoon damage remained. Relevant authority shall be contacted for appointing a Certified Arborist or equivalent to conduct a Tree Risk Assessment (TRA) on this tree in order to get Lands Department's approval on taking corresponding actions (e.g. pruning). Once the TRA appointment is confirmed, good written

and photographic records (e.g. personal, date and time, actions, etc.) should be made before, during and after any actions of treatment for the assessed tree (i.e. TA)
