**Expansion of Research and Residential Facilities for
The Swire Institute of Marine Science, Faculty of Science,
The University of Hong Kong at Cape d' Aguilar, Shek O, Hong Kong
Submission of Monthly Environmental Monitoring and Audit Report No.48**

**MONTHLY ENVIRONMENTAL MONITORING AND AUDIT
(EM&A) REPORT (NO. 48)**

**Expansion of Research and Residential Facilities for the Swire Institute of
Marine Science, The University of Hong Kong at Cape D'Aguiar, Shek O**

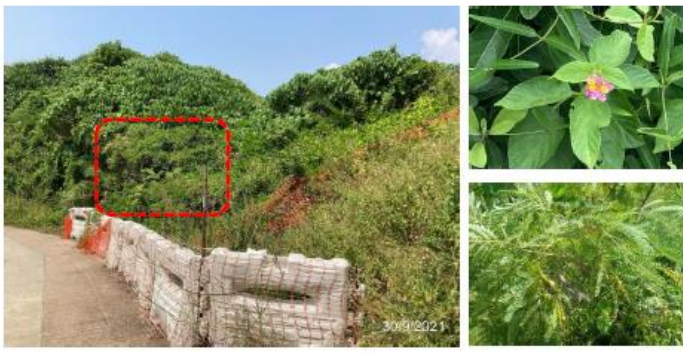
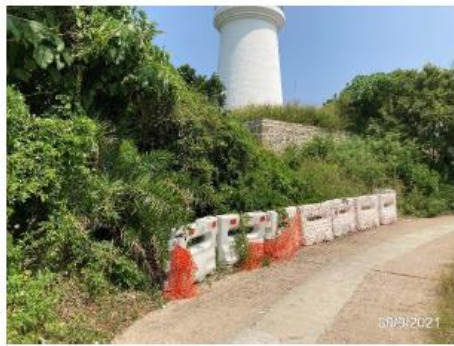
Plate 1. Photographic records of the six recorded plants species of conservation importance with protection zone.

2.4.5. Severe damage caused by Typhoon Mangkhut in September 2018 to the coastal vegetation remained. No *Lysimachia mauritiana* (濱海珍珠菜) could be observed in one of the protection zone near Academic Block (Site A) over 36 months. The original plants in this zone have certified as dead. However, a new healthy individual was observed nearby. In contrast, the

individual within current protection zone has ended by its biennial life cycle without new seedlings regenerated from seeds (Plate 1).

<p><i>Elaeagnus tutcheri</i> 香港胡頹子</p>	<p>Invasive weeds <i>Bidens alba</i> (白花鬼針草) in/around the protection zone shall be cleared, including roots, flowers and seeds (red dotted line)</p>

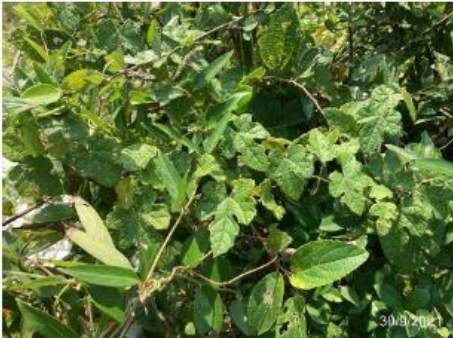
- 2.4.6. *Pittosporum tobira* (海桐) has shown slight dieback of twigs, with regeneration of young leaves. Invasive *Leucaena leucocephala* and *Lantana camara* within protection zone have been cleared together with other overgrown climbers.

<p><i>Pittosporum tobira</i> 海桐; sprouts of previously cleared invasive species emerged again (inset)</p>	<p>Collapsed fencing to be rectified</p>
