MONTHLY ENVIRONMENTAL MONITORING AND AUDIT (EM&A) REPORT (NO. 6)

**Expansion of Research and Residential Facilities for the Swire Institute of
Marine Science, The University of Hong Kong at Cape D'Aguilar, Shek O**

(Rev. 0)

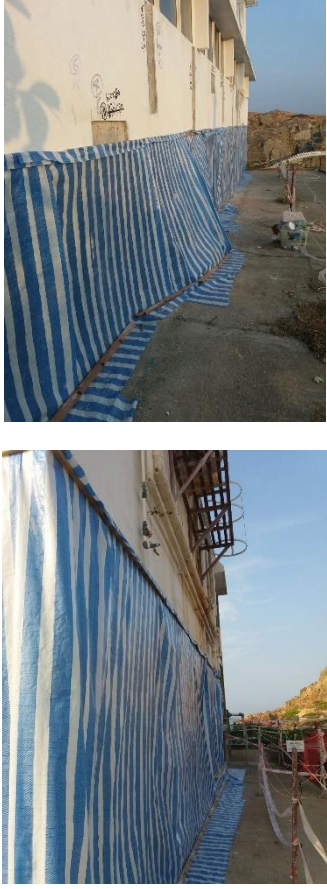
Date	Environmental Observations	Follow-up Status
22-Mar-2018	<p data-bbox="384 465 871 544">Waste was observed at protected zone of <i>Elaeagnus tucherii</i></p>      	<p data-bbox="938 443 1409 566">Rectified by HKU on 22-Mar-2018 Waste was removed and orange net was placed properly.</p>
22-Mar-2018	<p data-bbox="384 1570 815 1603">Storage was found outdoor at Site A</p>	<p data-bbox="938 1525 1350 1648">Rectified by HKU on 4-Apr-2018 Materials at Site A was covered by protective canvas properly.</p>

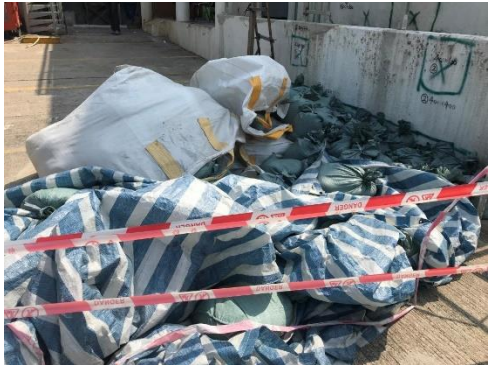
22-Mar-2018	<p>Sandbags/cement was not covered</p>

<p>Rectified by HKU on 29-Mar-2018 Sandbags/cement was covered up properly</p>

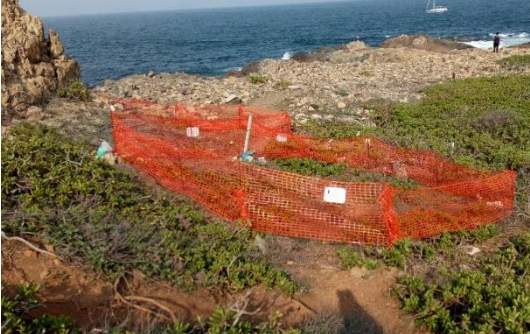
Date	Environmental Observations	Follow-up Status
22-Mar-2018	Orange net was not erected at 1m height	Rectified by HKU on 29-Mar-2018 Orange net was erected properly at 1m height
