Agreement No. CE 30/2018 (EP) Environmental Team for Kai Tak Sports Park – Design and Construction

Monthly EM&A Report for August 2020

September 2020

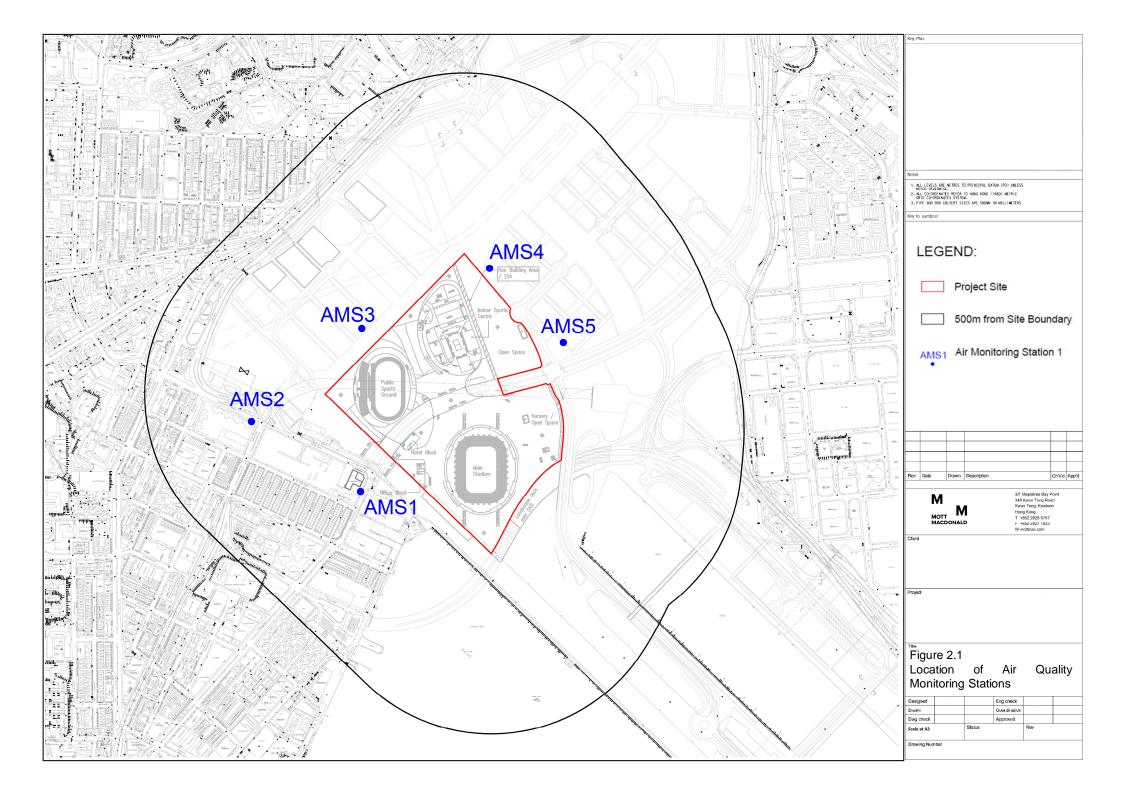
Table 2.2 describes the impact air quality monitoring stations and <u>Figure 2.1</u> shows their locations.

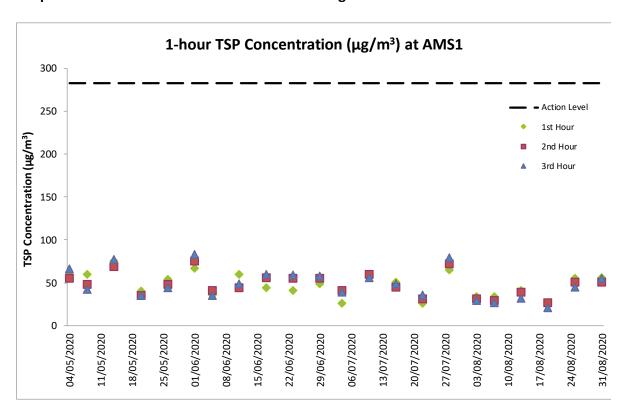
Graphical Presentation for 1-hour TSP Monitoring at AMS1

Date	Start Time	Finish Time	Weather	Wind Speed (m/s)	Wind Direction (deg)	1-hour TSP (μg/m³)
03-Aug-20	9:00	10:00	Cloudy	3.6	103	34
03-Aug-20	10:00	11:00	Cloudy	2.8	115	31
03-Aug-20	11:00	12:00	Cloudy	2.2	122	29
07-Aug-20	8:30	9:30	Fine	3.3	87	34
07-Aug-20	9:30	10:30	Fine	2.8	128	29
07-Aug-20	10:30	11:30	Fine	2.5	132	27
13-Aug-20	9:56	10:56	Fine	4.4	119	41
13-Aug-20	10:56	11:56	Fine	3.3	108	39
13-Aug-20	11:56	12:56	Fine	5.8	123	32
19-Aug-20	13:45	14:45	Cloudy	5.3	107	26
19-Aug-20	14:45	15:45	Cloudy	2.2	135	27
19-Aug-20	15:45	16:45	Cloudy	2.2	110	21
25-Aug-20	9:05	10:05	Sunny	3.3	240	55
25-Aug-20	10:05	11:05	Sunny	3.6	256	51
25-Aug-20	11:05	12:05	Sunny	4.2	274	45
31-Aug-20	9:03	10:03	Sunny	4.7	95	56
31-Aug-20	10:03	11:03	Sunny	3.9	91	51
31-Aug-20	11:03	12:03	Sunny	3.3	110	55

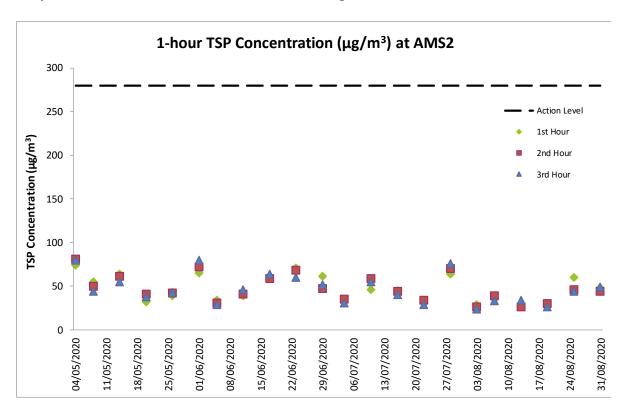
Graphical Presentation for 1-hour TSP Monitoring at AMS2

Date	Start Time	Finish Time	Weather	Wind Speed (m/s)	Wind Direction (deg)	1-hour TSF (μg/m³)
03-Aug-20	8:15	9:15	Cloudy	0.3	variable	29
03-Aug-20	9:15	10:15	Cloudy	4.2	114	26
03-Aug-20	10:15	11:15	Cloudy	3.1	100	24
07-Aug-20	8:20	9:20	Fine	3.1	90	35
07-Aug-20	9:20	10:20	Fine	2.2	115	39
07-Aug-20	10:20	11:20	Fine	3.3	120	33
13-Aug-20	9:06	10:06	Fine	3.3	105	28
13-Aug-20	10:06	11:06	Fine	4.2	120	26
13-Aug-20	11:06	12:06	Fine	3.3	133	34
19-Aug-20	13:30	14:30	Cloudy	4.7	98	29
19-Aug-20	14:30	15:30	Cloudy	4.2	115	30
19-Aug-20	15:30	16:30	Cloudy	1.7	124	26
25-Aug-20	8:22	9:22	Sunny	3.3	265	60
25-Aug-20	9:22	10:22	Sunny	4.4	252	46
25-Aug-20	10:22	11:22	Sunny	2.8	254	44
31-Aug-20	8:15	9:15	Sunny	3.3	100	48
31-Aug-20	9:15	10:15	Sunny	4.2	89	44
31-Aug-20	10:15	11:15	Sunny	3.3	90	49

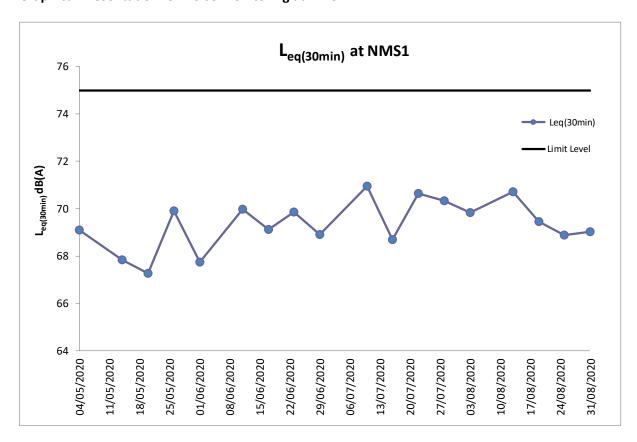
Graphical Presentation for Noise Monitoring at NMS1

Date	Time	Weather	L _{eq(5min)}	L ₁₀	L ₉₀	Measured L _{eq(30min)}
03-Aug-20	09:02	Cloudy	68.2	70.0	65.8	
03-Aug-20	09:07	Cloudy	69.7	71.4	67.6	
03-Aug-20	09:12	Cloudy	70.1	72.5	68.0	69.8
03-Aug-20	09:17	Cloudy	70.4	72.6	68.4	09.6
03-Aug-20	09:22	Cloudy	69.9	71.6	67.1	
03-Aug-20	09:27	Cloudy	70.4	72.3	68.2	
13-Aug-20	09:58	Fine	71.9	75.1	65.6	
13-Aug-20	10:03	Fine	69.6	73.2	65.3	
13-Aug-20	10:08	Fine	71.8	74.2	65.4	70.7
13-Aug-20	10:13	Fine	70.2	72.7	64.4	70.7
13-Aug-20	10:18	Fine	70.6	73.1	63.6	
13-Aug-20	10:23	Fine	69.6	72.6	64.2	
19-Aug-20	13:50	Cloudy	68.2	70.0	66.4	
19-Aug-20	13:55	Cloudy	69.4	71.5	67.6	
19-Aug-20	14:00	Cloudy	70.1	72.3	68.5	69.4
19-Aug-20	14:05	Cloudy	69.2	71.6	67.4	09.4
19-Aug-20	14:10	Cloudy	70.1	72.4	68.3	
19-Aug-20	14:15	Cloudy	69.4	71.6	67.1	
25-Aug-20	09:07	Sunny	68.2	70.0	66.4	
25-Aug-20	09:12	Sunny	69.1	71.3	67.5	
25-Aug-20	09:17	Sunny	69.4	71.5	67.7	68.9
25-Aug-20	09:22	Sunny	70.2	72.4	68.8	08.9

25-Aug-20	09:27	Sunny	68.2	70.6	66.9	
25-Aug-20	09:32	Sunny	67.7	69.8	65.1	
31-Aug-20	09:05	Sunny	68.2	70.1	66.3	
31-Aug-20	09:10	Sunny	68.8	70.4	66.7	
31-Aug-20	09:15	Sunny	69.7	71.5	67.0	69.0
31-Aug-20	09:20	Sunny	69.4	71.3	67.3	09.0
31-Aug-20	09:25	Sunny	68.2	70.0	66.1	
31-Aug-20	09:30	Sunny	69.6	71.9	67.4

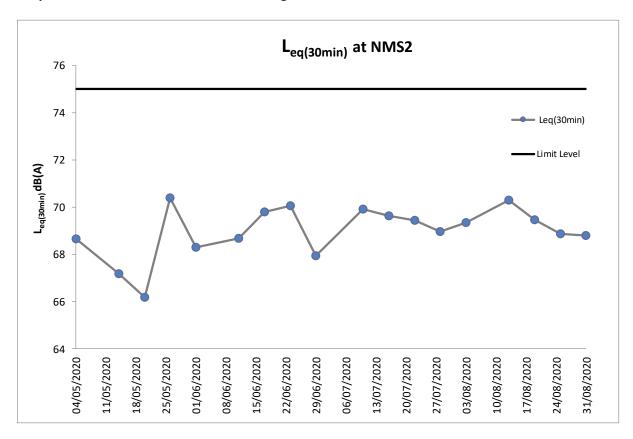
Graphical Presentation for Noise Monitoring at NMS2

Date	Time	Weather	L _{eq(5min)}	L ₁₀	L ₉₀	Measured L _{eq(30min)}
03-Aug-20	08:18	Cloudy	67.9	69.4	64.8	
03-Aug-20	08:23	Cloudy	68.4	70.6	65.2	
03-Aug-20	08:28	Cloudy	68.9	70.7	65.7	69.4
03-Aug-20	08:33	Cloudy	69.2	71.4	66.9	09.4
03-Aug-20	08:38	Cloudy	70.1	72.3	67.0	
03-Aug-20	08:43	Cloudy	70.9	72.5	67.2	
13-Aug-20	09:09	Fine	71.5	73.4	66.2	
13-Aug-20	09:14	Fine	70.7	73.4	66.0	
13-Aug-20	09:19	Fine	69.9	72.5	66.0	70.2
13-Aug-20	09:24	Fine	70.5	73.1	66.8	70.3
13-Aug-20	09:29	Fine	70.1	72.6	66.6	
13-Aug-20	09:34	Fine	68.6	70.7	64.8	
19-Aug-20	14:42	Cloudy	67.9	69.4	65.1	
19-Aug-20	14:47	Cloudy	68.7	70.6	66.2	
19-Aug-20	14:52	Cloudy	69.1	71.6	67.5	69.5
19-Aug-20	14:57	Cloudy	69.2	71.5	67.6	09.5
19-Aug-20	15:02	Cloudy	70.1	72.6	68.1	
19-Aug-20	15:07	Cloudy	71.1	73.1	69.2	
25-Aug-20	08:25	Sunny	68.1	70.4	66.3	
25-Aug-20	08:30	Sunny	67.2	69.5	65.0	
25-Aug-20	08:35	Sunny	67.9	69.6	65.3	68.9
25-Aug-20	08:40	Sunny	69.1	71.5	67.7	68.9

25-Aug-20	08:45	Sunny	69.9	71.8	67.6	
25-Aug-20	08:50	Sunny	70.2	72.7	68.3	
31-Aug-20	08:18	Sunny	68.2	70.3	65.7	
31-Aug-20	08:23	Sunny	67.9	69.4	64.1	
31-Aug-20	08:28	Sunny	69.1	71.5	66.0	68.8
31-Aug-20	08:33	Sunny	68.2	70.6	65.2	08.8
31-Aug-20	08:38	Sunny	70.1	72.4	66.1	
31-Aug-20	08:43	Sunny	68.9	70.6	65.7
