**Agreement No. CE 30/2018 (EP)
Environmental Team for Kai Tak Sports Park –
Design and Construction**

Monthly EM&A Report for December 2020

This is the 21st Monthly EM&A Report for the construction phase of the Project which summaries findings of the EM&A programme during the reporting period from 1 to 31 December 2020.

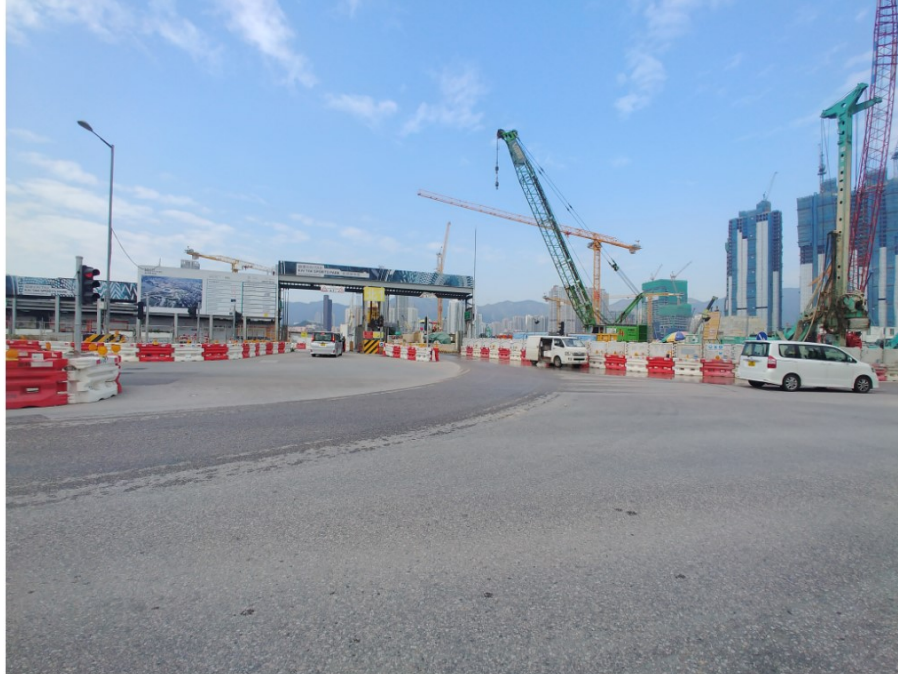
Photo 1a: Road surface condition at Gate N1 (8 December 2020)

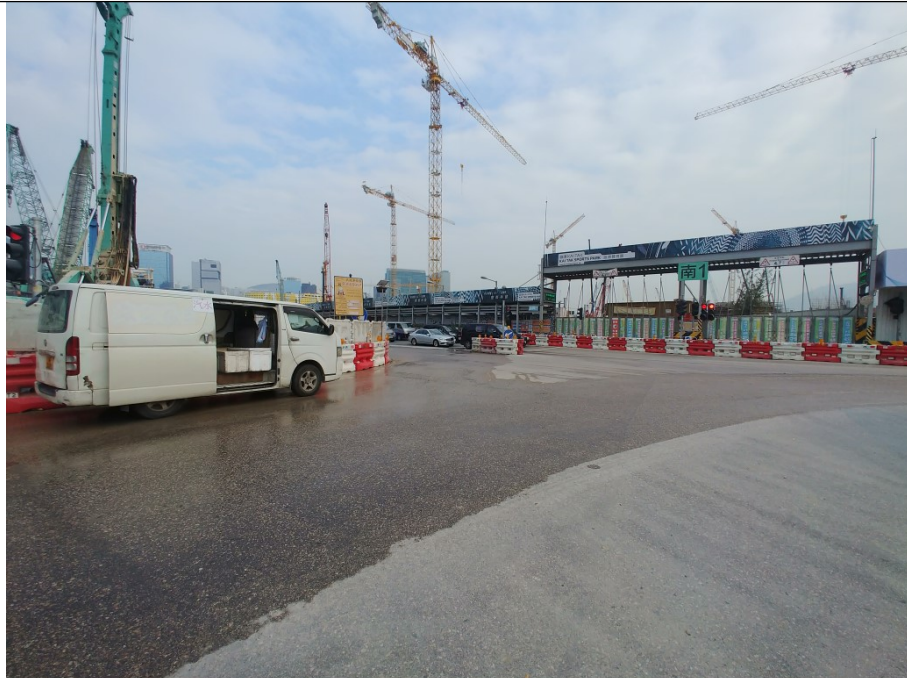
Photo 1b: Road surface condition at Gate N1 (8 December 2020)

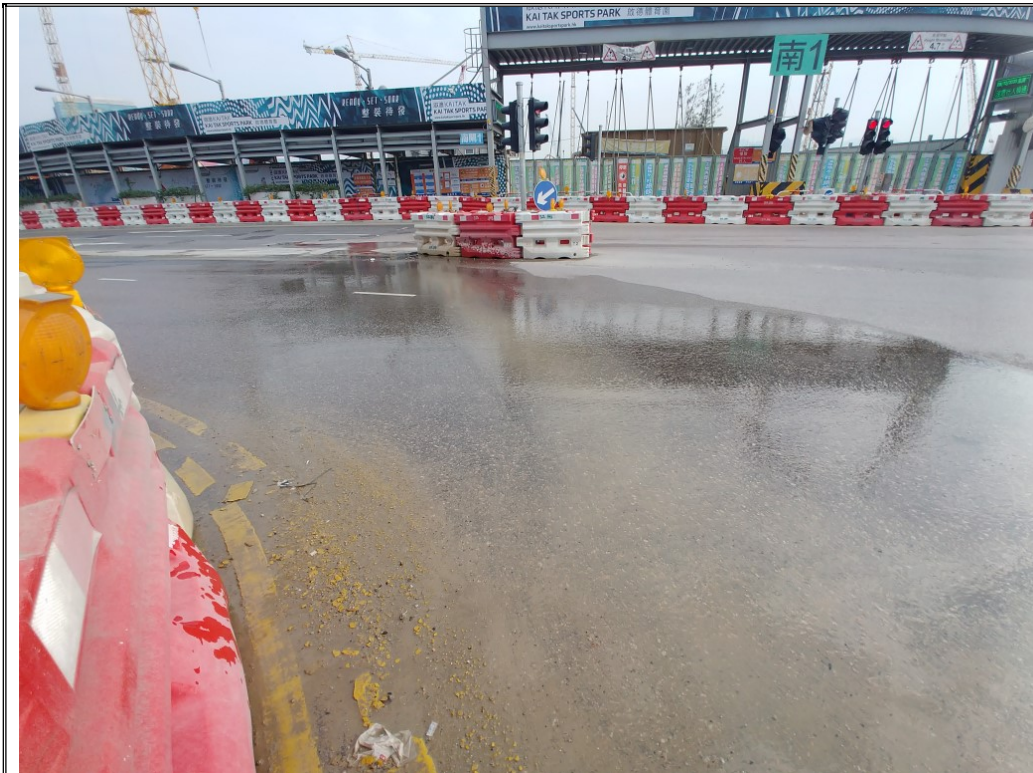
Date of Notification from EPD	Date of Complaint	Description of Complaint	Recommendations / Actions	Close-Out Date / Status
8 Dec 2020 (Referred by HAB)	8 Dec 2020	- Complaint of muddy water from Kai Tak Sports Park northern gate No. N1, affecting passing vehicles. -Complaint of water splashing out from the construction site due to malpractices on manual washing of vehicles. The water jetting directing to the Shing Kai Road and too close to the exit before leaving the Northern Gate No. N1.	1. Water spraying truck has been arranged for clearing the road surface at Shing Kai Road. 2. Worker has been arranged to clear the residual sludge on road surface at Shing Kai Road. 3. Contractor set up yellow line marker at northern gate No.1 and instructed the workers to provide washing within the yellow line area to prevent water jetting directing to the Shing Kai Road.	17 Dec 2020

Photo 1c. Muddy water observed outside Gate N1 (8 December 2020)

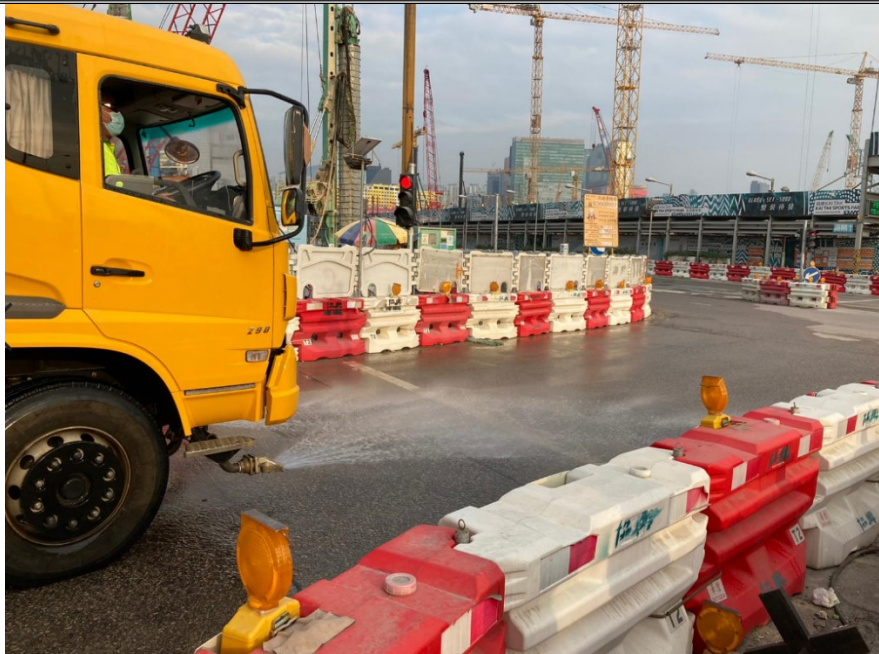
Photo 3: Water spraying truck to wash the road surface at Shing Kai Road (8 December 2020)

RECOMMENDATIONS / MITIGATION MEASURES / ACTIONS			
Environmental rectification actions were taken as follows:			
<p>1. Water spraying truck was arranged for washing the road surface at Shing Kai Road. (Photo 3)</p> <p>2. Worker was arranged to remove the residual sludge on roadside at Shing Kai Road. (Photo 4)</p> <p>3. Contractor had set up yellow line marker at Gate N1 and instructed the workers to wash the construction vehicles within the yellow line area and to prevent water jetting directing to the Shing Kai Road. (Photo 5a and 5b).</p> <p>4. As revealed at site inspection was conducted on 9 December 2020, no water jetting directing to the Shing Kai Road at gate N1 was observed.</p>			
Prepared by:	Sunny Chan	Title:	Environmental Team Leader
Signature:

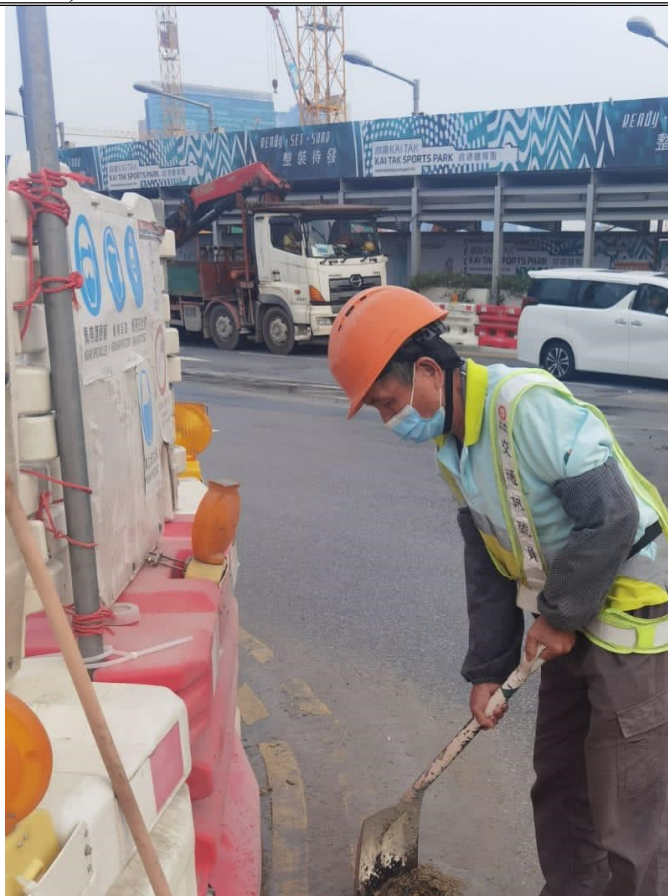
Photo 4: Worker to remove the residual sludge on road surface at Shing Kai Road(8 December 2020)

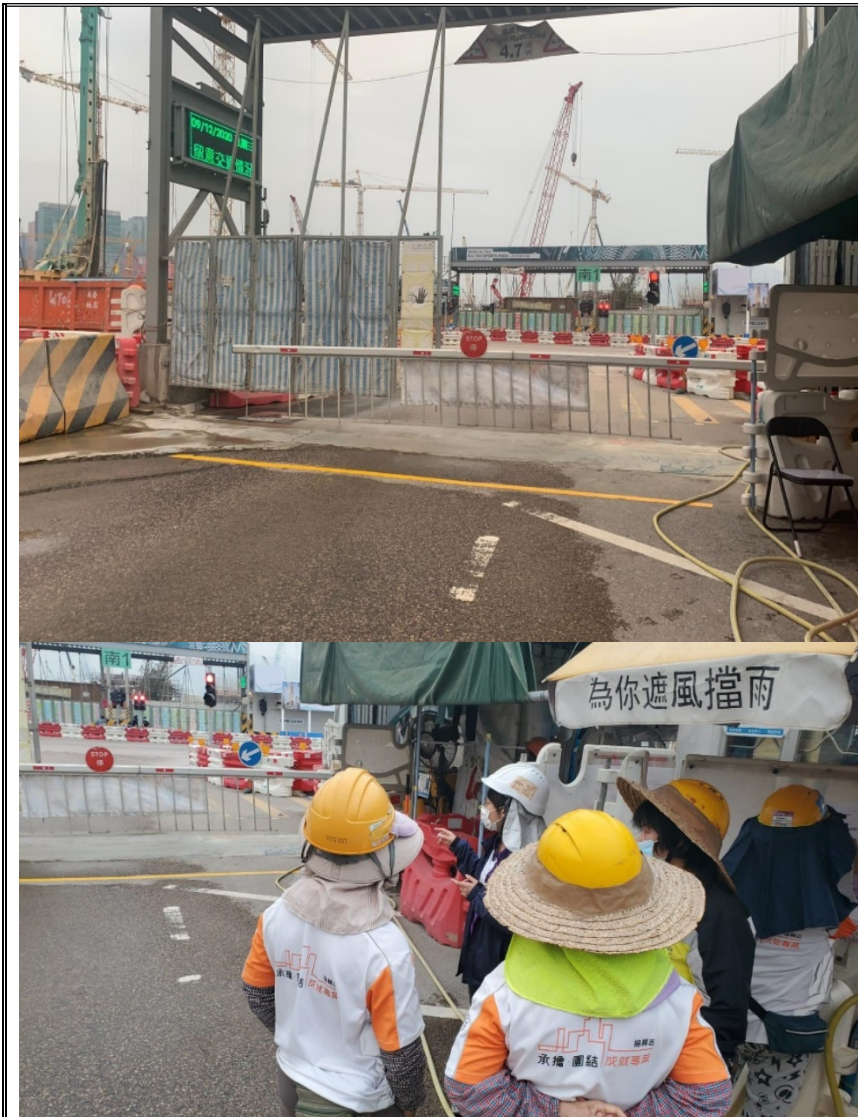
Photo 5a & 5b: Contractor set up yellow line marker at Gate N1 and instructed the workers to provide washing within the yellow line area and to prevent water jetting directing to the Shing Kai Road
