**Agreement No. CE 30/2018 (EP)
Environmental Team for Kai Tak Sports Park –
Design and Construction**

Monthly EM&A Report for February 2023

Kai Tak Sports Park - Investigation

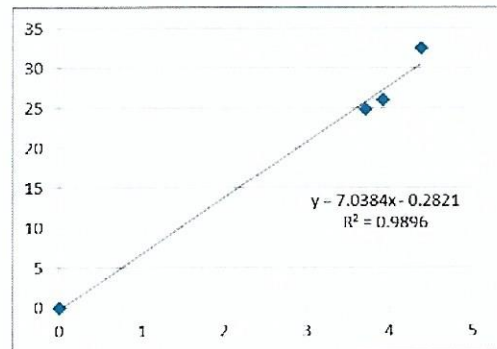
Slope (K-factor): 7.0384 (µg/m³)/CPM
Correlation Coefficient (R) 0.9947
Date of Issue 10 March 2022

1. **Strong Correlation (R>0.8)**
2. Factor 7.0384 (µg/m³)/CPM should be applied for TSP monitoring

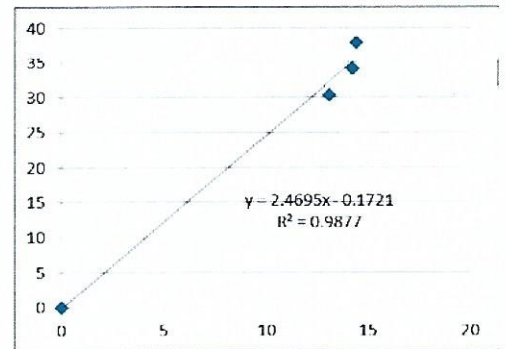
Correlation Coefficient (R) 0.9938

1. **Strong Correlation ($R > 0.8$)**
2. Factor 2.4695 ($\mu\text{g}/\text{m}^3$)/CPM should be applied for TSP monitoring

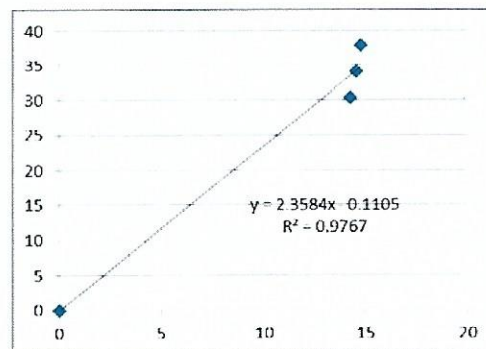
Slope (K-factor): 2.3584 ($\mu\text{g}/\text{m}^3$)/CPM
Correlation Coefficient (R) 0.9883
Date of Issue 2 June 2022

1. **Strong** Correlation ($R > 0.8$)
2. Factor 2.3584 ($\mu\text{g}/\text{m}^3$)/CPM should be applied for TSP monitoring

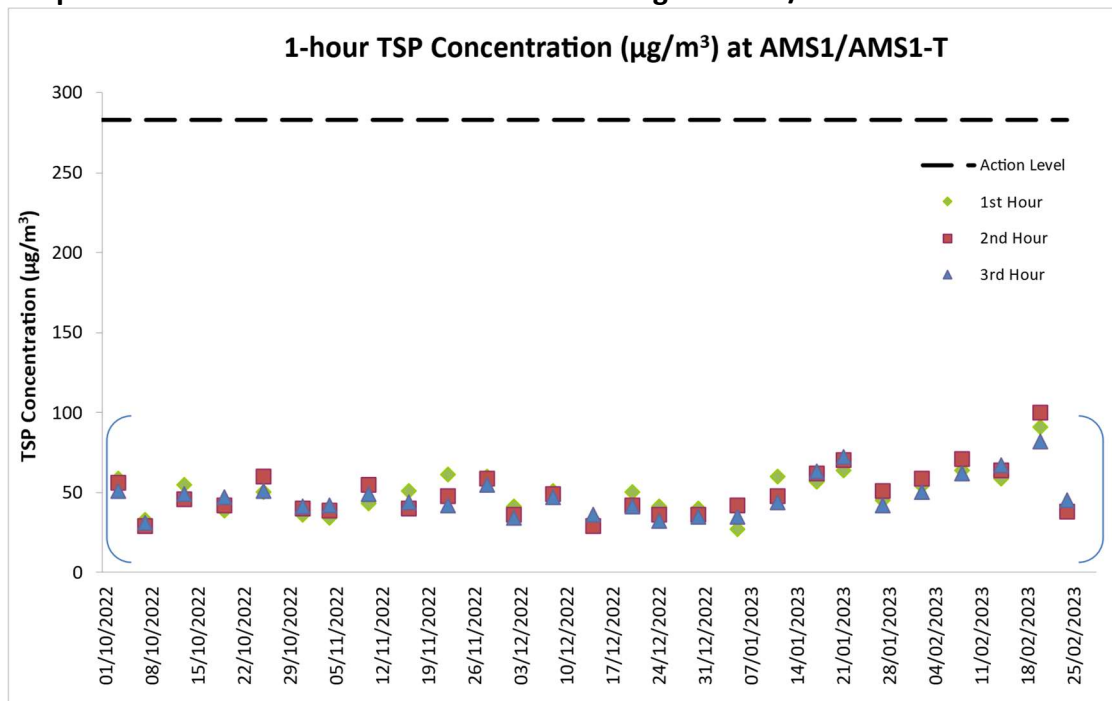
Graphical Presentation for 1-hour TSP Monitoring at AMS1/AMS1-T

* During the reporting period, monitoring station AMS1 was no longer open for impact monitoring from 1 September 2022, due to the relocation of the Hong Kong Society for the Blind Workshop. Temporary air quality monitoring station, AMS1-T was used to conduct dust monitoring in September 2022. Details of temporary alternative monitoring locations are presented in Temporary Alternative Proposal for Monitoring Station as proposed by ET and agreed by IEC dated 6 January 2021.

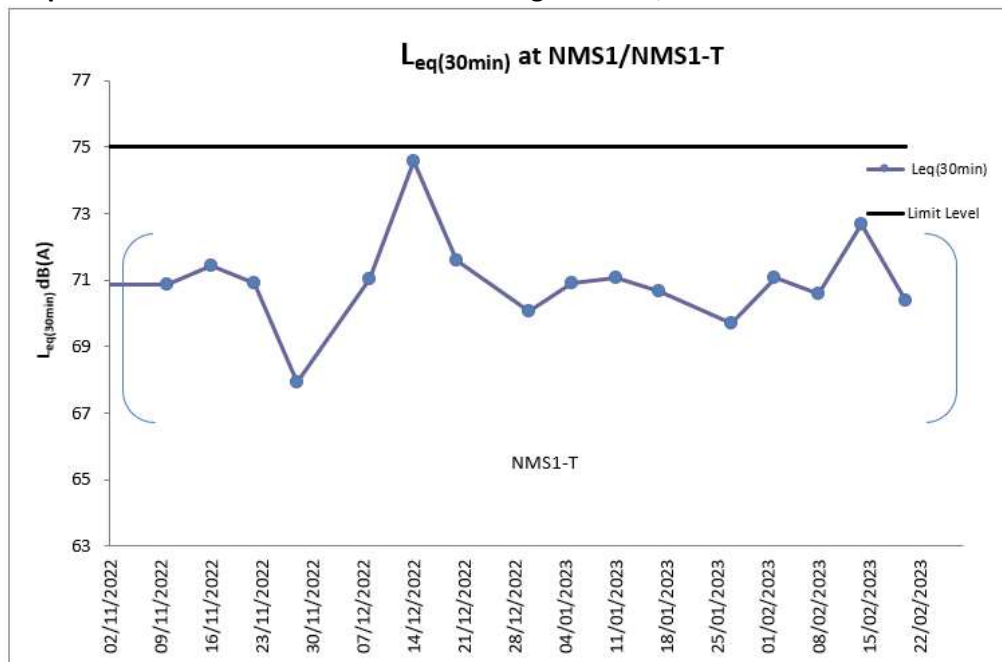
Graphical Presentation for Noise Monitoring at NMS1/NMS1-T

* During the reporting period, monitoring station NMS1 was no longer open for impact monitoring from 1 September 2022, due to relocation of the Hong Kong Society for the Blind Workshop. Temporary noise monitoring station, NMS1-T was used to conduct noise monitoring in September 2022. Details of temporary alternative monitoring locations are presented in Temporary Alternative Proposal for Monitoring Station as proposed by ET and agreed by IEC dated 6 January 2021.
