**Agreement No. CE 30/2018 (EP)  
Environmental Team for Kai Tak Sports Park –  
Design and Construction**

Monthly EM&A Report for May 2023

### Kai Tak Sports Park - Investigation

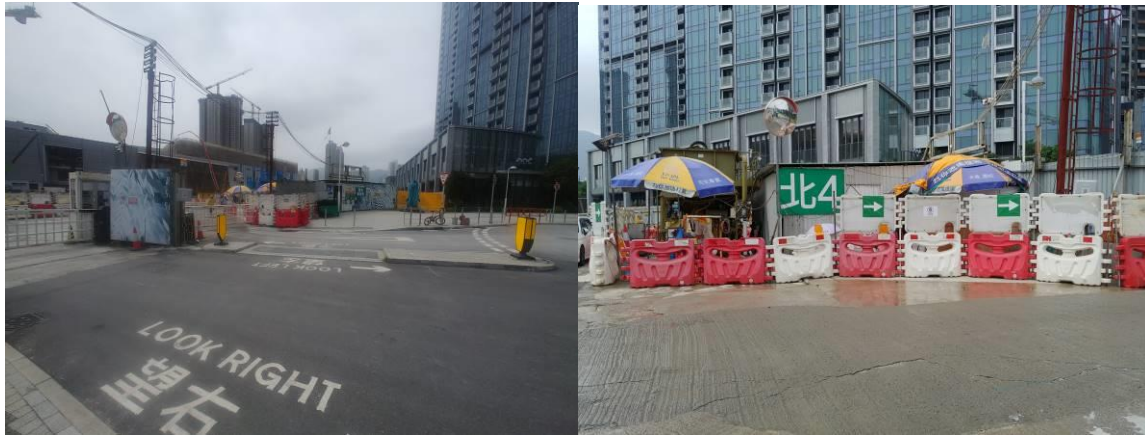
**Photo 1a and 1b:** No discharge of polluting wastewater from North Gate No. 4 at Muk Tai Street was observed (24 May 2023).

INVESTIGATION RESULT & RESPONSE		
ET, IEC and SOR notified on:	23 May 2023	
Investigation conducted on:	24 May 2023	
Result of investigation:	<p>Complaint investigation was carried out with contractor on 24 May 2023, the results of investigation were summarized as following:</p> <p>No discharge of polluting wastewater from North Gate No. 4 at Muk Tai Street was observed. (Photos 1a and 1b). The wastewater treatment plant on site was in normal condition. (Photos 2a, 2b and 2c) All wastewater effluent has been treated in accordance with the approved WPCO license (WT00034082-2019). (Photos 5a and 5b) All construction works carried out at northern site have been strictly followed the Construction Noise Permit requirement (GW-RE0400-23). (Photos 6a and 6b)</p> <p>In conclusion, water pollution control mitigation measures at the Kai Tak Sports Park have been implemented and maintained. All construction works carried out have been fulfilling the relevant environmental legislations, WPCO licence and CNP requirement during the concerned period.</p>

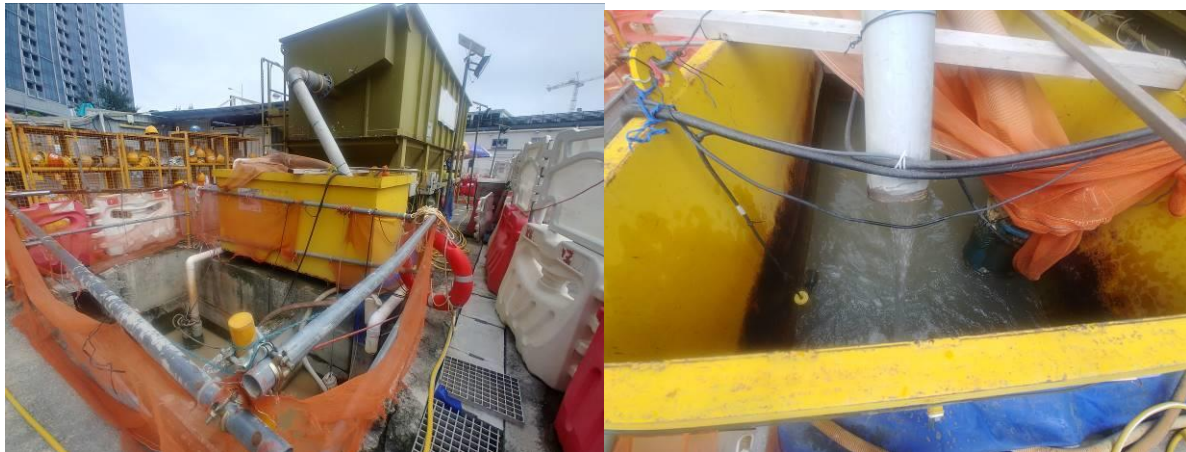
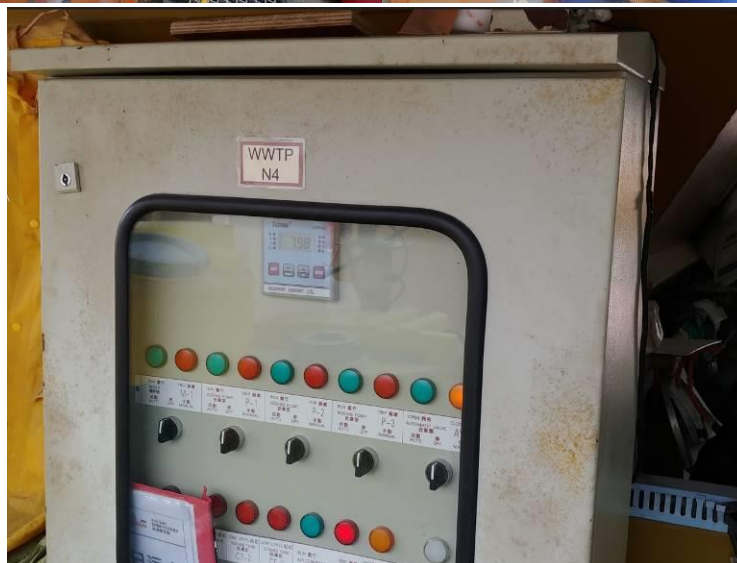
**Photo 2a, 2b and 2c:** Wastewater treatment plant is set up at North 4 Gate and wastewater has been treated in accordance with the approved WPCO discharge license. (24 May 2023)

RECOMMENDATIONS / MITIGATION MEASURES / ACTIONS			
Environmental mitigation measures have been maintained as follow:			
1. Self-monitoring of wastewater discharge sample had been conducted and reported monthly. (Photo 3)			
2. Regular pest control measures had been provided near North Gate No. 4 Area. (Photo 4)			
Prepared by:	Sunny Chan	Title:	Environmental Team Leader
Signature:

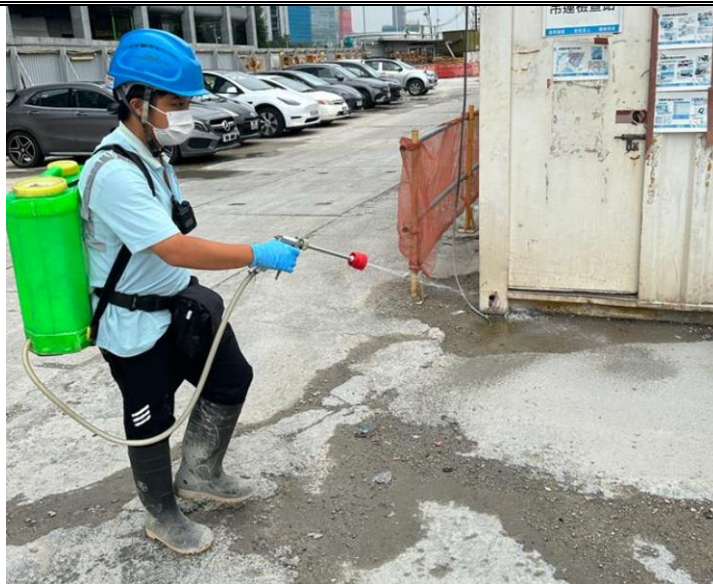
**Photo 4:** Regular pest control measures had been provided near North Gate No. 4 Area.
