CONTRACT NO. HY/2019/14
NEW WANG TONG RIVER BRIDGE
UNDER ENVIRONMENTAL PERMIT
NO. EP-555/2018

Proposal For
Cancellation of Water Quality Monitoring at Station W3

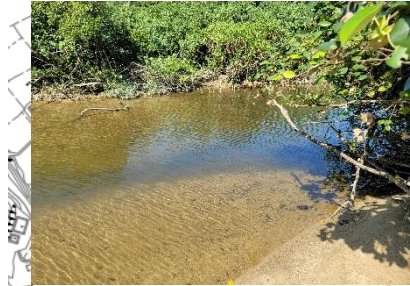
Photo 6
Shallow water depth at W4

2.1.2 At the location near to WMS W4, it was found that water depth of the minor tributary at Wang Tong River to Tai Wai Yuen is around 0.3 metres. Hence, it is deduced that water depth in the upstream area, i.e. WMS W3, would be equal to or less than 0.3m.

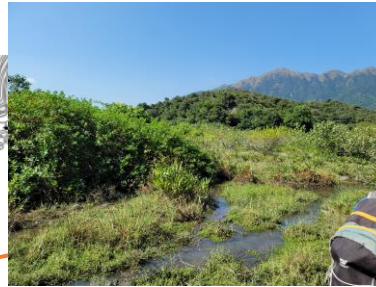
Photo 5
Large piece of muddy mangrove ground

- 3.3.1 Working in high-density mangrove near WMS W3 could induce safety issue. Sampling personnel and their equipment would easily get injury or damage when passing through branches of the mangroves. Slippery muddy ground of mangroves would increase chances of falling. This type of work environment is unfavourable for health of sampling personnel.

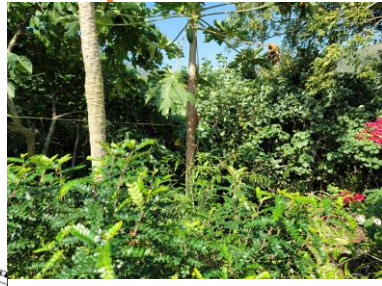
Photo 2
High-density trees obstructed access.

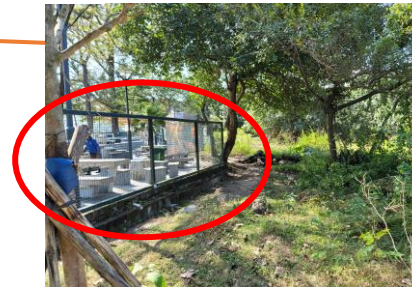
Photo 4
Fenced-off area

2.1.1 Field visit was conducted on 5 November 2020 by ET. It was observed that the access to WMS W3 at Wang Tong River was obstructed by high-density mangroves. Alternative land access along the upstream of W4 to access W3 is unavailable due to fenced-off area by owner(s).

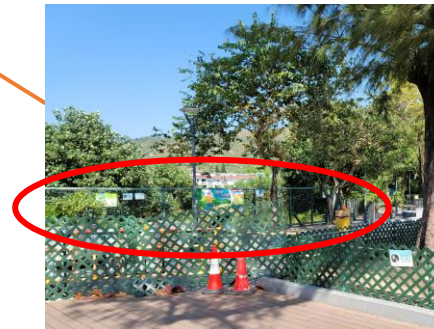
Photo 3
Mangrove area was being fenced off.
