Baseline Vegetation Survey Report – August 2019

*CEDD Contract No. GE/2018/01
Landslip Prevention and Mitigation Programme, 2017,
Package K, Landslip Prevention and Mitigation Works–*

*Detailed Baseline Vegetation Survey before Commencement of Works at
Study Area 11NE-B/SA3, Razor Hill, Clear Water Bay Road*

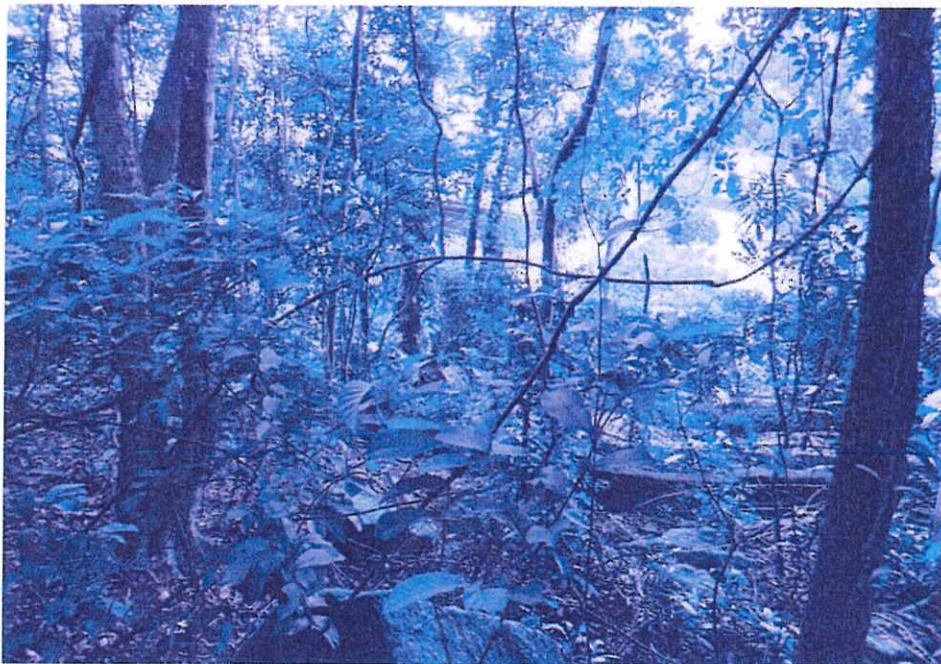
The Works Area is a secondary forest dominated by *Symplocos glauca* and *Machilus chekiangensis*, with the understory occupied by some dominant local shrub and herbaceous species, e.g. *Sarcandra glabra*, *Cyclosorus parasiticus*, *Cibotium barometz* and *Psychotria asiatica* (general view in **Cover photo**). The canopy cover of the woodland is moderately dense and reaches about 10 meters in average.

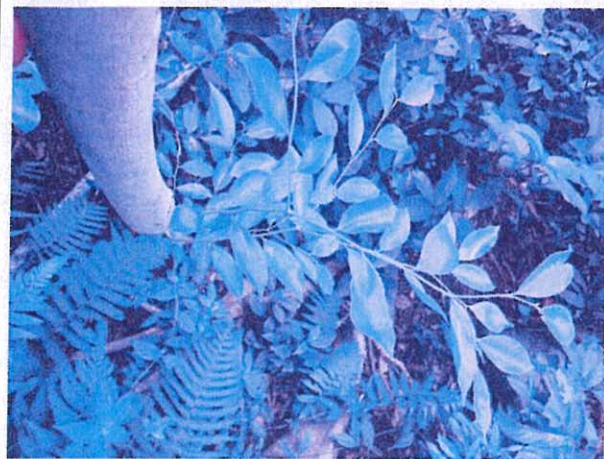
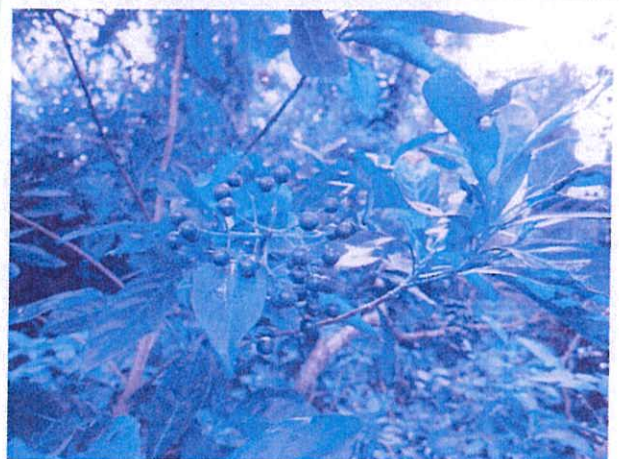
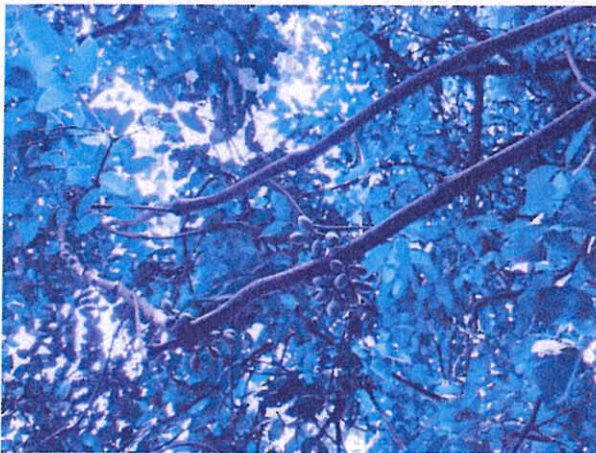
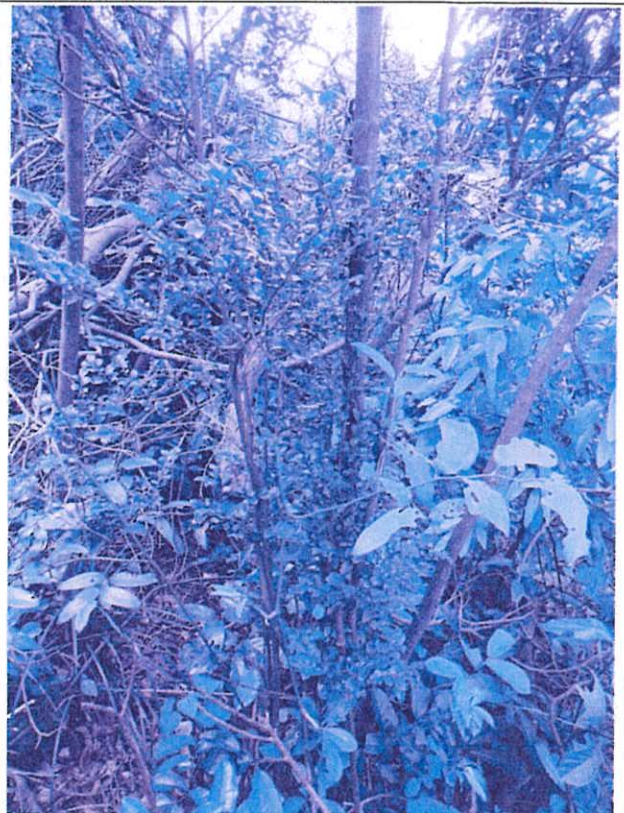
Plate 1. Photographic records of the five plant species of conservation importance recorded during present vegetation survey.

Four out of five plant species of conservation importance (i.e. *Aquilaria sinensis*, *Pavetta hongkongensis*, *Gnetum luofuense* and *Cibotium barometz*) could be located at corresponding locations indicated by previously submitted Project Profile (**Plate 1**). Current results are summarized in **Table 2**.

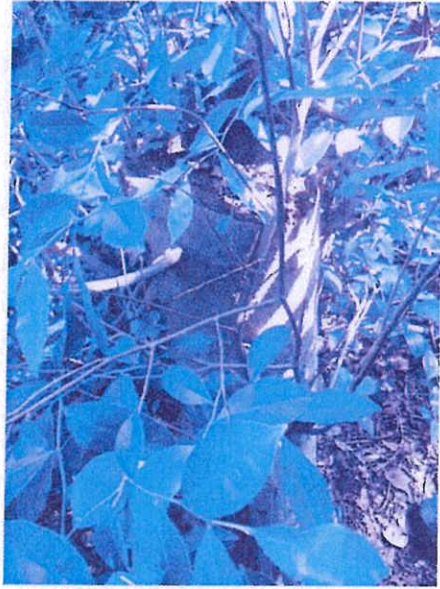
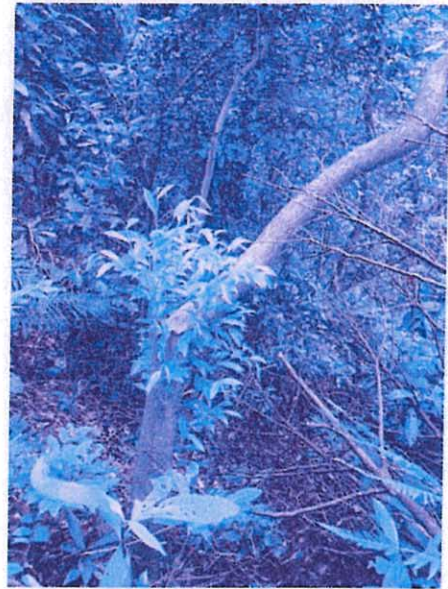
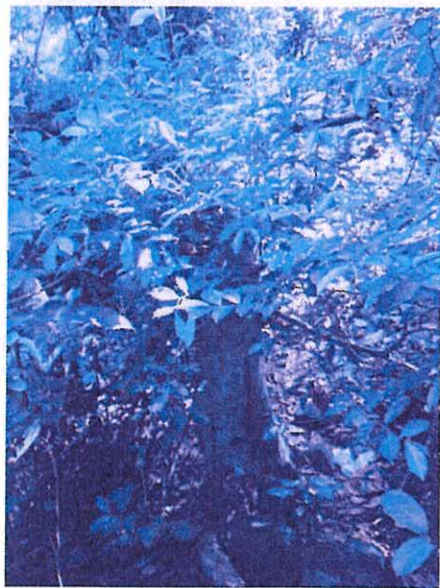
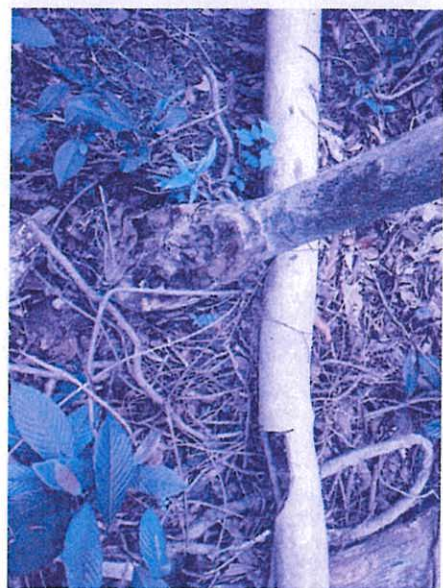
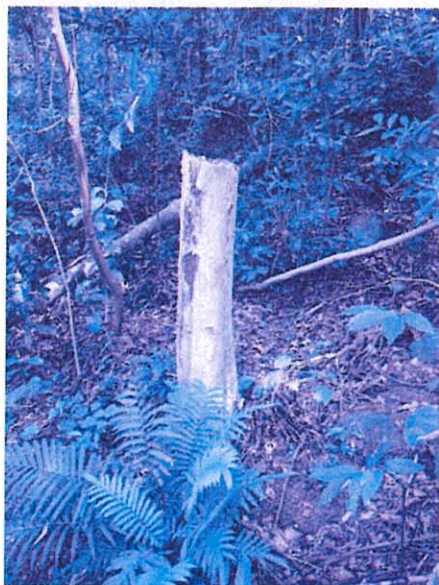
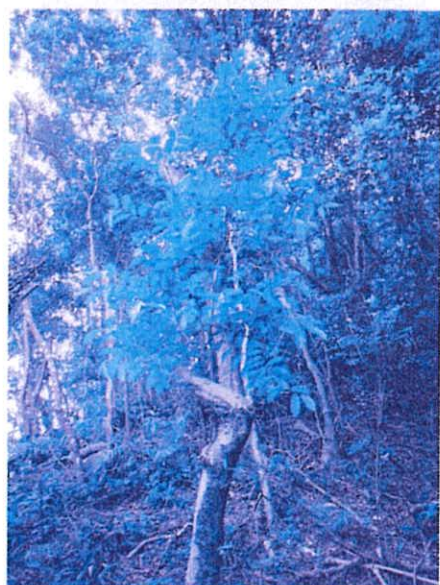
Plate 2. Signs of illegal harvest of *Aquilaria sinensis* at the Works Area.

Plant protection zone is especially for *Aquilaria sinensis*, which has been targeted for illegal harvest at this site (**Plate 2**), some effective example of PPZ against *Aquilaria sinensis* are illustrated in **Plate 3**. Retained and preserved plants should be monitored regularly by a plant specialist to ensure their condition throughout the construction phase.

All recorded individuals of plant species with conservation importance should be retained *in-situ* and fenced off either in group (for plants grow closely together) or individually to prevent from being damaged or disturbed during any construction work. Nets, fence or wire mesh of at least 1.5m high are recommended to be used to surround the robust fenced area as plant protection zone (PPZ). The PPZ shall be at least 1.5m setback from stems for trees and 1m radius for seedlings, shrubs, herbs or climber in concern.
