20th Monthly Monitoring Report – May 2022

CEDD Contract No. GE/2018/01

*Landslip Prevention and Mitigation Programme, 2017,
Package K, Landslip Prevention and Mitigation Works–*

Study Area I1NE-B/SA3, Razor Hill, Clear Water Bay Road

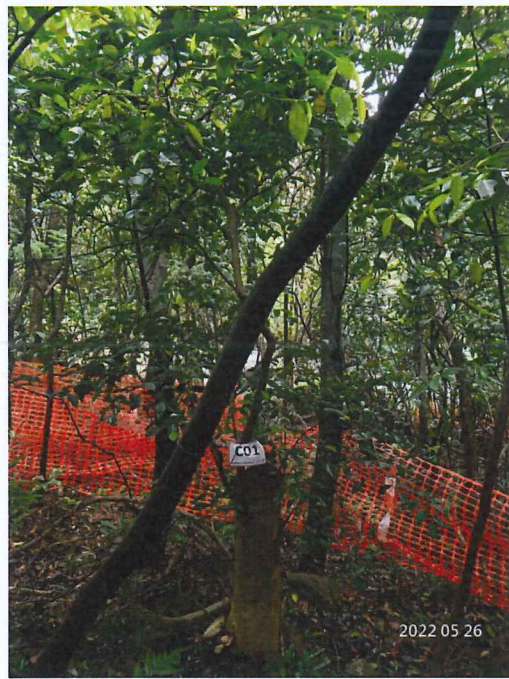
C01 & 02

Plate 2. Photographic records of plant species of conservation importance detected within the Works Site. Eye-catching orange fence shall be set up as soon as possible for all recorded plants (in progress). Fine-tune rectification shall also be made in order to keep suitable setback distance from trunks/ stems (1.5m for mature stems; 1m from seedlings and the climber *Gnetum luofuense*).

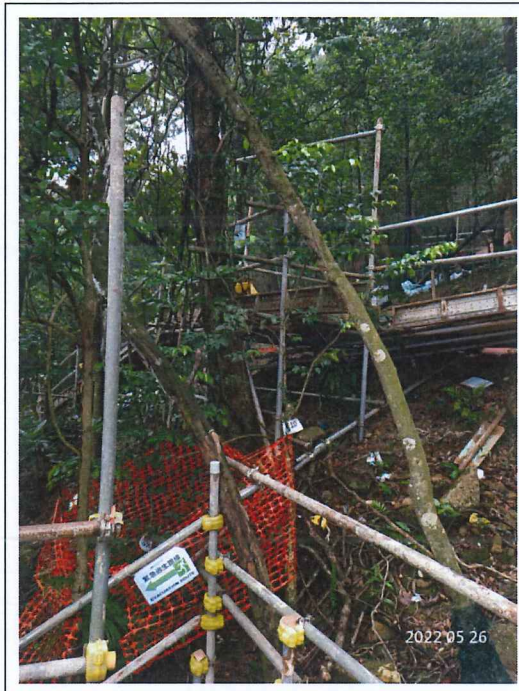
C08 & C09

No new sign of illegal harvest of *Aquilaria sinensis* since last incident on C09 and C78.

From old wounds observed in other *Aquilaria sinensis* trees during early stage of baseline survey, this site has been under threats of illegal harvesting. With the proposed slope works trying best to protect and preserve existing plant species of conservation importance, the client shall make good and prompt communication/ reporting to the relevant departments (including AFCD/ police force) in order to facilitate ad-hoc patrol enforcement and detail investigation.
