Agreement No. PI 3/2020
Independent Environmental Checker for
Lei Yue Mun Waterfront Enhancement Project
Verification of Coral Translocation Plan (Version 5.0)

Contract No. CV/2020/09
Construction of
Lei Yue Mun Public Landing Facility

Coral Translocation Plan
(Version 5.0)

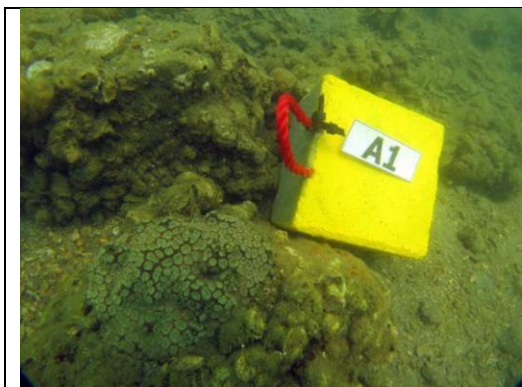
Photo 5.1 Concrete block in bright color can be used for coral tagging.

- 5.3 For hard corals, the selected colonies will be tagged with a labelled stone or concrete block placed next to each tagged colony (**Photo 5.1**) or using plastic tags (~3.5 cm diameter) glued onto boulders adjacent to the coral colonies.

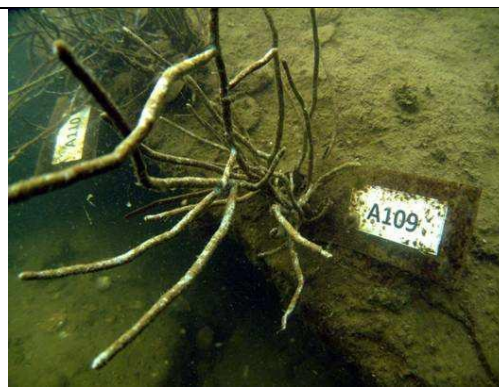
Photo 5.2 Laminated labels can be used for tagging corals with fragments or branching structures, and tied onto the basal section of octocoral and black corals.

- 5.4 For octocorals, the selected colonies will be tagged with laminated labels or plastic tags using cable ties (**Photo 5.2**).

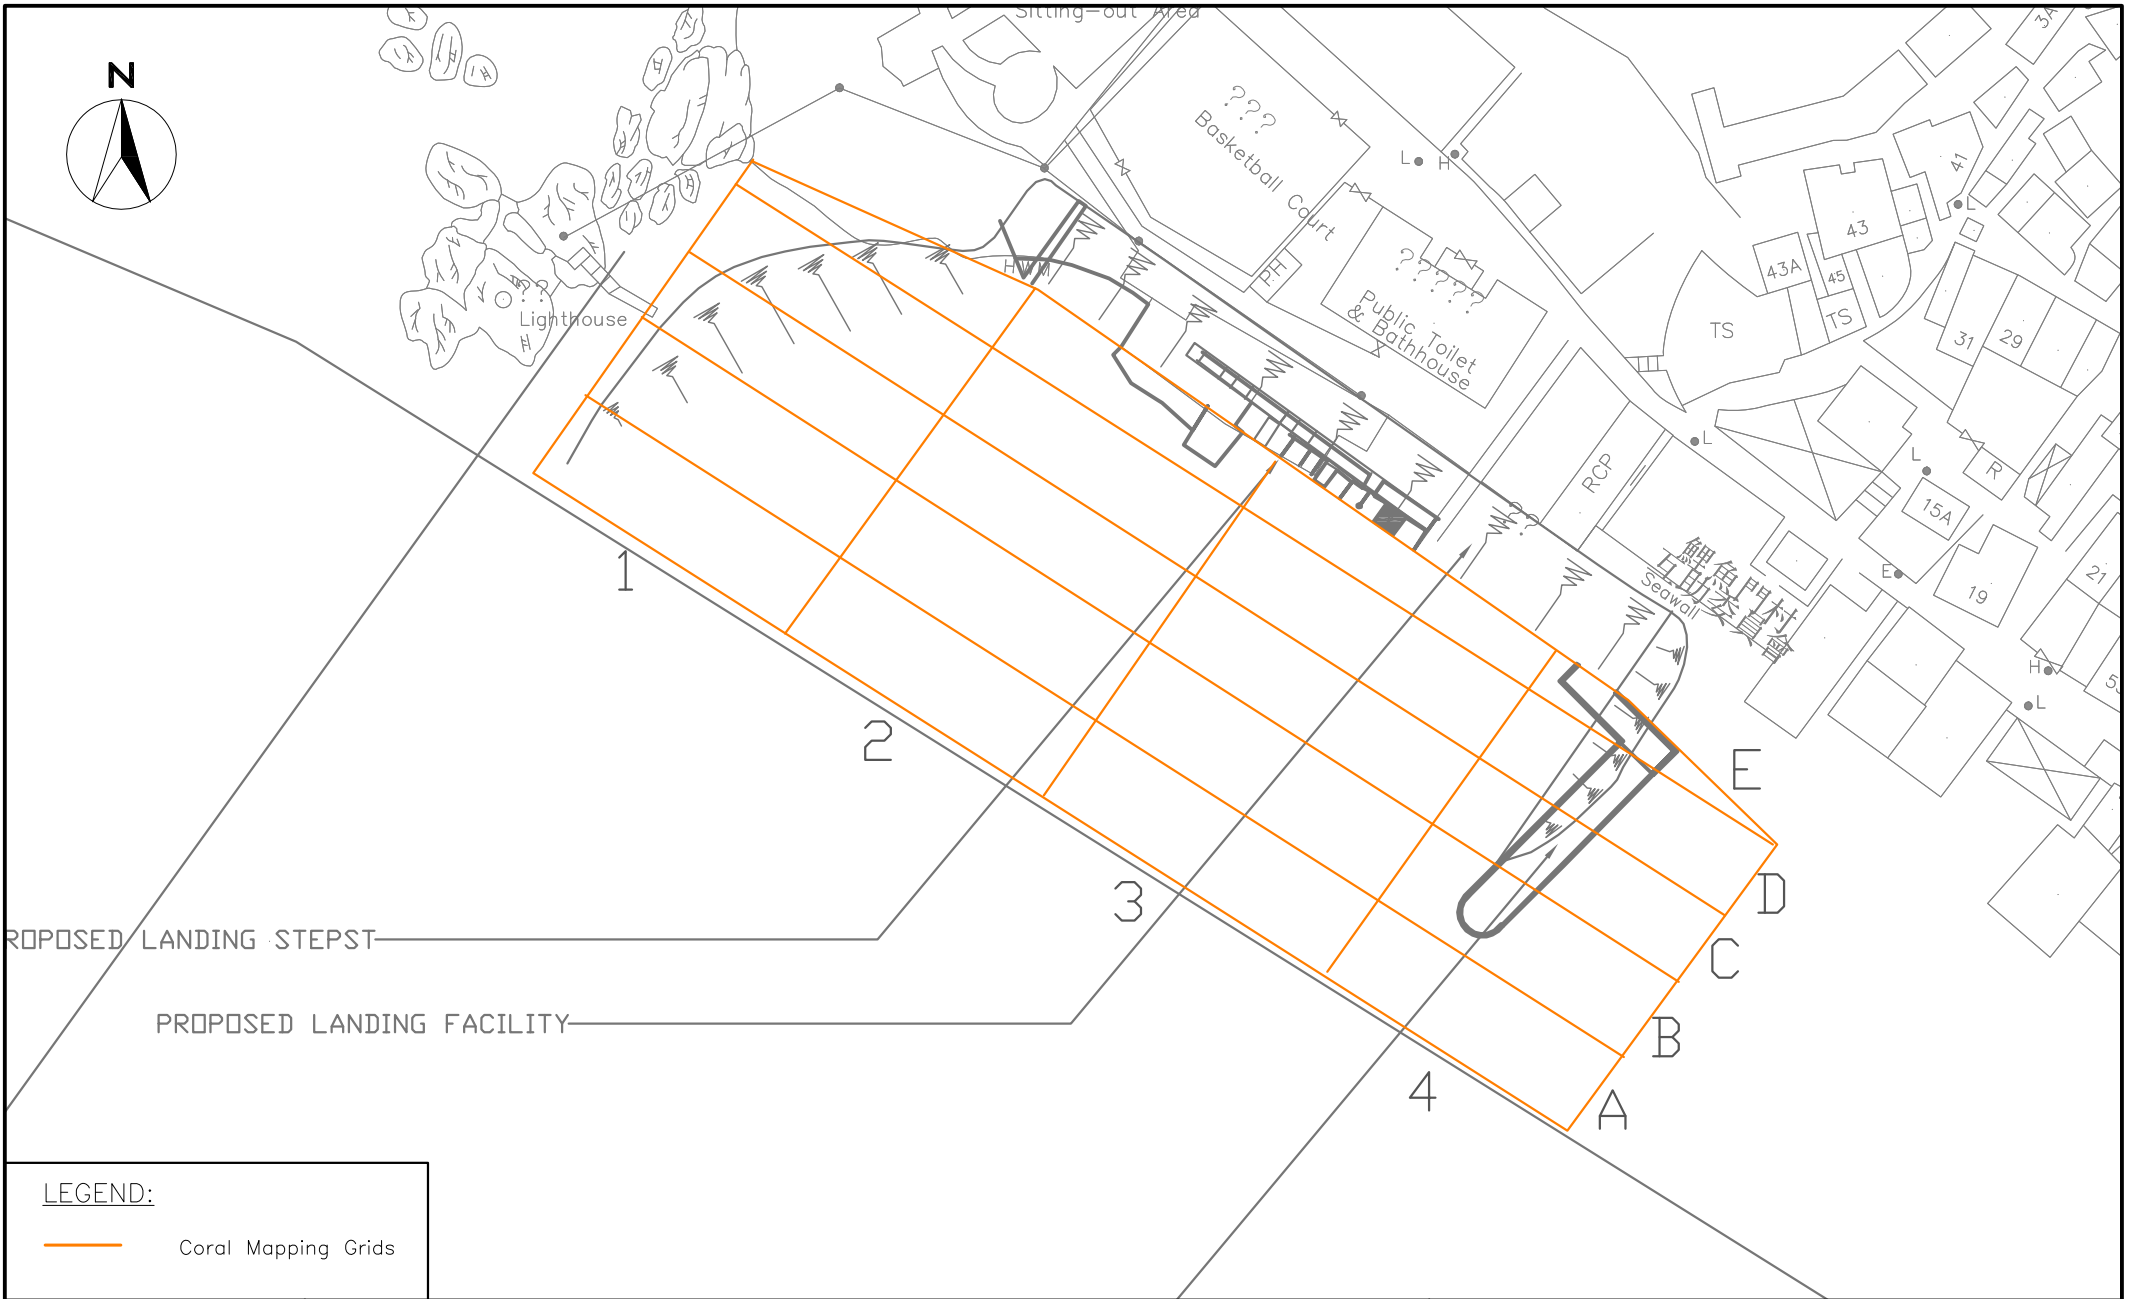
SCALE	1:2000 @A4	DATE	Mar 2021	
CHECK	IT	DRAWN	JT	
Project No.	WEC20026	FIGURE NO.	3	REV —

Contract No. CV/2020/09
 Construction of Lei Yue Mun Public Landing Facility
 Coral Mapping Survey Grids

- 2.2 The coral mapping area (approx. 120 x 40 m) was further divided into grids for mapping the location of coral colonies inside each grid (**Figure 3**). The mapping area was divided into 20 grids, labelled as columns 1 to 4 and rows A to E.

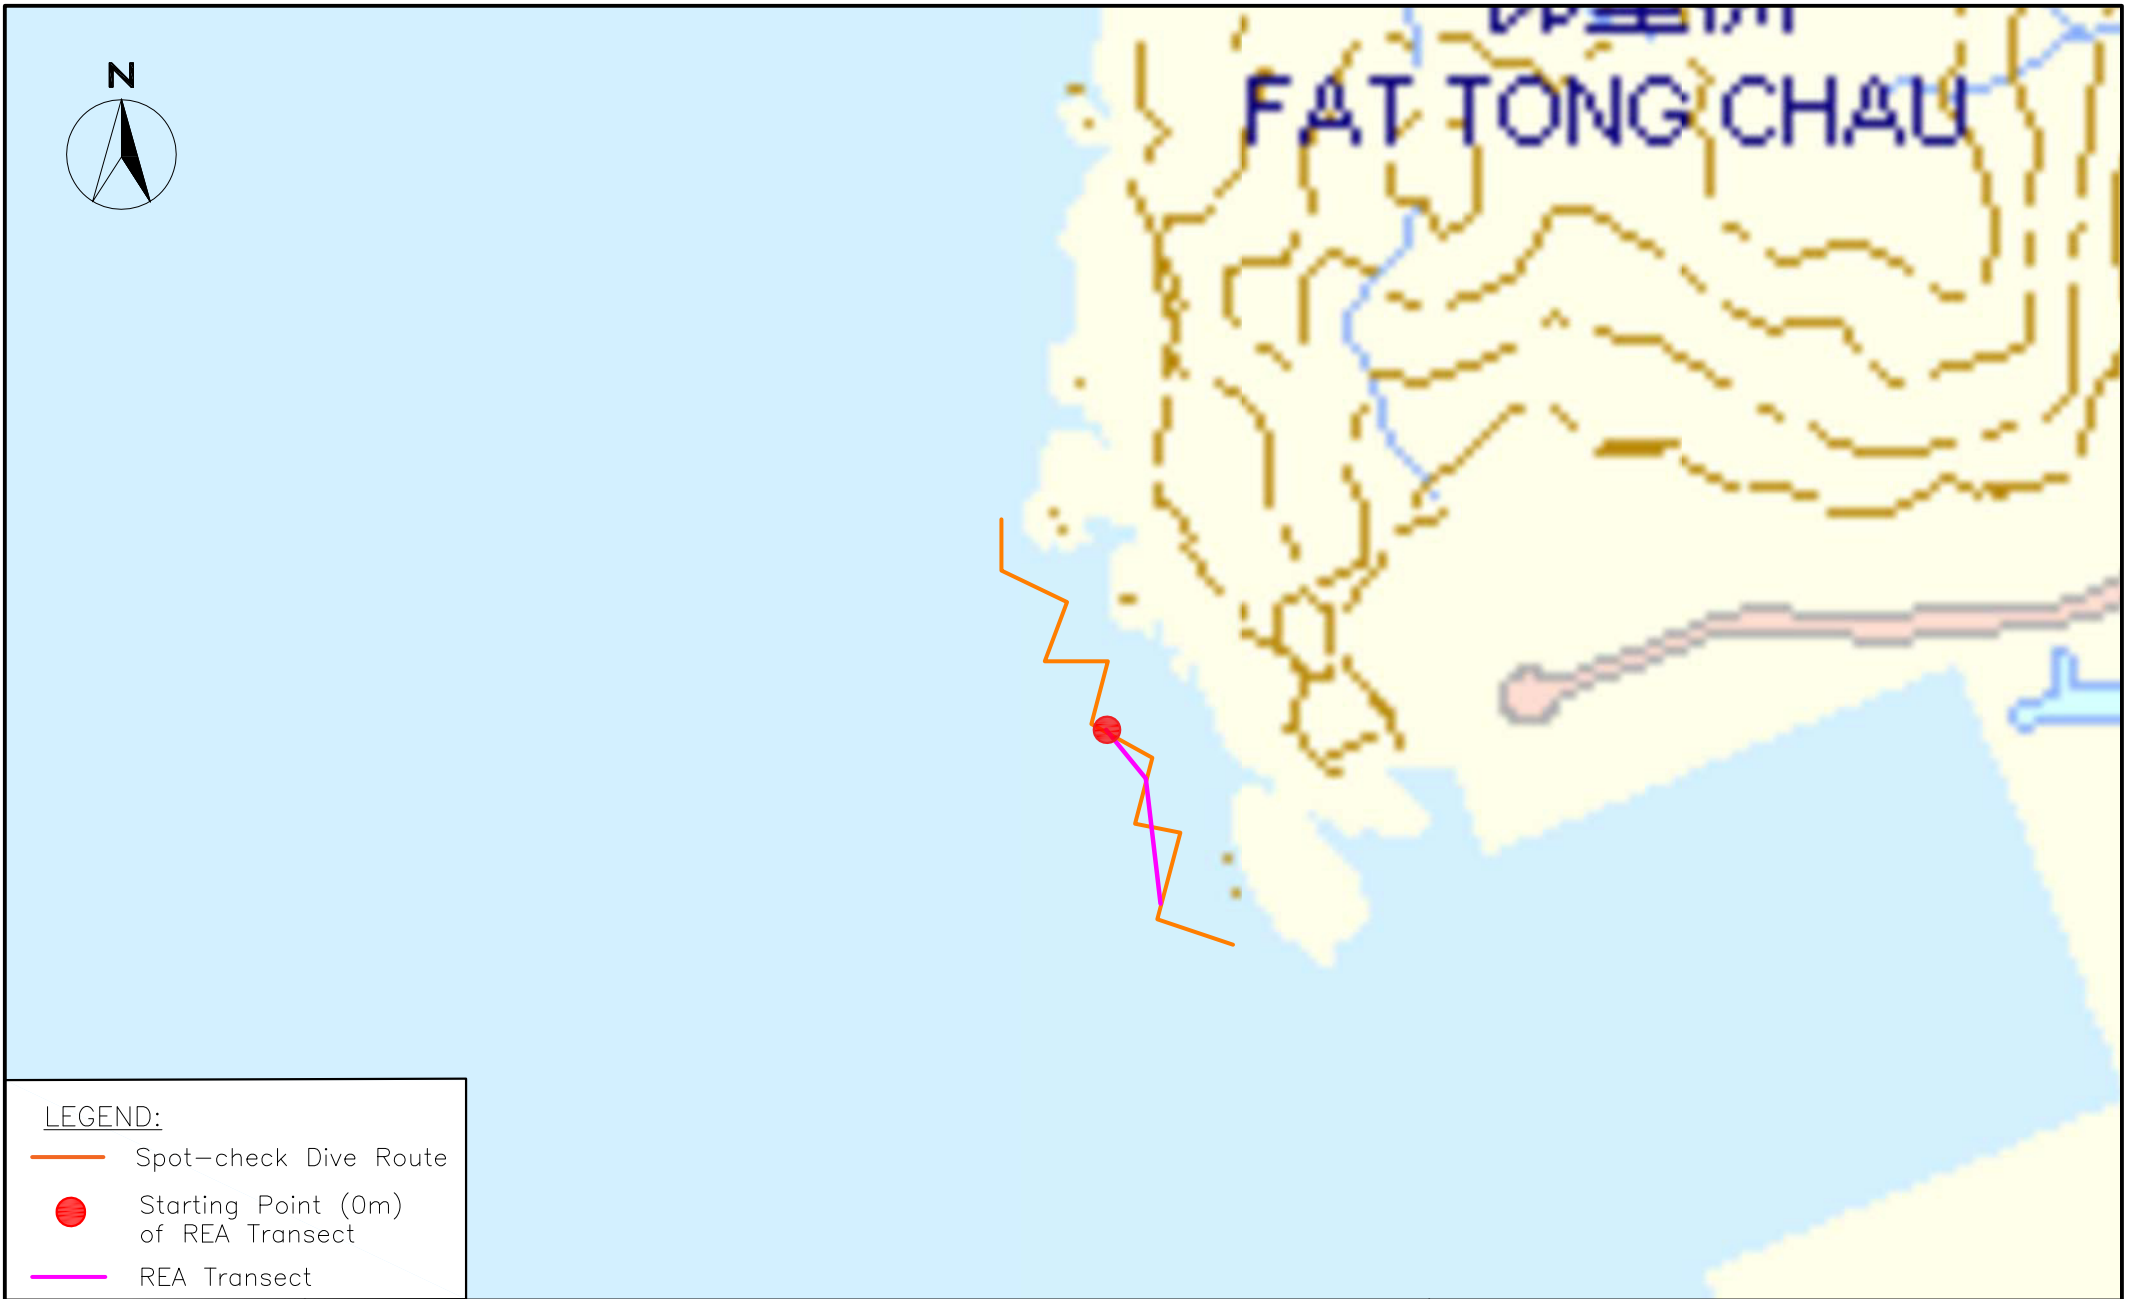
-   Spot-check Dive Route
-   Starting Point (0m) of REA Transect
-   REA Transect

- 3.2 The spot-check dive survey at Fat Tong Chau (FTC), Junk Bay was conducted on 6th March 2021. The location the spot-check dive survey is shown in **Figure 5b**.

- 3.7 The location the REA survey is shown in **Figure 5b**. Ecological and substrate attributes, and taxonomic Inventories along the REA transects at the sites are presented in **Table 3.2**. Records of coral colonies are presented in **Table 3.3**. The occurrence and size range of each observed coral species at each survey location are summarized in **Table 3.4**. Photos of the survey locations, representative taxa and corals along the transect are shown in **Appendices Ia, Ib and Ic**.
