# Monthly EM&A Report (November 2022)

**Contract No. SPW 07/2020 Environmental Team for Construction of Yuen Long Effluent Polishing Plant Stage 1**

**Independent Environmental Checker for Construction of Yuen Long Effluent Polishing Plant Stage 1 (2022-2023)**

**EP Condition 3.4 – Monthly EM&A Report for November 2022**

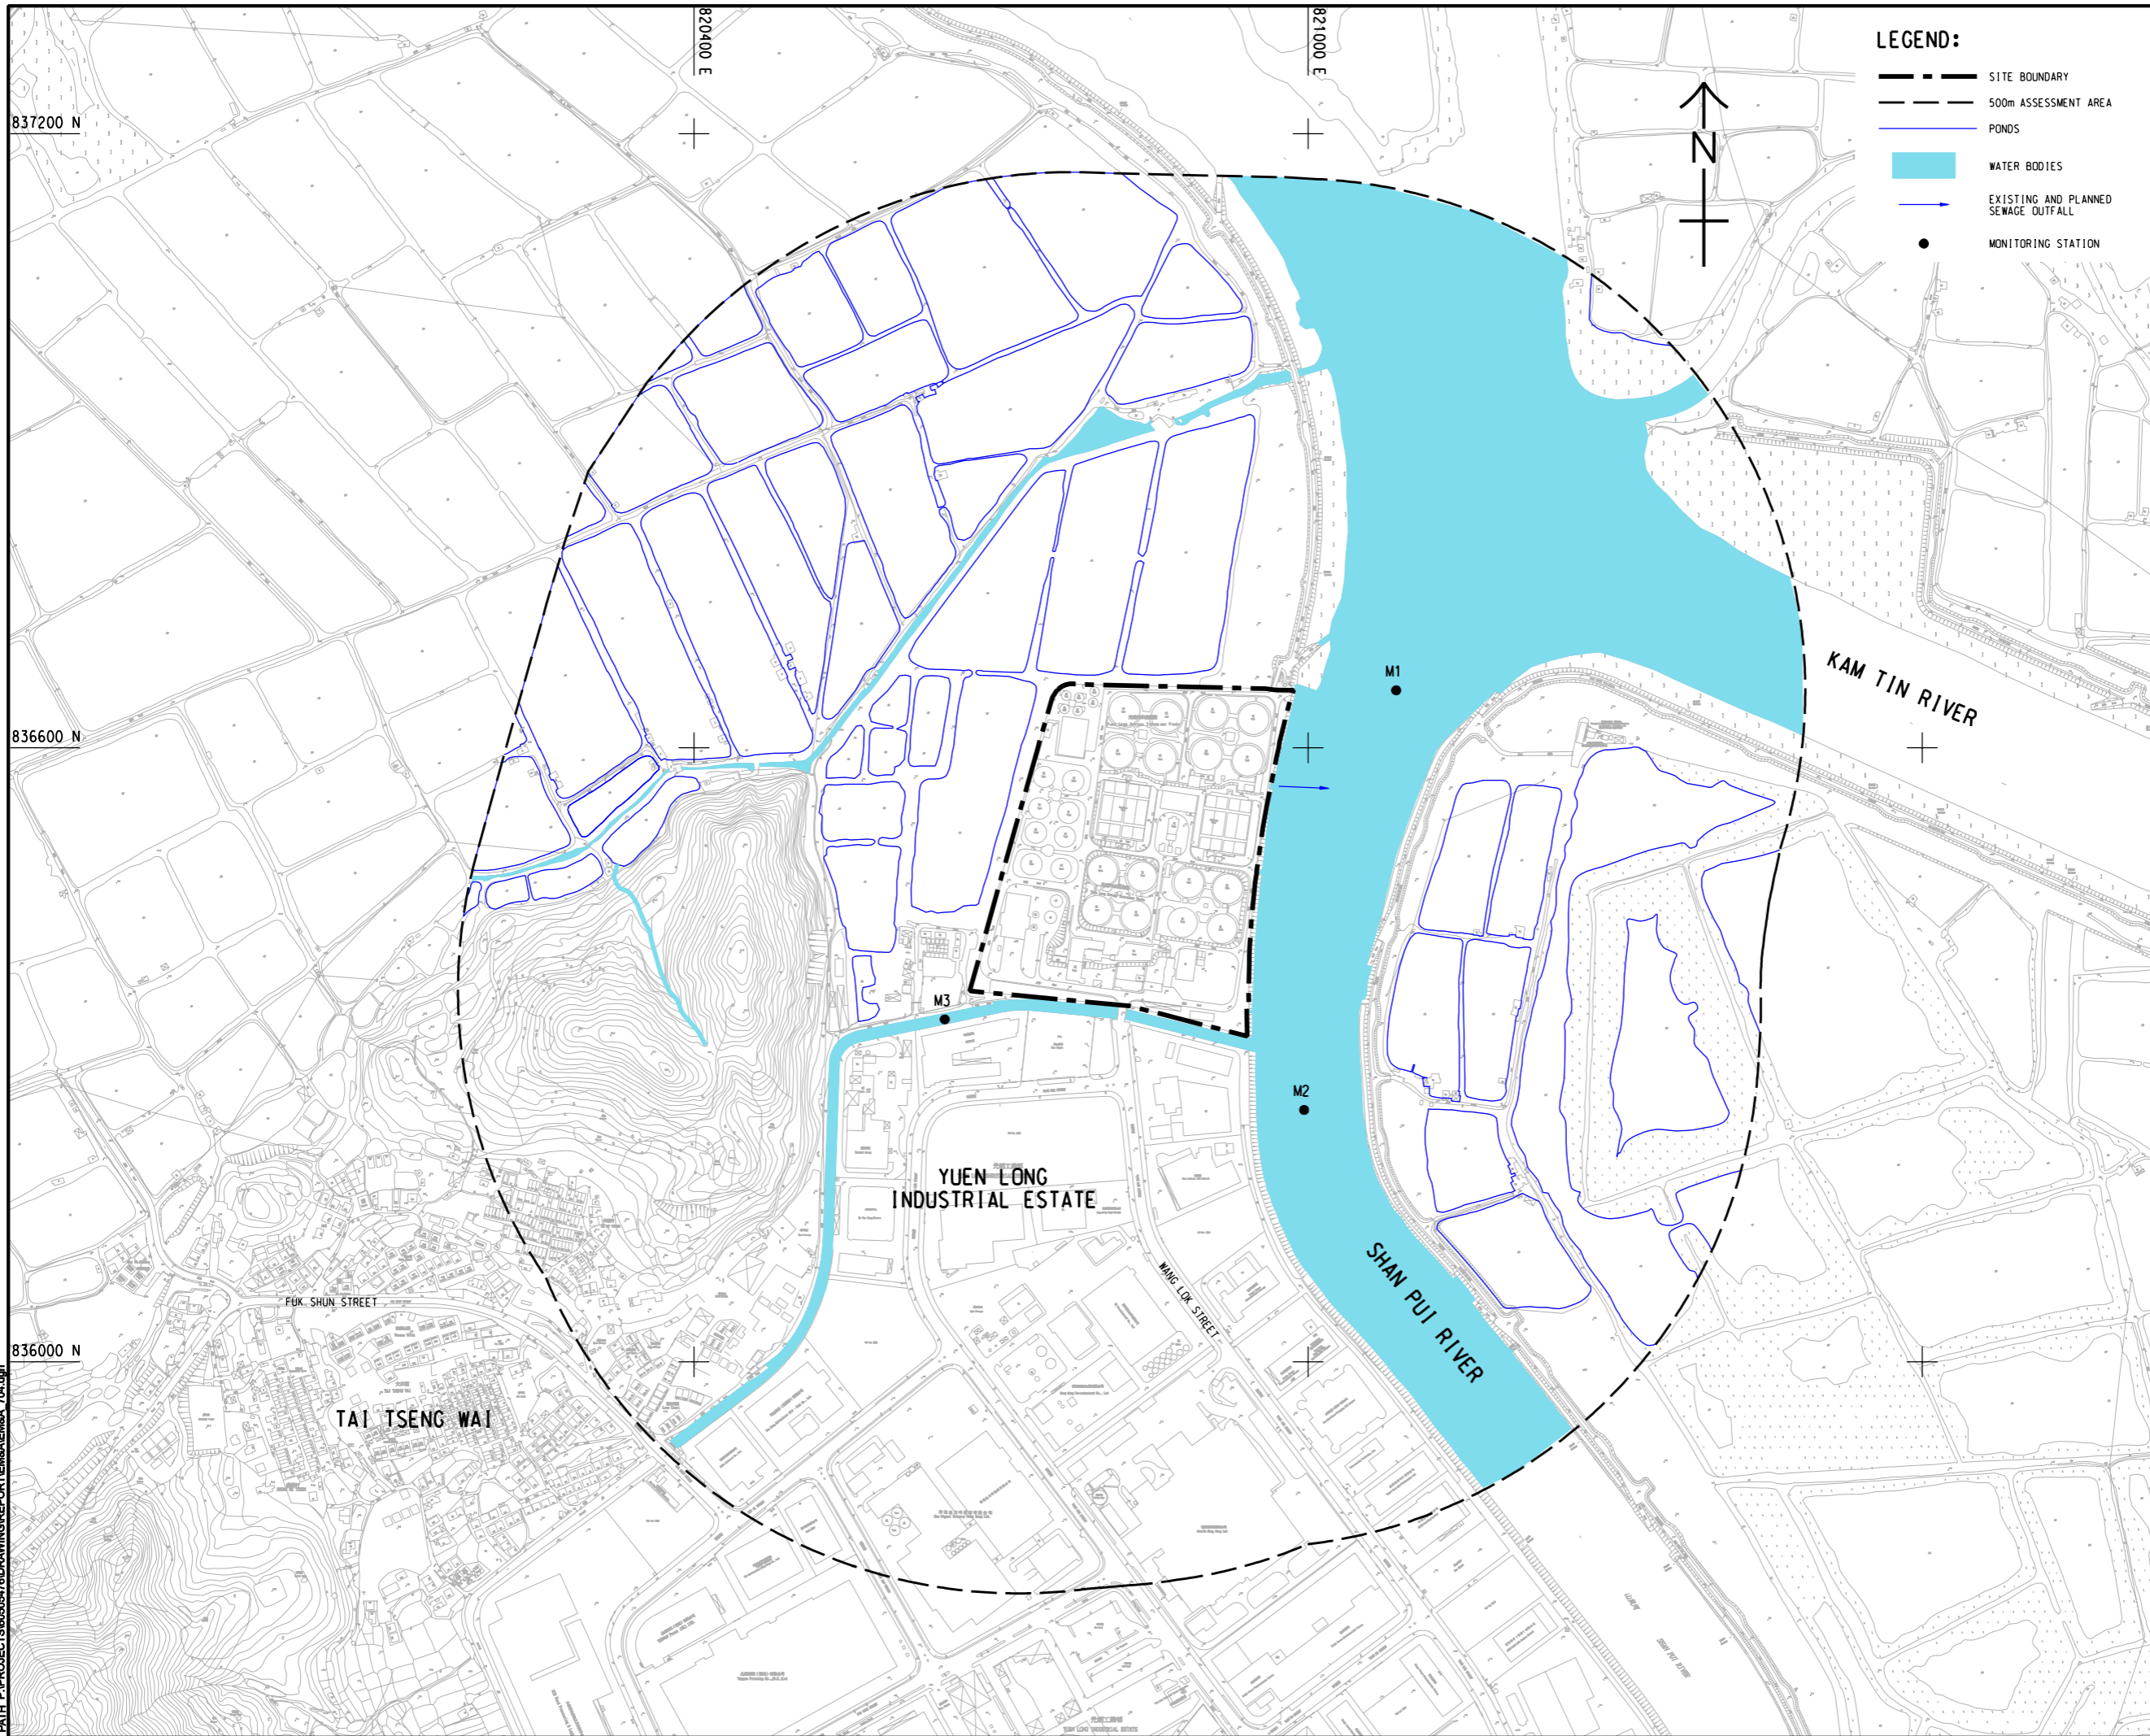
Water Quality Monitoring Locations

- SITE BOUNDARY
- 500m ASSESSMENT AREA
- PONDS
- WATER BODIES
- EXISTING AND PLANNED SEWAGE OUTFALL
- MONITORING STATION

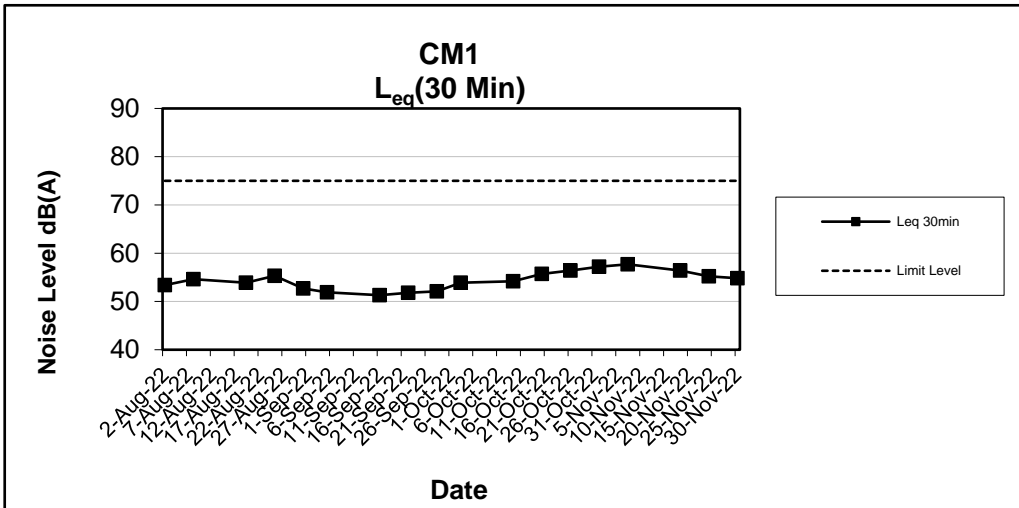
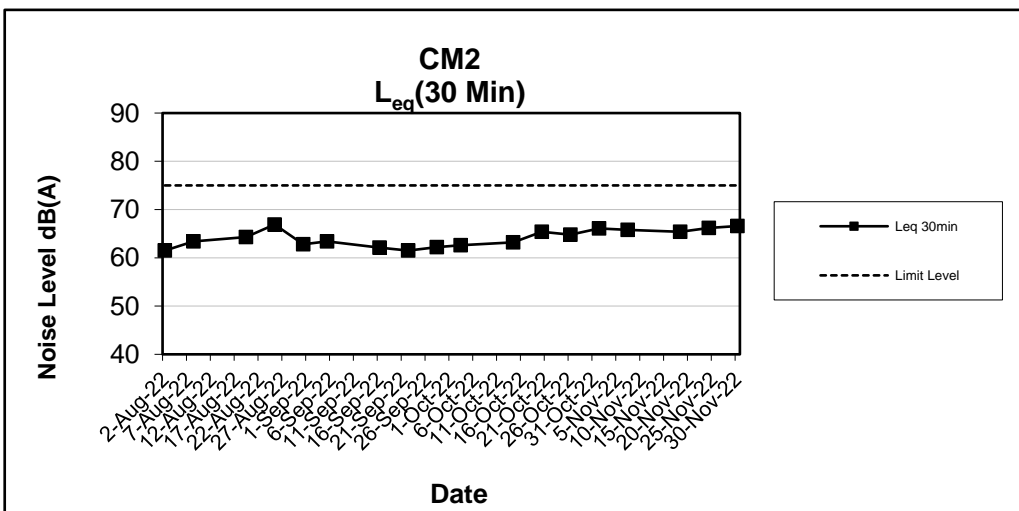
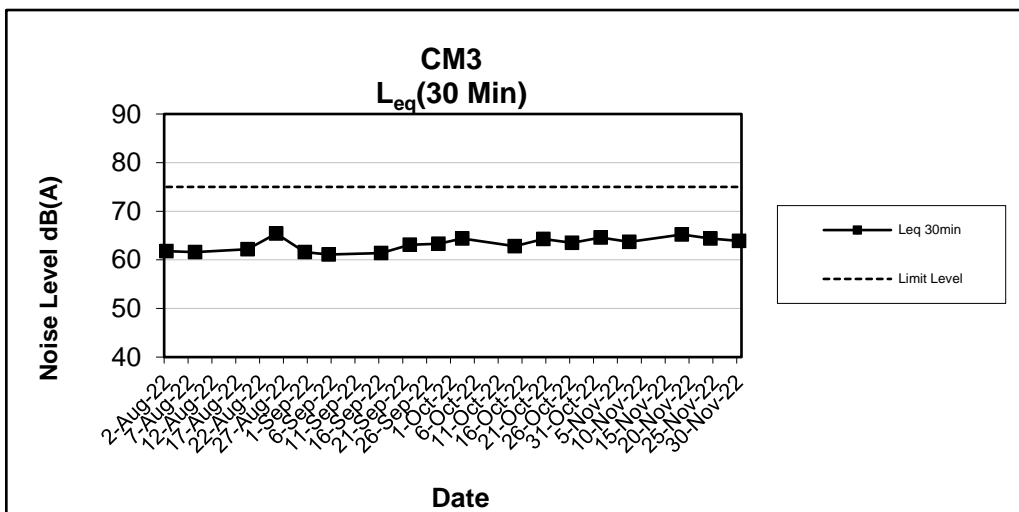
**Noise Monitoring Results**

CM1, CM2 and CM3: Free-field measurement (+3dB(A) correction has been applied).

No raining or wind with speed over 5 m/s was observed during noise monitoring according to the onsite observation.

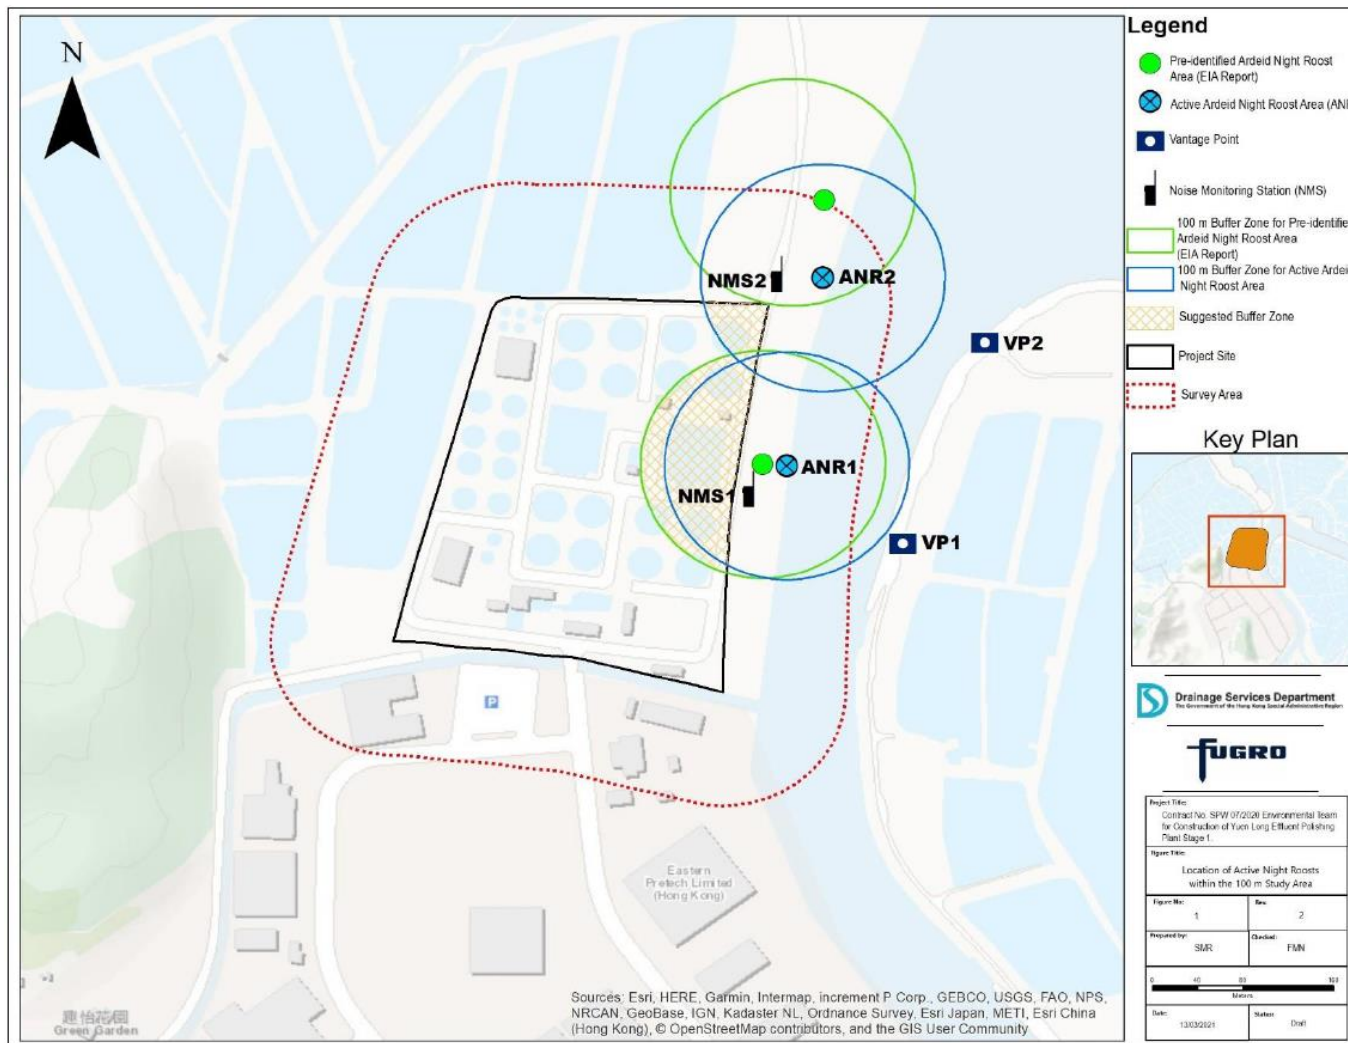
**O.1 Map of the Monitoring Area, Vantage Points for Observation of Active Night Roosts and Noise Monitoring Stations**

Appendix O.1: Monitoring Area, Vantage Points for Observation of Active Night Roosts and Noise Monitoring Stations

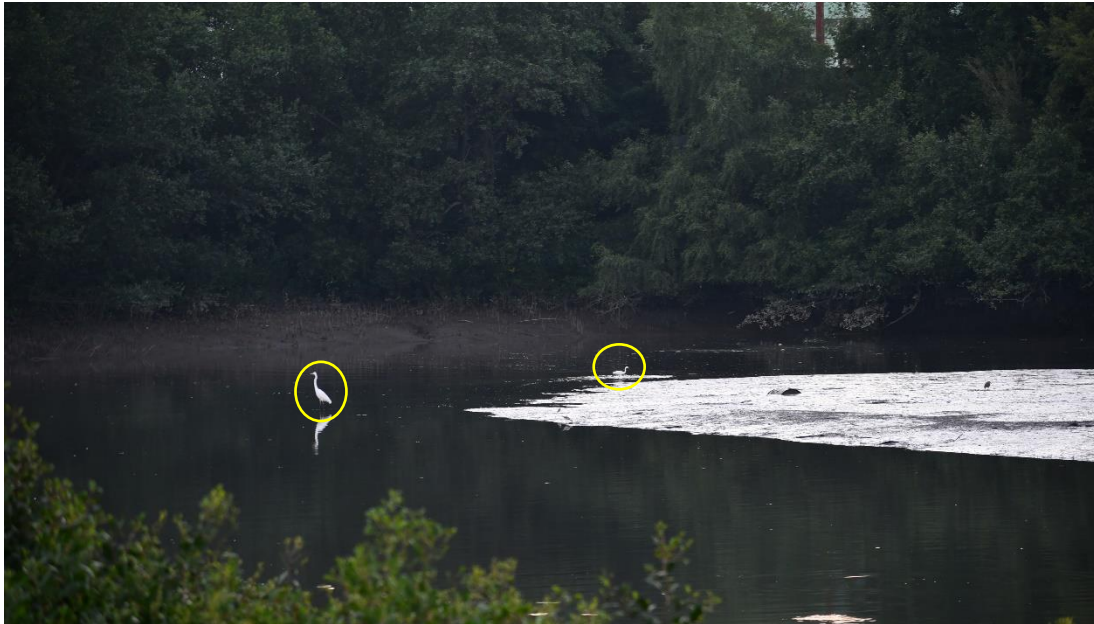
Appendix O.2.1a: Pre-roost aggregate of Little Egret *Egretta garzetta* and Great Egret *Ardea alba* in the mudflat area east of the Project boundary observed on 11 November 2022 around 17:20

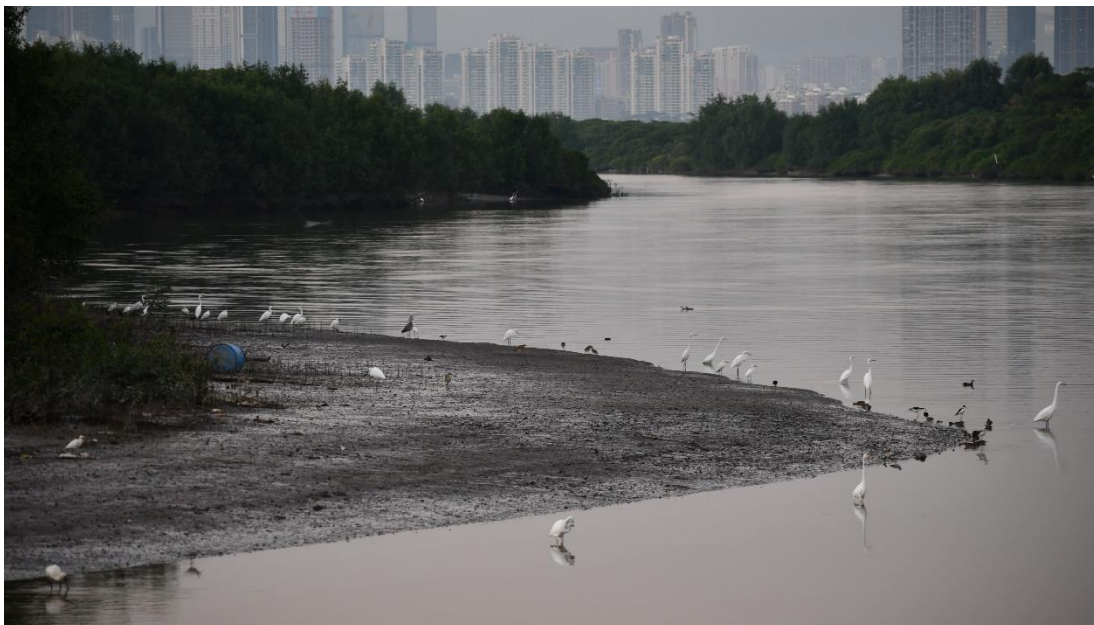
Appendix O.2.1b: Pre-roost aggregate of Great Egret *Ardea alba*, Little Egret *Egretta garzetta* and Grey Heron *Ardea cinerea* in the mudflat area northeast of the Project boundary observed on 11 November 2022 around 17:20

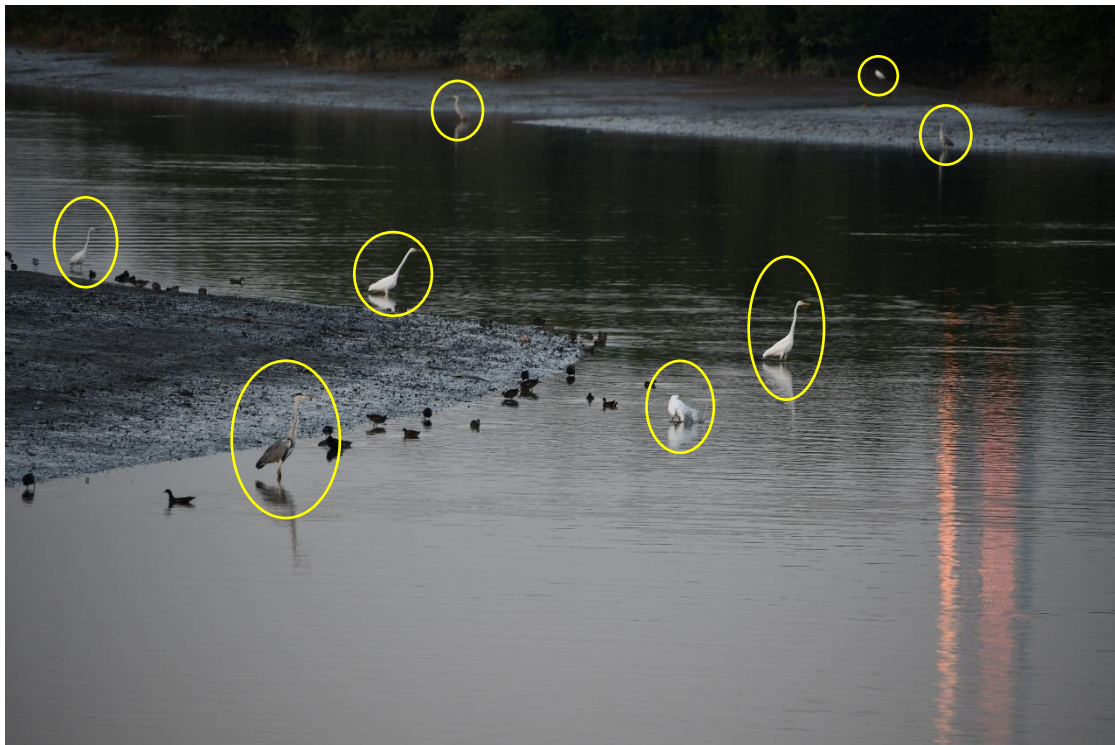
Appendix O.2.1c: Pre-roost aggregate of Great Egret *Ardea alba*, Little Egret *Egretta garzetta* and Grey Heron *Ardea cinerea* in the mudflat area northeast of the Project boundary observed on 11 November 2022 around 17:20

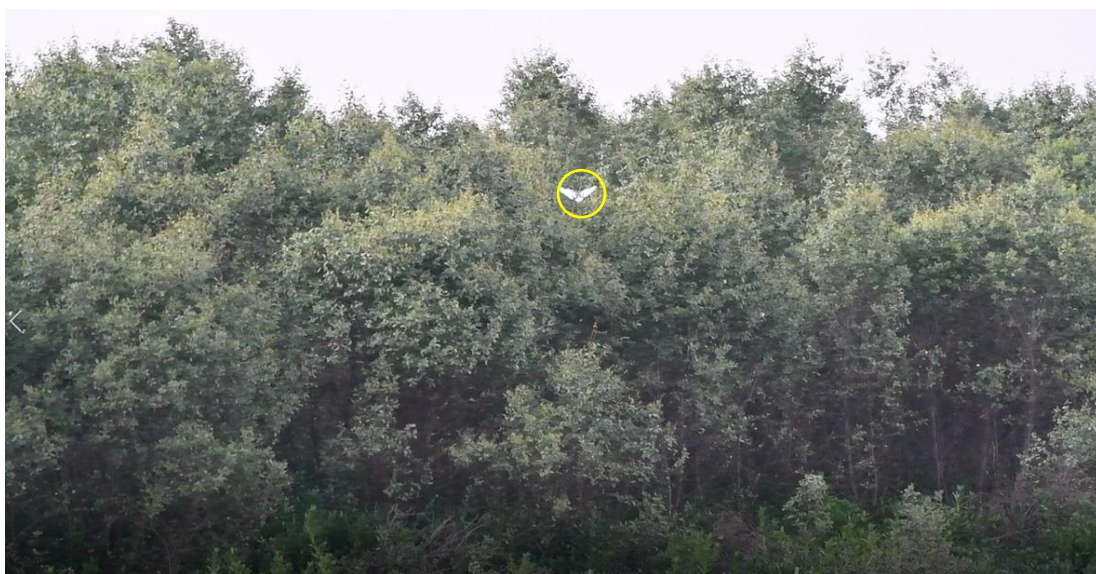
For the final night roost at around 17:40, one individual of Grey Heron *Ardea cinerea* were observed at the roosting area ANR1 utilizing the understory to canopy layer of the roosting substrate *Sonneratia apetala* and *S. caseolaris*; while seven individuals of Chinese Pond Heron *Ardeola bacchus*, seven individuals of Little Egret *Egretta garzetta*, and three individuals of Great Egret *Ardea alba* were also noted at ANR2 that utilized the understory layer of the aforementioned roosting substrate.

No disturbance (construction related and/or otherwise) to the active night roost areas was observed during the period. Bird droppings were observed within the vicinity of the roosting area located east of the Project boundary.

Appendix O.2.2: Active night roost on *Sonneratia apetala* and *S. caseolaris* mangrove roosting substrate located northeast of the Project boundary observed on 11 November 2022 around 17:40

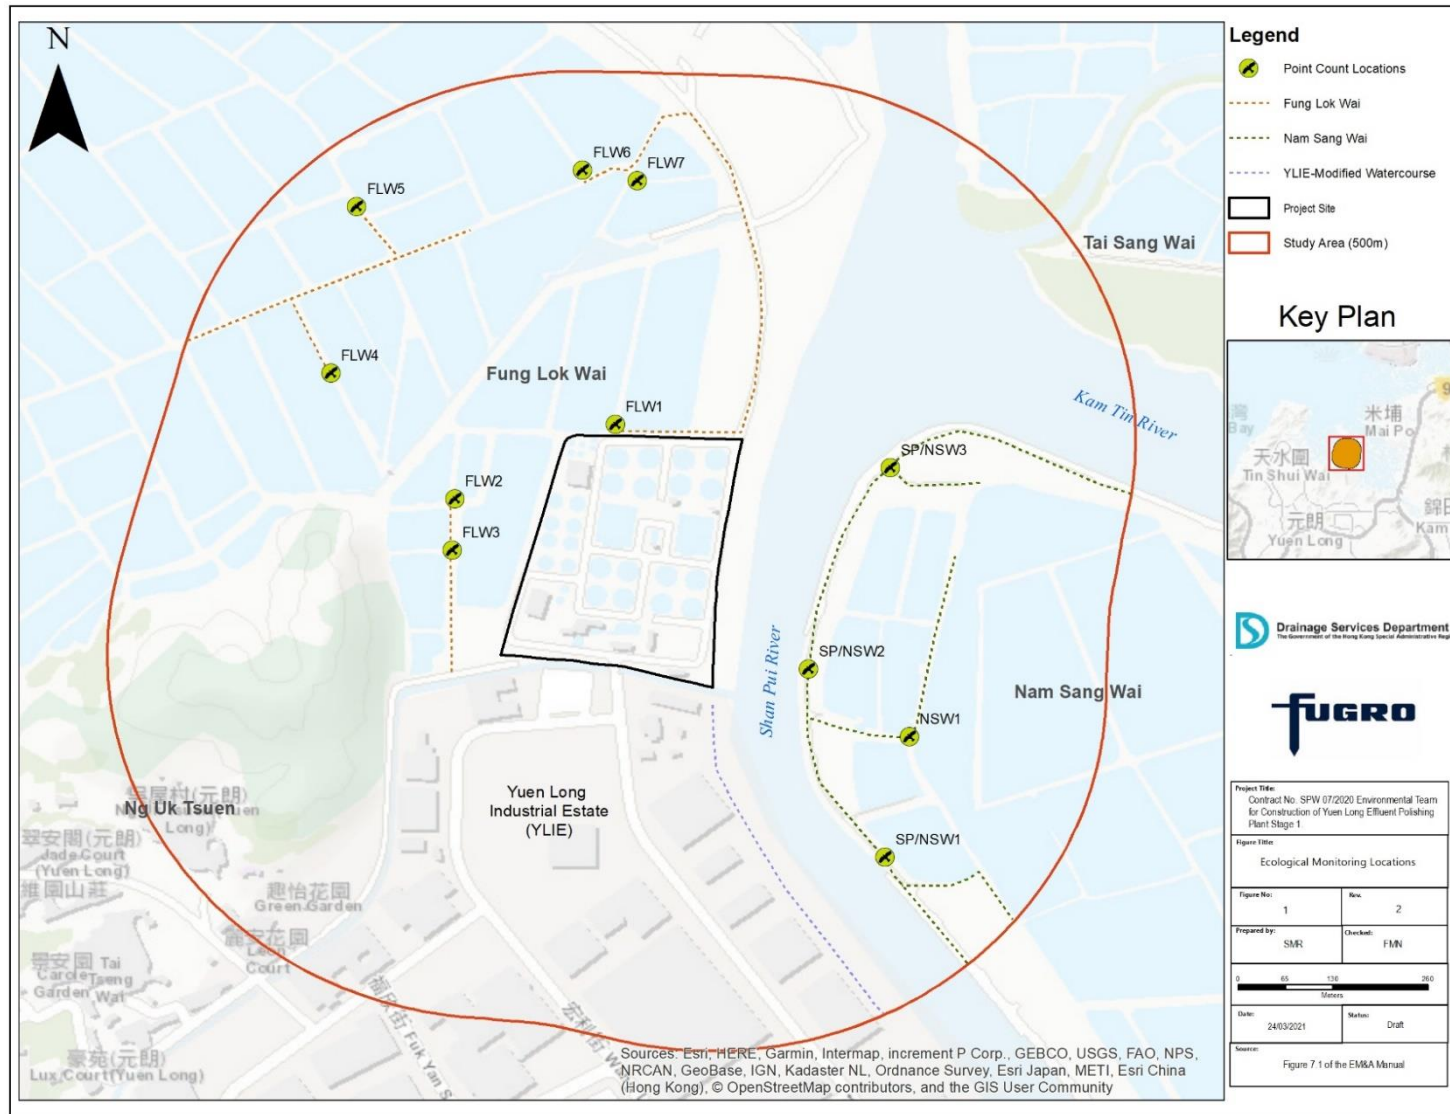
Ecological Bird Monitoring Area with Locations  
of Point Count Sites and Transect Routes

Appendix P: Ecological bird monitoring area with the locations of point count sites and transect routes
