# Monthly EM&A Report (December 2022)

**Contract No. SPW 07/2020 Environmental Team for Construction of Yuen Long Effluent Polishing Plant Stage 1**

**Independent Environmental Checker for Construction of Yuen Long Effluent Polishing Plant Stage 1 (2022-2023)**

**EP Condition 3.4 – Monthly EM&A Report for December 2022**

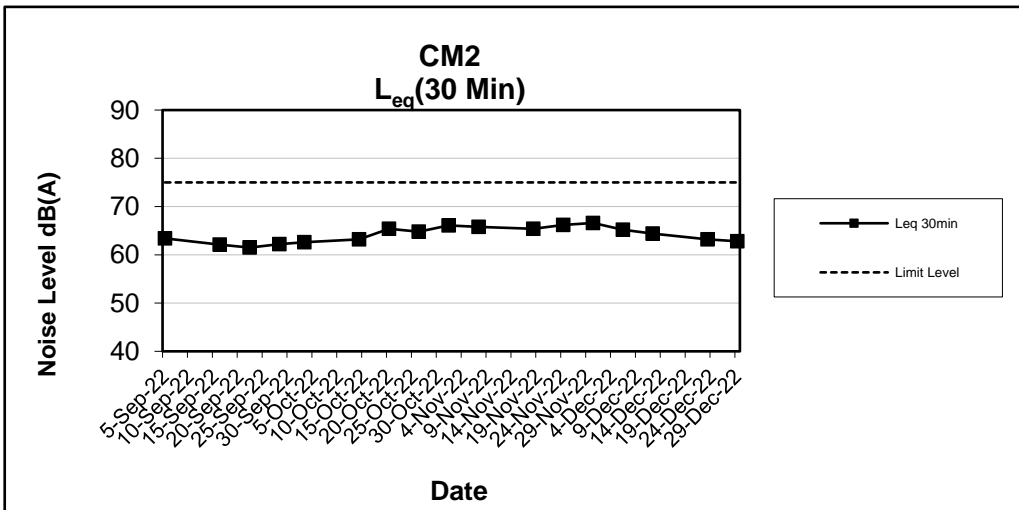
**Noise Monitoring Results**

CM1, CM2 and CM3: Free-field measurement (+3dB(A) correction has been applied).

No raining or wind with speed over 5 m/s was observed during noise monitoring according to the onsite observation.

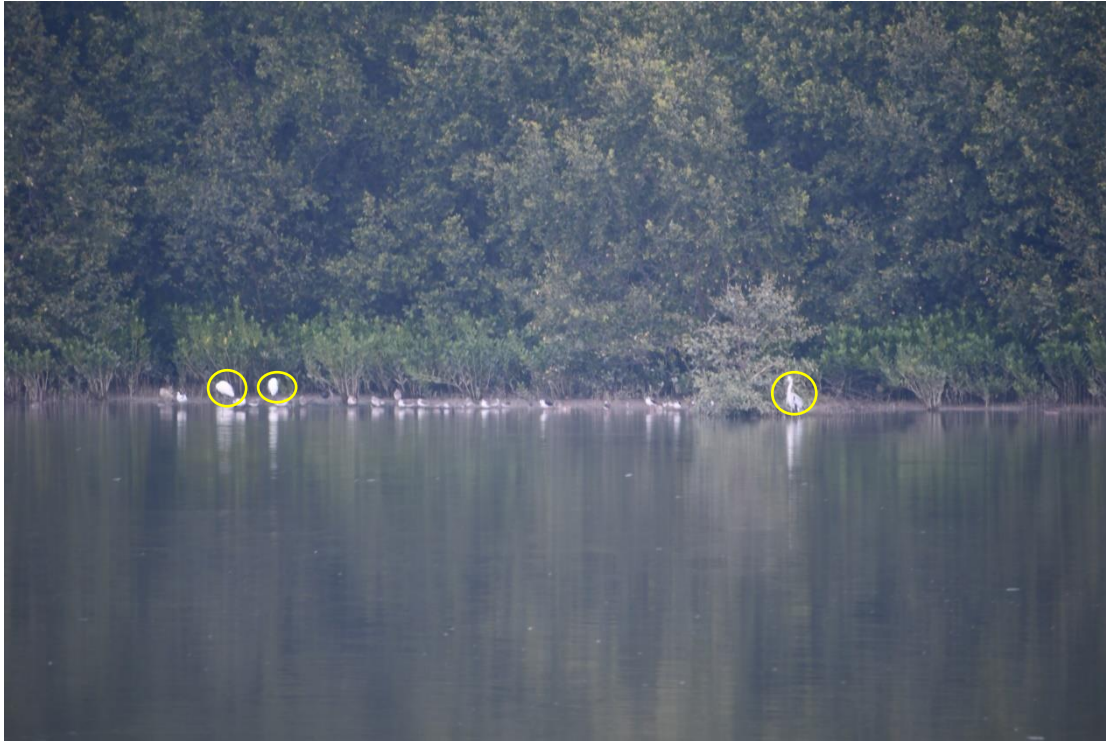
Appendix O.2.1a: Pre-roost aggregate of Great Egret *Ardea alba* and Grey Heron *Ardea cinerea* east of the Project boundary observed on 15 December 2022 around 17:20

The monitoring activity was conducted on 15 December 2022 and started around 16:42 (one hour before sunset) on a high tide condition. During the pre-roost period (PRP), the period when avian individuals gather first before flying into a night roost, four Great Egret *Ardea alba* and two Grey Herons *Ardea cinerea* were observed in pre-roost aggregate (PRA) around 17:20 at the east side (ANR1) of the Project boundary while two Great Egrets *Ardea alba*, and four Grey Heron *Ardea cinerea* were concurrently noted at the northeast side (ANR2) of the Project boundary during the period (**Table 5.2**).

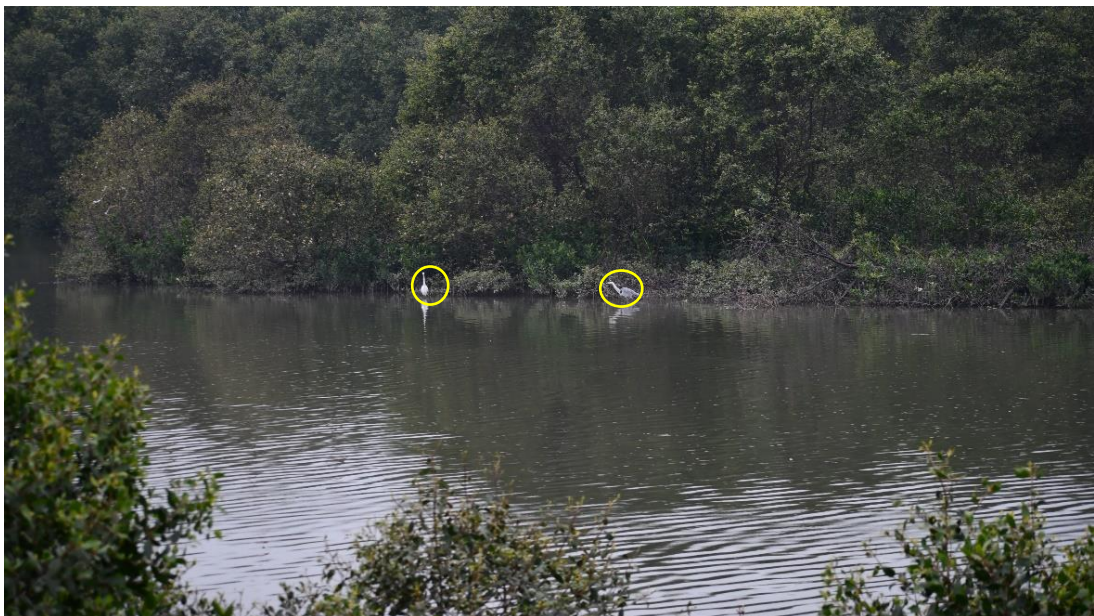
Appendix O.2.1b: Pre-roost aggregate of Great Egret *Ardea alba* and Grey Heron *Ardea cinerea* northeast of the Project boundary observed on 15 December 2022 around 17:20

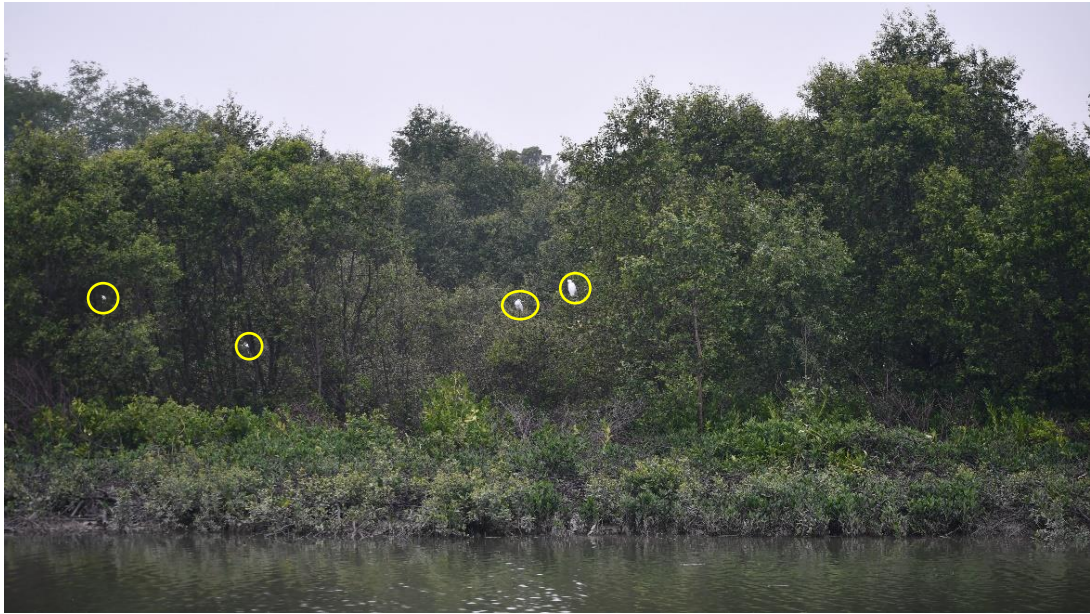
Appendix O.2.2: Active night roost on *Sonneratia apetala* and *S. caseolaris* mangrove roosting substrate located northeast of the Project boundary observed on 15 December 2022 around 17:36

For the final night roost at around 17:36, individuals of Chinese Pond Heron *Ardeola bacchus* (3), Little Egret *Egretta garzetta* (2), Great Egret (7) and Grey Heron (3) were observed at the roosting area ANR1 utilizing the understory to canopy layer of the roosting substrate *Sonneratia apetala* and *S. caseolaris*; while, other individuals of similar species Chinese Pond Heron *Ardeola bacchus* (9), Little Egret *Egretta garzetta* (7), Great Egret (6) and Grey Heron (5) were also noted at ANR2 that utilized the understory to canopy layer of the aforementioned roosting substrate.

No disturbance (construction related and/or otherwise) to the active night roost areas was observed during the period. Bird droppings were observed within the vicinity of the roosting area located east of the Project boundary.
