H2H Express Submarine Cable

Post-Project Coral Survey Report

5 August 2021

Project No.: 0586211

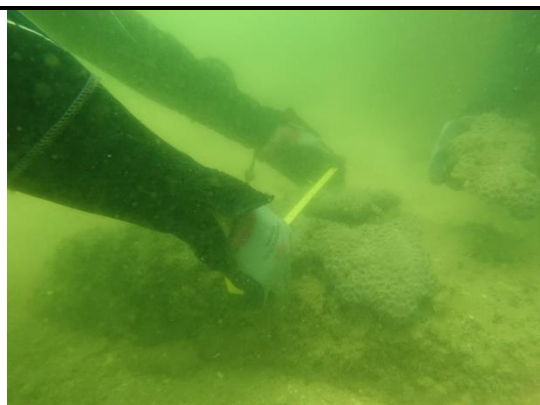
a) A diver was measuring the diameter of a coral colony.

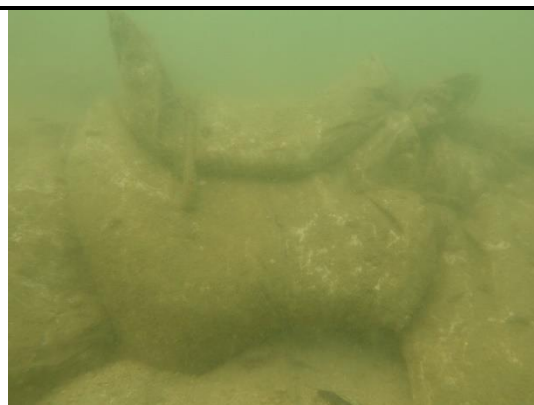
The coverage of hard corals was observed to be <5% within the Coral Survey Area. No octocoral or black coral was recorded during the survey. A number of sand bags (about 30 cm L x 30 cm W x 15 cm H), which were not recorded in the Pre-installation Coral Survey, were observed within the Coral Survey Area. There was no observed impact to the coral colonies within the Coral Survey Area due to the presence of sand bags. Overall, there is no change of hard coral coverage when compared to the Pre-installation Coral Survey conducted in March 2021.

b) Sand bags were found during the survey.

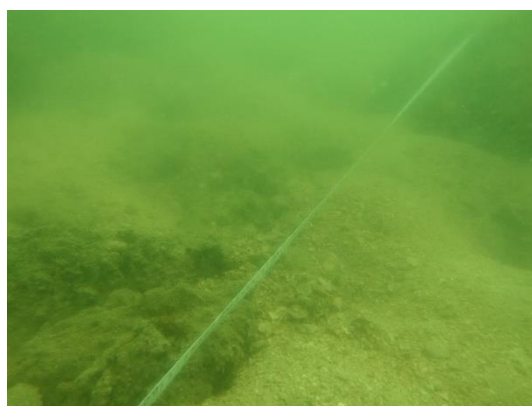
c) An overview of the substratum in the shallower region (-2 to -5 mCD) of the Coral Survey Area, composed of mainly sandy substrates and boulders / rubbles.

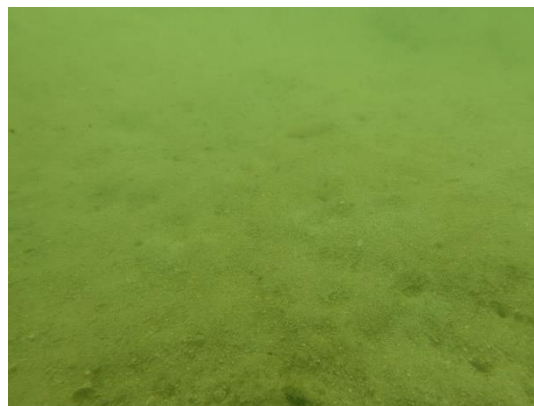
d) An overview of the substratum in the deeper region (-5 to -10 mCD) of the Coral Survey Area, composed of mainly sandy and silty substrates.
