Agreement No. CE 32/2021 (CE)
Improvement Works at Lai Chi Wo Pier and Tung Ping Chau Public Pier
- Design and Construction
Environmental Permit No. EP-586/2021
Submission of Monthly EM&A Report No. 6 for Lai Chi Wo Pier

Monthly EM&A Report No. 6 for Lai Chi Wo Pier
(5207869-OR102f -00)

**Monthly EM&A Report No. 6 for Lai Chi Wo Pier
[Period from 1 to 31 July 2022]**

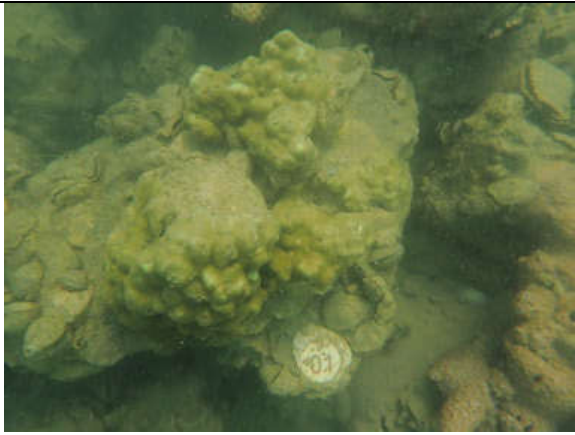
Coral No.	Translocated Coral Colony
1

An underwater photograph showing a large, irregularly shaped coral colony with a porous, yellowish-green surface. A small, circular white tag with the number '01' is attached to the lower right side of the colony. The background is dark and slightly hazy, suggesting an underwater environment.
2

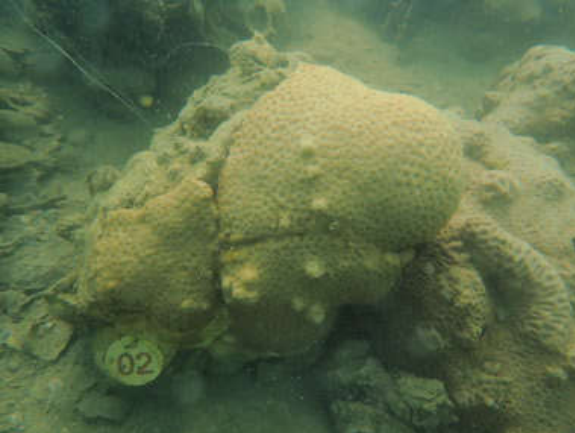
An underwater photograph of a large, rounded coral colony with a highly porous, yellowish-green texture. A small, circular green tag with the number '02' is attached to the lower left side. The surrounding water is clear, and other coral structures are visible in the background.
3

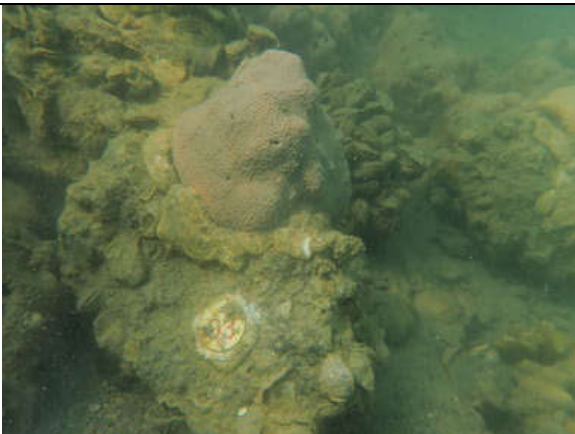
An underwater photograph of a coral colony with a smooth, rounded, light-colored top section. A small, circular yellow tag with the number '03' is attached to the lower part of the colony. The background shows a rocky seabed with other coral fragments.

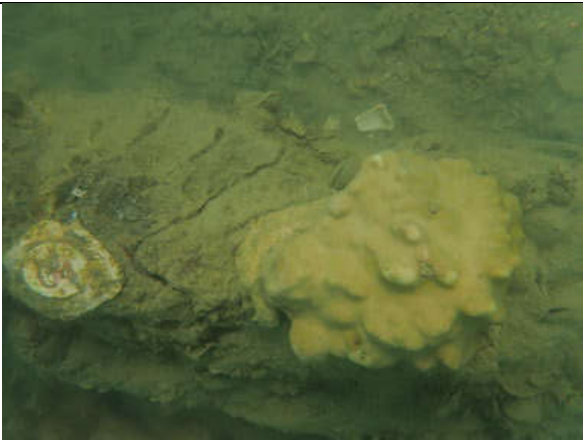
Coral No.	Translocated Coral Colony
4

An underwater photograph showing a coral colony on a rocky substrate. The coral is a pale yellowish-green color and has a somewhat rounded, irregular shape. To the left of the main colony, there is a smaller, circular, and more textured coral structure. The surrounding water is slightly turbid and greenish, and the background shows a dark, rocky seabed.

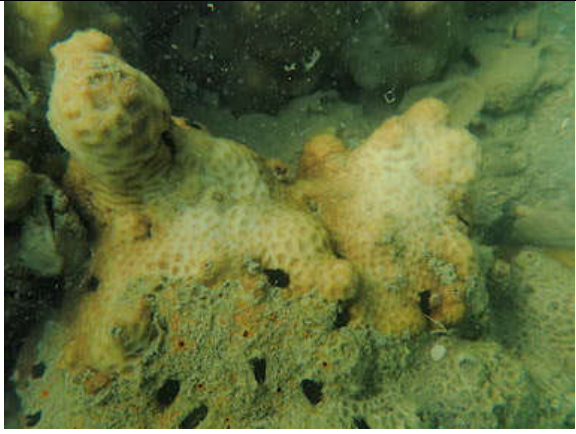
3

2.2.2.14. The tagged natural hard coral colonies existing at the recipient site were also monitored. Except the tagged natural coral colony no. 3, which showed 60% bleaching, no partial mortality, sediment or bleaching in the general condition of these existing natural coral colonies were observed during the monitoring.

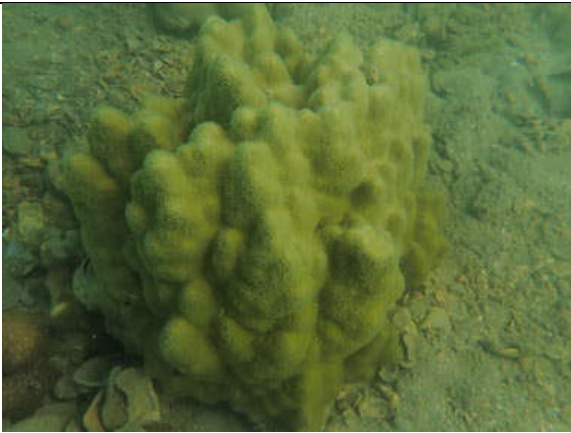
Coral No.	Tagged Natural Coral Colony
10

A photograph of a large, green, bumpy coral colony on a sandy seabed. The coral has a textured, almost cauliflower-like appearance with many small, rounded protrusions. It is situated on a light-colored, sandy bottom with some scattered debris and other smaller coral fragments visible in the background.
