Agreement No. CE 32/2021 (CE)
Improvement Works at Lai Chi Wo Pier and
Tung Ping Chau Public Pier
- Design and Construction

Monthly EM&A Report No. 9 for Lai Chi Wo Pier
(5207869-OR102i-00)

**Environmental Permit No. EP-586/2021
Environmental Certification Sheet**

**Monthly EM&A Report No. 9 for Lai Chi Wo Pier
[Period from 1 to 31 October 2022]**

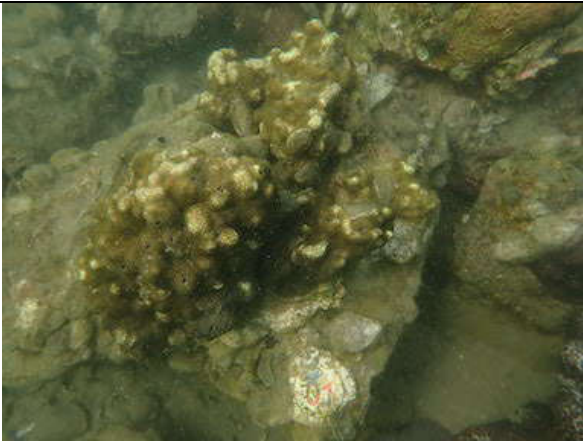
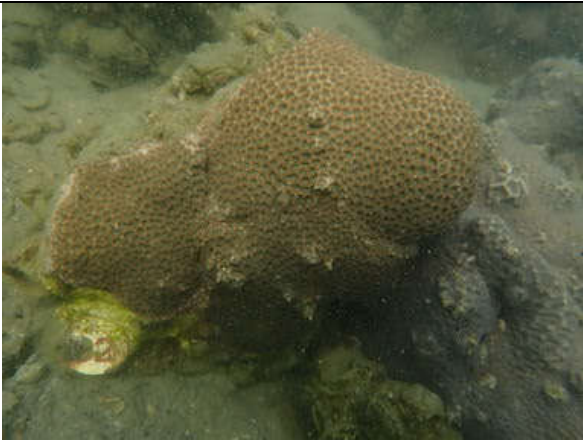
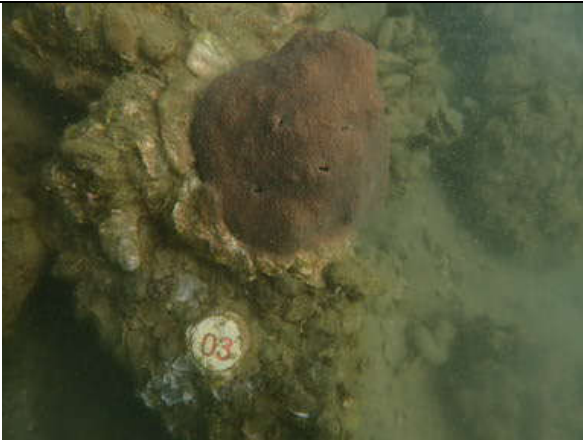
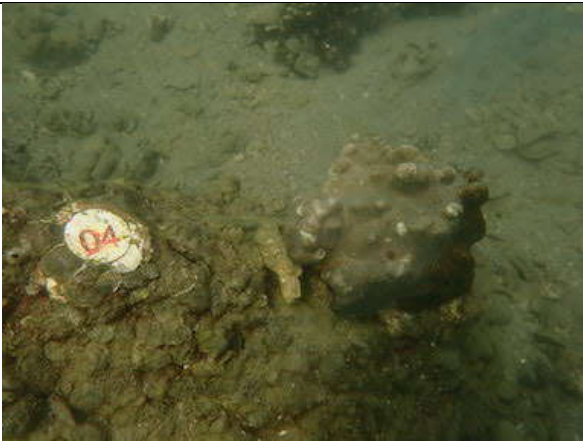
Photo Plate 1

2.2.2.13. All translocated hard coral colonies were monitored. The health condition of all the translocated coral colonies was observed to be good in general. No partial mortality, sediment or bleaching in the general condition of the translocated coral colonies were found during the monitoring.

Coral No.	Translocated Coral Colonies
1

An underwater photograph showing a coral colony with a yellowish, porous appearance. A small, circular white tag with a red border and the number '01' is attached to the coral.
2

An underwater photograph of a large, brown, dome-shaped coral colony with a regular, grid-like pattern of polyps. A small, circular white tag with a red border and the number '02' is attached to the base of the colony.
3

An underwater photograph of a dark brown, rounded coral colony. A small, circular white tag with a red border and the number '03' is attached to the base of the colony.

An underwater photograph showing a coral colony on a rocky substrate. A white circular tag with the letters 'DA' written in red is attached to the coral. The water is slightly turbid, and the background shows more of the reef structure.

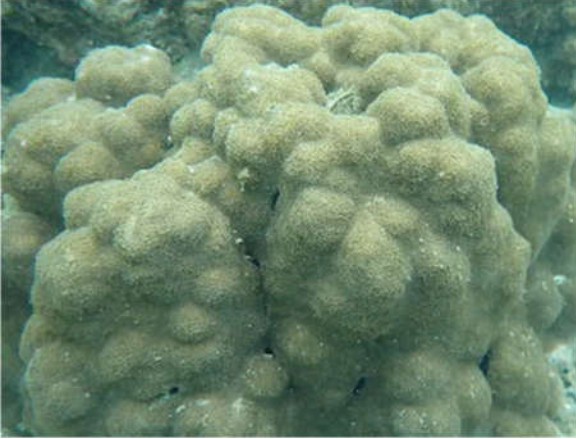
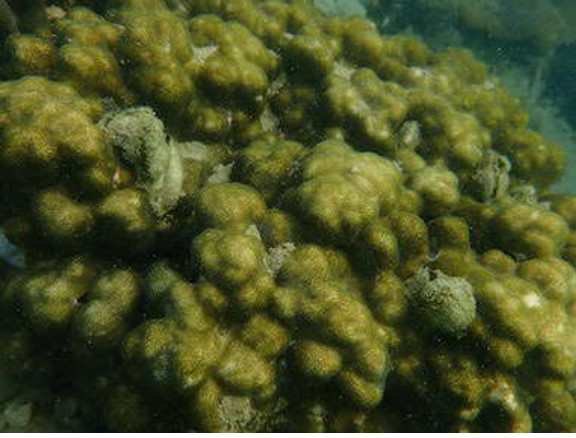
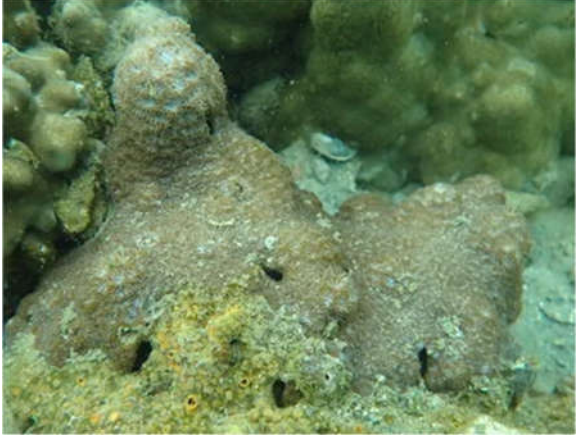
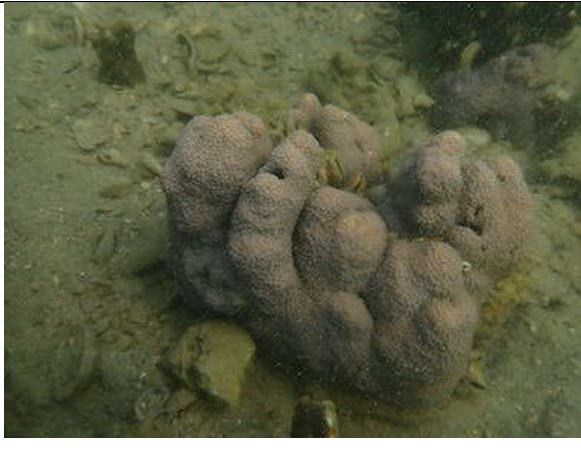
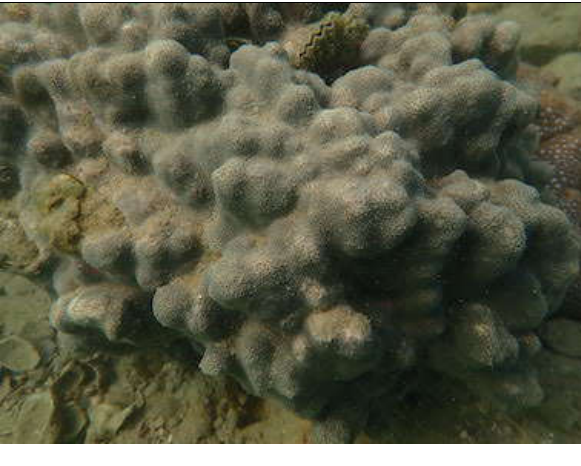
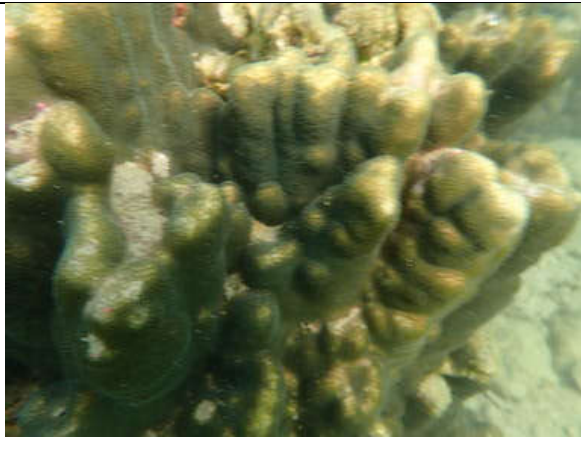
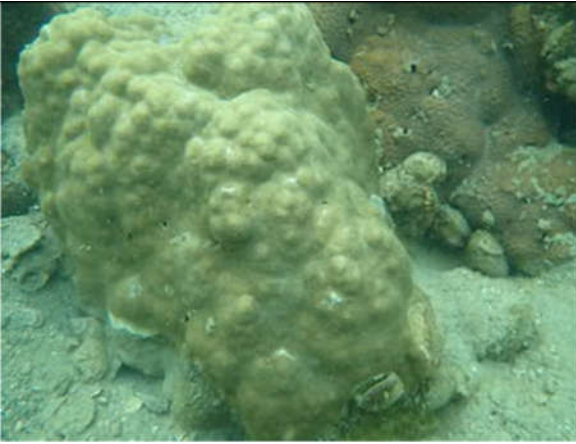
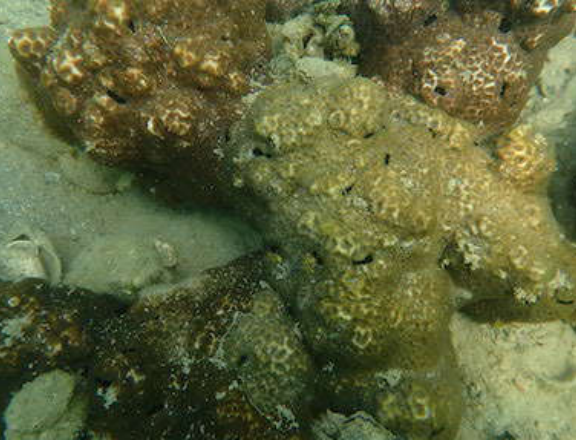
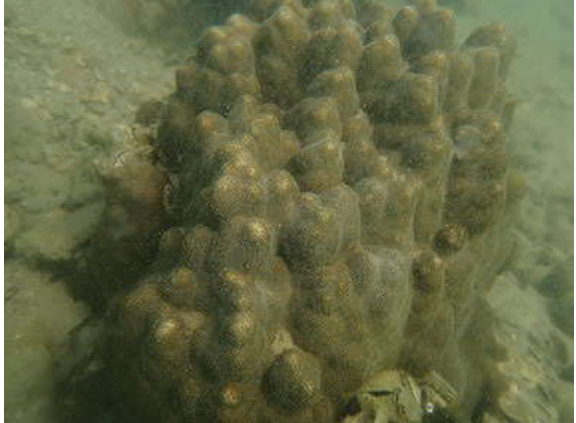
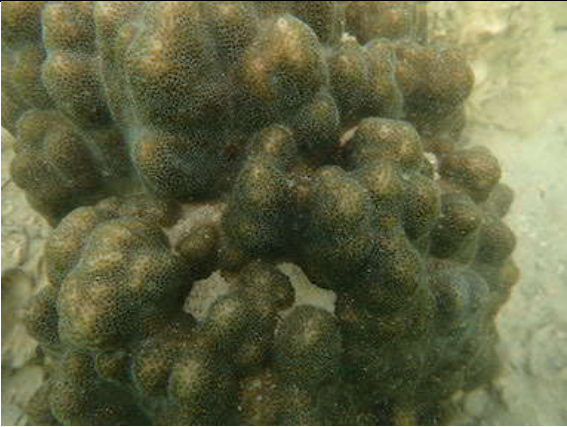
Photo Plate 2

2.2.2.14. The tagged natural hard coral colonies existing at the recipient site were also monitored. All of the tagged natural coral colonies were in good condition. No partial

mortality, sediment or bleaching in the general condition of these existing natural coral colonies were observed during the monitoring.

Coral No.	Tagged Natural Coral Colonies
1

An underwater photograph showing a large, rounded, light-colored coral colony. The coral has a bumpy, textured surface and is surrounded by other smaller coral structures in the background.
2

An underwater photograph showing a dense, yellowish-brown coral colony. The coral has a rounded, bumpy texture and is surrounded by other coral structures in the background.
3

An underwater photograph showing a large, brownish, irregularly shaped coral colony. The coral has a rough, textured surface and is surrounded by other coral structures in the background.
