Agreement No. CE 32/2021 (CE)
Improvement Works at Lai Chi Wo Pier and
Tung Ping Chau Public Pier
- Design and Construction

Monthly EM&A Report No. 12 for Lai Chi Wo Pier
(5207869-OR102I-00)

**Monthly EM&A Report No. 12 for Lai Chi Wo Pier
[Period from 1 to 31 January 2023]**

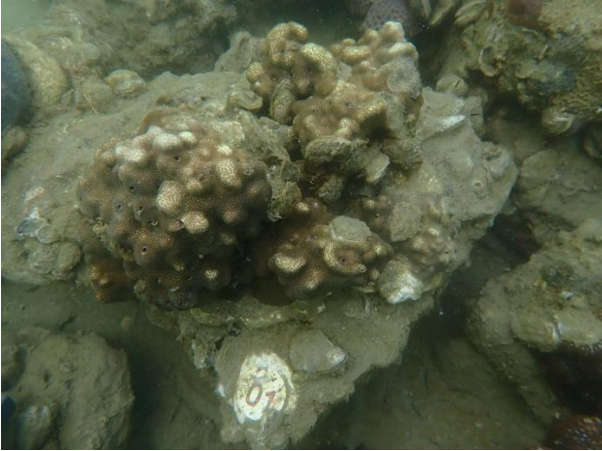
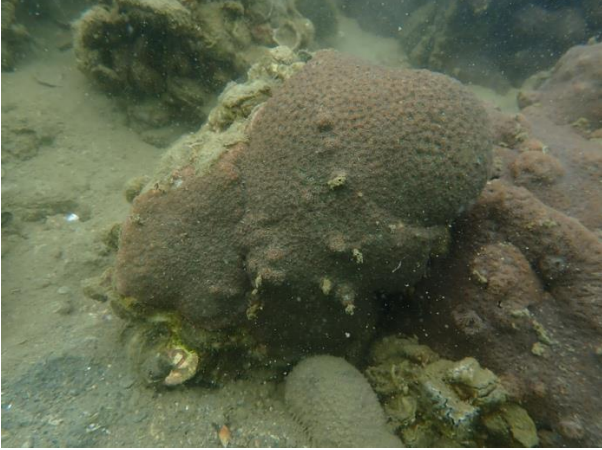
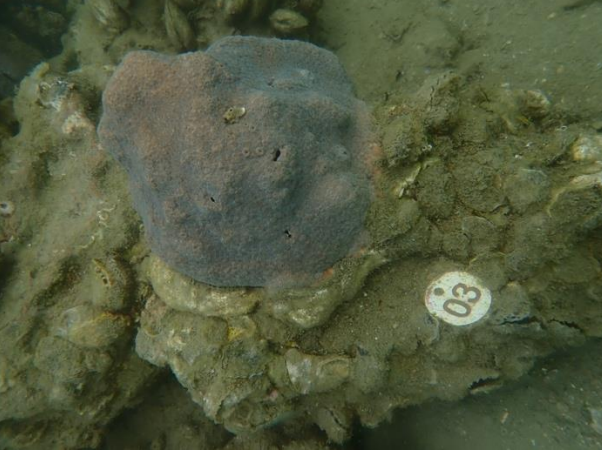
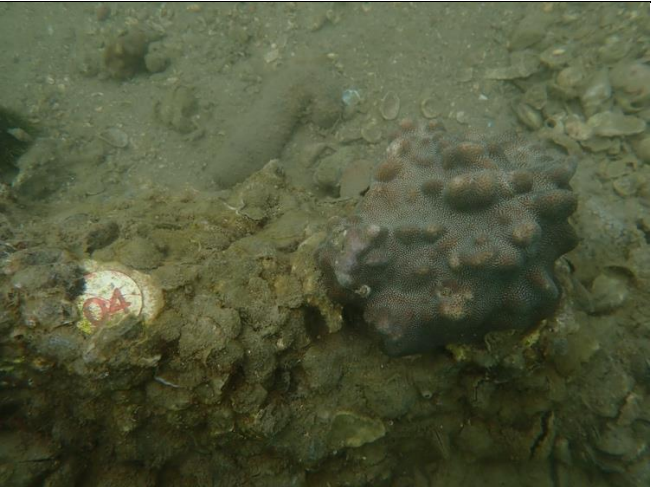
- 2.2.2.11. The translocated hard coral colonies were monitored at the recipient site, and the general health conditions (size, condition, mortality, bleaching and sediment) were recorded (**Table 2.8**). Photos of each translocated coral colony taken during the post-translocation monitoring are shown in Photo Plate 1 of **Appendix D2**.
- 2.2.2.12. The tagged natural hard coral colonies existing at the recipient site were also monitored and photos of each coral colony taken during the post-translocation

2.2.2.13. All translocated hard coral colonies were monitored. The health condition of all the translocated coral colonies was observed to be good in general. No partial mortality, sediment or bleaching in the general conditions of the translocated coral colonies were found during the monitoring.

- 2.2.2.15. No exceedance of Action or Limit Level for coral post-translocation monitoring was recorded in the reporting period.
- 2.2.2.16. As the general condition of translocated coral colonies were good with no partial mortality, sediment or bleaching observed throughout the 1-year post-translocation monitoring (**Table 2.10**), the coral translocation is concluded to be successful and no further monitoring is required. All the tags on the corals were removed after the last monitoring survey.

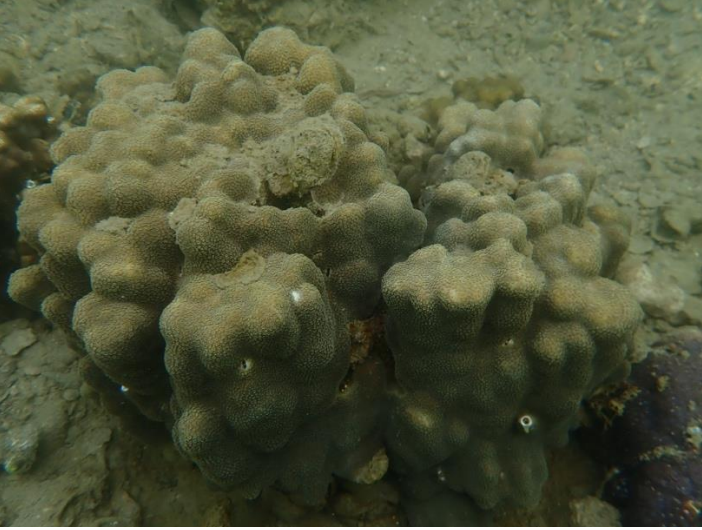
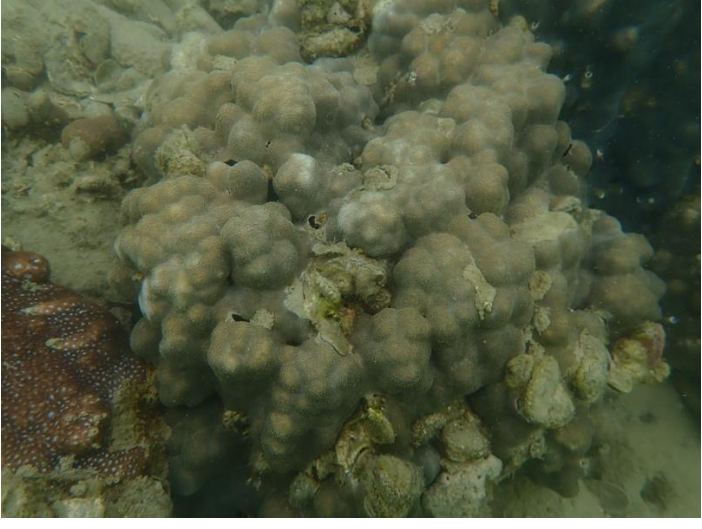
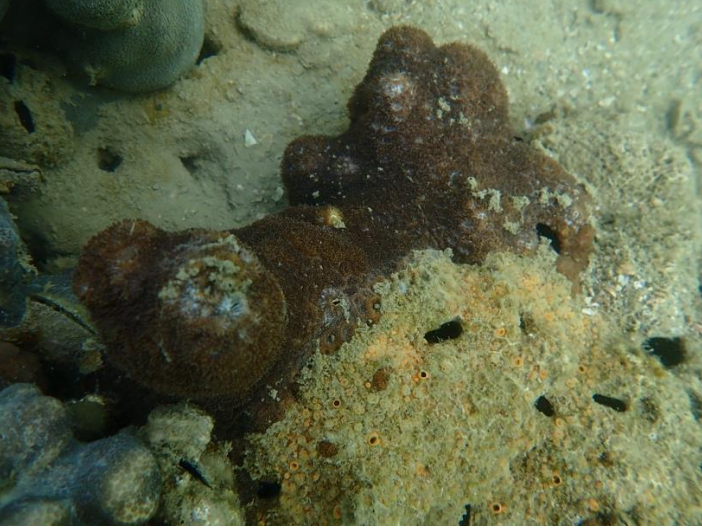
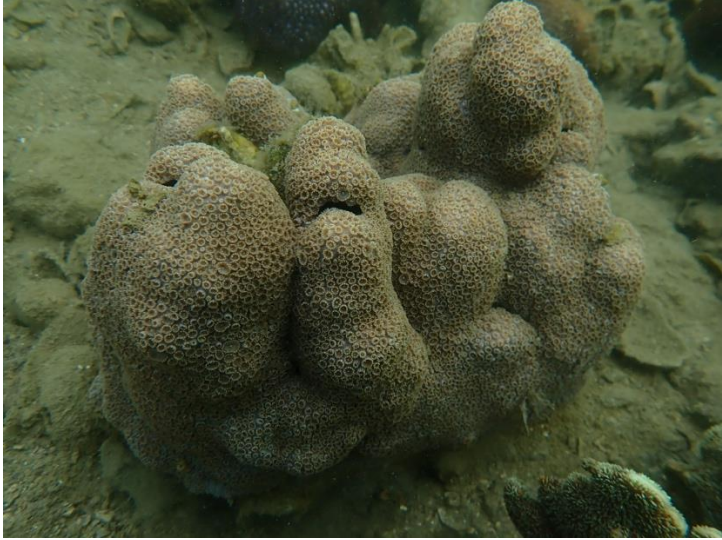
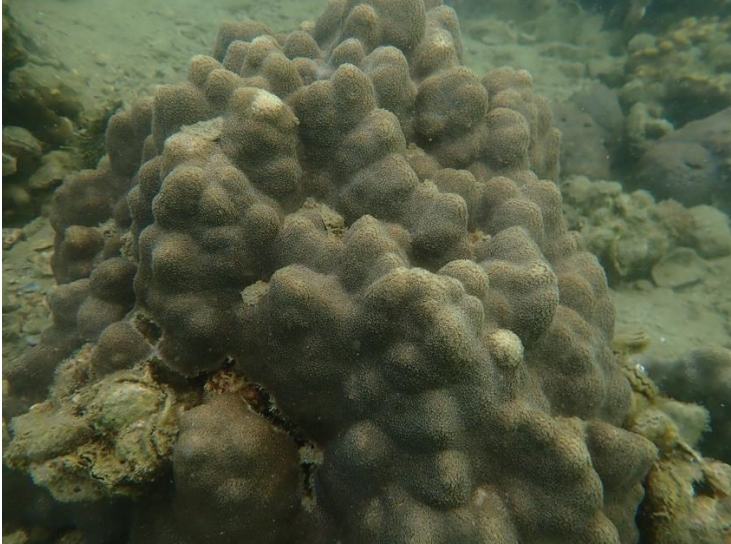
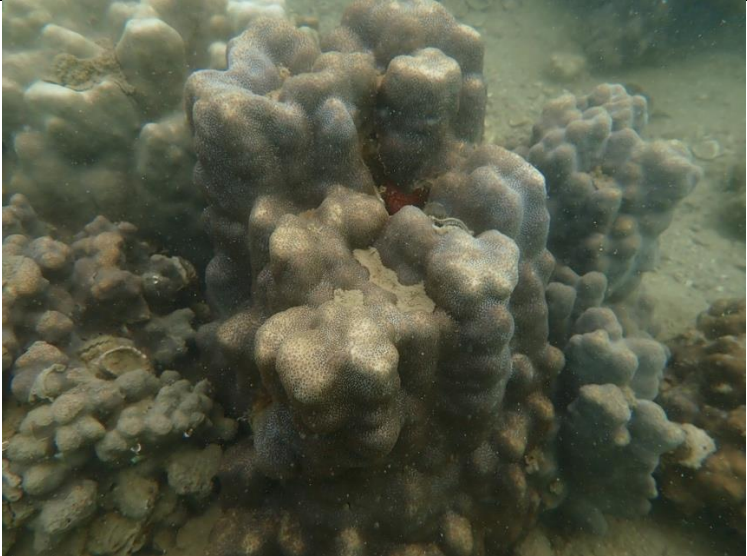
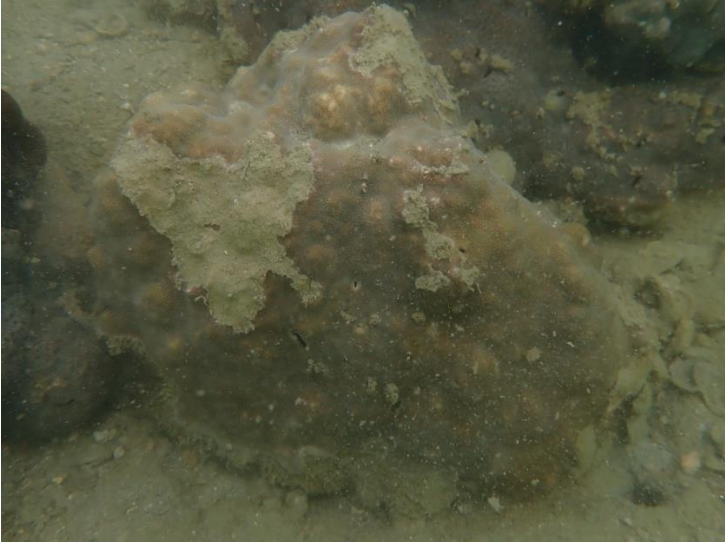
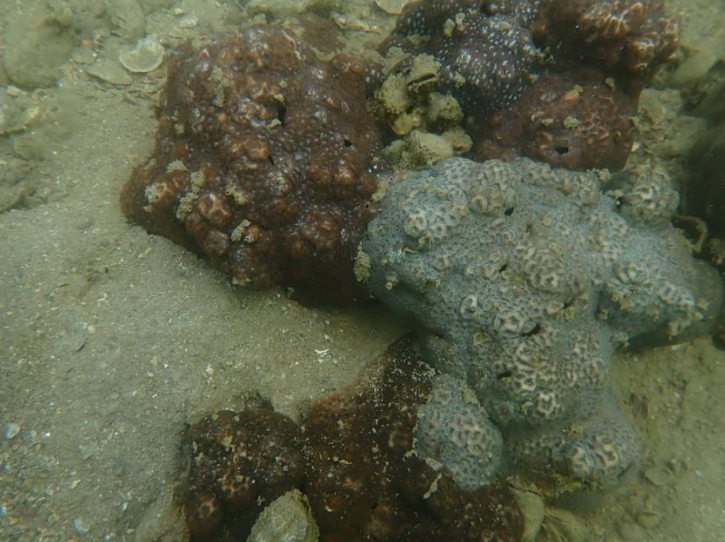
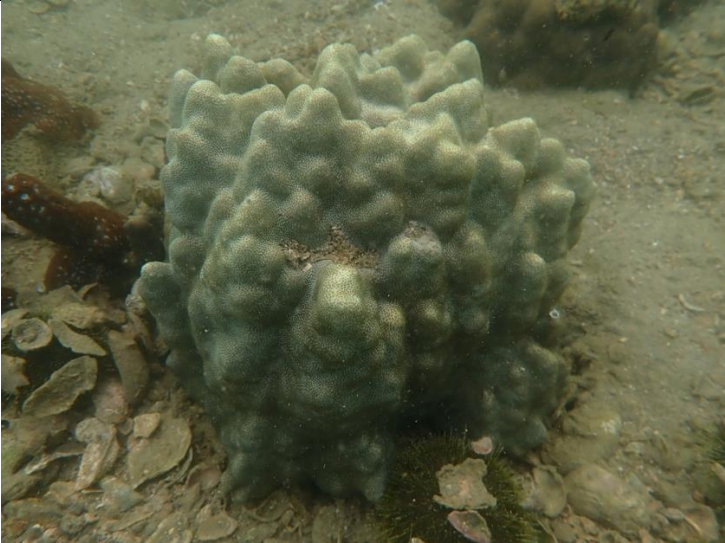
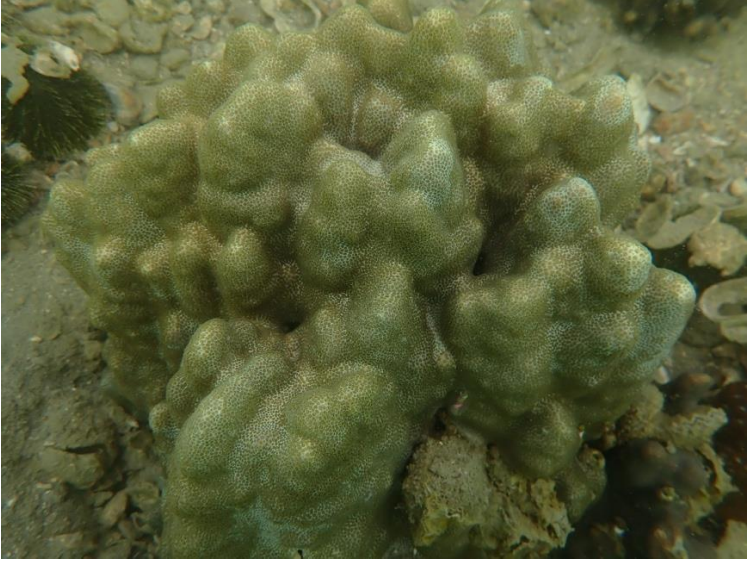
monitoring are shown in Photo Plate 2 ^[1] of **Appendix D2**. The general health conditions (size, condition, mortality, bleaching and sediment) were recorded (**Table 2.9**).

2.2.2.14. The tagged natural hard coral colonies existing at the recipient site were also monitored. All of the tagged natural coral colonies were in good condition, except for natural coral #7 with 10% partial mortality. No partial mortality, sediment or

bleaching in the general condition of the other tagged natural coral colonies were observed during the monitoring.
