**Agreement No. CE 32/2021 (CE)**  
**Improvement Works at Lai Chi Wo Pier and Tung Ping Chau Public Pier**  
**– Design and Construction**  
**Environmental Permit No. EP-587/2021**  
**Submission of Coral Translocation Plan for Tung Ping Chau Public Pier (Rev. 1)**

## Agreement No. CE 32/2021 (CE) Improvement Works at Lai Chi Wo Pier and Tung Ping Chau Public Pier -Design and Construction

Coral Translocation Plan at Tung Ping Chau Public  
Pier (Rev.1)  
(5207869-OR017B-01)

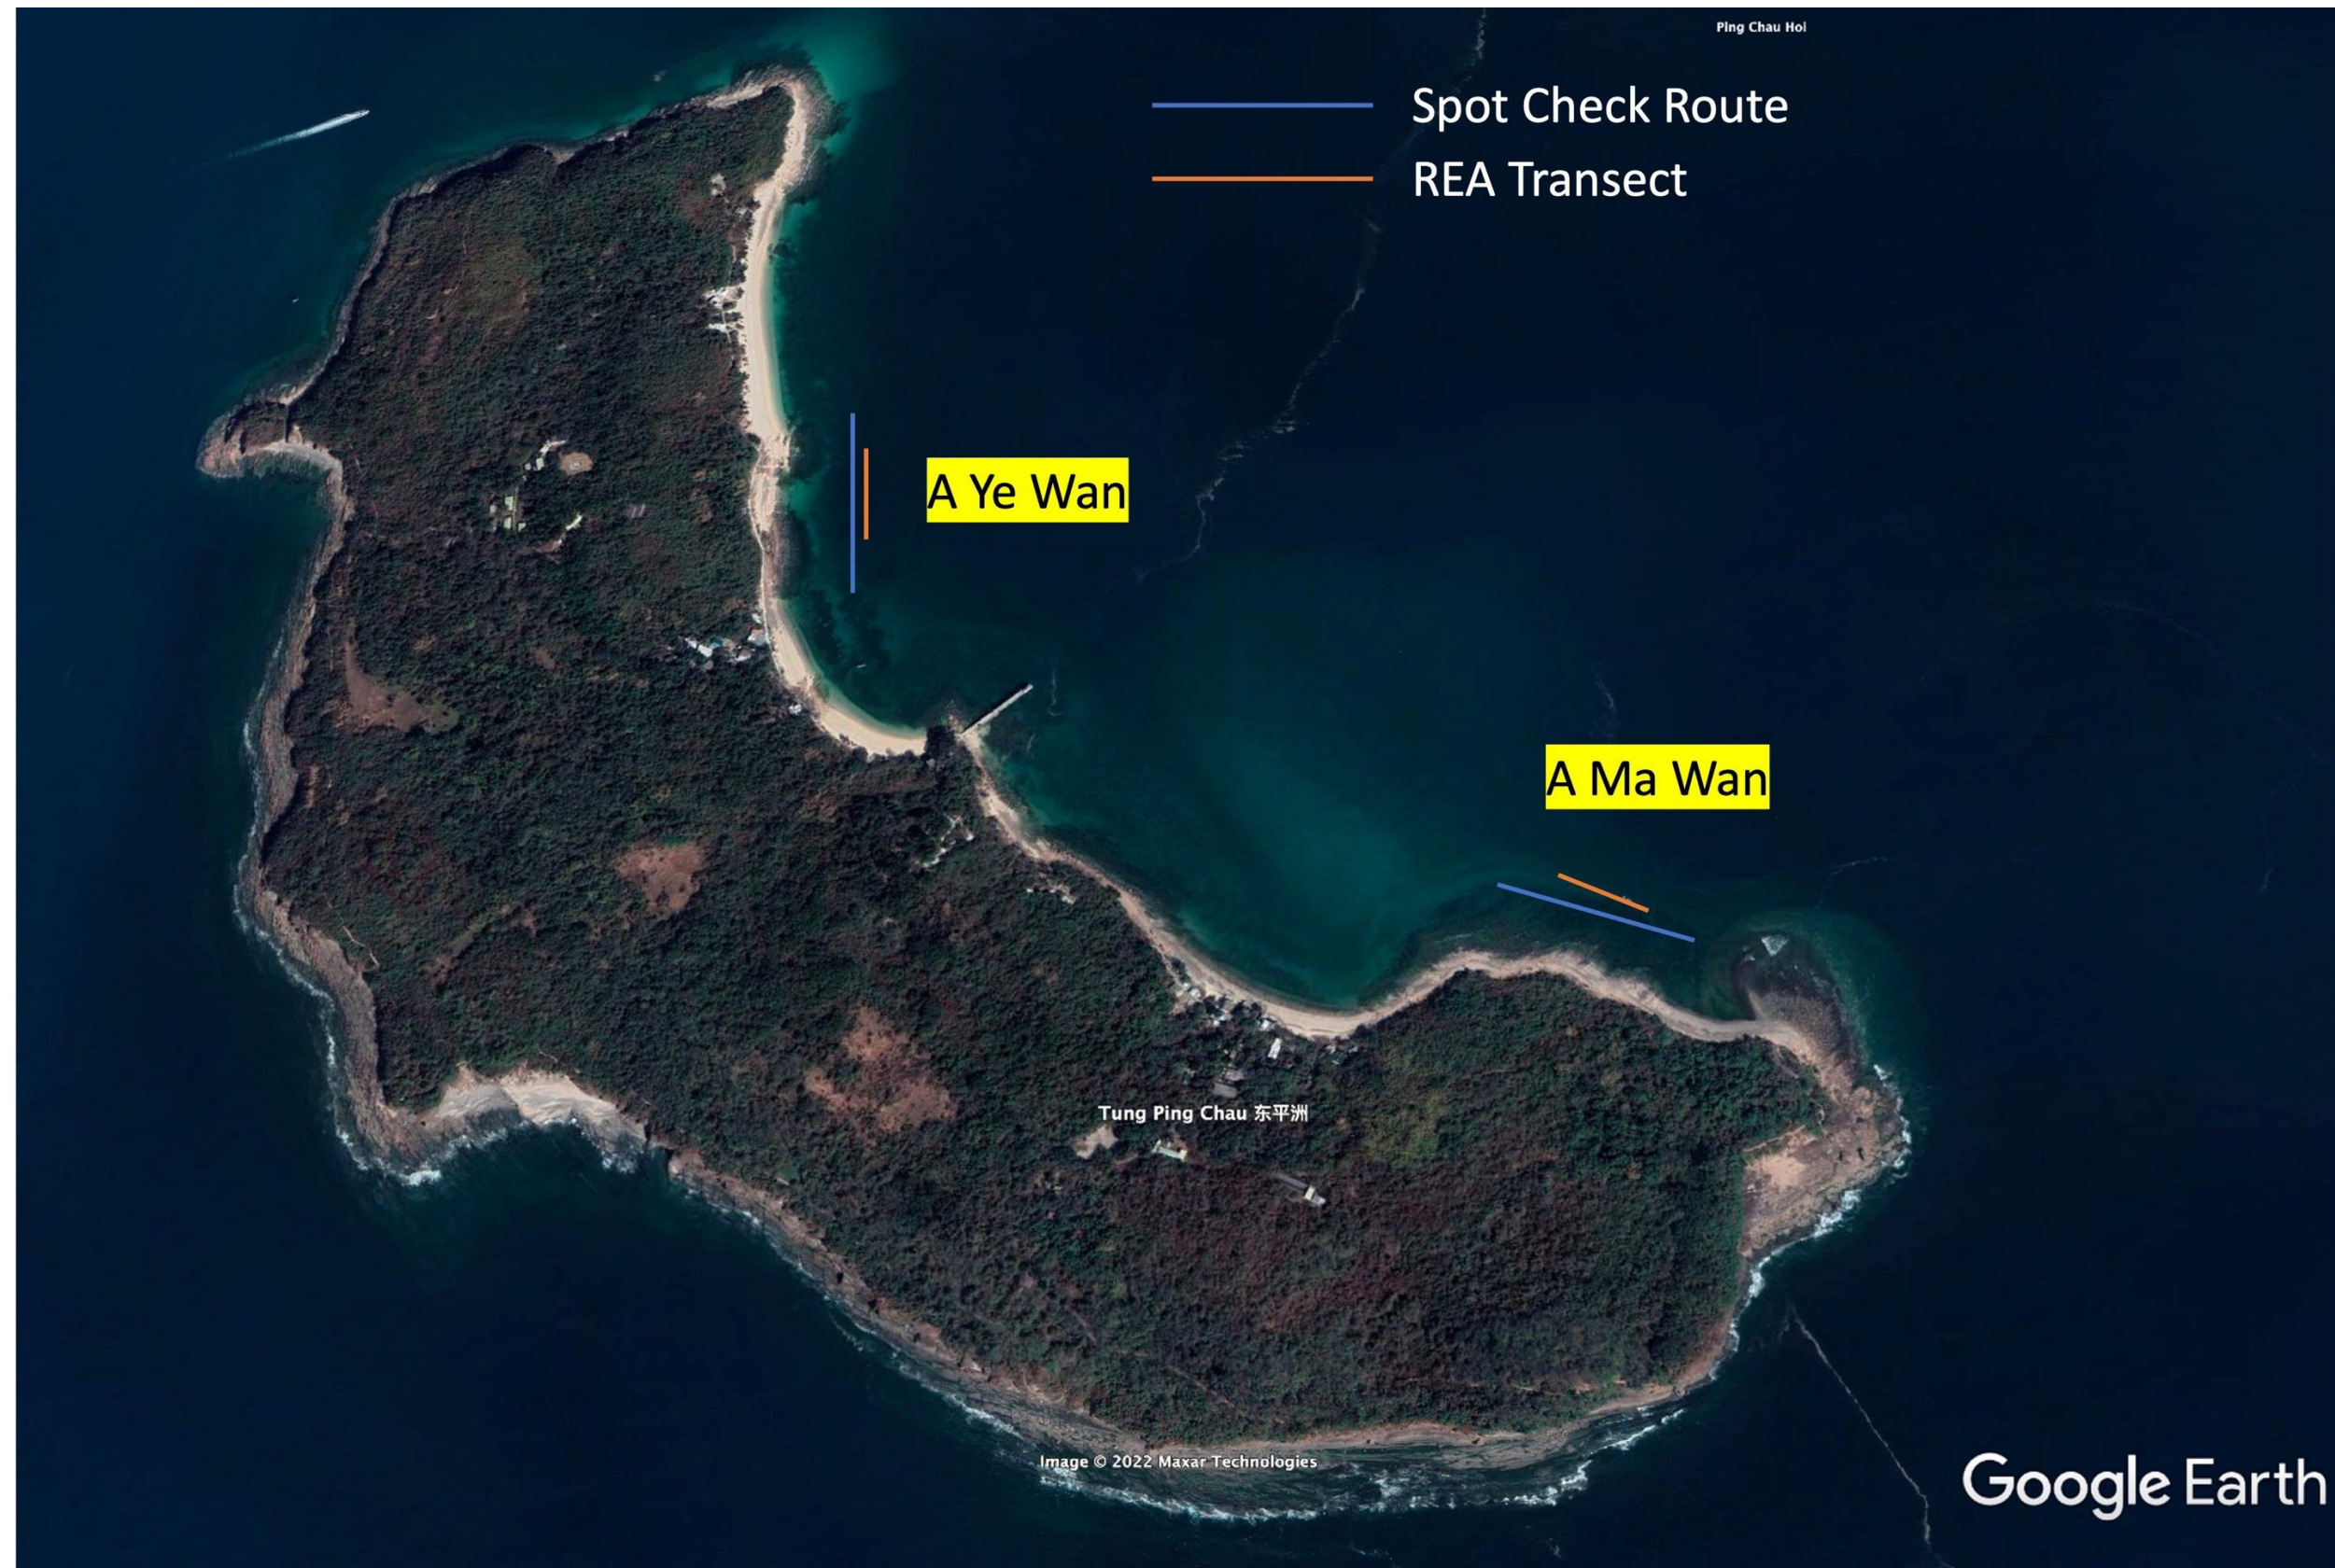
Figure 4 Location of Spot Check and REA Survey

- 2.2.11 A 100 m transect was laid down along the coastline which covered part of spot check site A Ma Wan (**Figure 4**). The average depth for the transect was about 3 m and visibility around 1.5 m
- 2.2.12 The substrate along the transect line is mainly composed of natural bedrocks (**Table 2.12**). Common marine life such as common sponges, bryozoans, rock oyster *Saccostrea cucullata*, common green mussel *Perna viridis*, *Diadema* sea urchin and tubeworm *Sabelastarte japonica* were found on survey area.

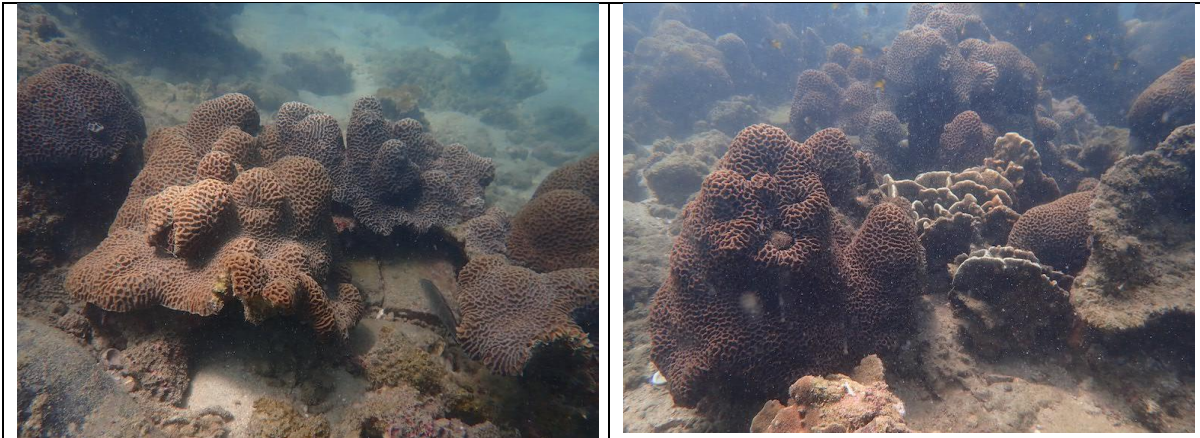
Big coral colonies recorded in A Ma Wan

2.2.13 This site supported high percentage (51-75%) of hard coral. A total of 24 coral species (**Table 2.13**) were recorded during the REA survey. They were of medium to large size (about 15 to 100 cm in diameter) and in high coverage. All the coral colonies were in good condition.

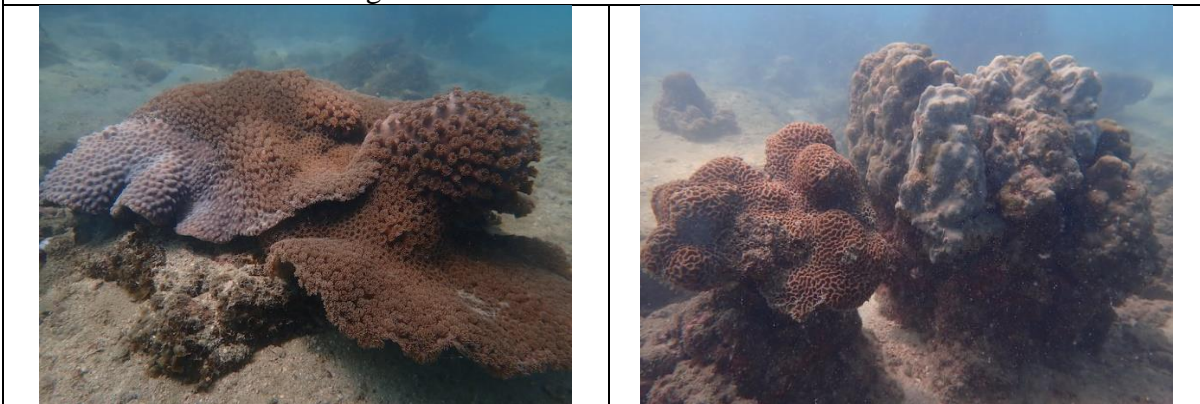
Big coral colonies recorded in A Ye Wan

2.2.16 This site supported medium percentage (31 to 50%) of hard coral. A total of 21 coral species (**Table 2.16**) were recorded during the REA survey. They were of medium to large size (about 15 to 100 cm in diameter) and in high coverage. All the coral colonies were in good condition.
