Removal of 132kV Overhead Line and Pylons for P-Line

Ecological Management
Plan (P1 to P6)

5 May 2022

Project No.: 0585151

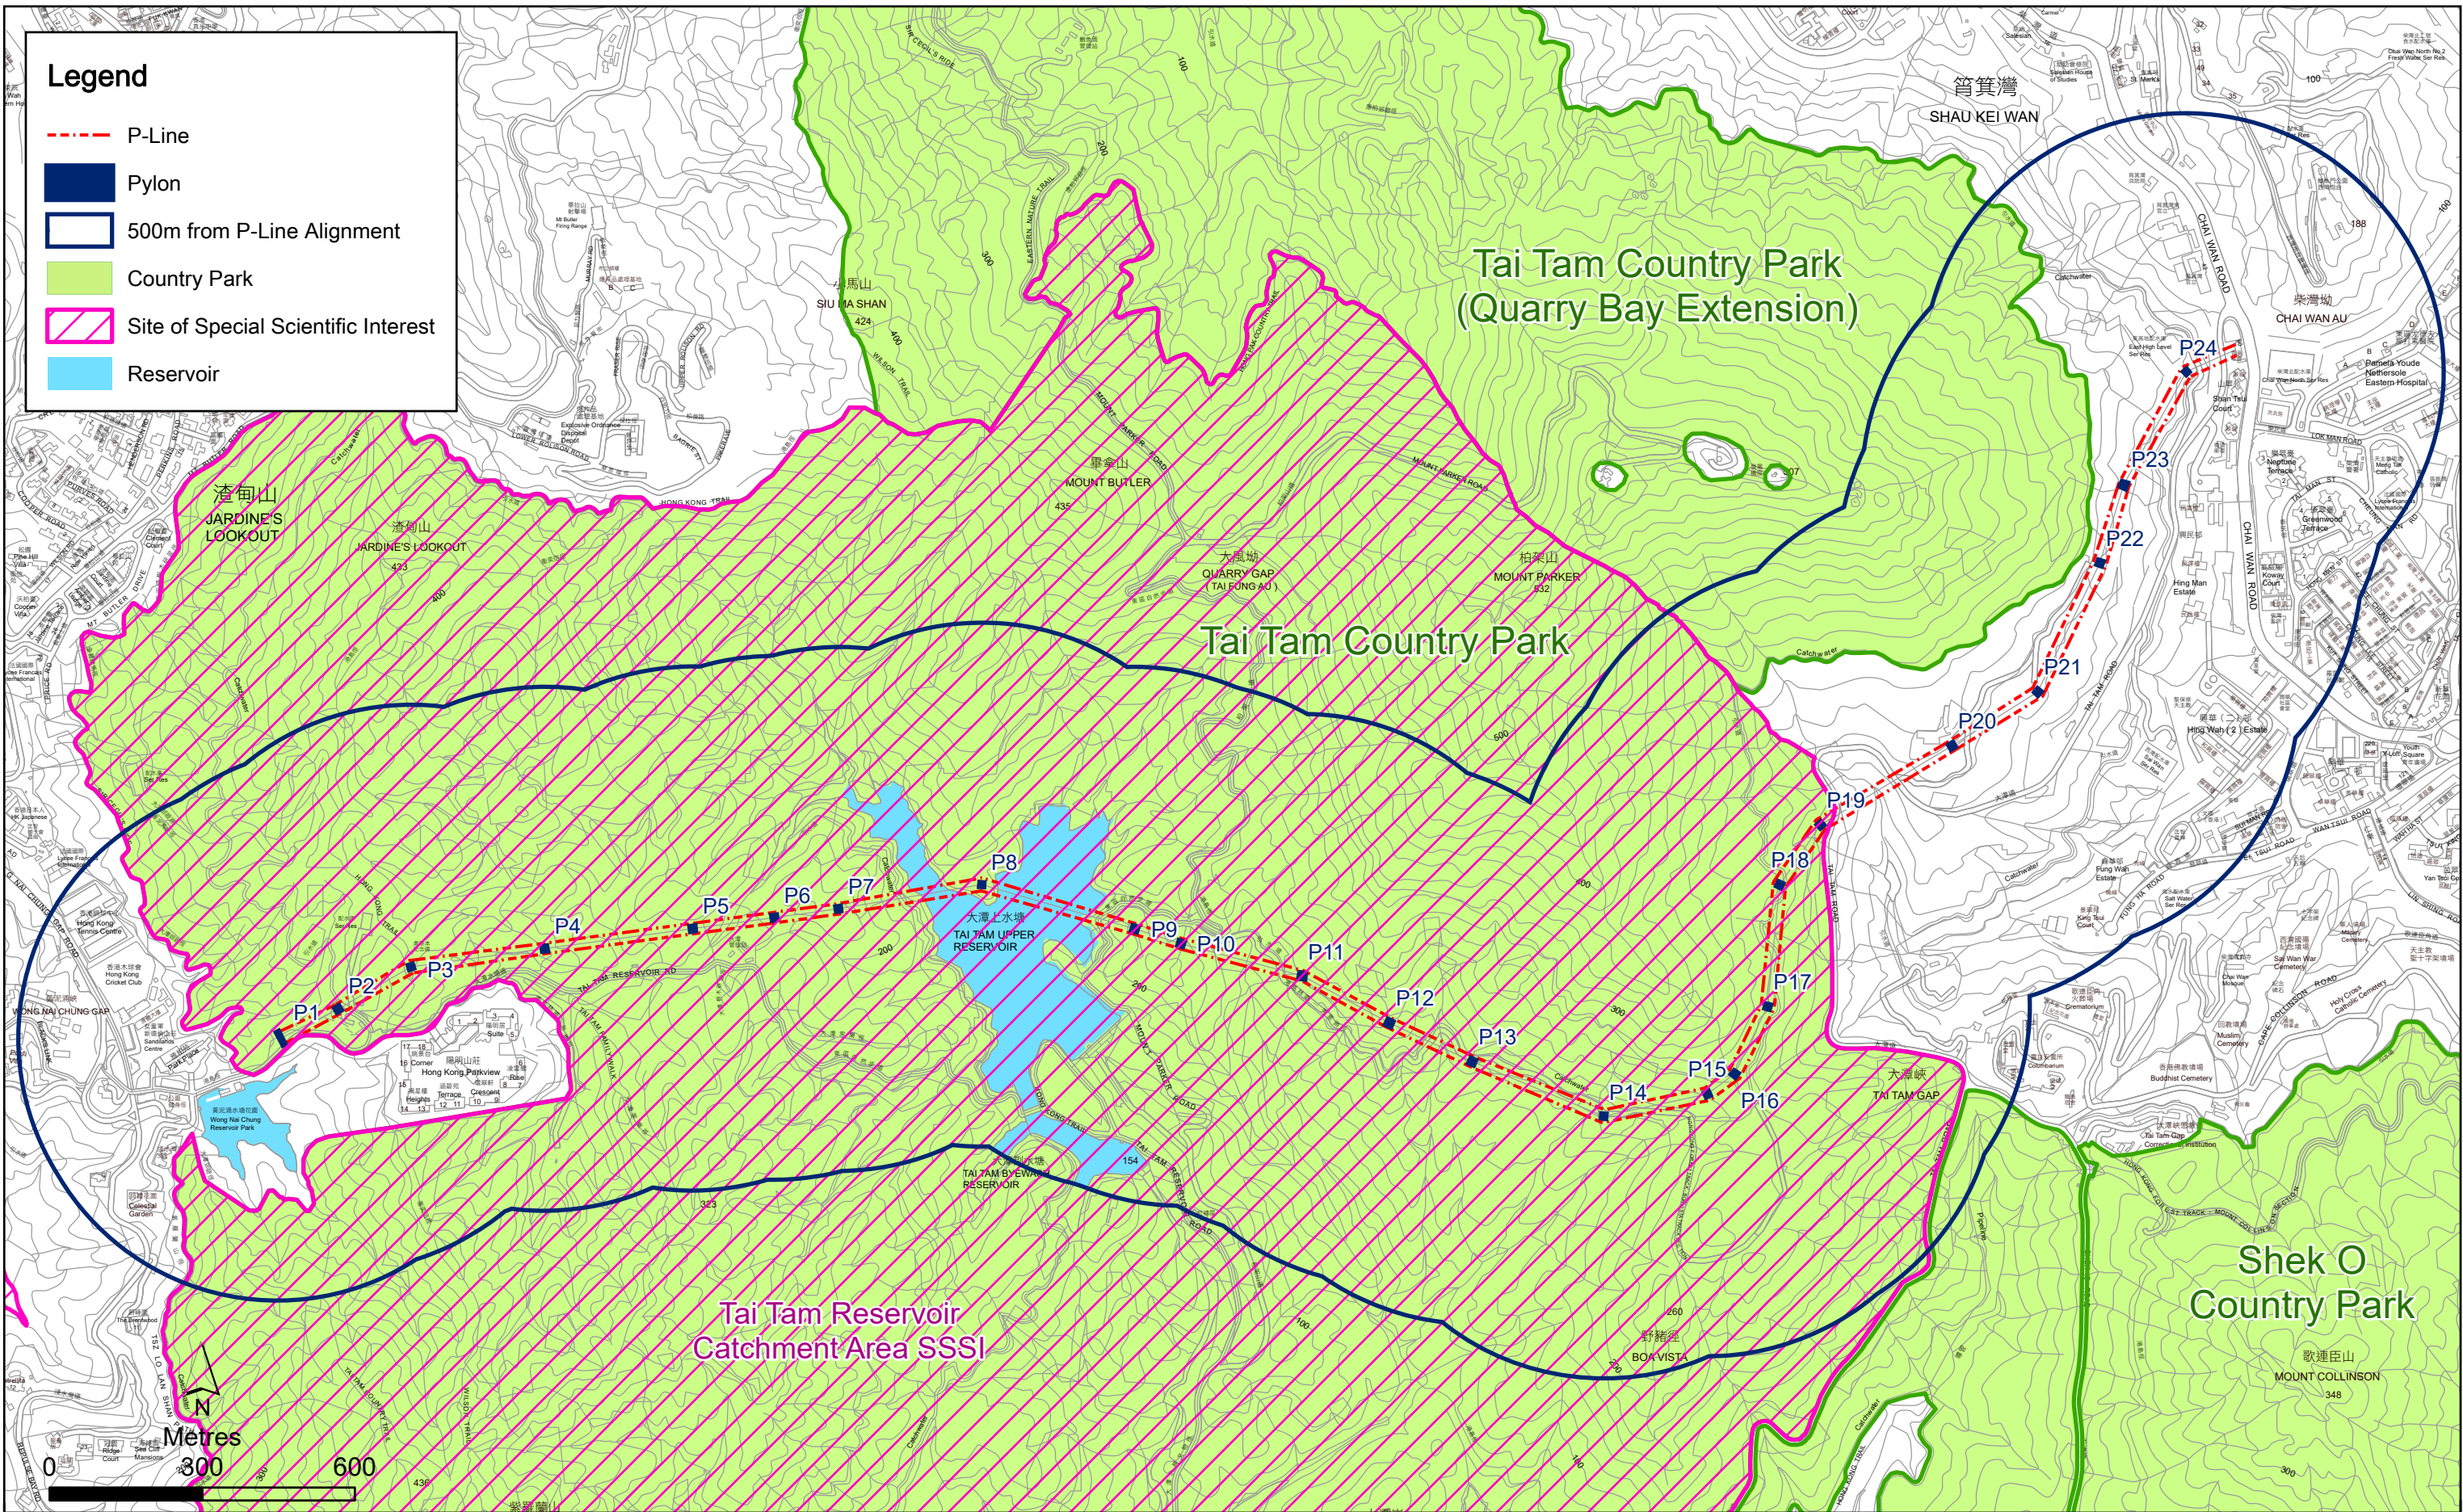
Figure 1.1

Removal of 132kV Overhead Line and Pylons for P-Line

The P-Line (Parker Line from Deep Water Bay Road to Tai Tam Road with total length of 4.7km) has been in services for more than 40 years and aged at various extent depending on the locations of the pylons and localised climatic conditions. The P-line is no longer in use. Hong Kong Electric (HKE) is proposing to remove the 132kV overhead line (OHL) and pylons of P-Line from Deep Water Bay Road to Tai Tam Road. The overall alignment of P-Line is shown in **Figure 1.1**.

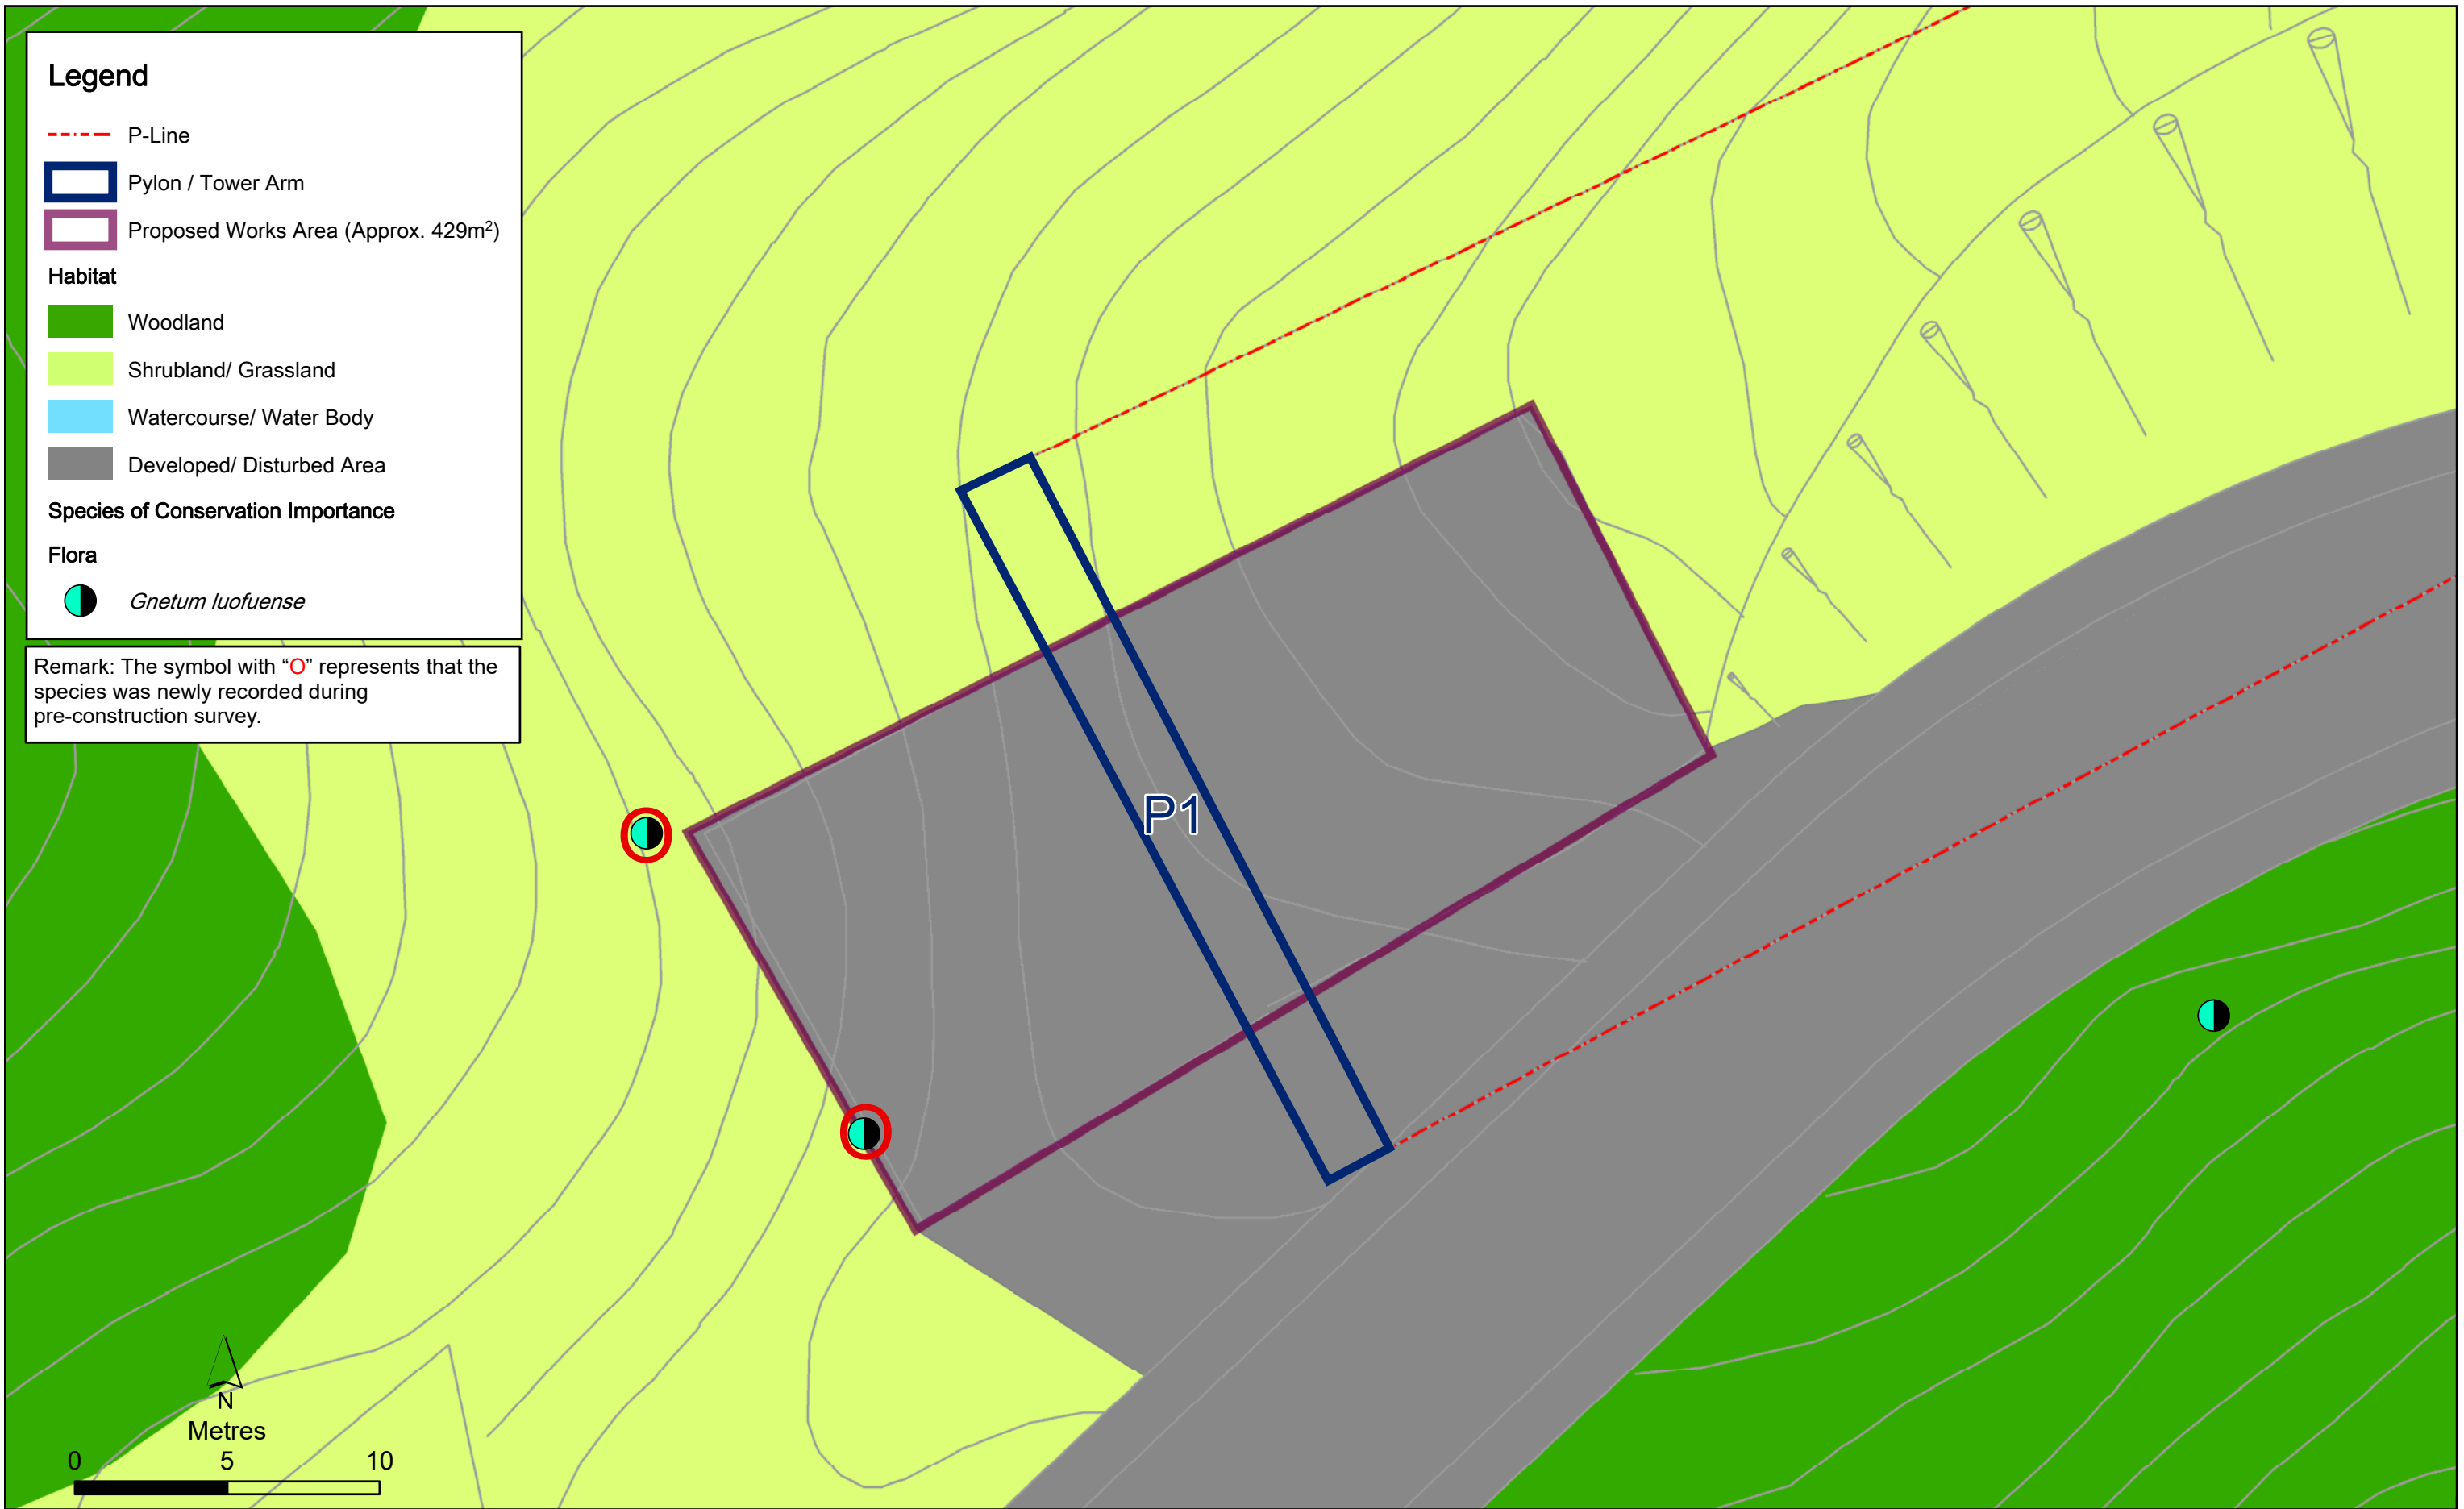
Figure 2.1.1

Zoom-in Habitat Map for Pylon P1

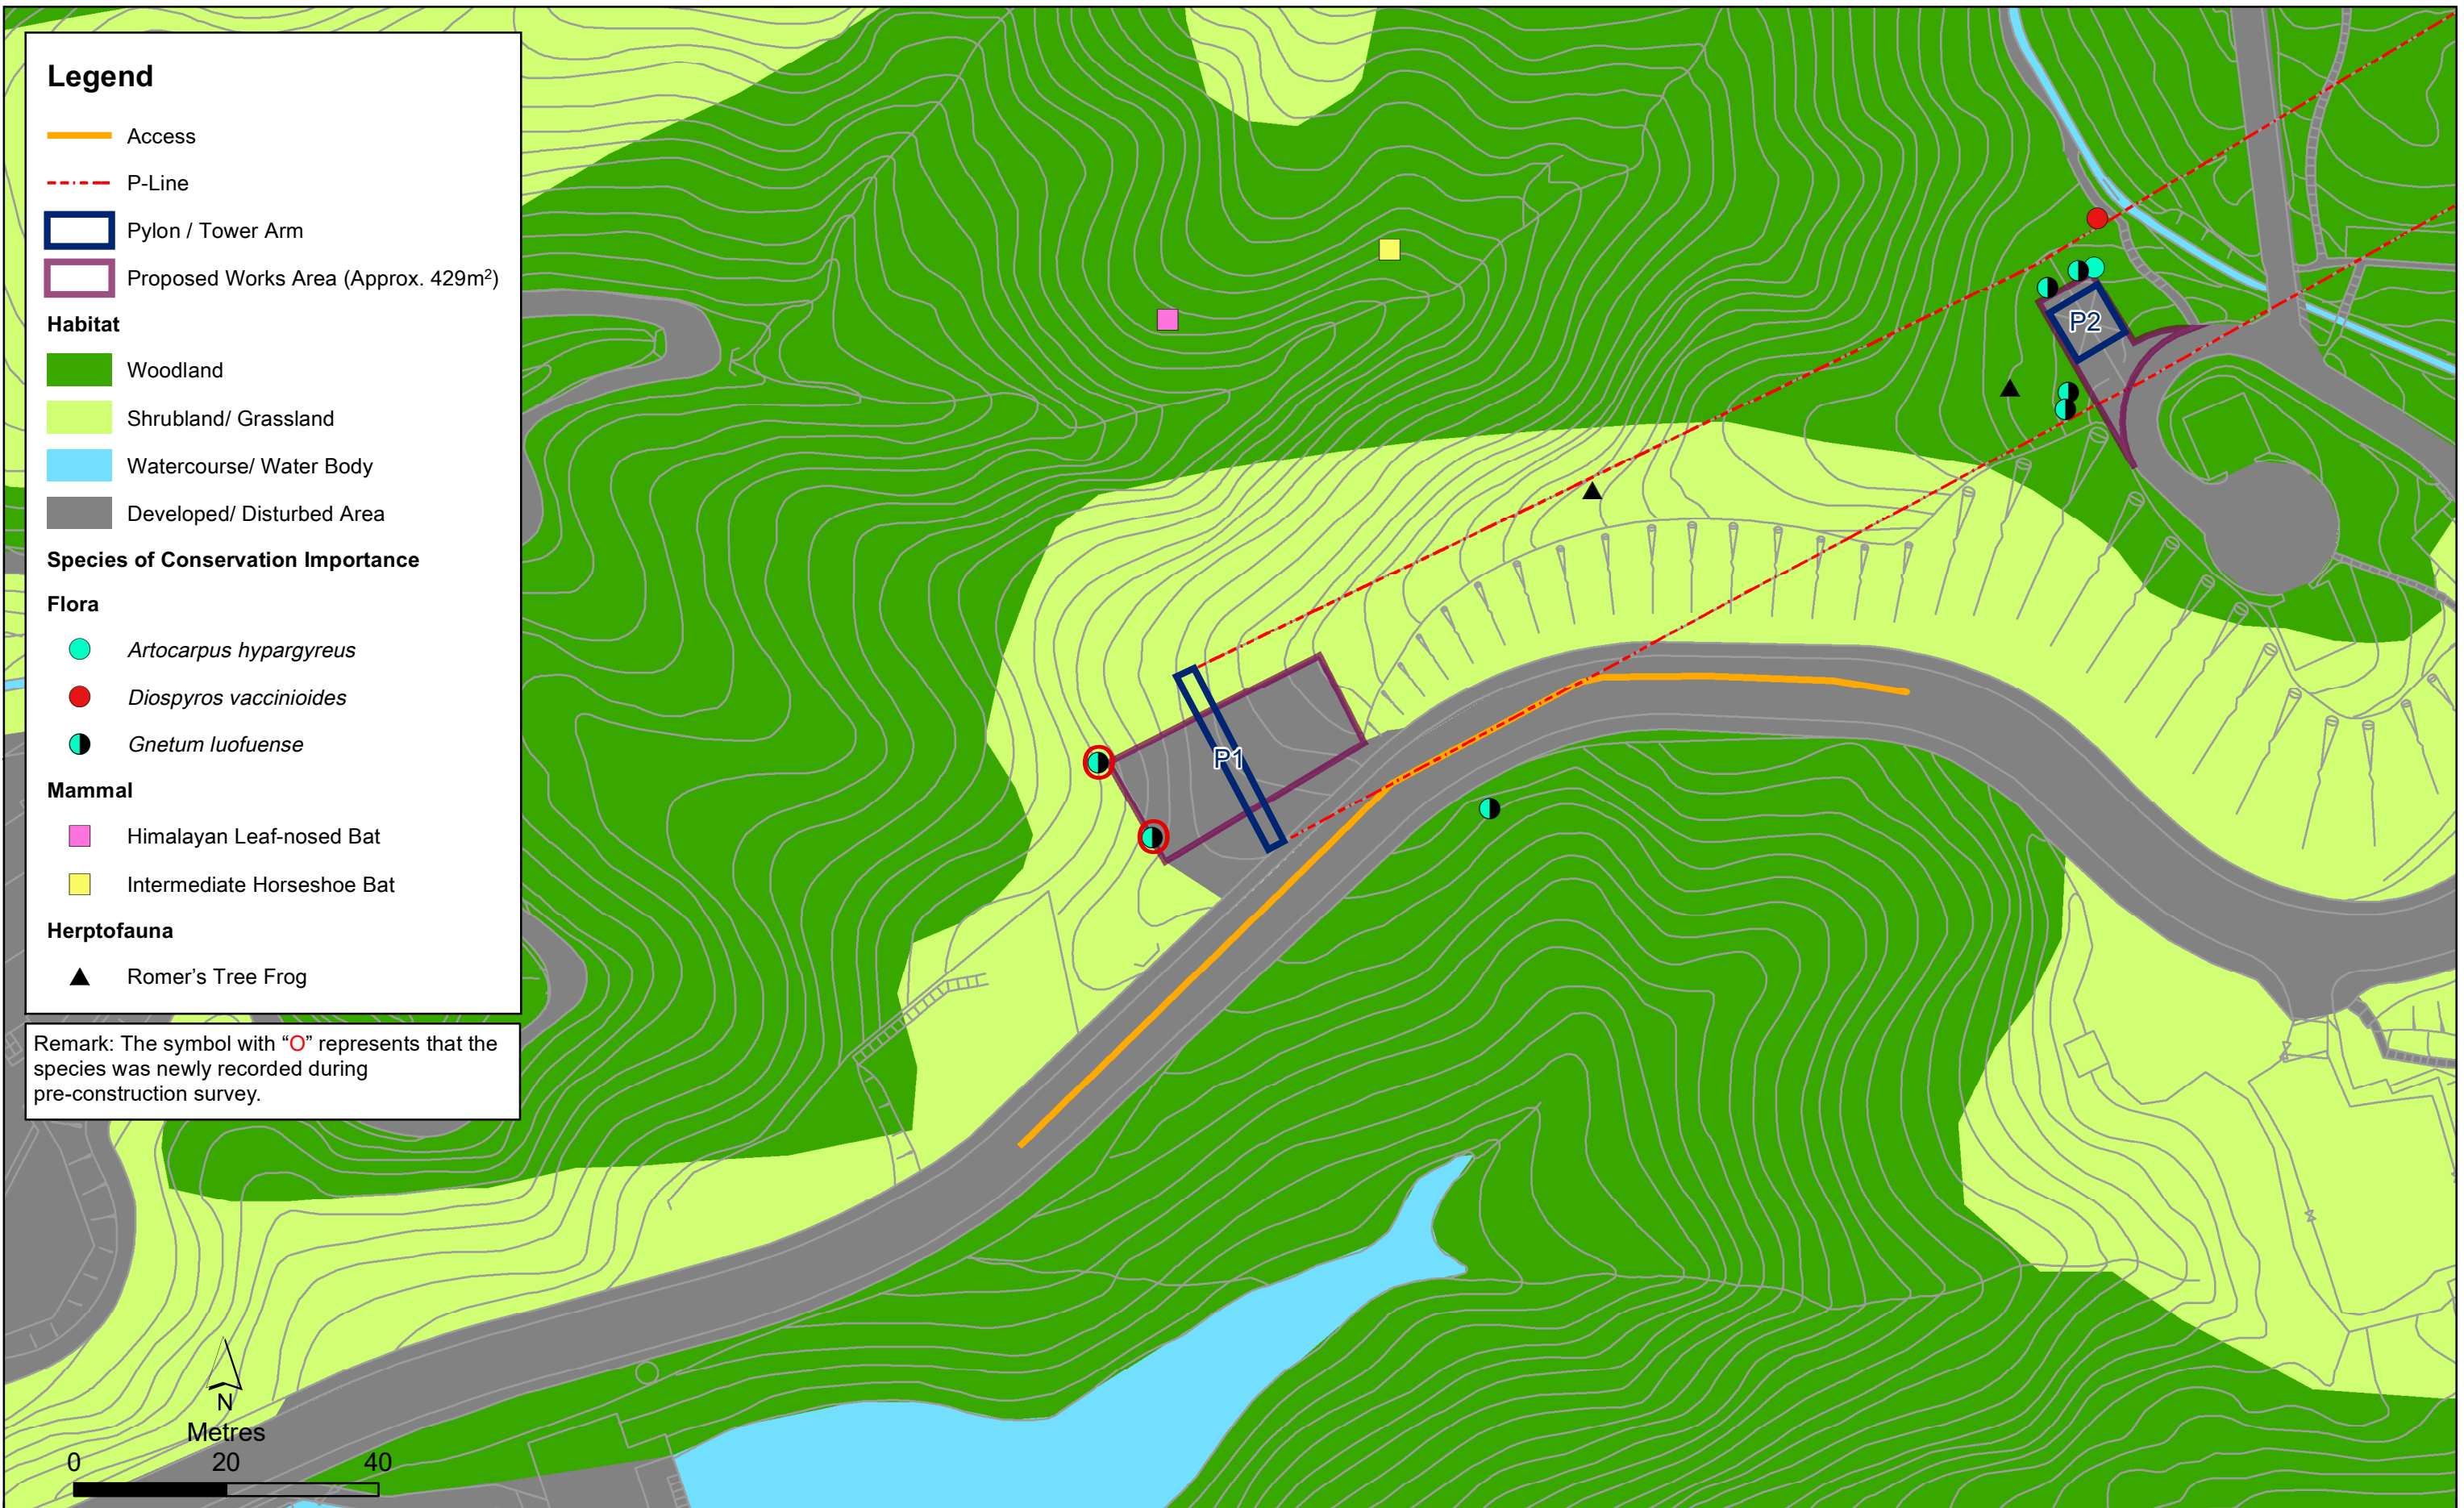
Figure 2.1.1a

Zoom-out Habitat Map for Pylon P1

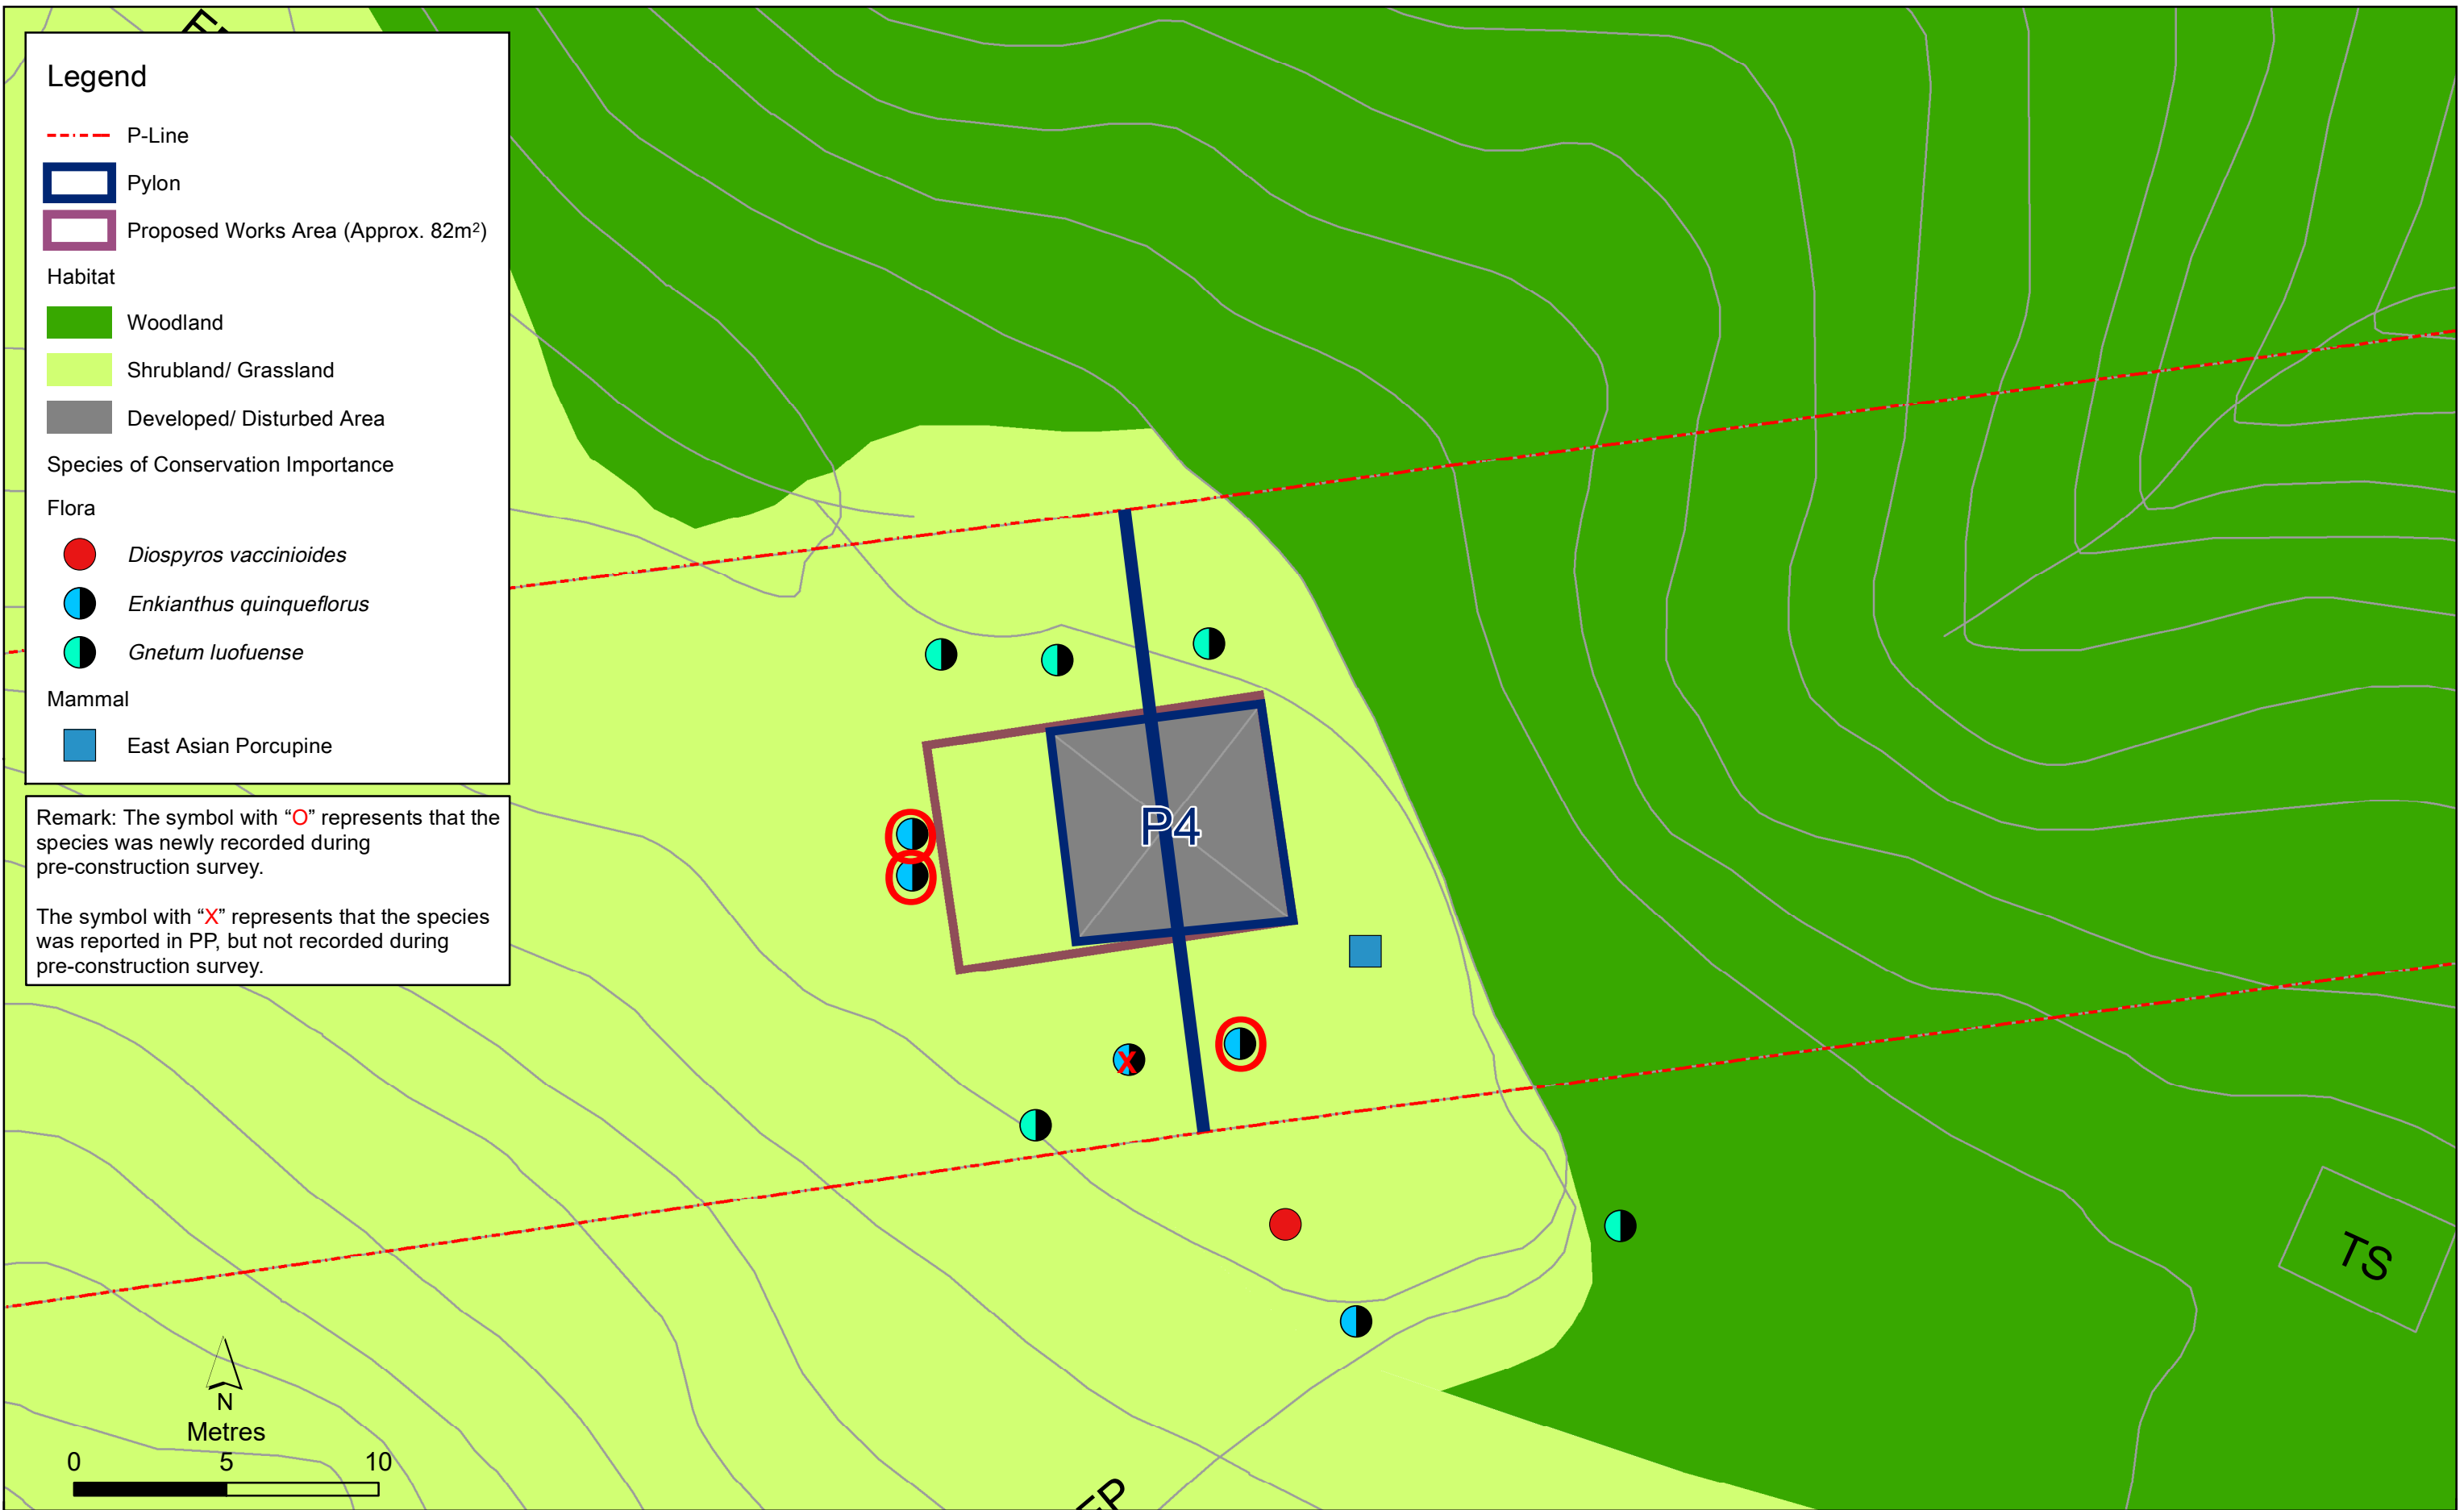
Figure 2.1.4

Zoom-in Habitat Map for Pylon P4

Three individuals of *Gnetum luofuense*, *Rhododendron spp* and *Enkianthus quinqueflorus* reported in PP at P3 and P4 were not recorded during pre-construction survey (**Figures 2.1.3 to 2.1.4**).

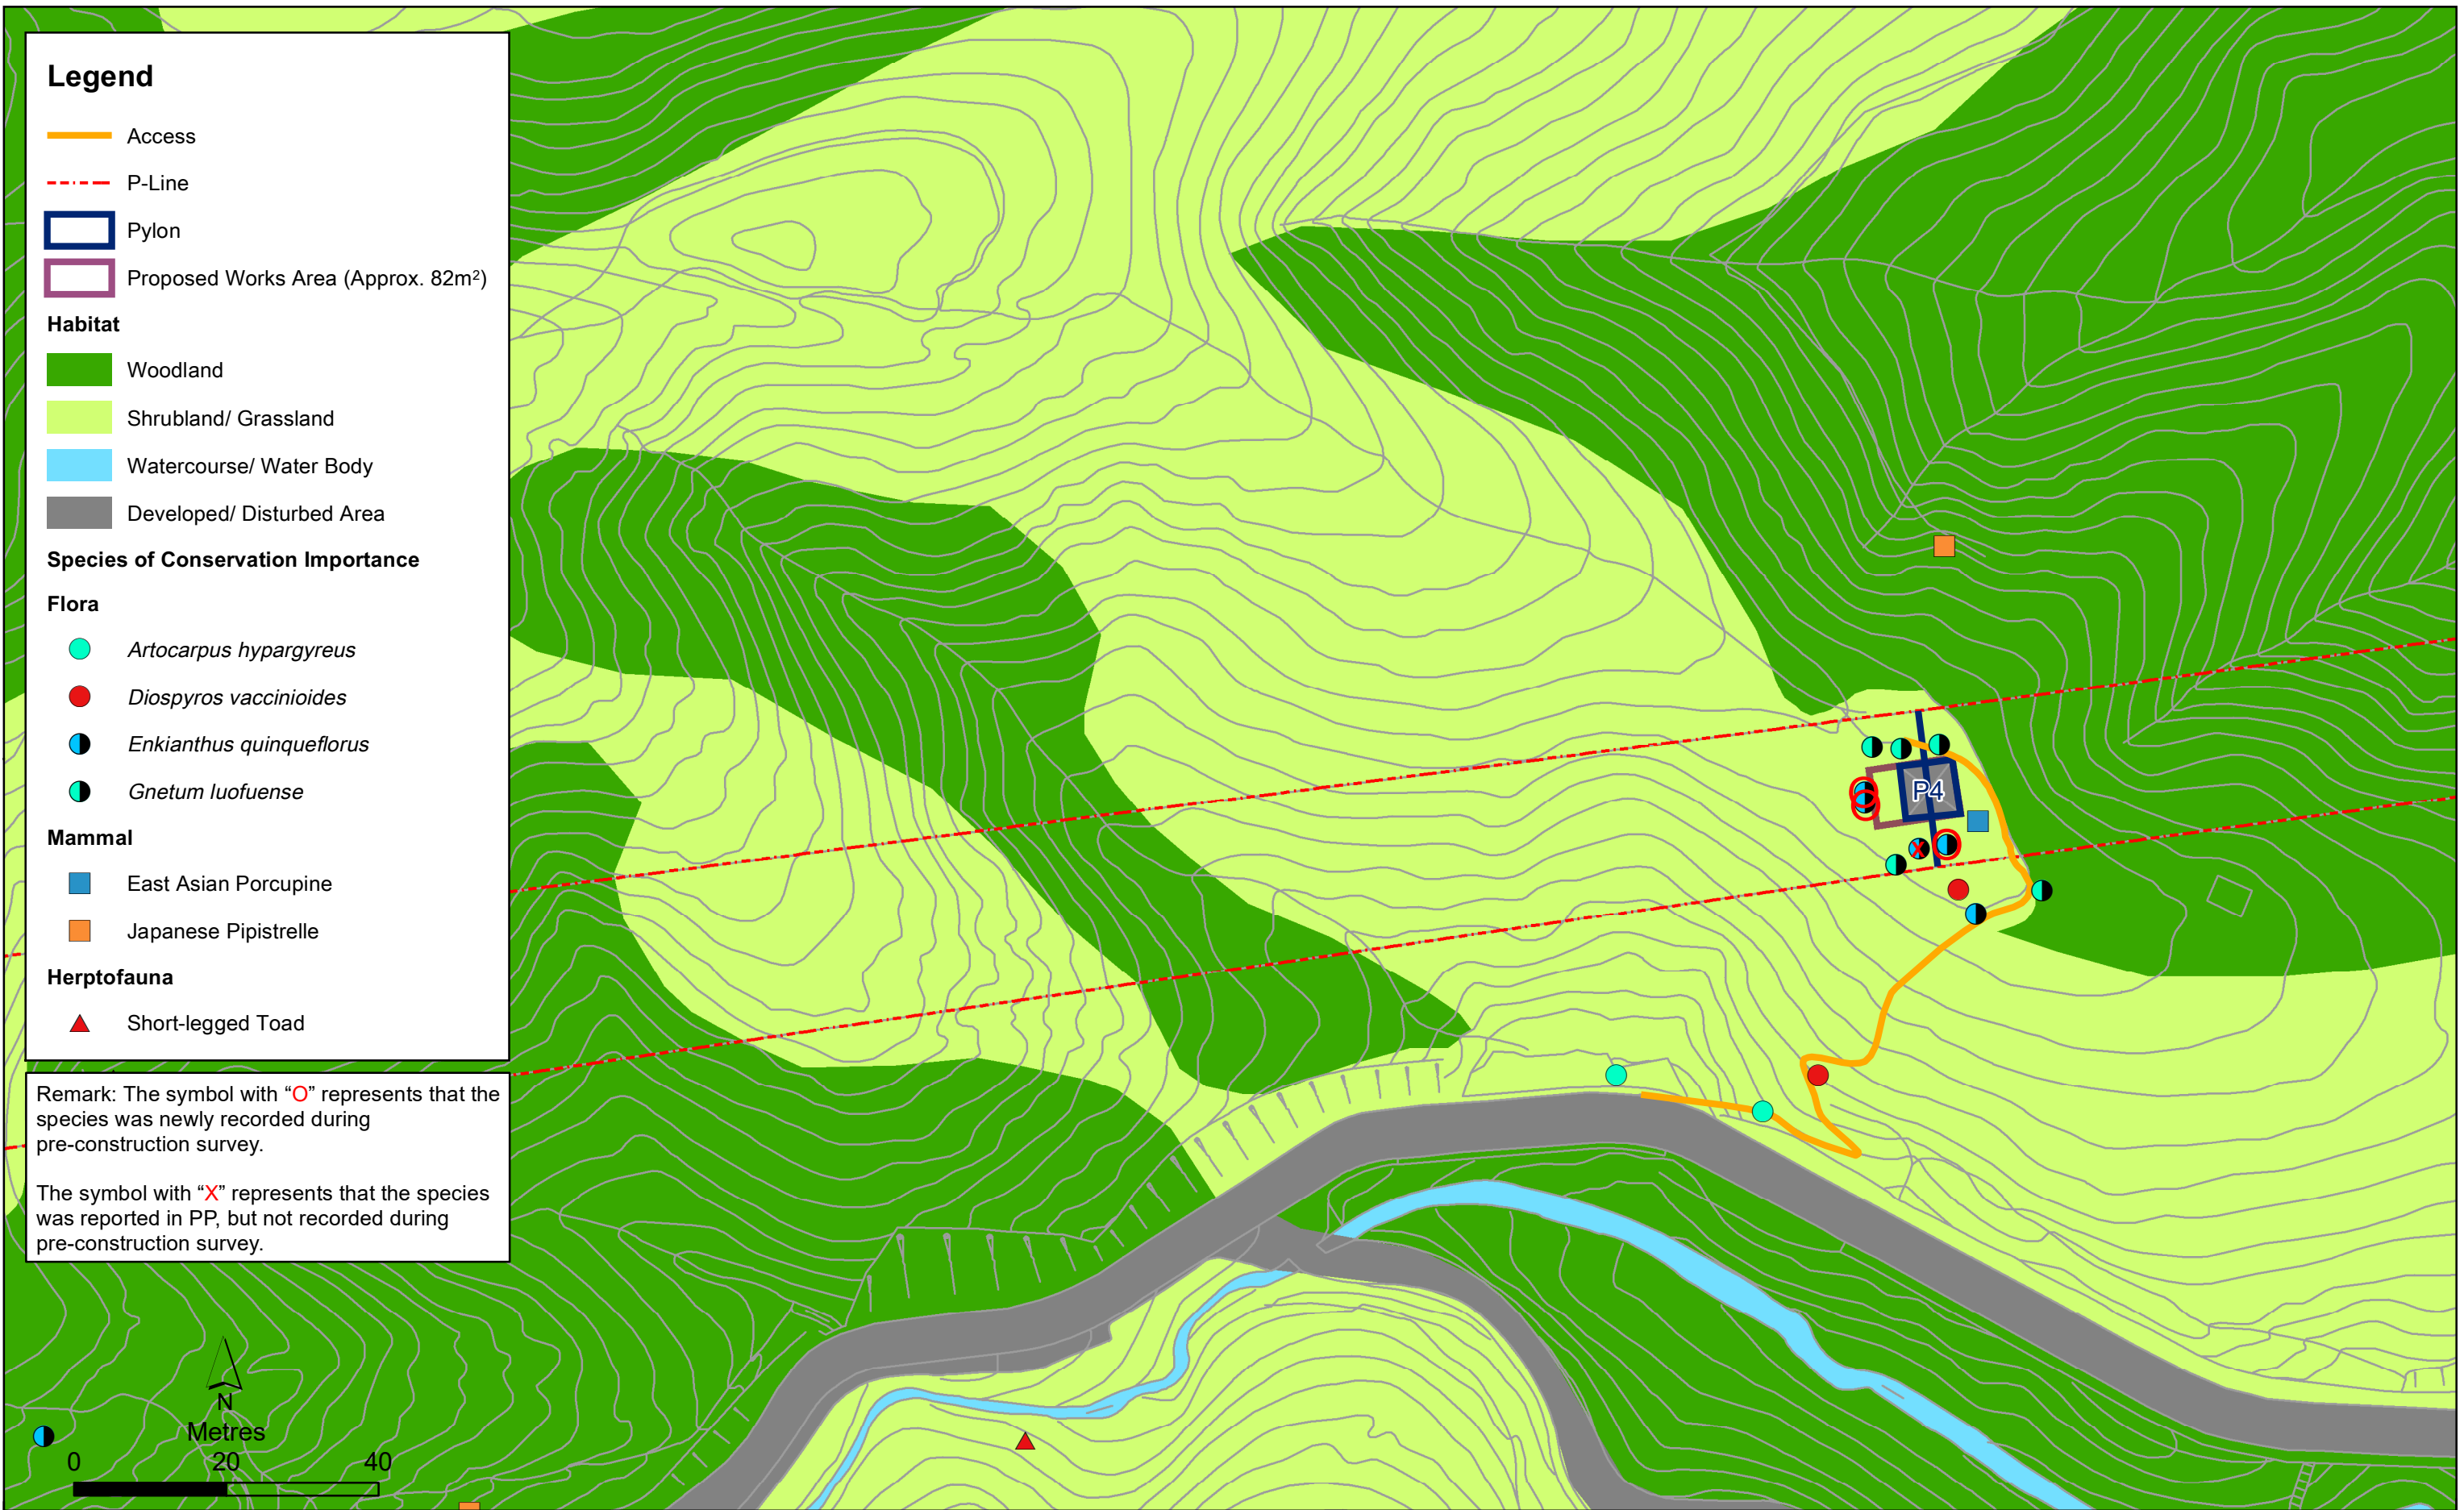
Figure 2.1.4a

Zoom-out Habitat Map for Pylon P4

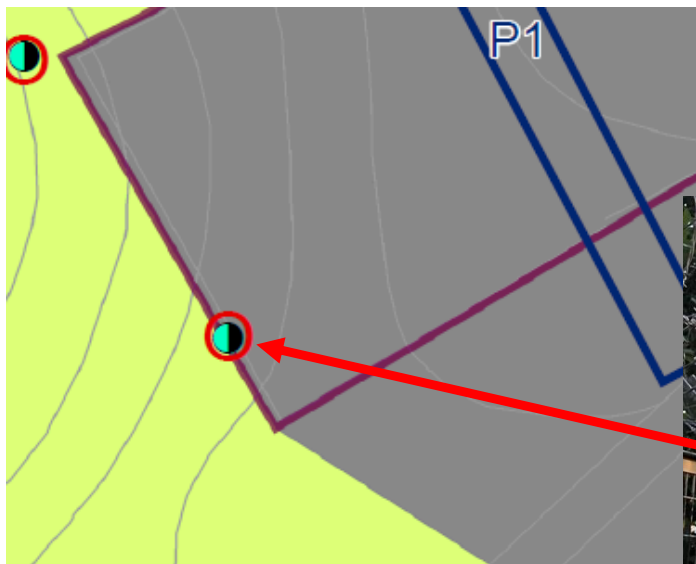
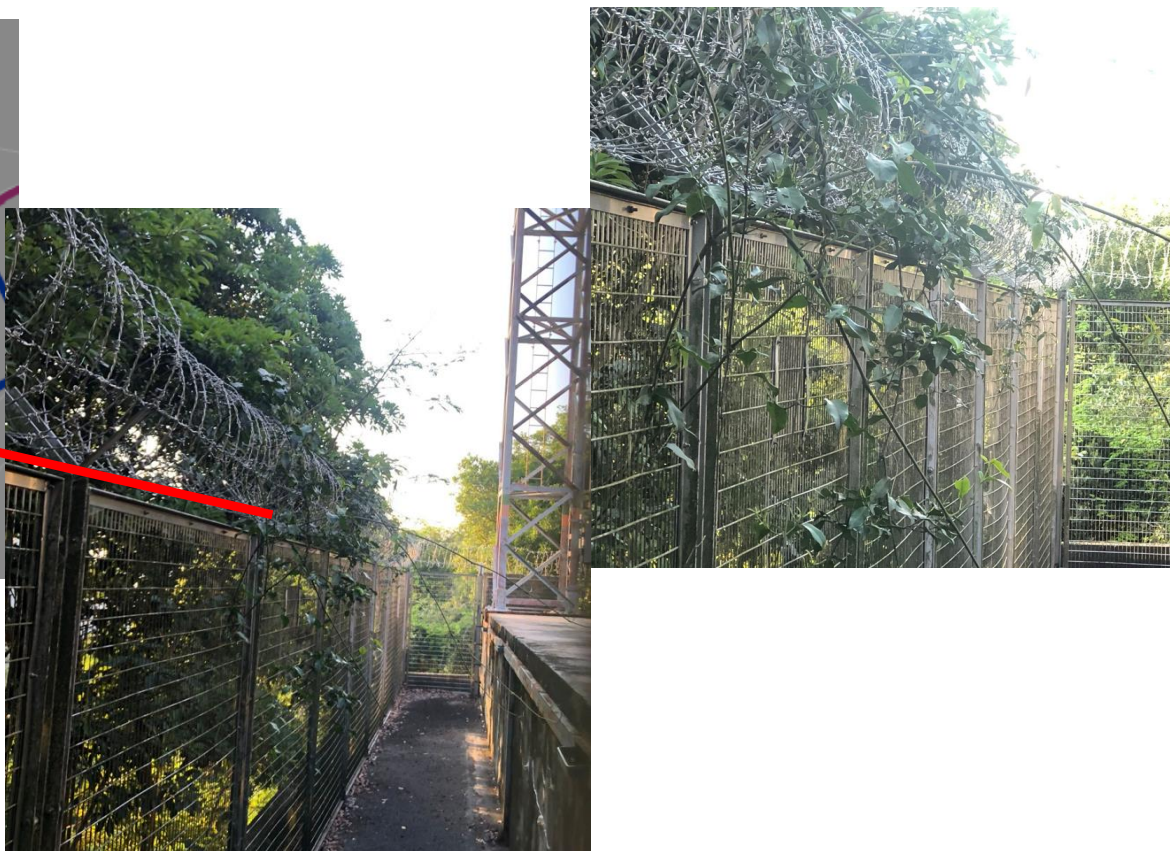
Gnetum luofuense recorded within the proposed work area at P1 (slightly entangling on fencing)

As the *Gnetum luofuense* at P1 was found not entangling the fence tightly, it is proposed to gently disentangle it from the fence and put the disentangled part on adjacent unaffected vegetated area outside the works area which will not be affected by the dismantling work.

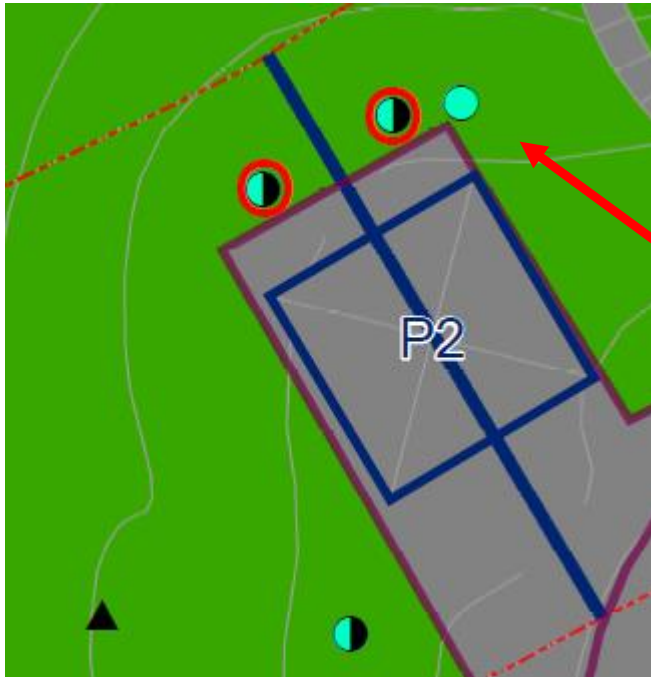
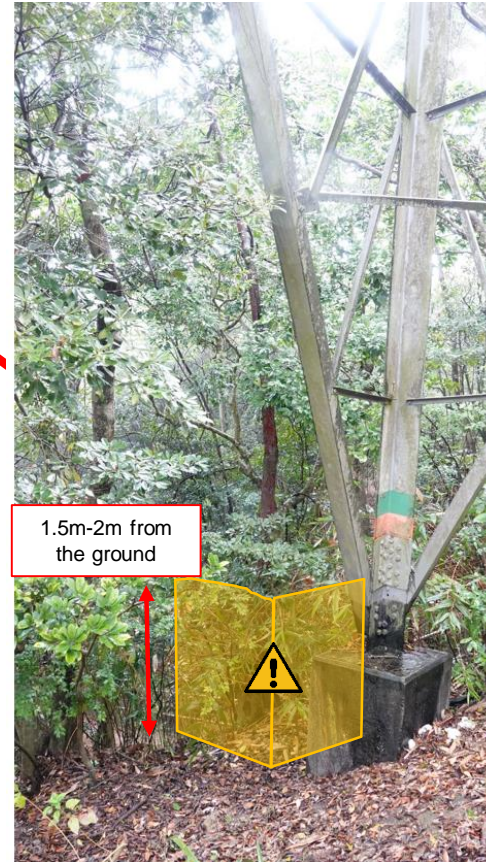
A protective fencing with 1.5m-2m will be erected around the dripline of the tree subject to site condition and the steep slope. It is not feasible to setup equipment/platform to enclose the tree with temporary protective net which is 9m tall.

Artocarpus hypargyreus was recorded immediately adjacent to the proposed work area.

Artocarpus hypargyreus recorded immediately adjacent to the proposed work area at P2 will be preserved in-situ and it is confirmed with the contractor that there will be no direct conflict with the dismantling work as assessed during planning the P-line removal procedure. Considering it is closely located to the proposed work area of P2, a protective fencing with 1.5m-2m will be erected around the dripline of the tree to avoid potential impact under the Project subject to site condition and steep slope (**Annex A2**). The protective fencing will be removed upon completion of works. It is not feasible to setup equipment/platform to enclose the tree with temporary protective net which is ~9m tall. The Contractor will ensure that the top parts of pylon segments will not have direct contact with the *Artocarpus hypargyreus* during dismantling works.

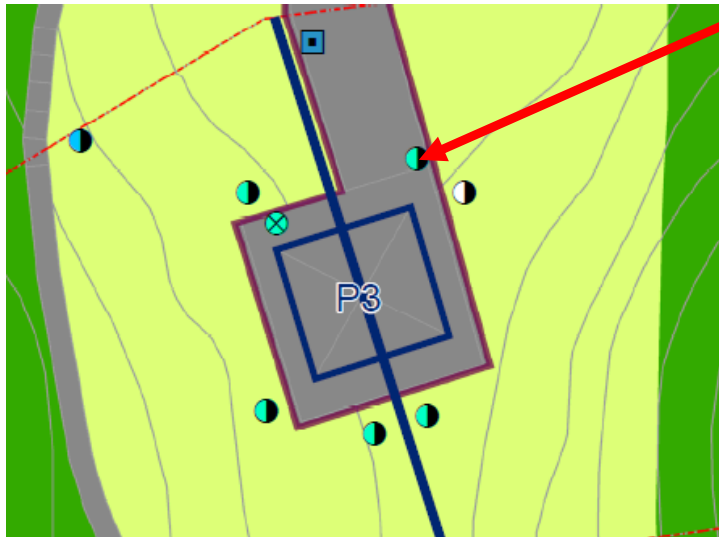
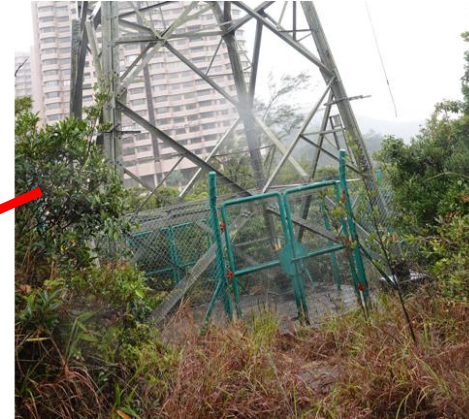
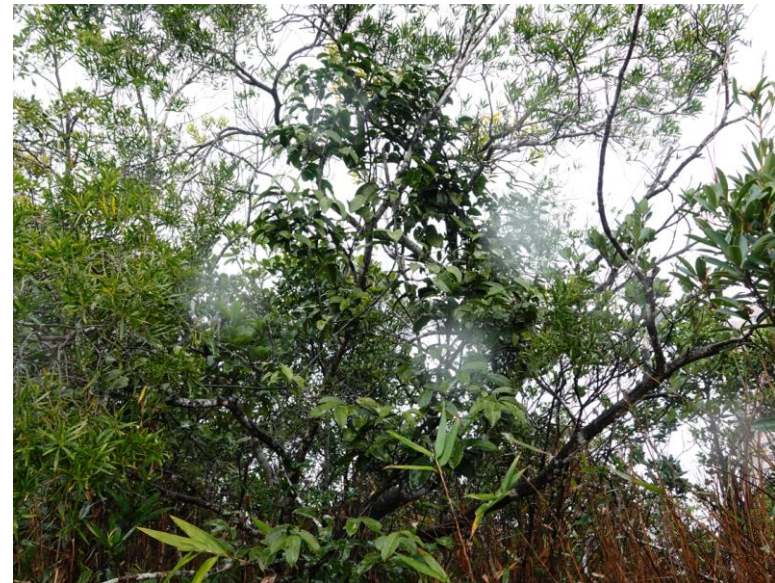
Gnetum luofuense recorded within the proposed work area at P3 (entangling on shrub)

The *Gnetum luofuense*, found at P3 and P6, are climbing on shrub and tree. Erecting a protective metal cage for the shrub and tree would be large and extensive, an extensive footing would also be required to support the cage. This would further disturb the adjacent vegetated area and result in additional vegetation loss. Moreover, large equipment would be required to bring into the site for erection / installation of the extensive metal cage. Transportation of large equipment to the site would possibly damage the vegetation alongside the footpath (which is not expected for the original arrangements). Given the *Gnetum luofuense* at P3 and P6 were located at the fringe of proposed works areas, soft protective nets and fencing (**Annexes A4, A7 and A8**) with warning sign in sharp colour with the intention to alert the workers to be aware of the species will be provided in order to avoid the species being damaged during the removal works. The deployment and removal of the soft protective net will be conducted with extra care to prevent any potential damage of the plants. A temporary fencing will be erected for the shrub and dripline of the branches entangled by *Gnetum luofuense*.
