Removal of 132kV Overhead Line and Pylons for P-Line

Ecological Management
Plan (P1 to P6)

5 May 2022

Project No.: 0585151

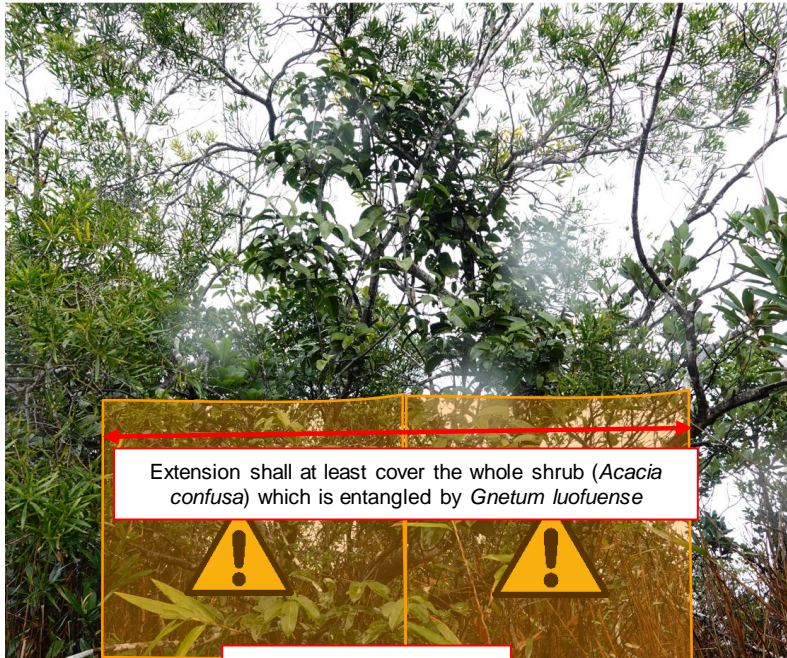
Temporary protective fencing

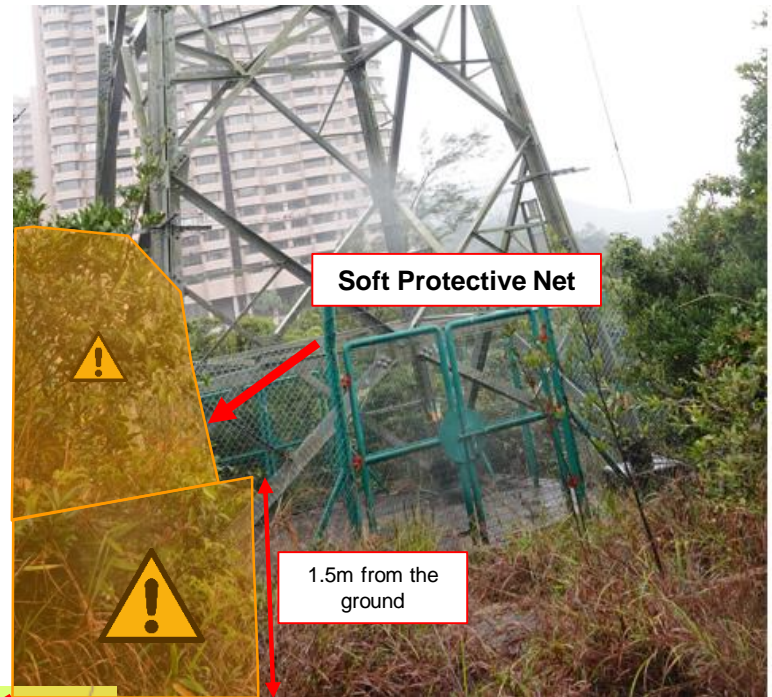
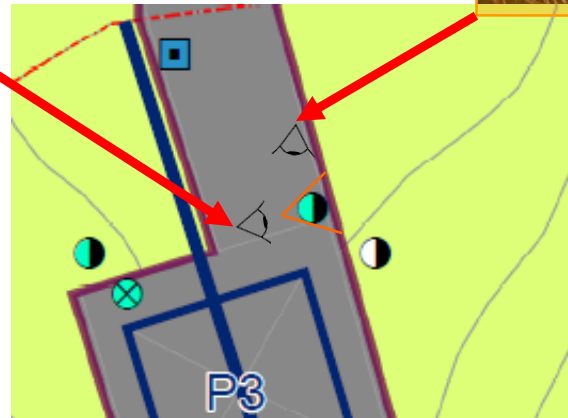
Temporary protective fencing will be erected as indicated. The shrub entangled by *Gnetum luofuense* (shaded area) will be covered/surrounded by soft protective net with warning sign in sharp colour as appropriate to alert workers' awareness. The deployment and removal of the soft protective net will be conducted with extra care to prevent any potential damage of the plants.

P3	<i>Gnetum luofuense</i>	Temporary protective fencing will be erected for the shrub (<i>Acacia confusa</i>) which entangled by <i>Gnetum luofuense</i> in order to set up a protection zone. The identified individual will be marked by warning sign during decommission work to ensure workers are aware of the concerned plant. The shrub entangled by <i>Gnetum luofuense</i> will also be covered/surrounded by soft protective net as appropriate to alert workers' awareness. The deployment and removal of the soft protective net will be conducted with extra care to prevent any potential damage of the plants. (Annexes A3 and A4).
P5	<i>Paramesotriton hongkongensis</i> (at a natural stream immediately adjacent to the footpath connecting to P5)	Temporary fencing with soft PVC tape/net and warning sign in sharp colour will be erected along the footpath to P5 in order to limit the activities by the workers and alert workers' awareness to protect the natural stream (Annex A5). The Contractor will ensure the temporary fencing will not entangle any animal. A gap of at least 50cm at the bottom of the fencing will be arranged and allowed for the animals freely move across the fenced footpath. Temporary fencing will be setup and removed on each working day, and it will not be left on-site overnight and during non-working hours. Briefing to workers will be provided to avoid pollution to the natural stream adjacent to the footpath.

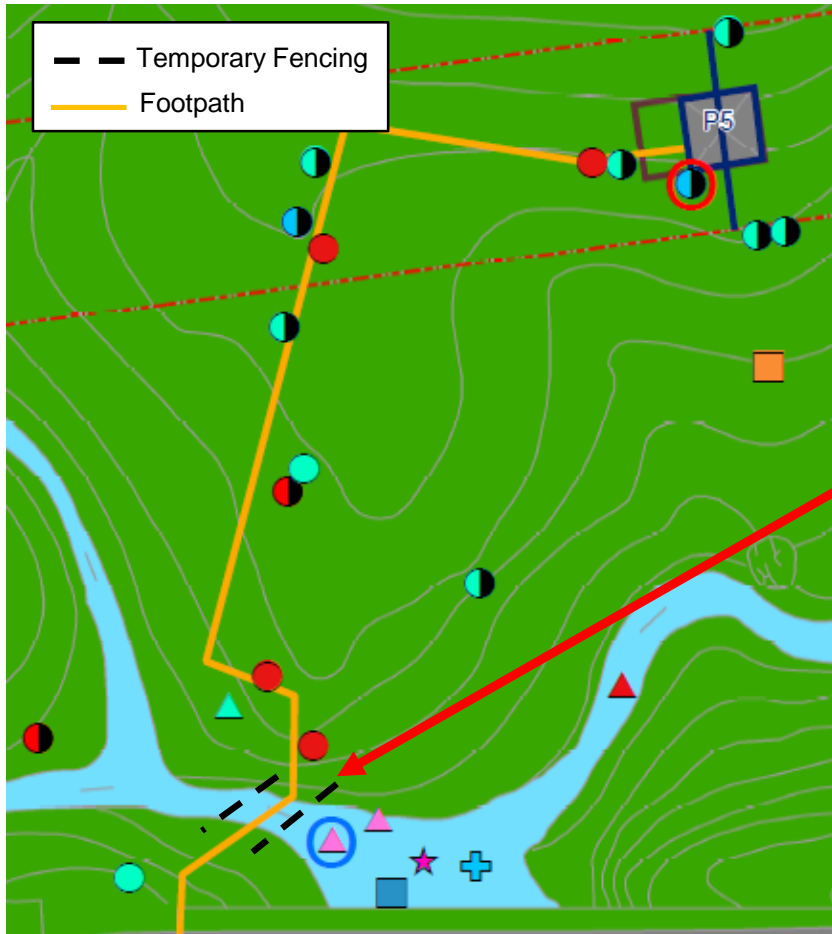
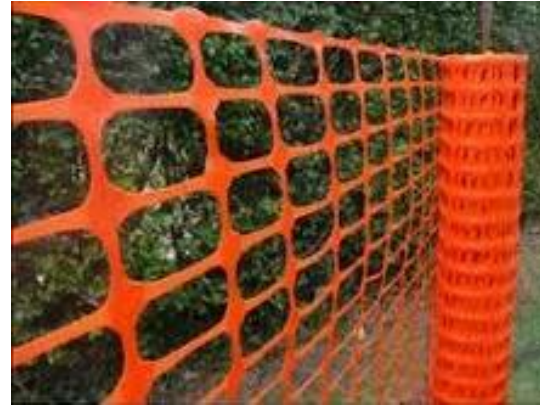
Temporary fencing with soft PVC tape/net and warning sign in sharp colour will be erected along the footpath to P5 to protect natural stream. A gap of at least 50cm at the bottom of the fencing will be arranged and allowed for the animals freely move across the fenced footpath. Temporary fencing will be setup and removed on each working day, and it will not be left on-site overnight and during non-working hours.

Paramesotriton hongkongensis was newly recorded at a natural stream immediately adjacent to the footpath connecting to P5.

As *Paramesotriton hongkongensis* was recorded at the natural stream immediately adjacent to the footpath connecting to P5 during AFCD's site inspection, temporary fencing with soft PVC tape/net and warning sign in sharp colour is proposed to be erected along the footpath to P5 in order to limit the activities by the workers and alert worker's awareness to protect the natural stream (**Annex A5**). The Contractor will ensure the temporary fencing will not entangle any animal. A gap of at least 50cm at the bottom of the fencing will be arranged and allowed for the animals freely move across the fenced footpath. Temporary fencing will be setup and removed on each working day, and it will not be left on-site overnight and during non-working hours. Briefing to workers will be provided to avoid pollution to the natural stream adjacent to the footpath.

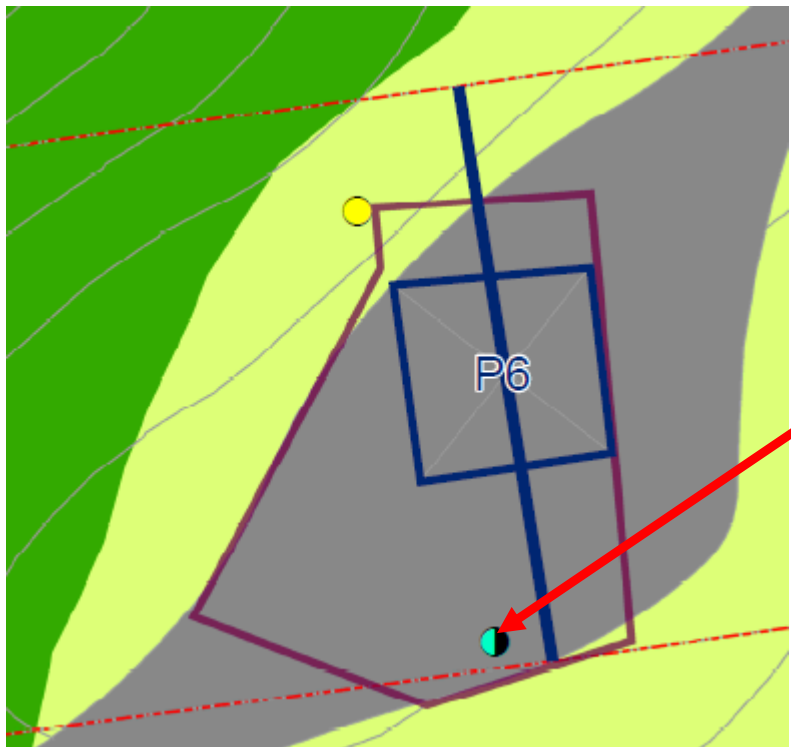
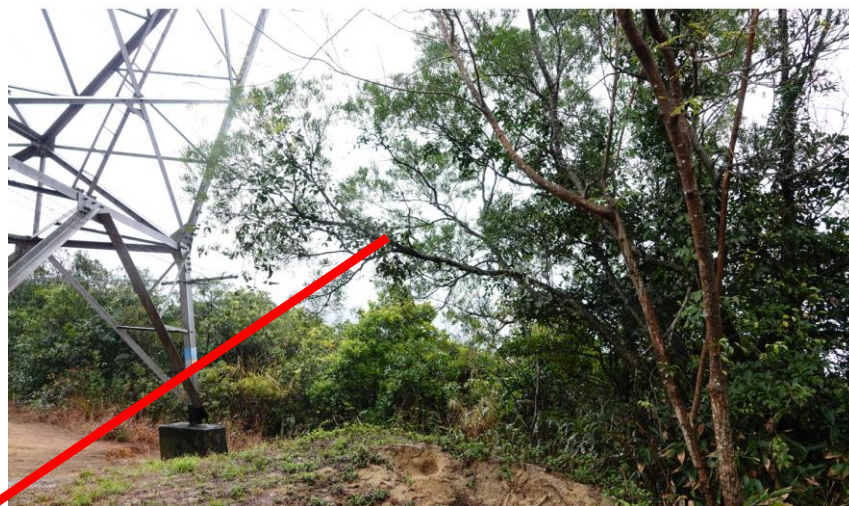
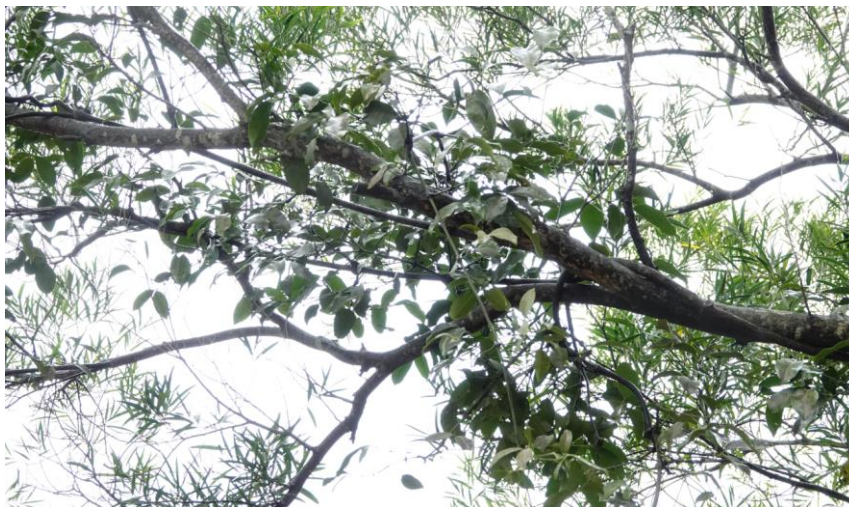
Gnetum luofuense recorded within the proposed work area at P6 (entangling on tree HKE-P6-007)

P6	<i>Gnetum luofuense</i>	The branches of <i>Acacia confusa</i> at P6 which are entangled by <i>Gnetum luofuense</i> will be well covered/surrounded by soft protective net as appropriate to alert workers' awareness. The identified individual will be marked by warning sign during decommission work to ensure workers are aware of the concerned plant. The deployment and removal of the soft protective net will be conducted with extra care to prevent any potential damage of the plants. A protective fencing with 1.5m-2m will erected around the dripline of the branches entangled by <i>Gnetum luofuense</i> to avoid potential impact from the Project (Annexes A6, A7 and A9).

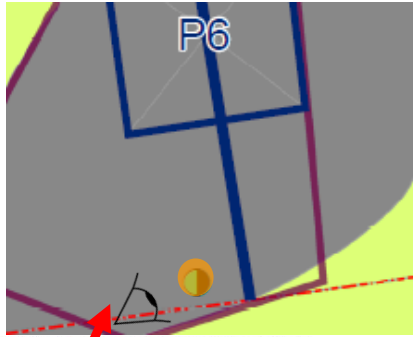
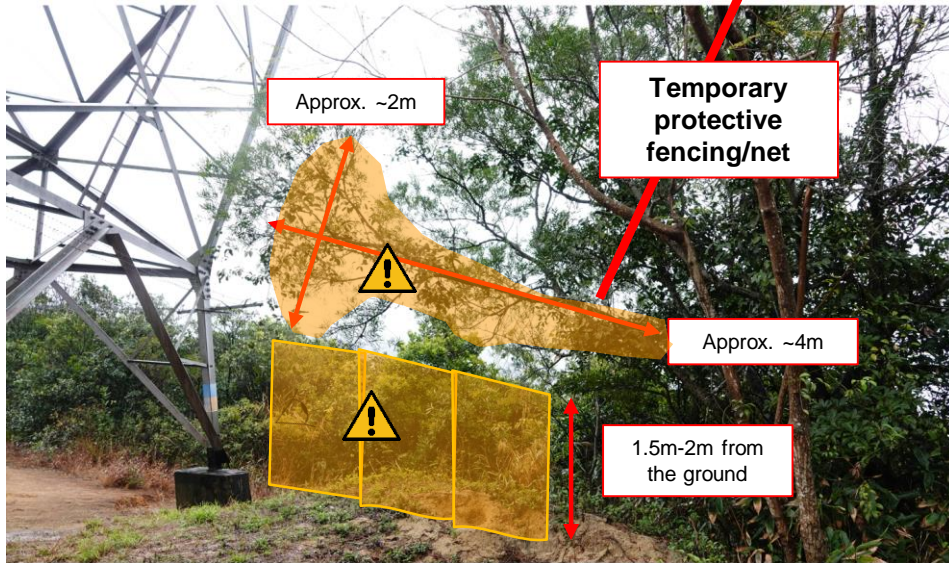
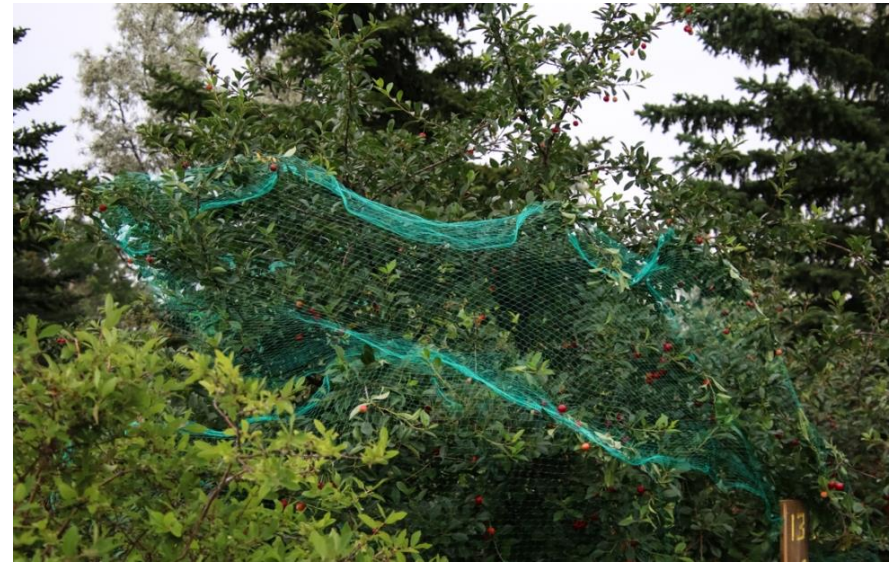
The branches of *Acacia confusa* entangled by *Gnetum luofuense* (shaded area) will be well covered/surrounded by soft protective net with warning sign in sharp colour as appropriate to alert workers' awareness. The deployment and removal of the soft protective net will be conducted with extra care to prevent any potential damage of the plants.

A protective fencing with 1.5m-2m will be erected around the dripline of the entangled branches.

As indicated, only the branches entangled by *Gnetum luofuense* will be covered with soft protective net shown in **Annex A8**

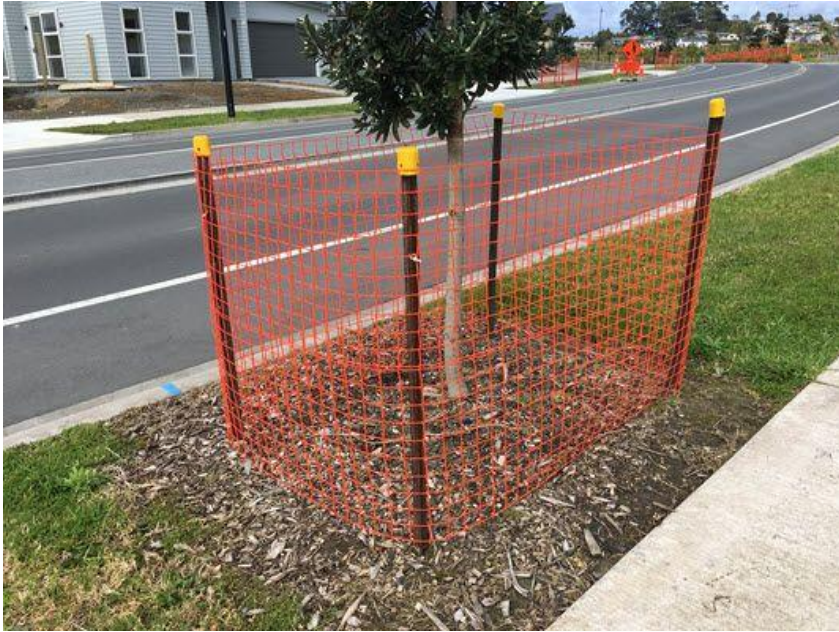
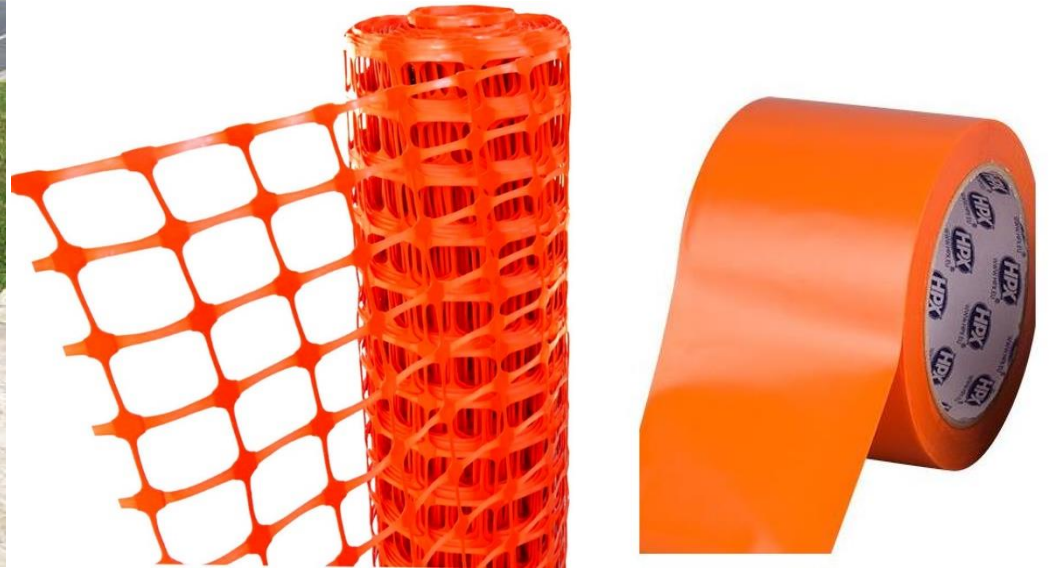
Similar Type of Temporary protective net/fencing that will be provided at P2, P3 and P6

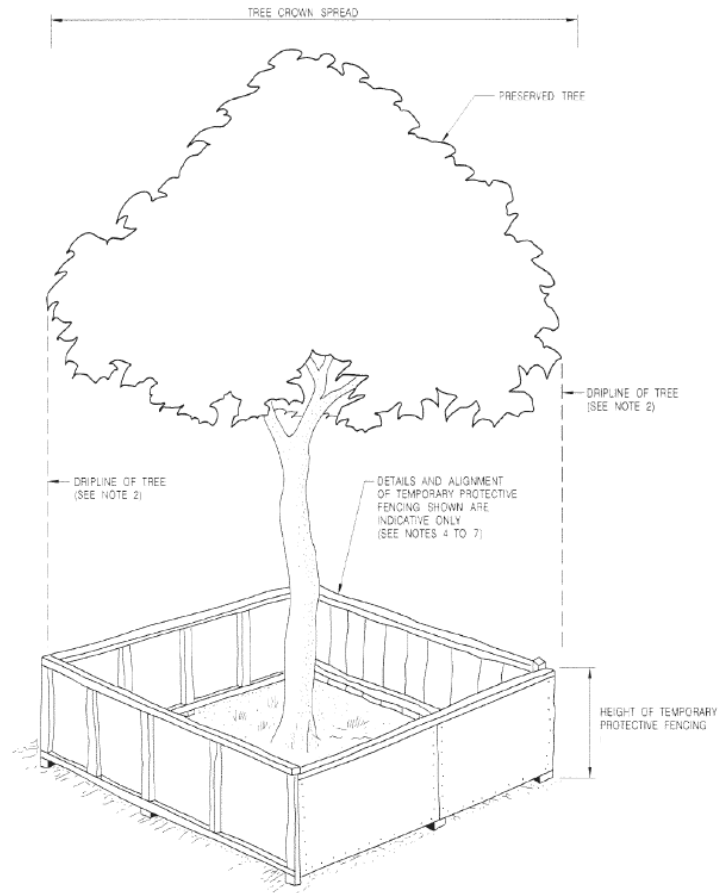
Temporary protective fencing with 1.5m-2m will be erected around the dripline of the tree. The Contractor will maintain the protective measures in good condition during the dismantle work.
