# Removal of 132kV Overhead Line and Pylons for P-Line

Ecological Management  
Plan (P15 to P19)

19 December 2022

Project No.: 0585151

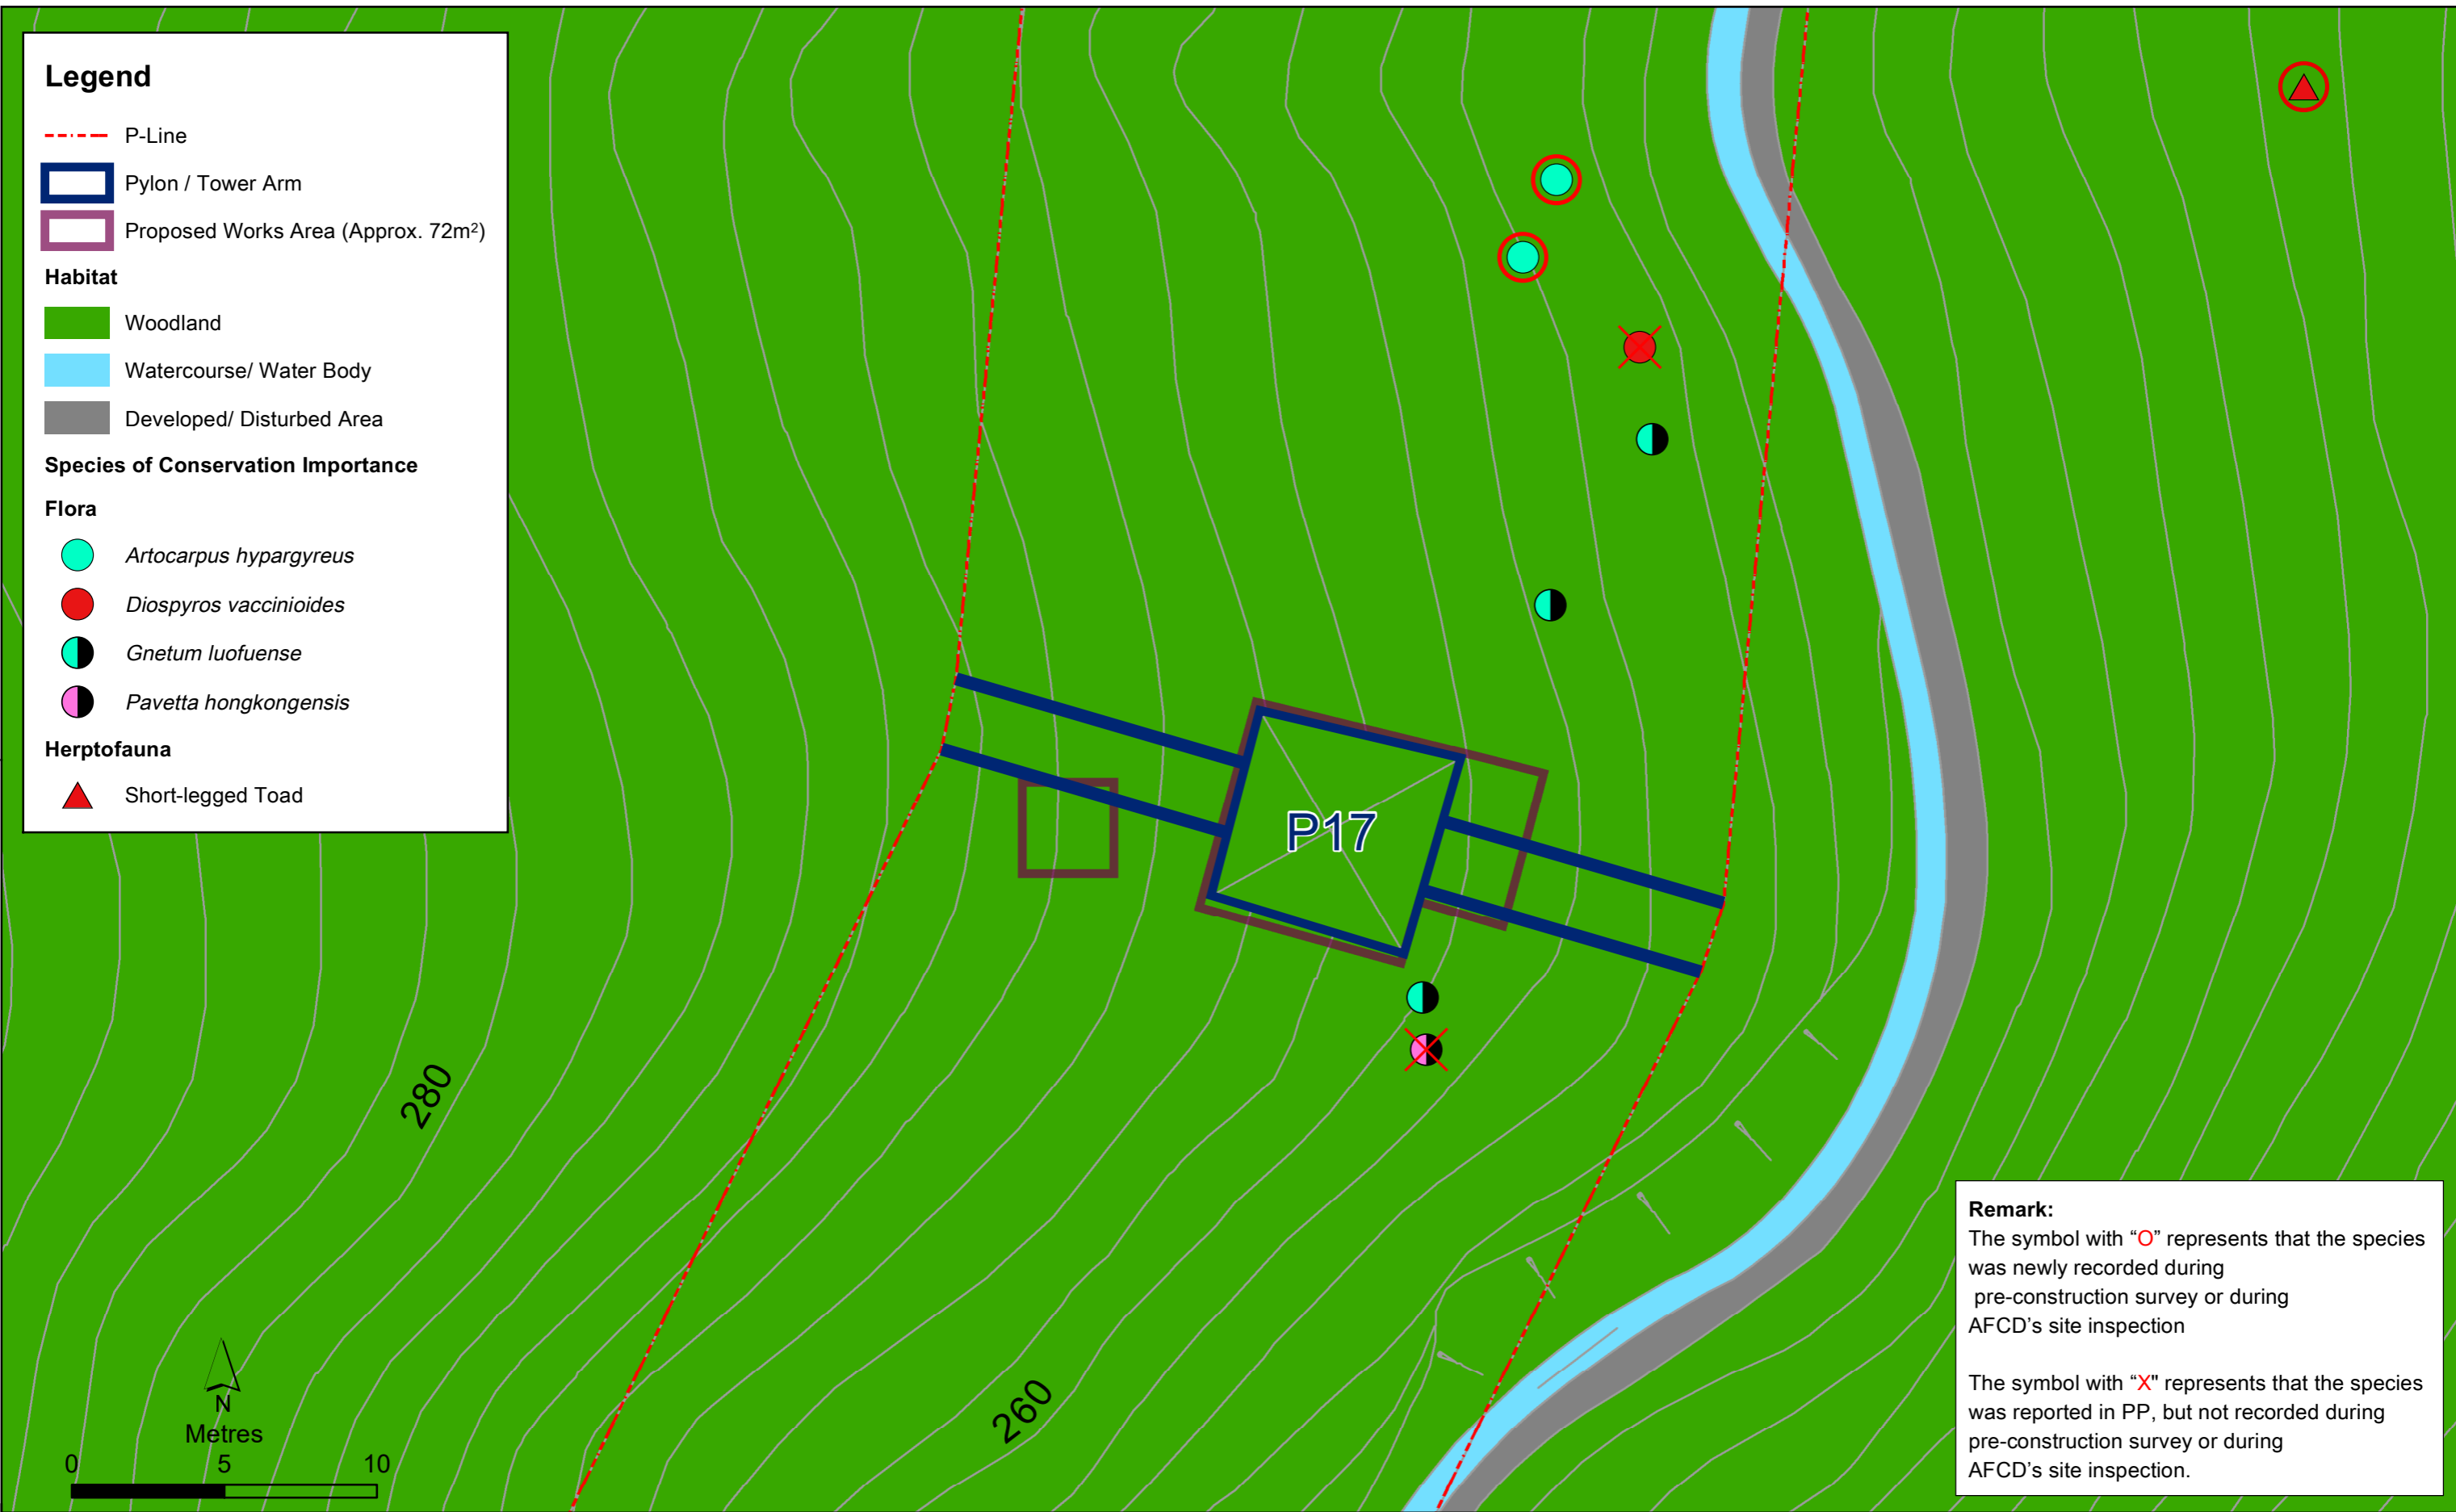
Figure 2.1.3

Zoom-in Habitat Map for Pylon P17

Three individuals of *Diospyros vaccinioides*, three individuals of *Gnetum luofuense*, one *Pavetta hongkongensis*, one *Artocarpus hypargyreus*, one Small Indian Civet, one Crested Serpent Eagle and one Romer's Tree Frog reported in PP at P15, P16, P17 and P19 were not recorded during the pre-construction survey or during AFCD's site inspection (**Figures 2.1.1, 2.1.2, 2.1.3 and 2.1.5**).

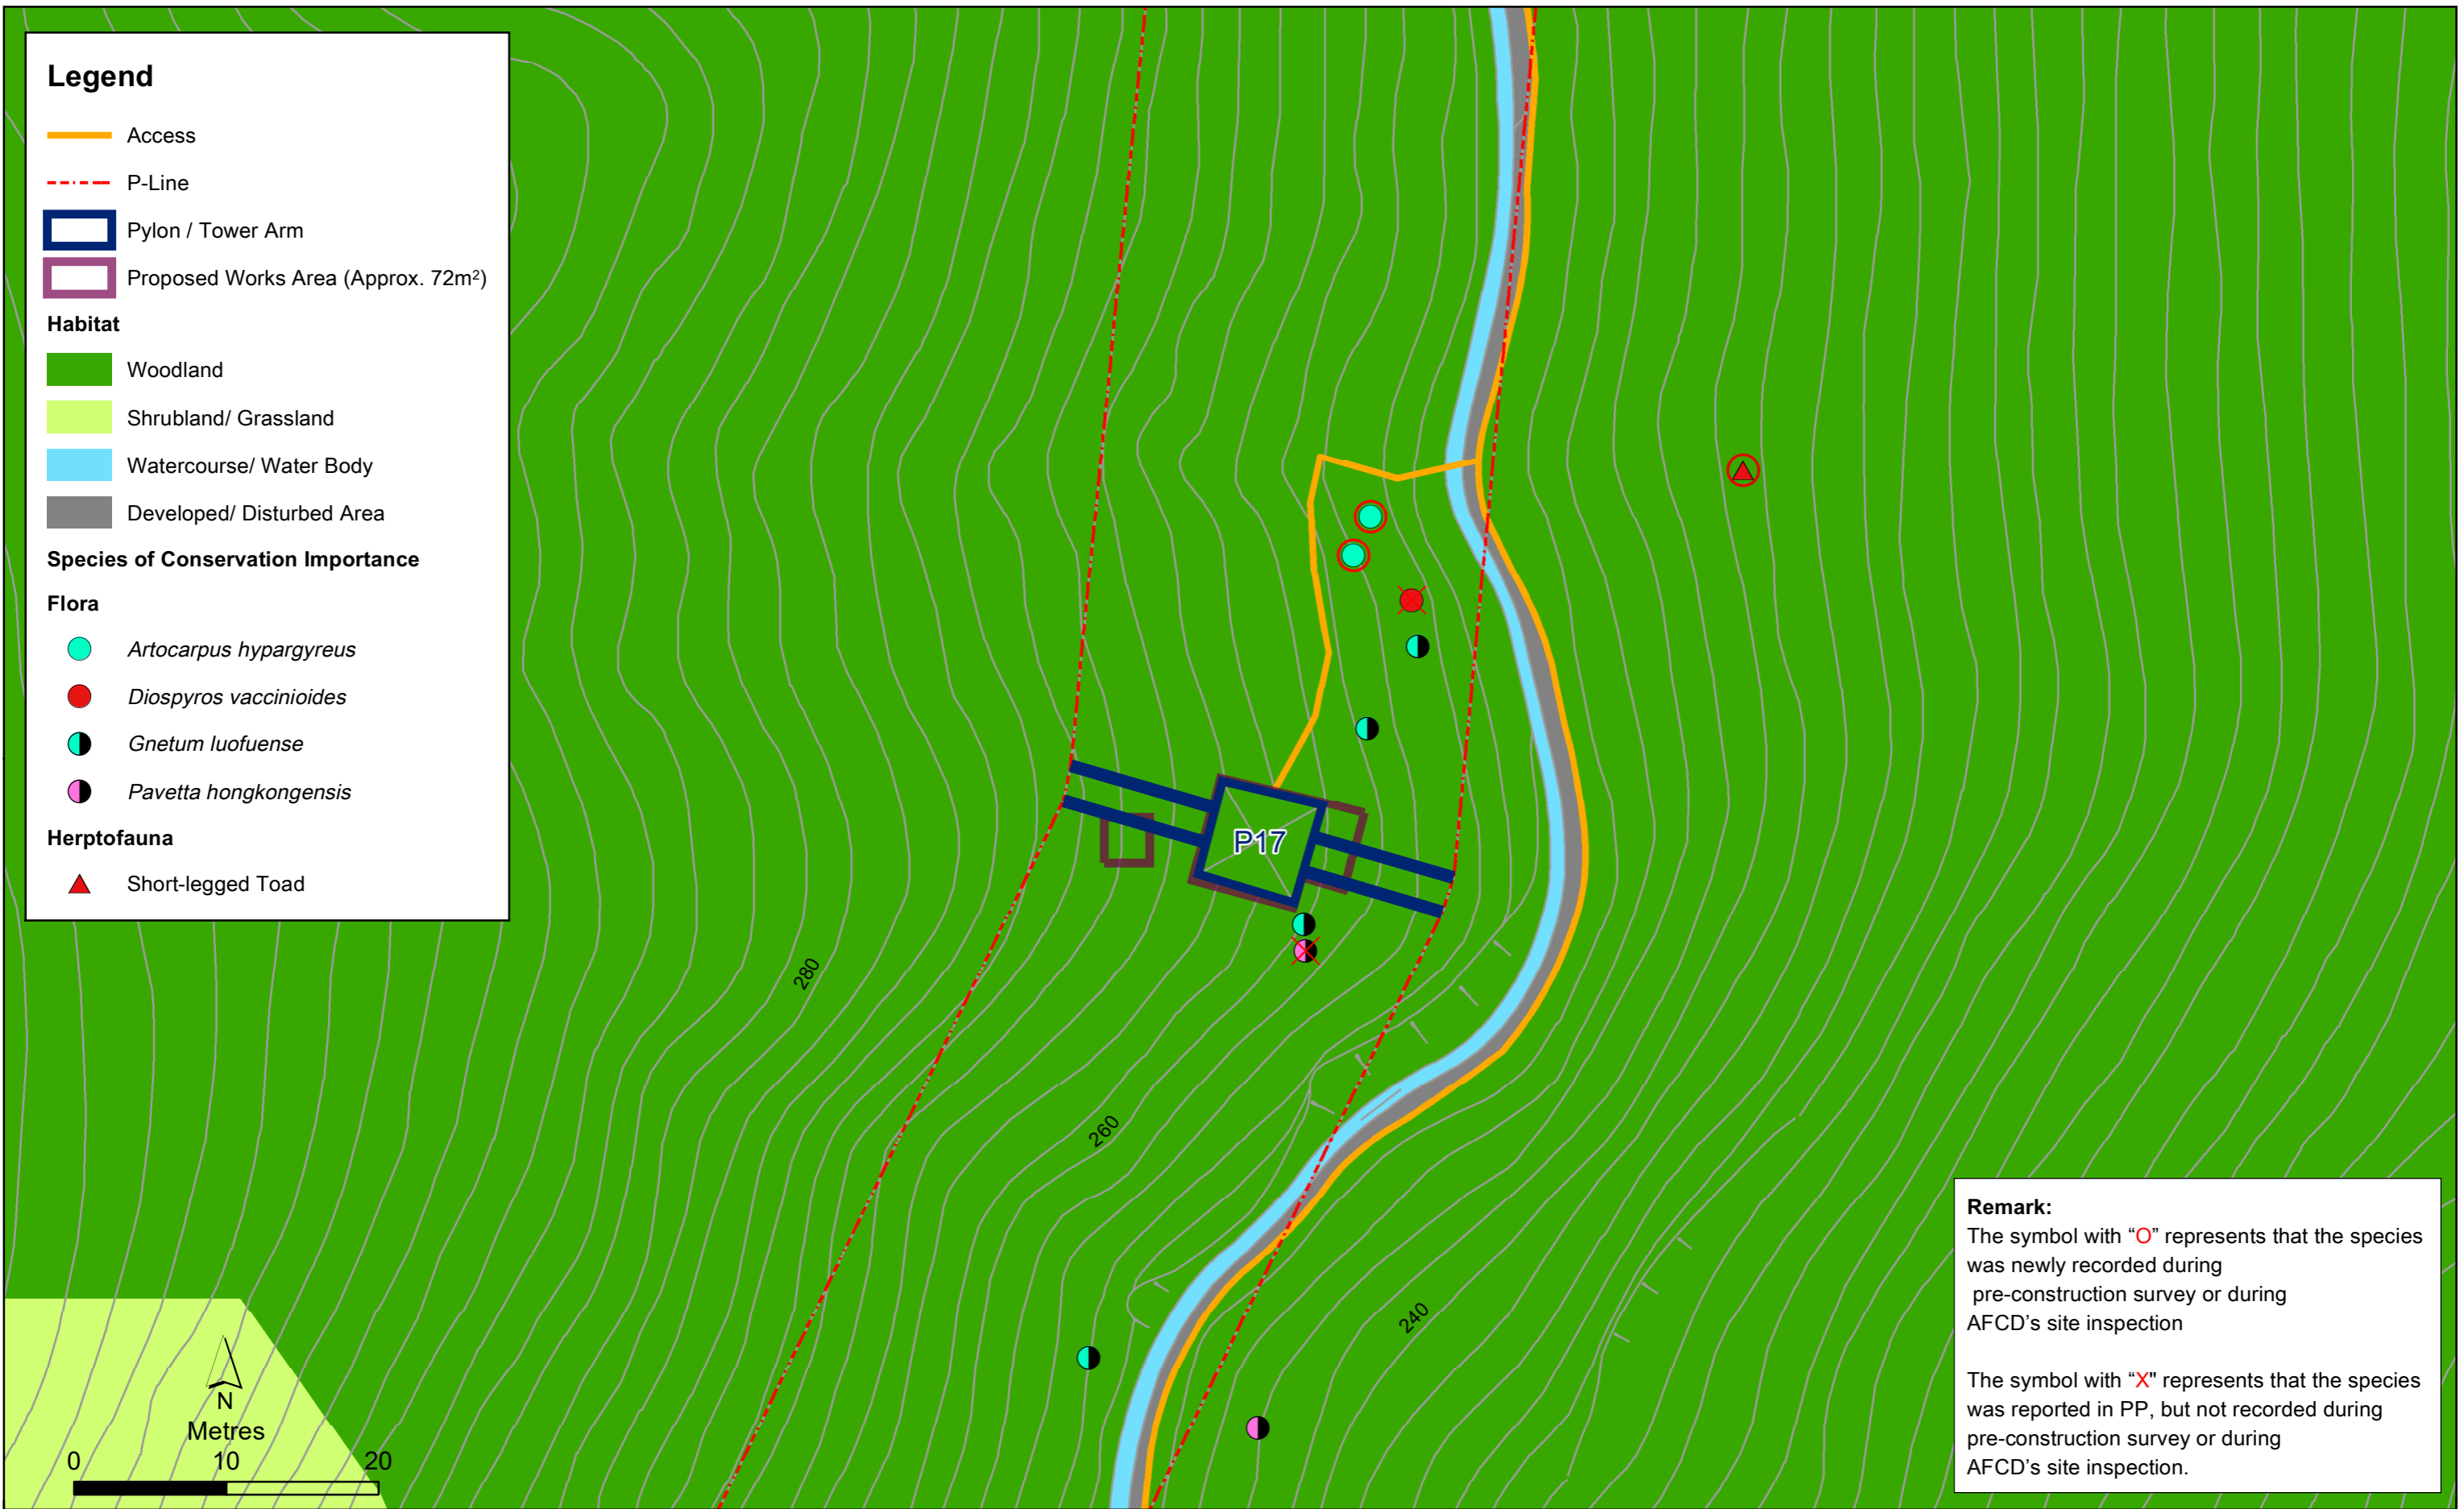
Figure 2.1.3a

Zoom-out Habitat Map for Pylon P17

The equipment and removal of materials will be delivered to the Project site via existing vehicular roads by crane lorry and/or footpaths manually. For those areas which are not accessible via existing vehicular roads and/or footpaths, it will be transported by helicopter, such that construction of new access route and associated vegetation clearance are not required. The footpath access to respective pylons are as shown in **Figure 2.1.1a to 2.1.5a**.

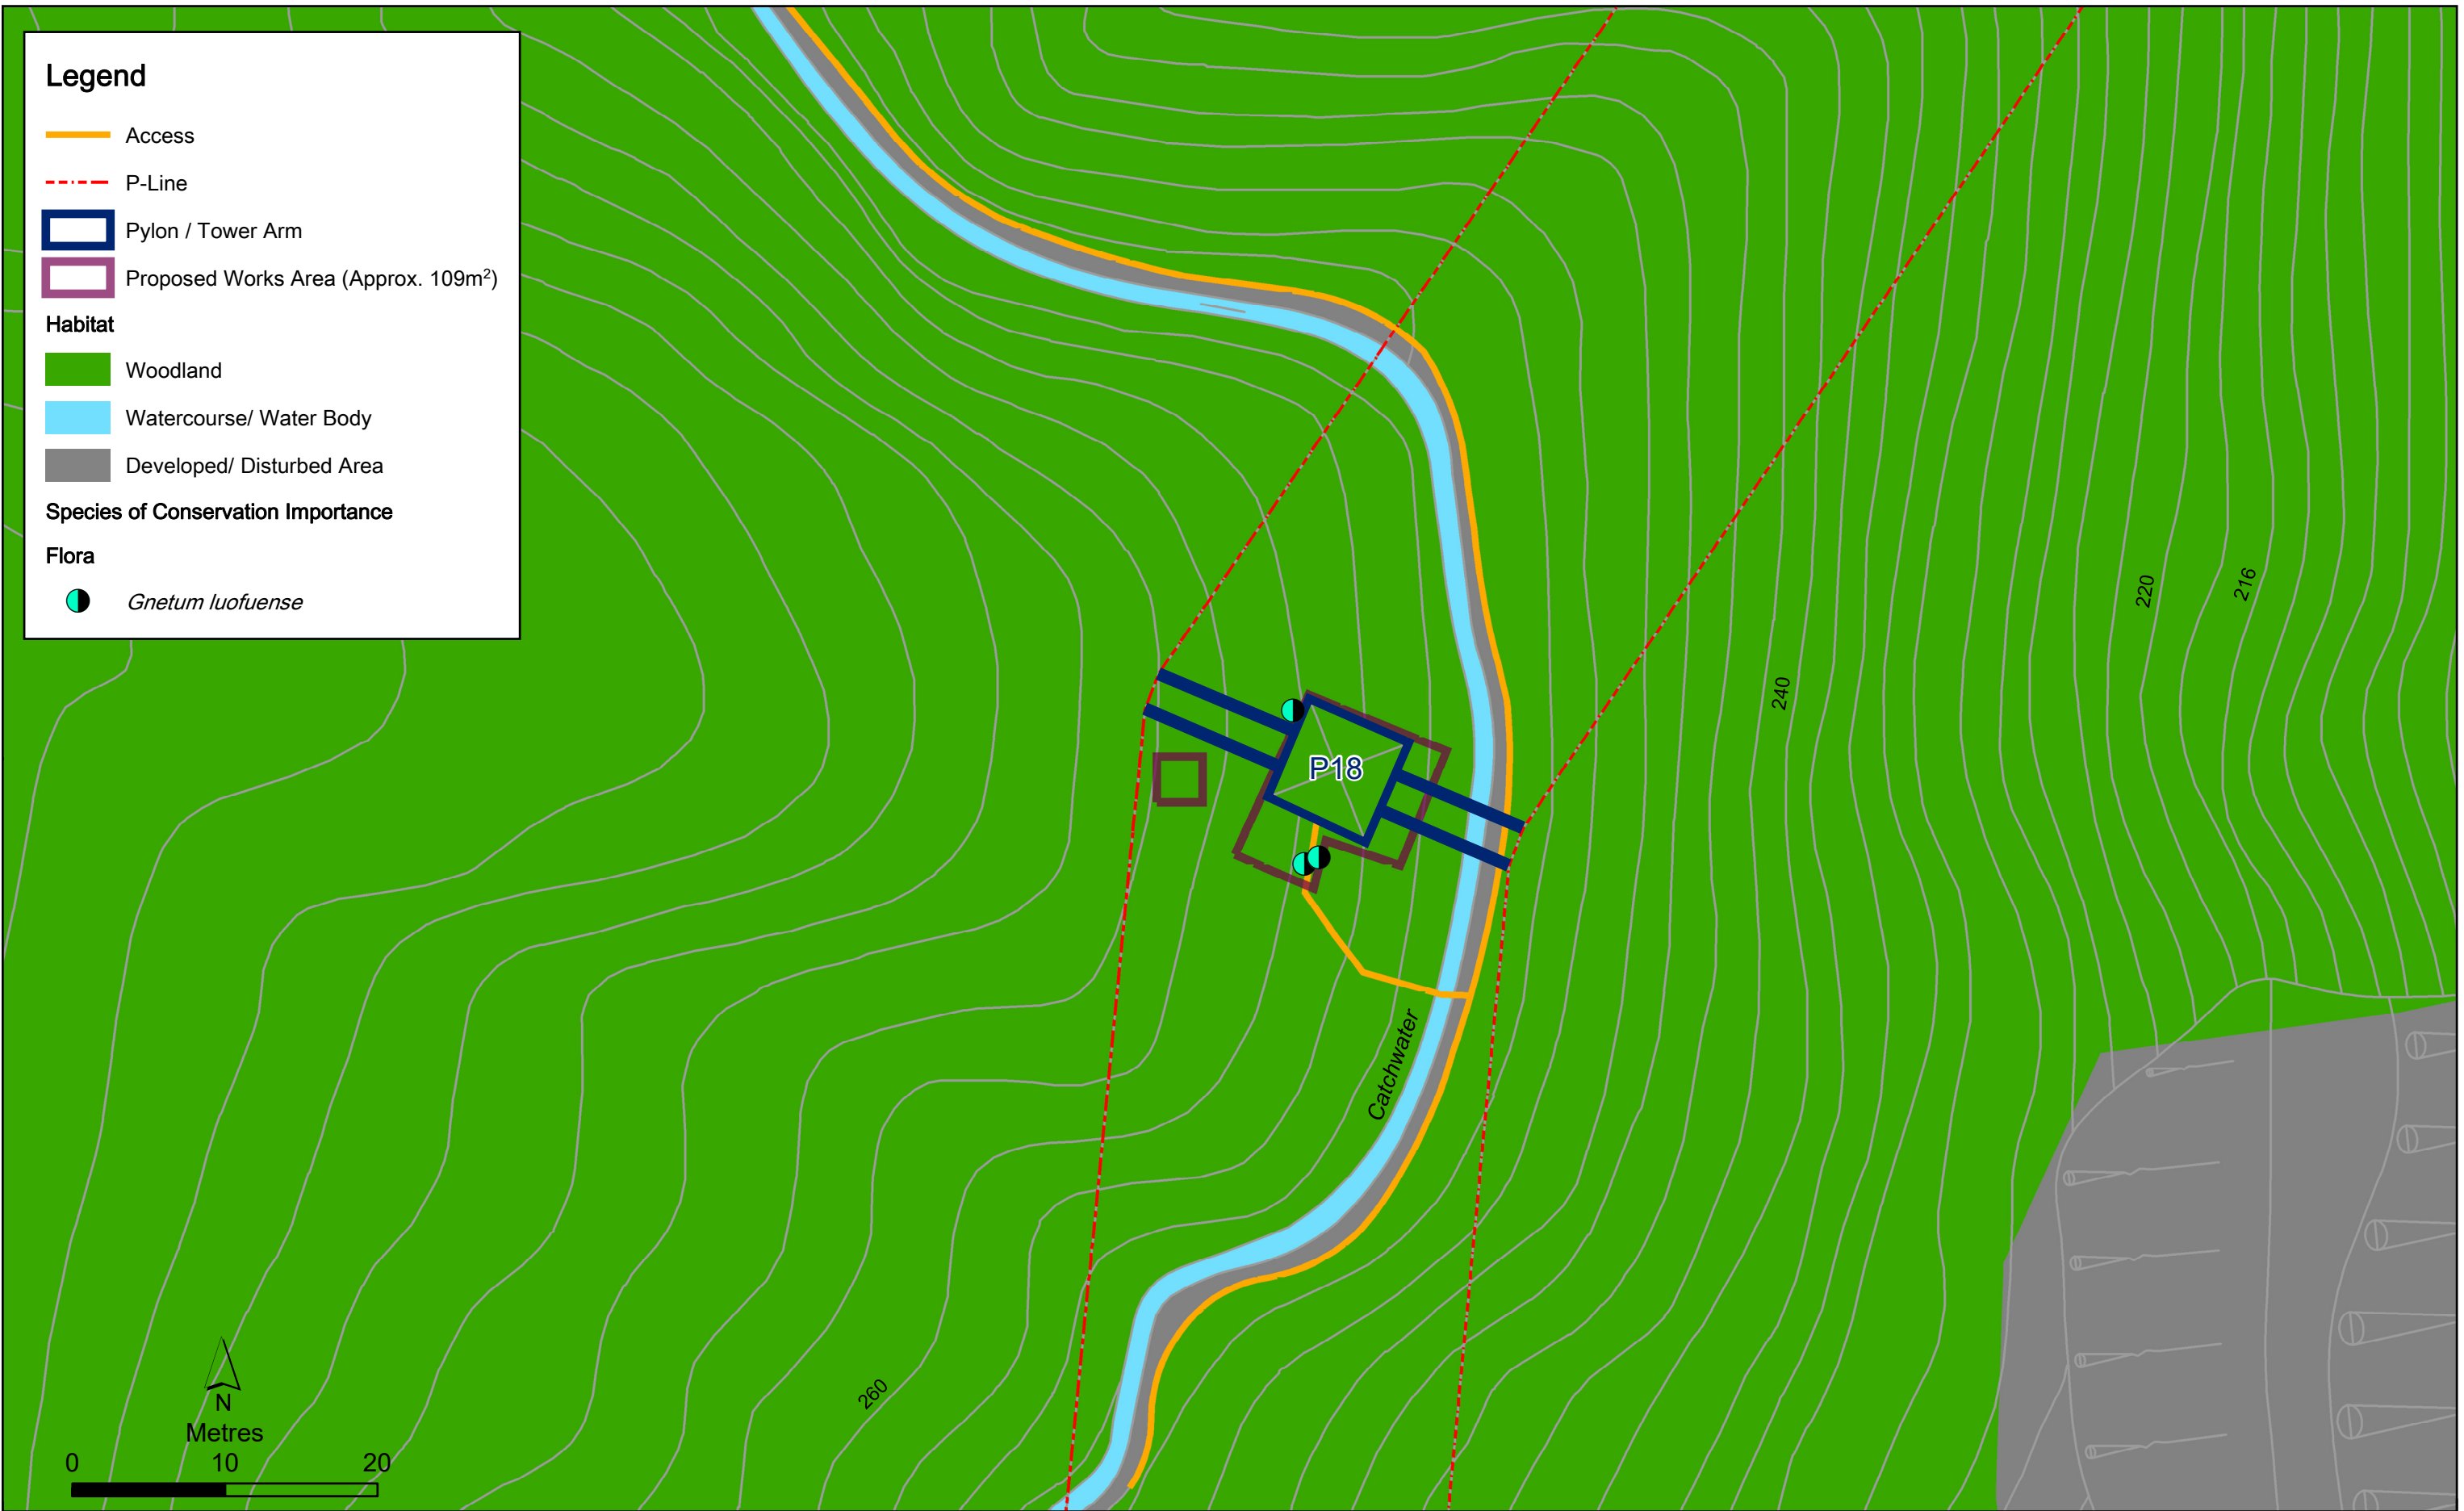
Figure 2.1.4a

Zoom-out Habitat Map for Pylon P18

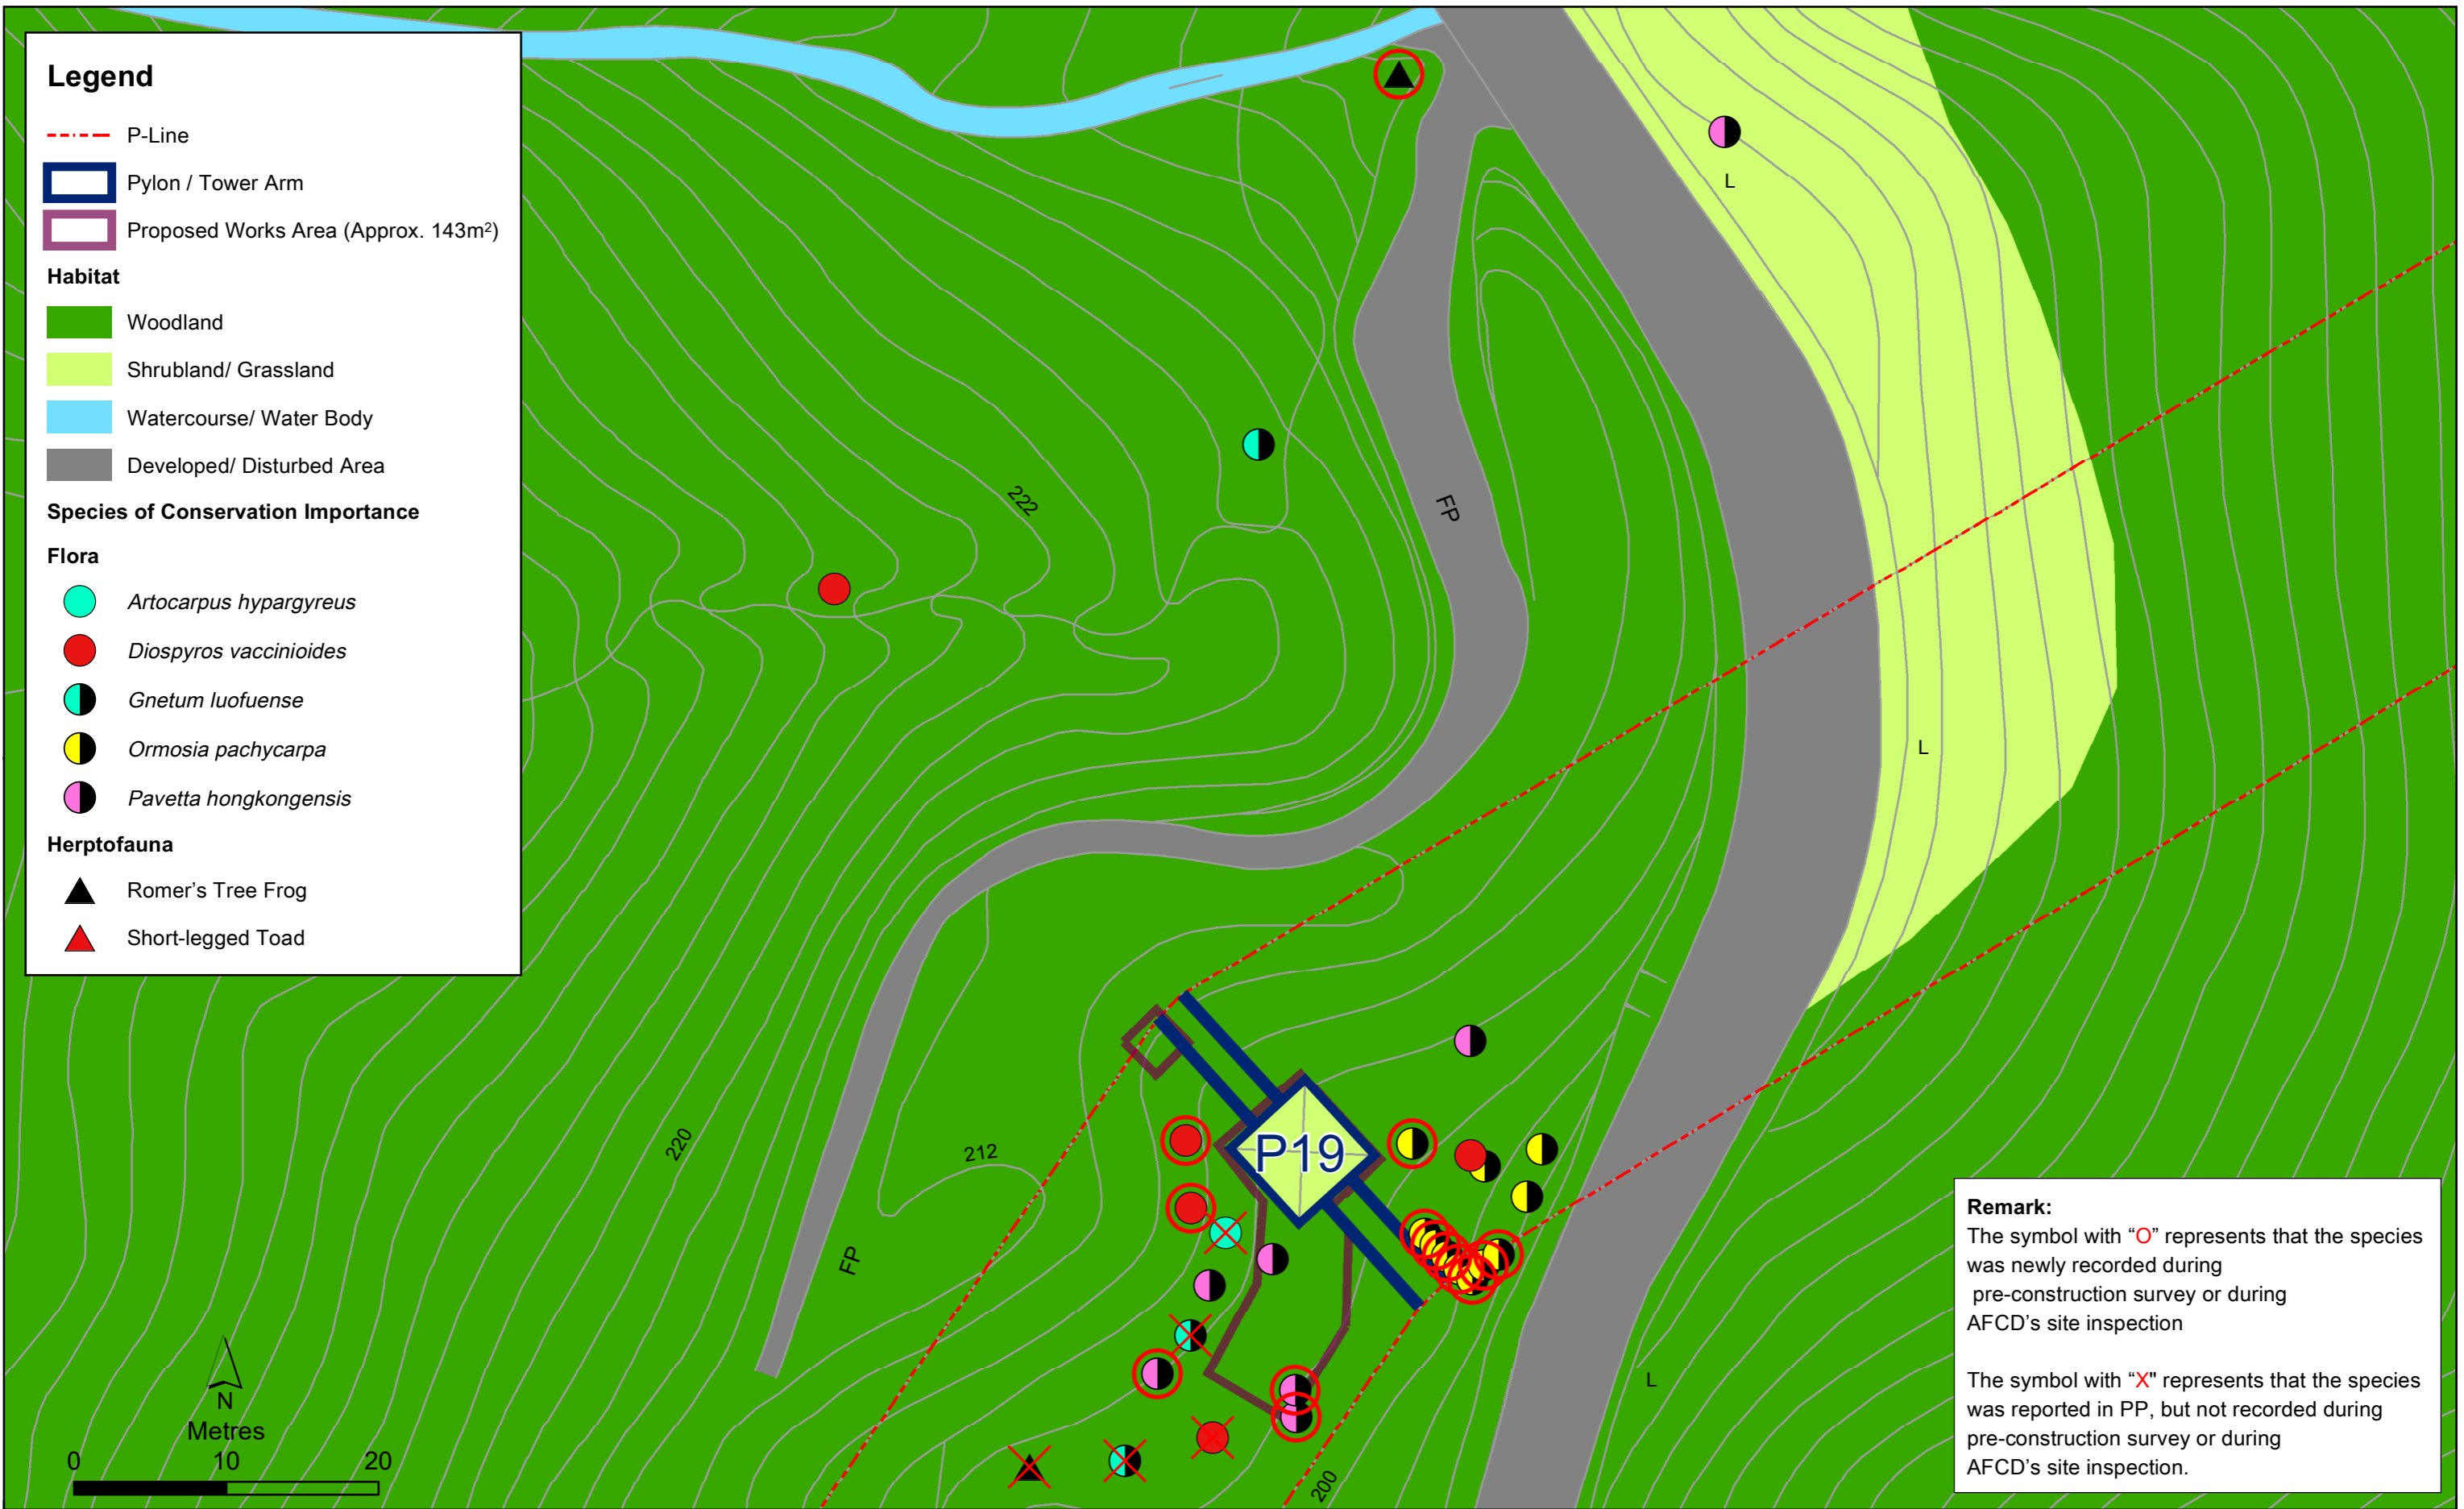
Figure 2.1.5

Zoom-in Habitat Map for Pylon P19

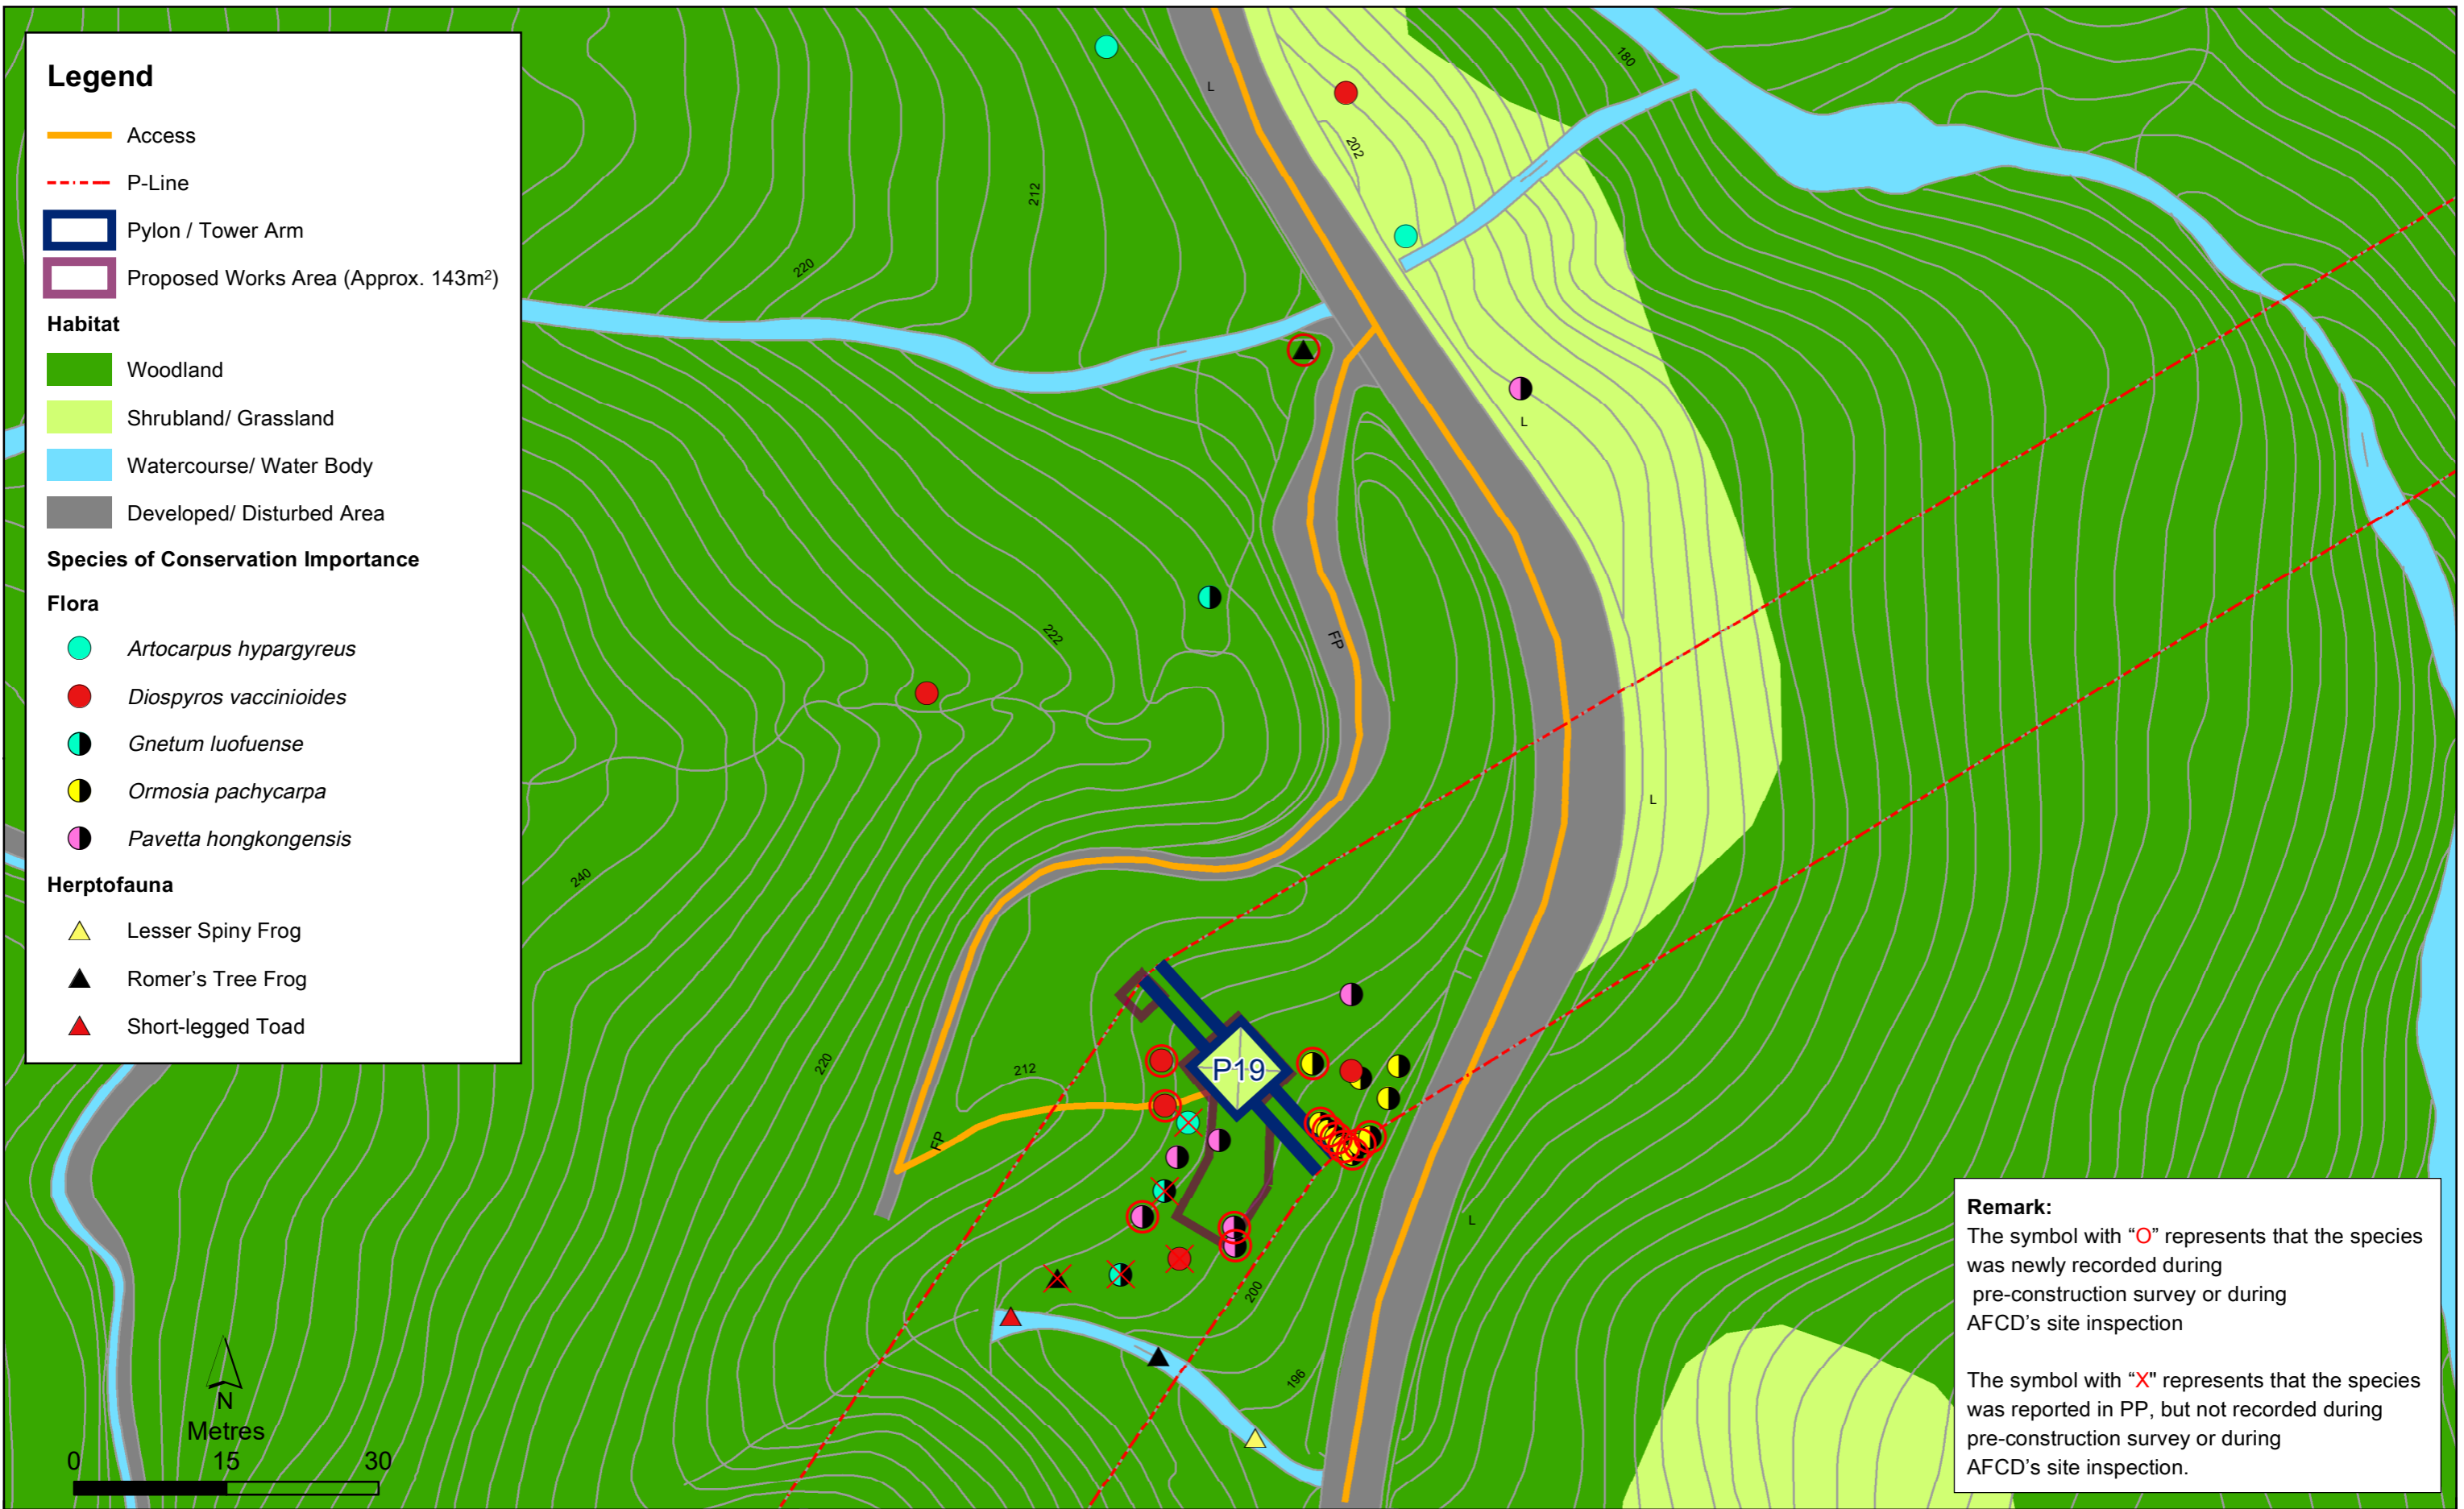
Figure 2.1.5a

Zoom-out Habitat Map for Pylon P19

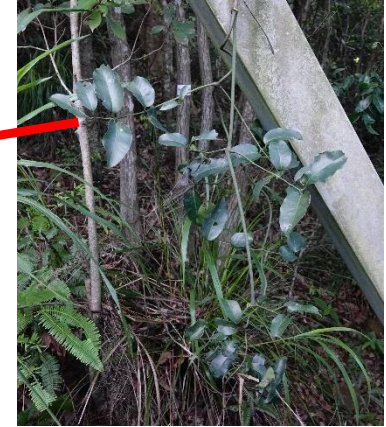
*Gnetum luofuense* recorded within the proposed work area at P18 (entangling on pylon)

The *Gnetum luofuense* found at P15 and P18 are climbing on shrub or on the pylon. The *Gnetum luofuense* entangling on shrub, were located at the fringe of proposed works areas, soft protective nets and temporary protective fencing (**Annexes A6-1, A7, A8, A10 & A11**) with warning sign in sharp colour with the intention to alert the workers to be aware of the species will be provided in order to avoid the species being damaged during the removal works. The deployment and removal of the soft protective net will be conducted with extra care to prevent any potential damage of the plants. A temporary fencing will be erected for the shrub and dripline of the branches entangled by *Gnetum luofuense*. As one *Gnetum luofuense* at P18 was found not entangling the pylon tightly, it is proposed to gently disentangle it from the pylon and put the disentangled part on adjacent unaffected vegetated area outside the works area which will not be affected by the dismantling work (**Annex A9**).

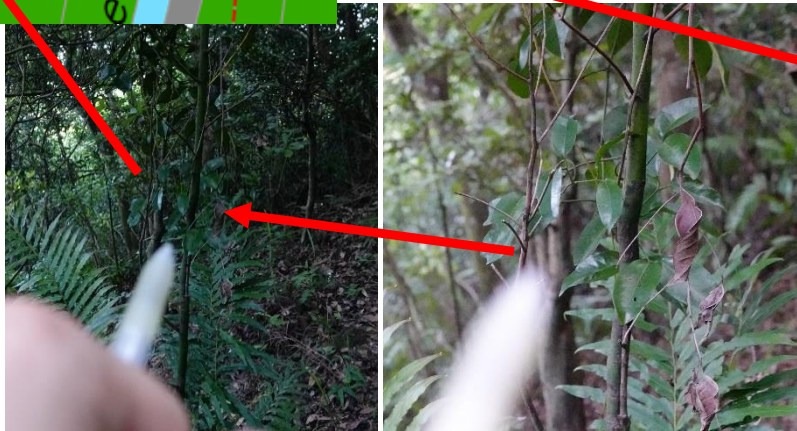
*Gnetum luofuense* recorded within the proposed work area at P18

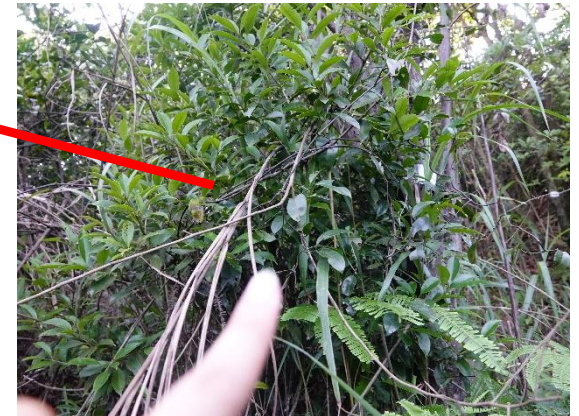
*Gnetum luofuense* recorded within the proposed work area at P18

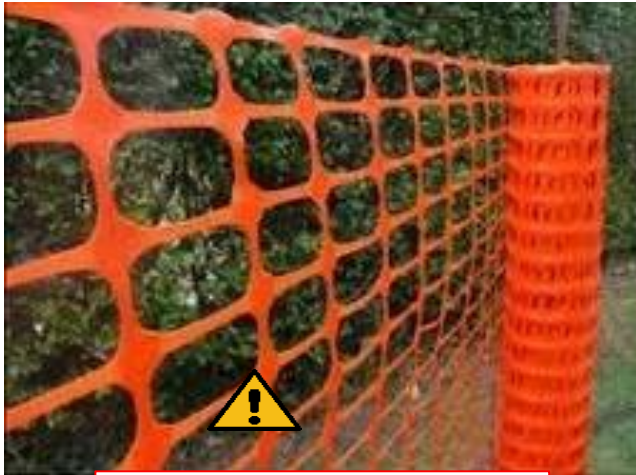
**Soft protective net**

The soft protective net with warning sign in sharp colour will be used to cover the species that may be potentially affected by the dismantle works. The soft net allows to cover irregular shape of flora species and species growing off the ground, in particular for the climber *Gnetum luofuense*. The net with warning sign aims to alert workers that the presence of the species.

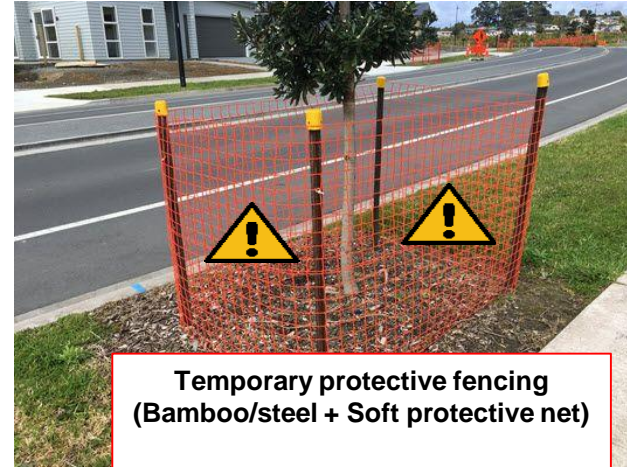
**Temporary protective fencing  
(Bamboo/steel + Soft protective net)**

Temporary protective fencing is made use of soft protective net with Bamboo/steel surrounded in order to provide a more robust structure for protection purpose. When area is available, it will be used for the shrubs/tree entangled by *Gnetum luofuense* at the **edge** of proposed work area .

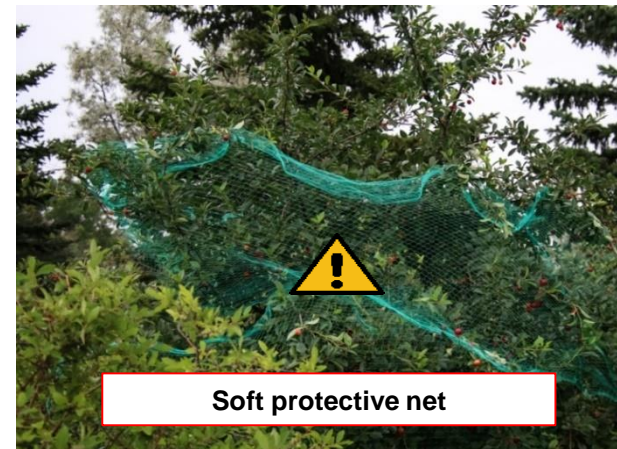
**Soft protective net**

As indicated, the shrubs/tree entangled by *Gnetum luofuense* will be covered with soft protective net.

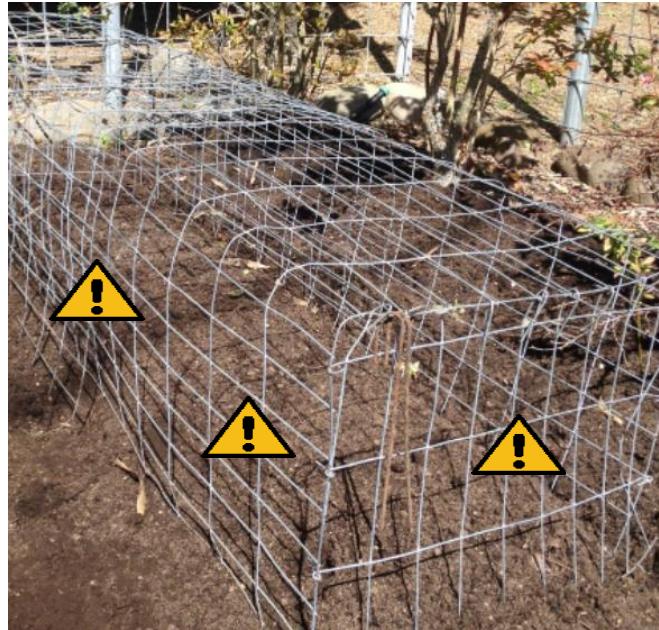
**Temporary Metal Cage**

When area is available, temporary metal cage will be built around the identified plant with the aim to avoid damage during the dismantling works.

Two *Pavetta hongkongensis* were recorded at P19 located at the fringe of proposed works areas will be also provided with protective measure. Temporary metal cage with a minimum height of 30cm will be erected around the dripline of the seedlings to avoid potential impact under the Project (**Annexes A6-1 & A13**). The temporary metal cage will be removed upon completion of works. The Contractor will ensure that the parts of pylon segments will not have direct contact with the identified *Pavetta hongkongensis*.
