# Removal of 132kV Overhead Line and Pylons for P-Line

Ecological Management  
Plan (P15 to P19)

19 December 2022

Project No.: 0585151

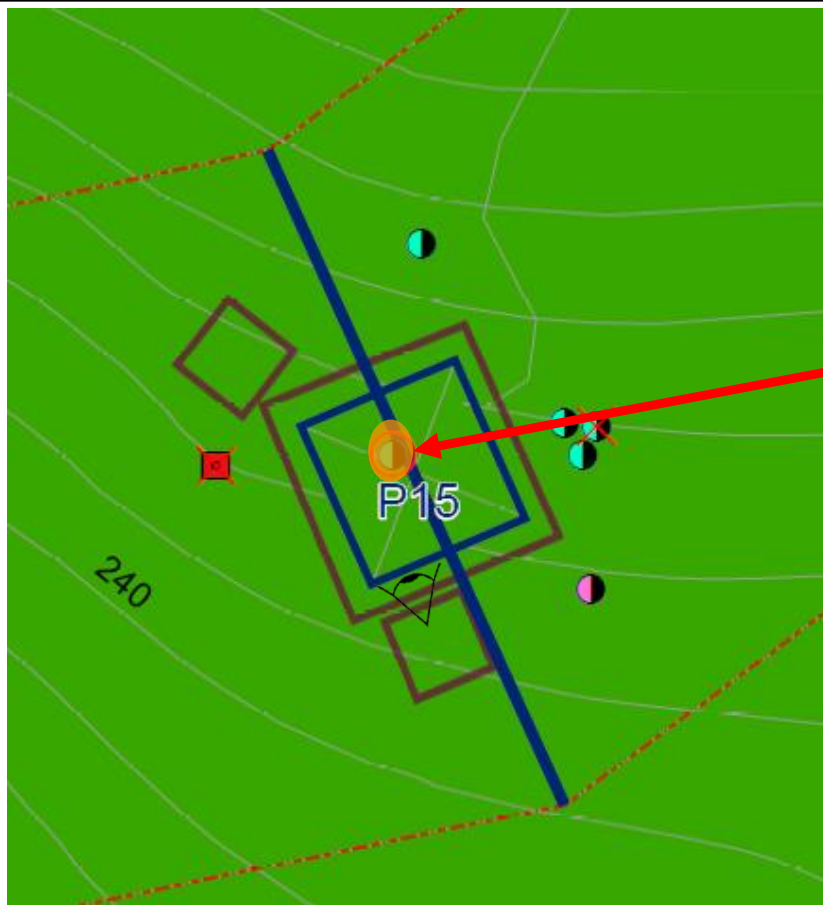
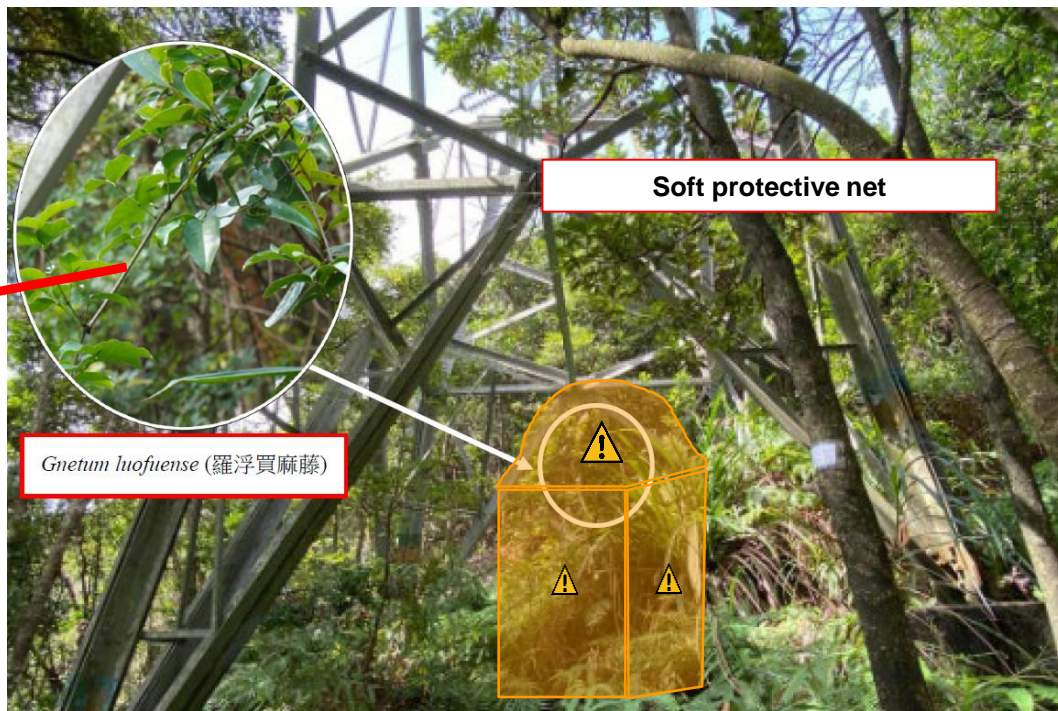
When area is available, temporary metal cage will be built around the identified plant with the aim to avoid damage during the dismantling works.

Soft protective net

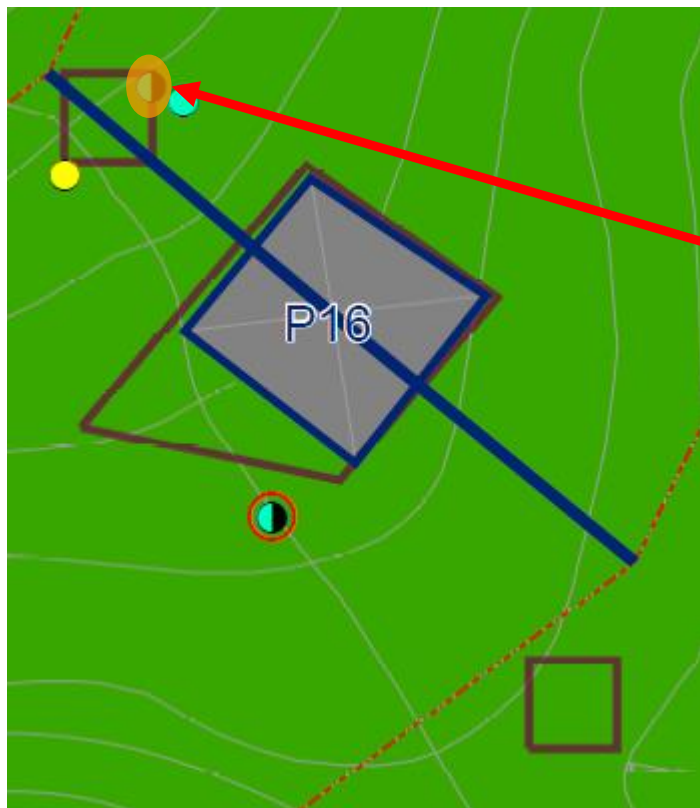
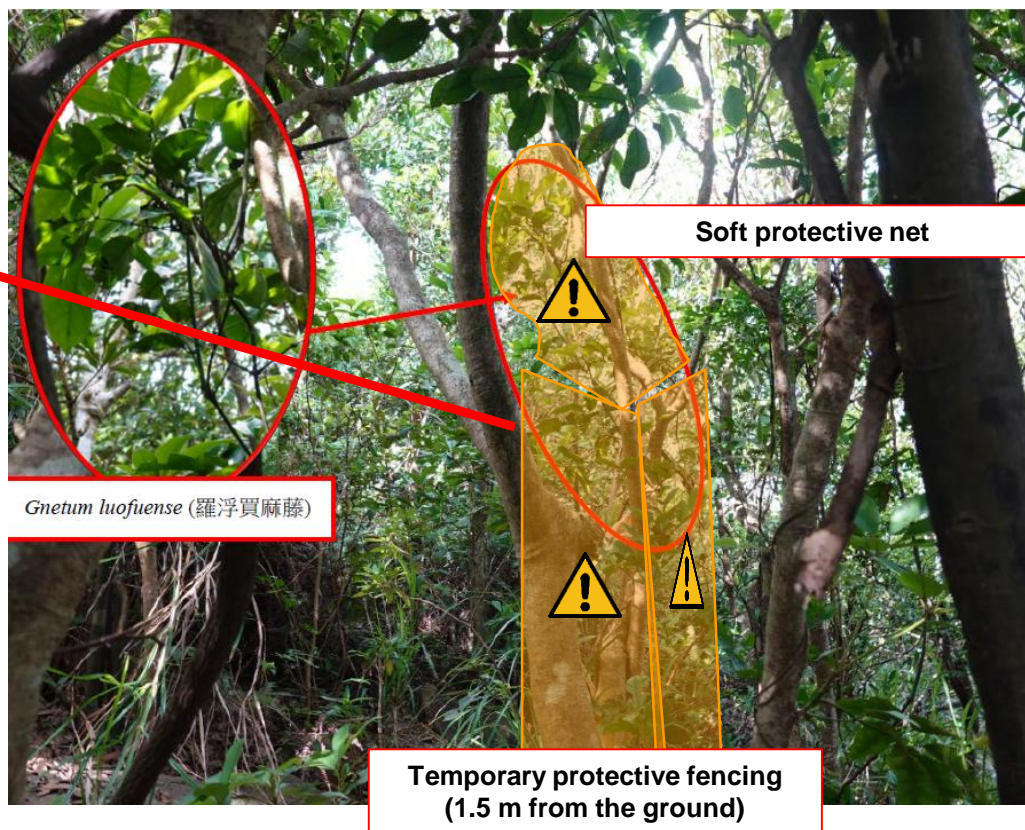
As the species is located at edge of proposed work area, temporary protective fencing (1.5m above ground) will be erected around the shrub which is entangled by *Gnetum luofuense*. The entangled branches above 1.5m of the ground will be covered by soft protective net.

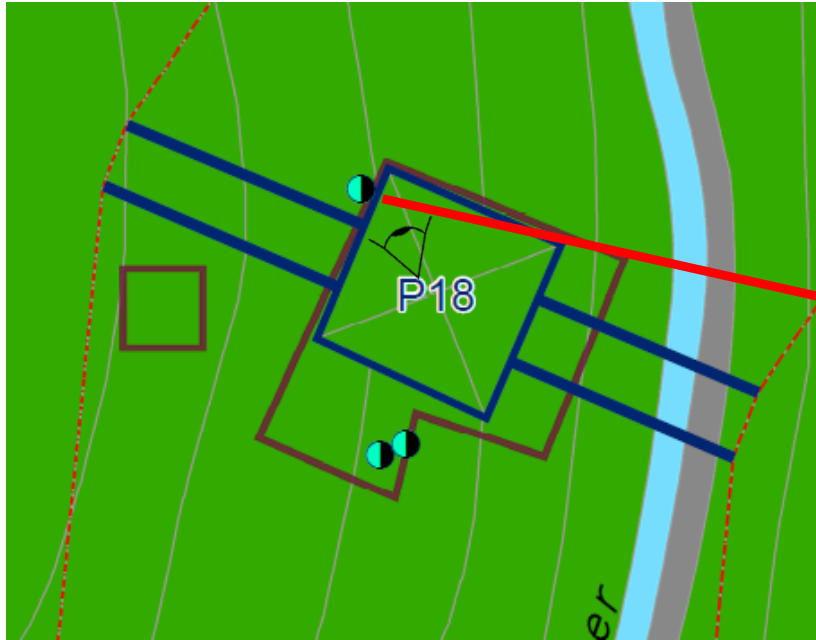
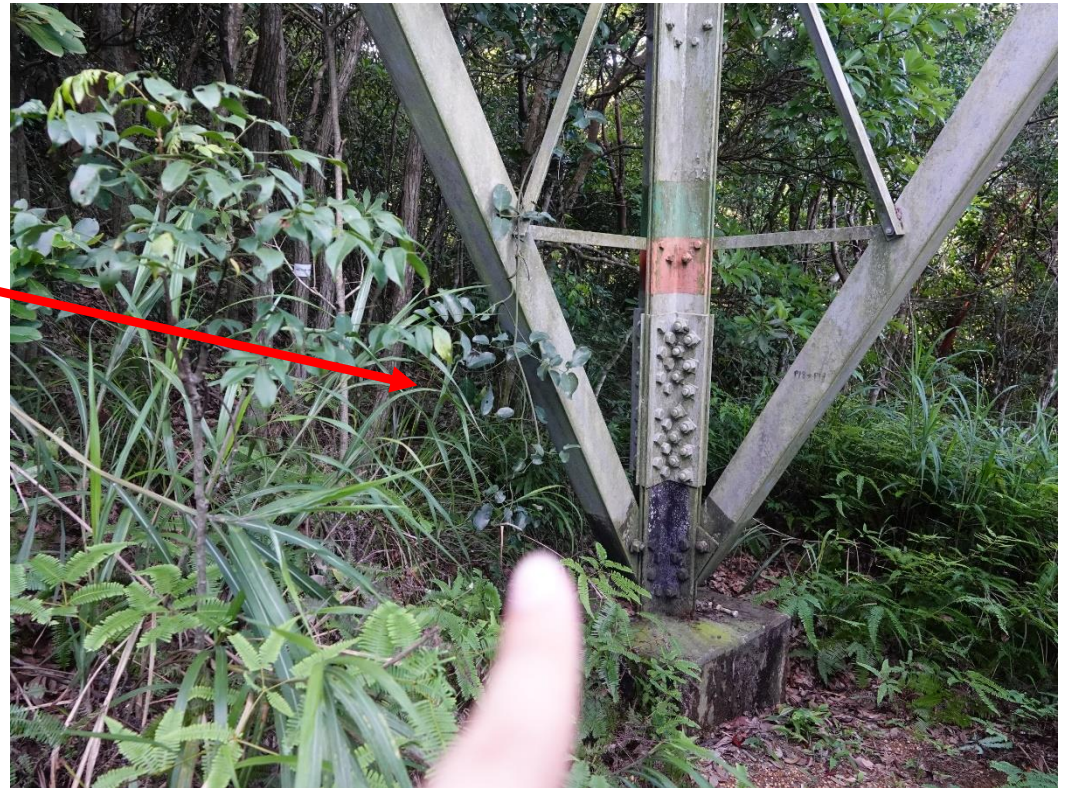
*Gnetum luofuense* recorded within the proposed work area at P18 (slightly entangling on pylon), after gently disentangling could be moved to adjacent vegetation outside of work area.

The *Gnetum luofuense* found at P15 and P18 are climbing on shrub or on the pylon. The *Gnetum luofuense* entangling on shrub, were located at the fringe of proposed works areas, soft protective nets and temporary protective fencing (**Annexes A6-1, A7, A8, A10 & A11**) with warning sign in sharp colour with the intention to alert the workers to be aware of the species will be provided in order to avoid the species being damaged during the removal works. The deployment and removal of the soft protective net will be conducted with extra care to prevent any potential damage of the plants. A temporary fencing will be erected for the shrub and dripline of the branches entangled by *Gnetum luofuense*. As one *Gnetum luofuense* at P18 was found not entangling the pylon tightly, it is proposed to gently disentangle it from the pylon and put the disentangled part on adjacent unaffected vegetated area outside the works area which will not be affected by the dismantling work (**Annex A9**).

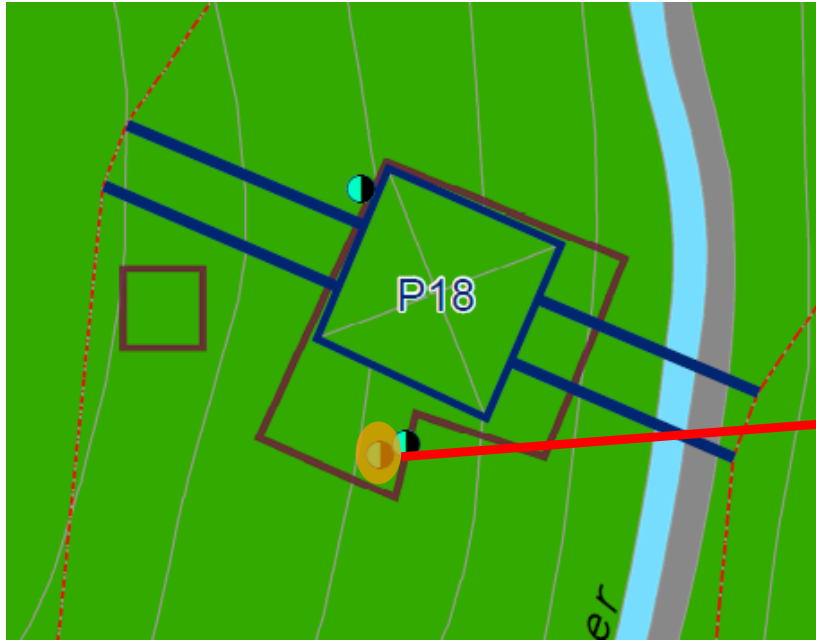
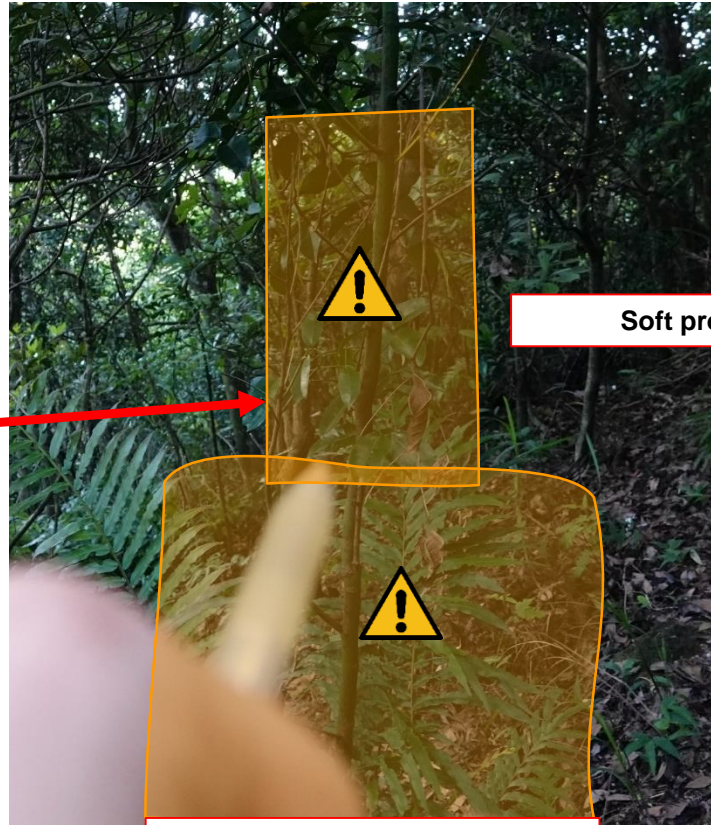
As the species is located at edge of proposed work area, temporary protective fencing (1.5m above ground) will be erected around the shrub which is entangled by *Gnetum luofuense*. The entangled branches above 1.5m of the ground will be covered by soft protective net.

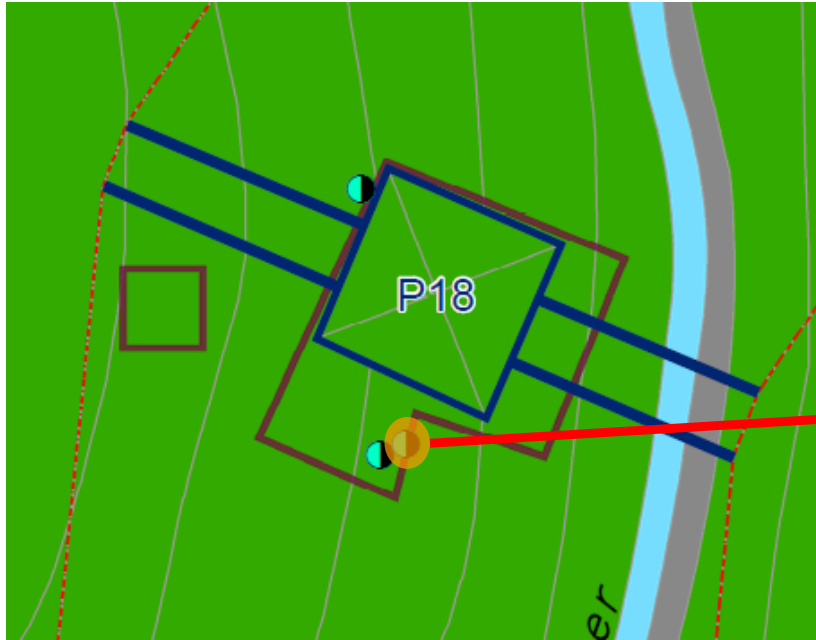
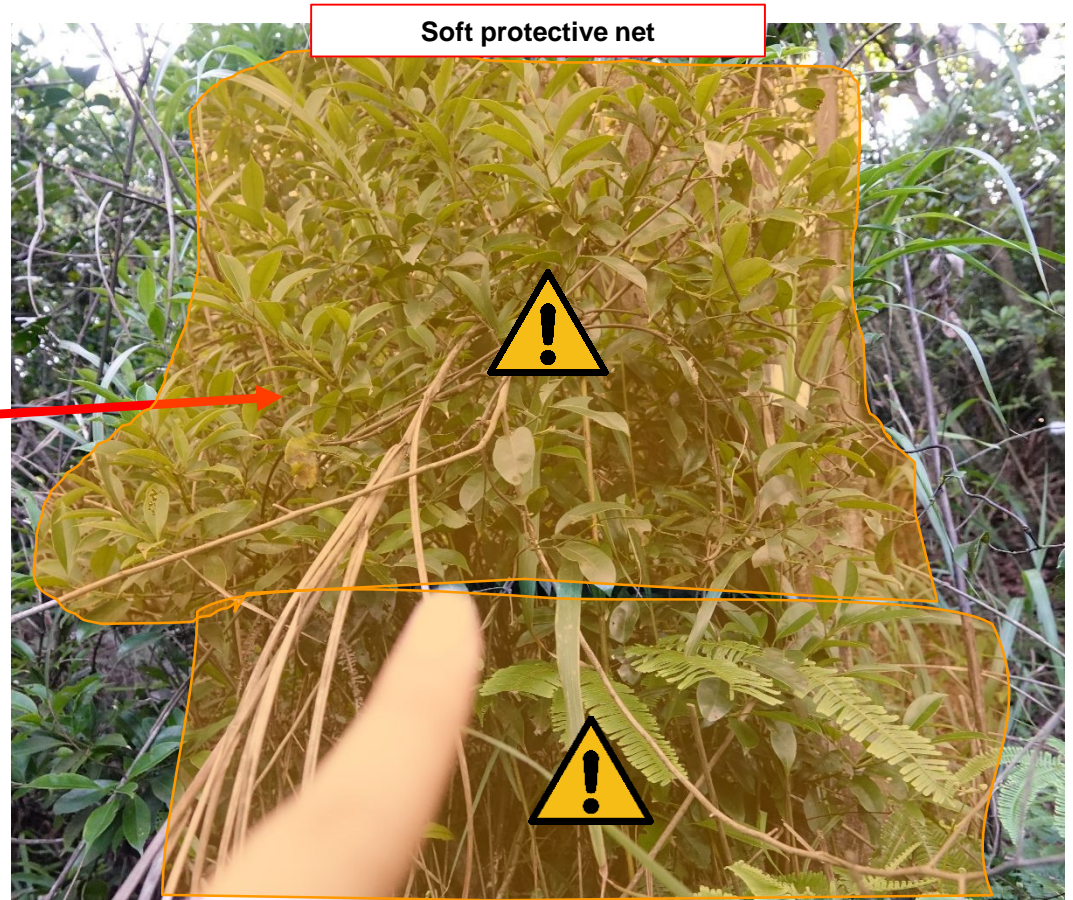
As the species is located at edge of proposed work area, temporary protective fencing (1.5m above ground) will be erected around the shrub which is entangled by *Gnetum luofuense*. The entangled branches above 1.5m of the ground will be covered by soft protective net.

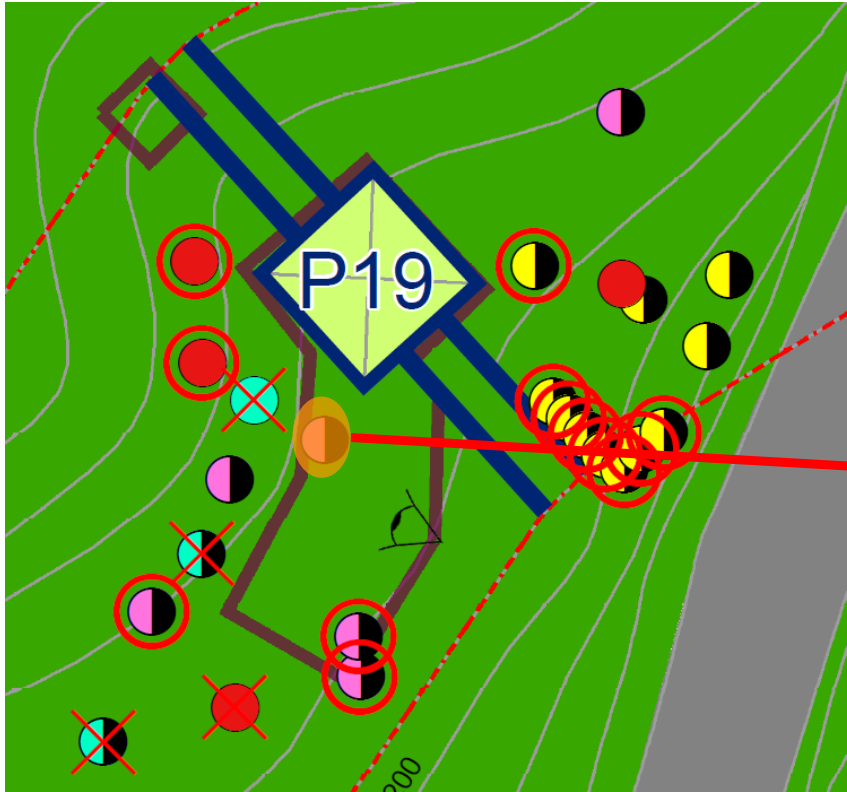
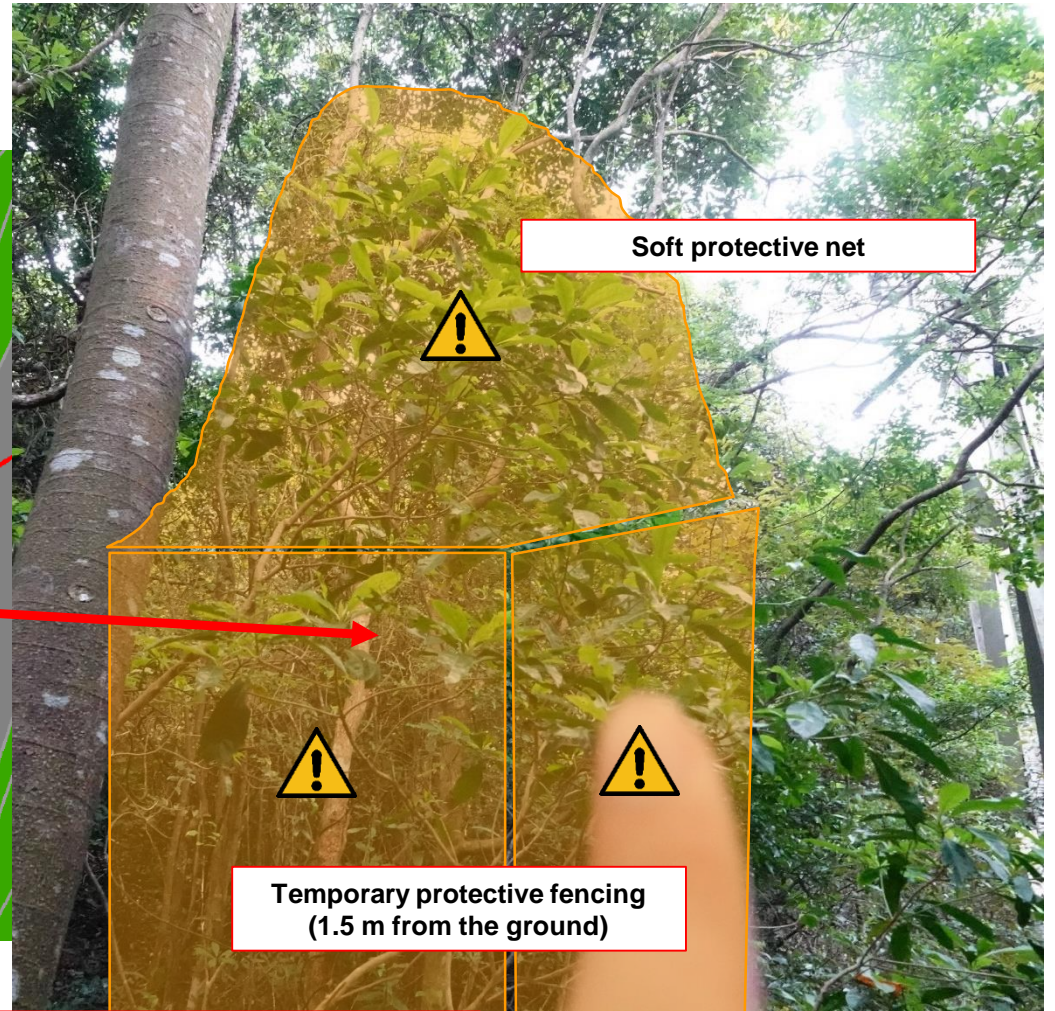
As the species is located at edge of proposed work area, temporary protective fencing (1.5m above ground) will be erected around the shrub which is *Pavetta hongkongensis*. The branches above 1.5m of the ground will be covered by soft protective net.

Given one *Pavetta hongkongensis* at P19 was located at the fringe of proposed works areas, soft protective nets and temporary protective fencing (**Annexes A6-1 & A12**) with warning sign in sharp colour with the intention to alert the workers to be aware of the species will be provided in order to avoid the species being damaged during the removal works. The deployment and removal of the soft protective net will be conducted with extra care to prevent any potential damage of the plants. A temporary fencing will be erected for the shrub and dripline of the branches.

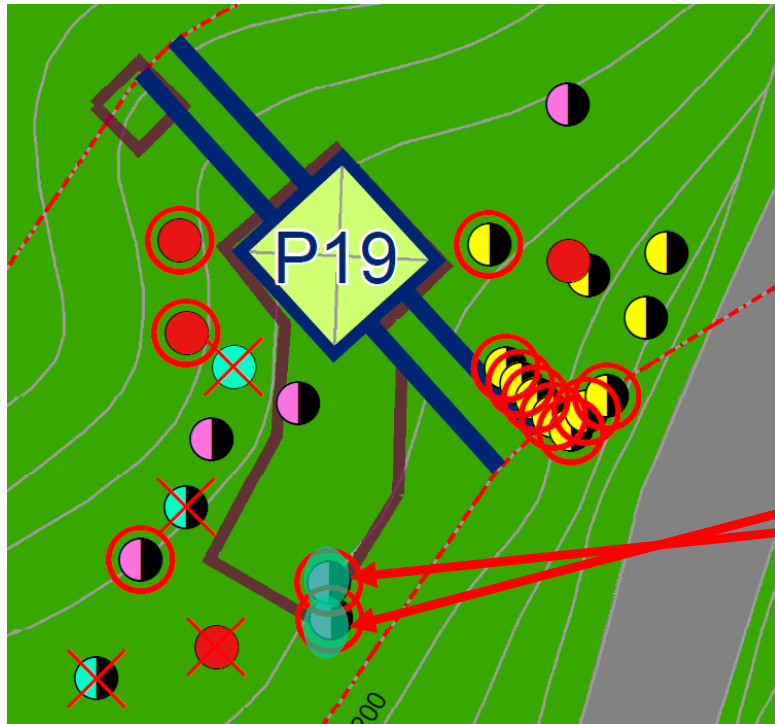
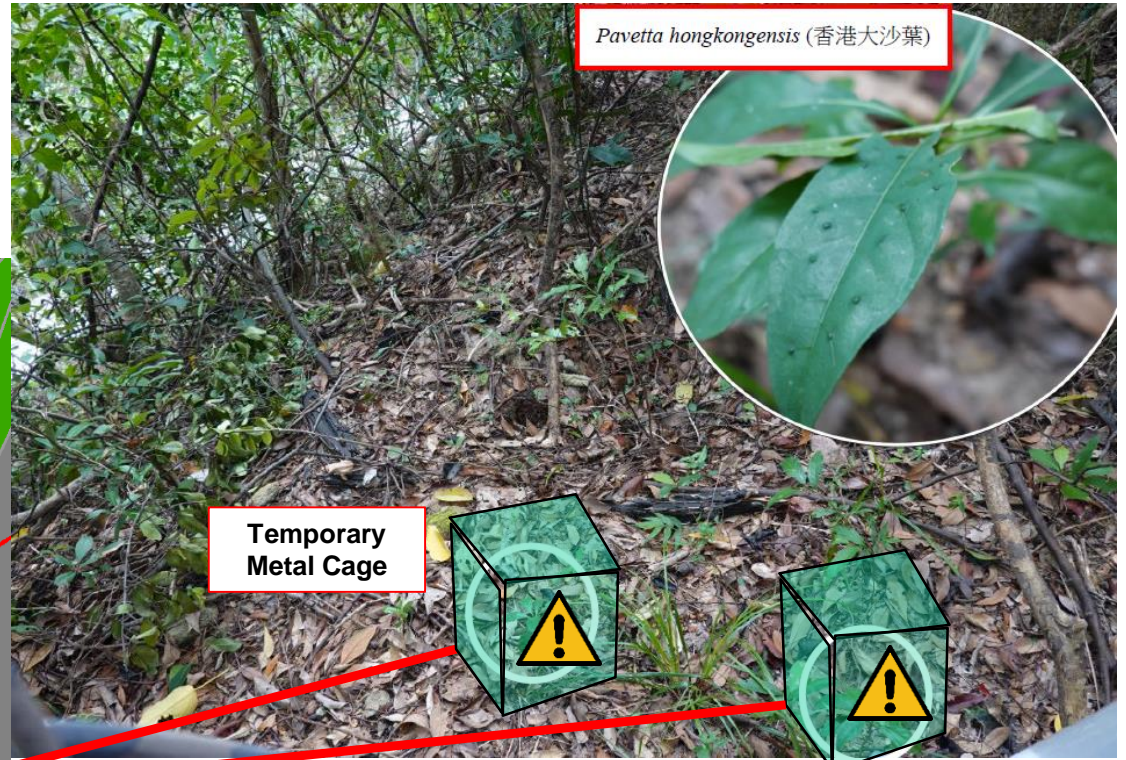
*Pavetta hongkongensis* (shaded area) will be well covered by temporary metal cage considering the individual is small in size

Two *Pavetta hongkongensis* were recorded at P19 located at the fringe of proposed works areas will be also provided with protective measure. Temporary metal cage with a minimum height of 30cm will be erected around the dripline of the seedlings to avoid potential impact under the Project (**Annexes A6-1 & A13**). The temporary metal cage will be removed upon completion of works. The Contractor will ensure that the parts of pylon segments will not have direct contact with the identified *Pavetta hongkongensis*.

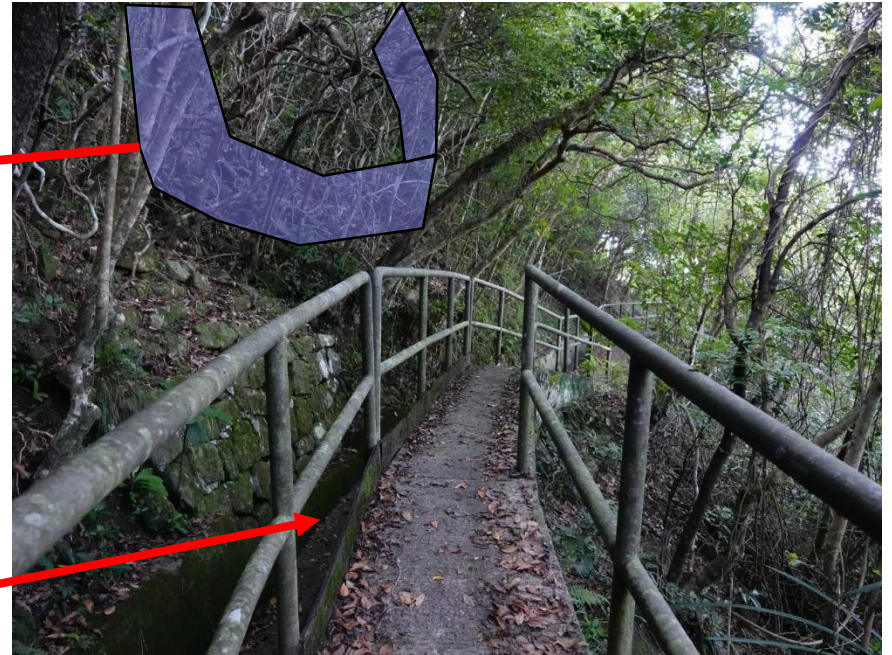
**Example of  
Temporary  
fencing**

The temporary fencing should have at least 0.5m in height and no hole for animal to pass.

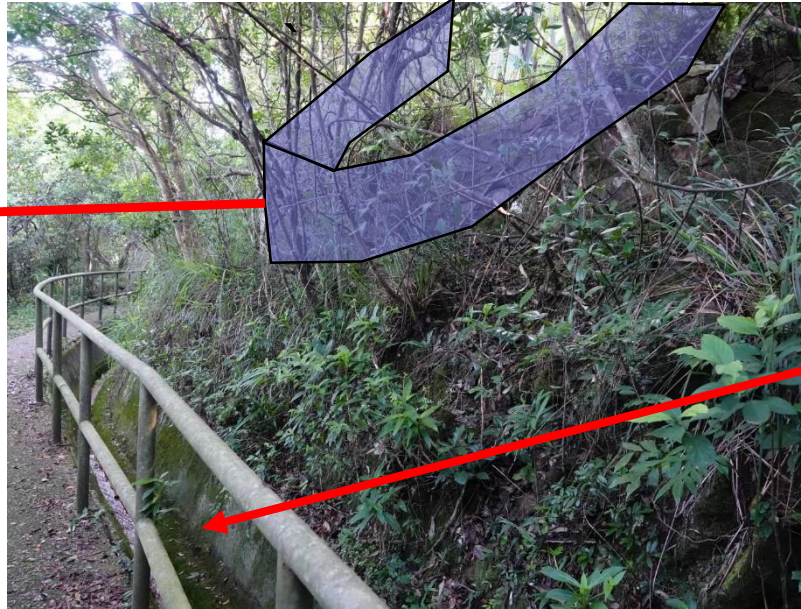
**Example of Temporary fencing**

**Channelled watercourse at P18**

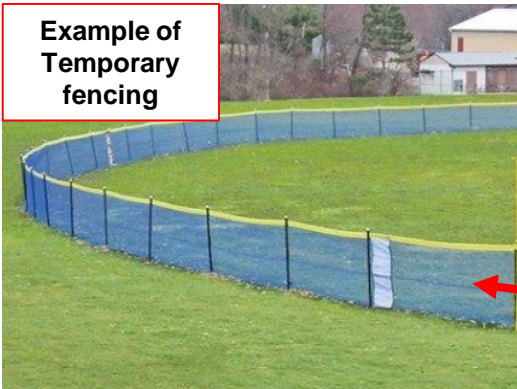
The temporary fencing should have at least 0.5m in height and no hole for animal to pass.

Calls of Short-legged Toad and Romer's Tree Frog were heard from the natural stream near P17 and P19 respectively. Given that the natural stream is separated by a concrete channel and walk trail from P17, while natural stream is of relatively far distance from P19, as such indirect impact to these two species is considered to be insignificant. Considering the close distance between P18 and channelized watercourse, dismantling works to be carried out at P17 and P18 will be scheduled out of wet season (April to October). In order to further avoid the impact, temporary fence with a height of 0.5m will be erected around the proposed works area at P17 and P18 to prevent amphibian species of conservation importance (if any) from returning to the works areas (**Annexes A15 & 16**).

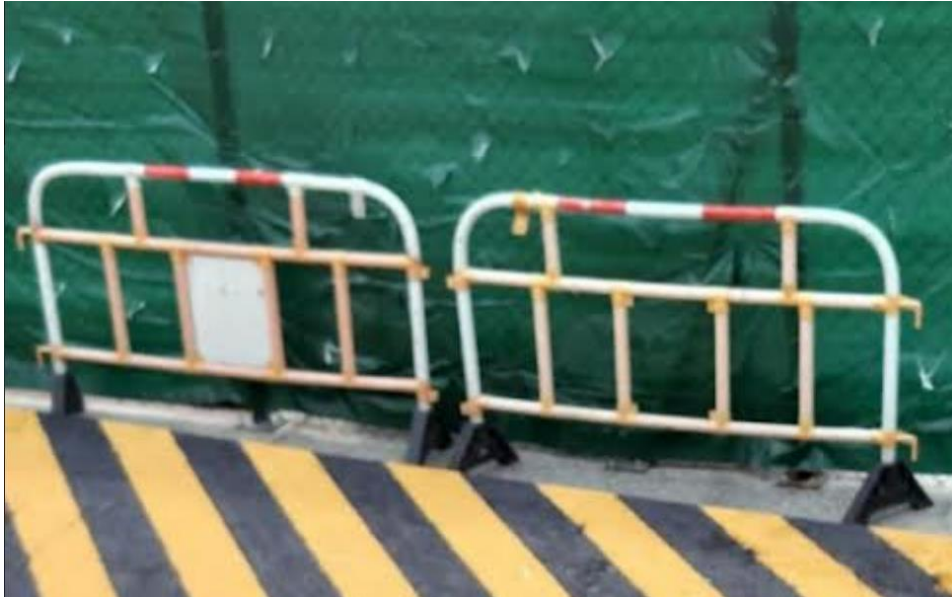
**Temporary Fence**

When area is available, temporary fence will be used to mark proposed works area.

The boundary of the works area will be clearly marked by temporary fence where possible, and soft PVC tape at area where space is limited, before and during the proposed works to avoid impacts on the flora and fauna species of conservation importance recorded nearby (**Annex A17**). The works area boundaries will be regularly checked to ensure that they are not breached and that no damage occurs to surrounding areas/ country parks.

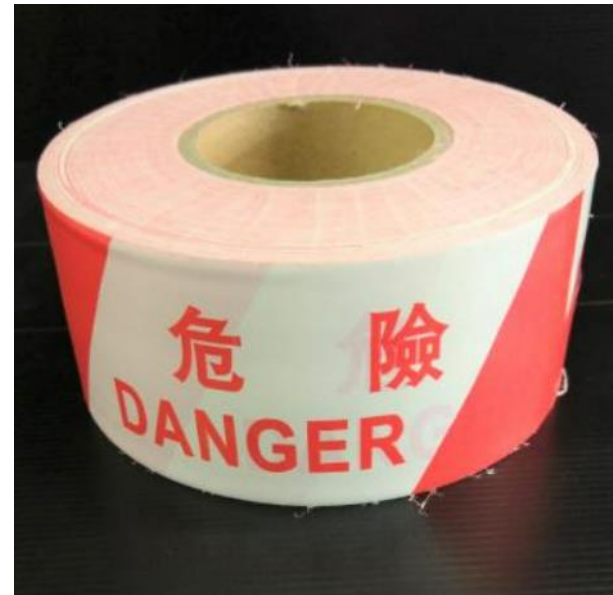
**PVC Tape**

When area is limited, PVC tape will be used to mark proposed works area.
