# Removal of 132kV Overhead Line and Pylons for P-Line

Ecological Management  
Plan (P7 to P14)

22 September 2022

Project No.: 0585151

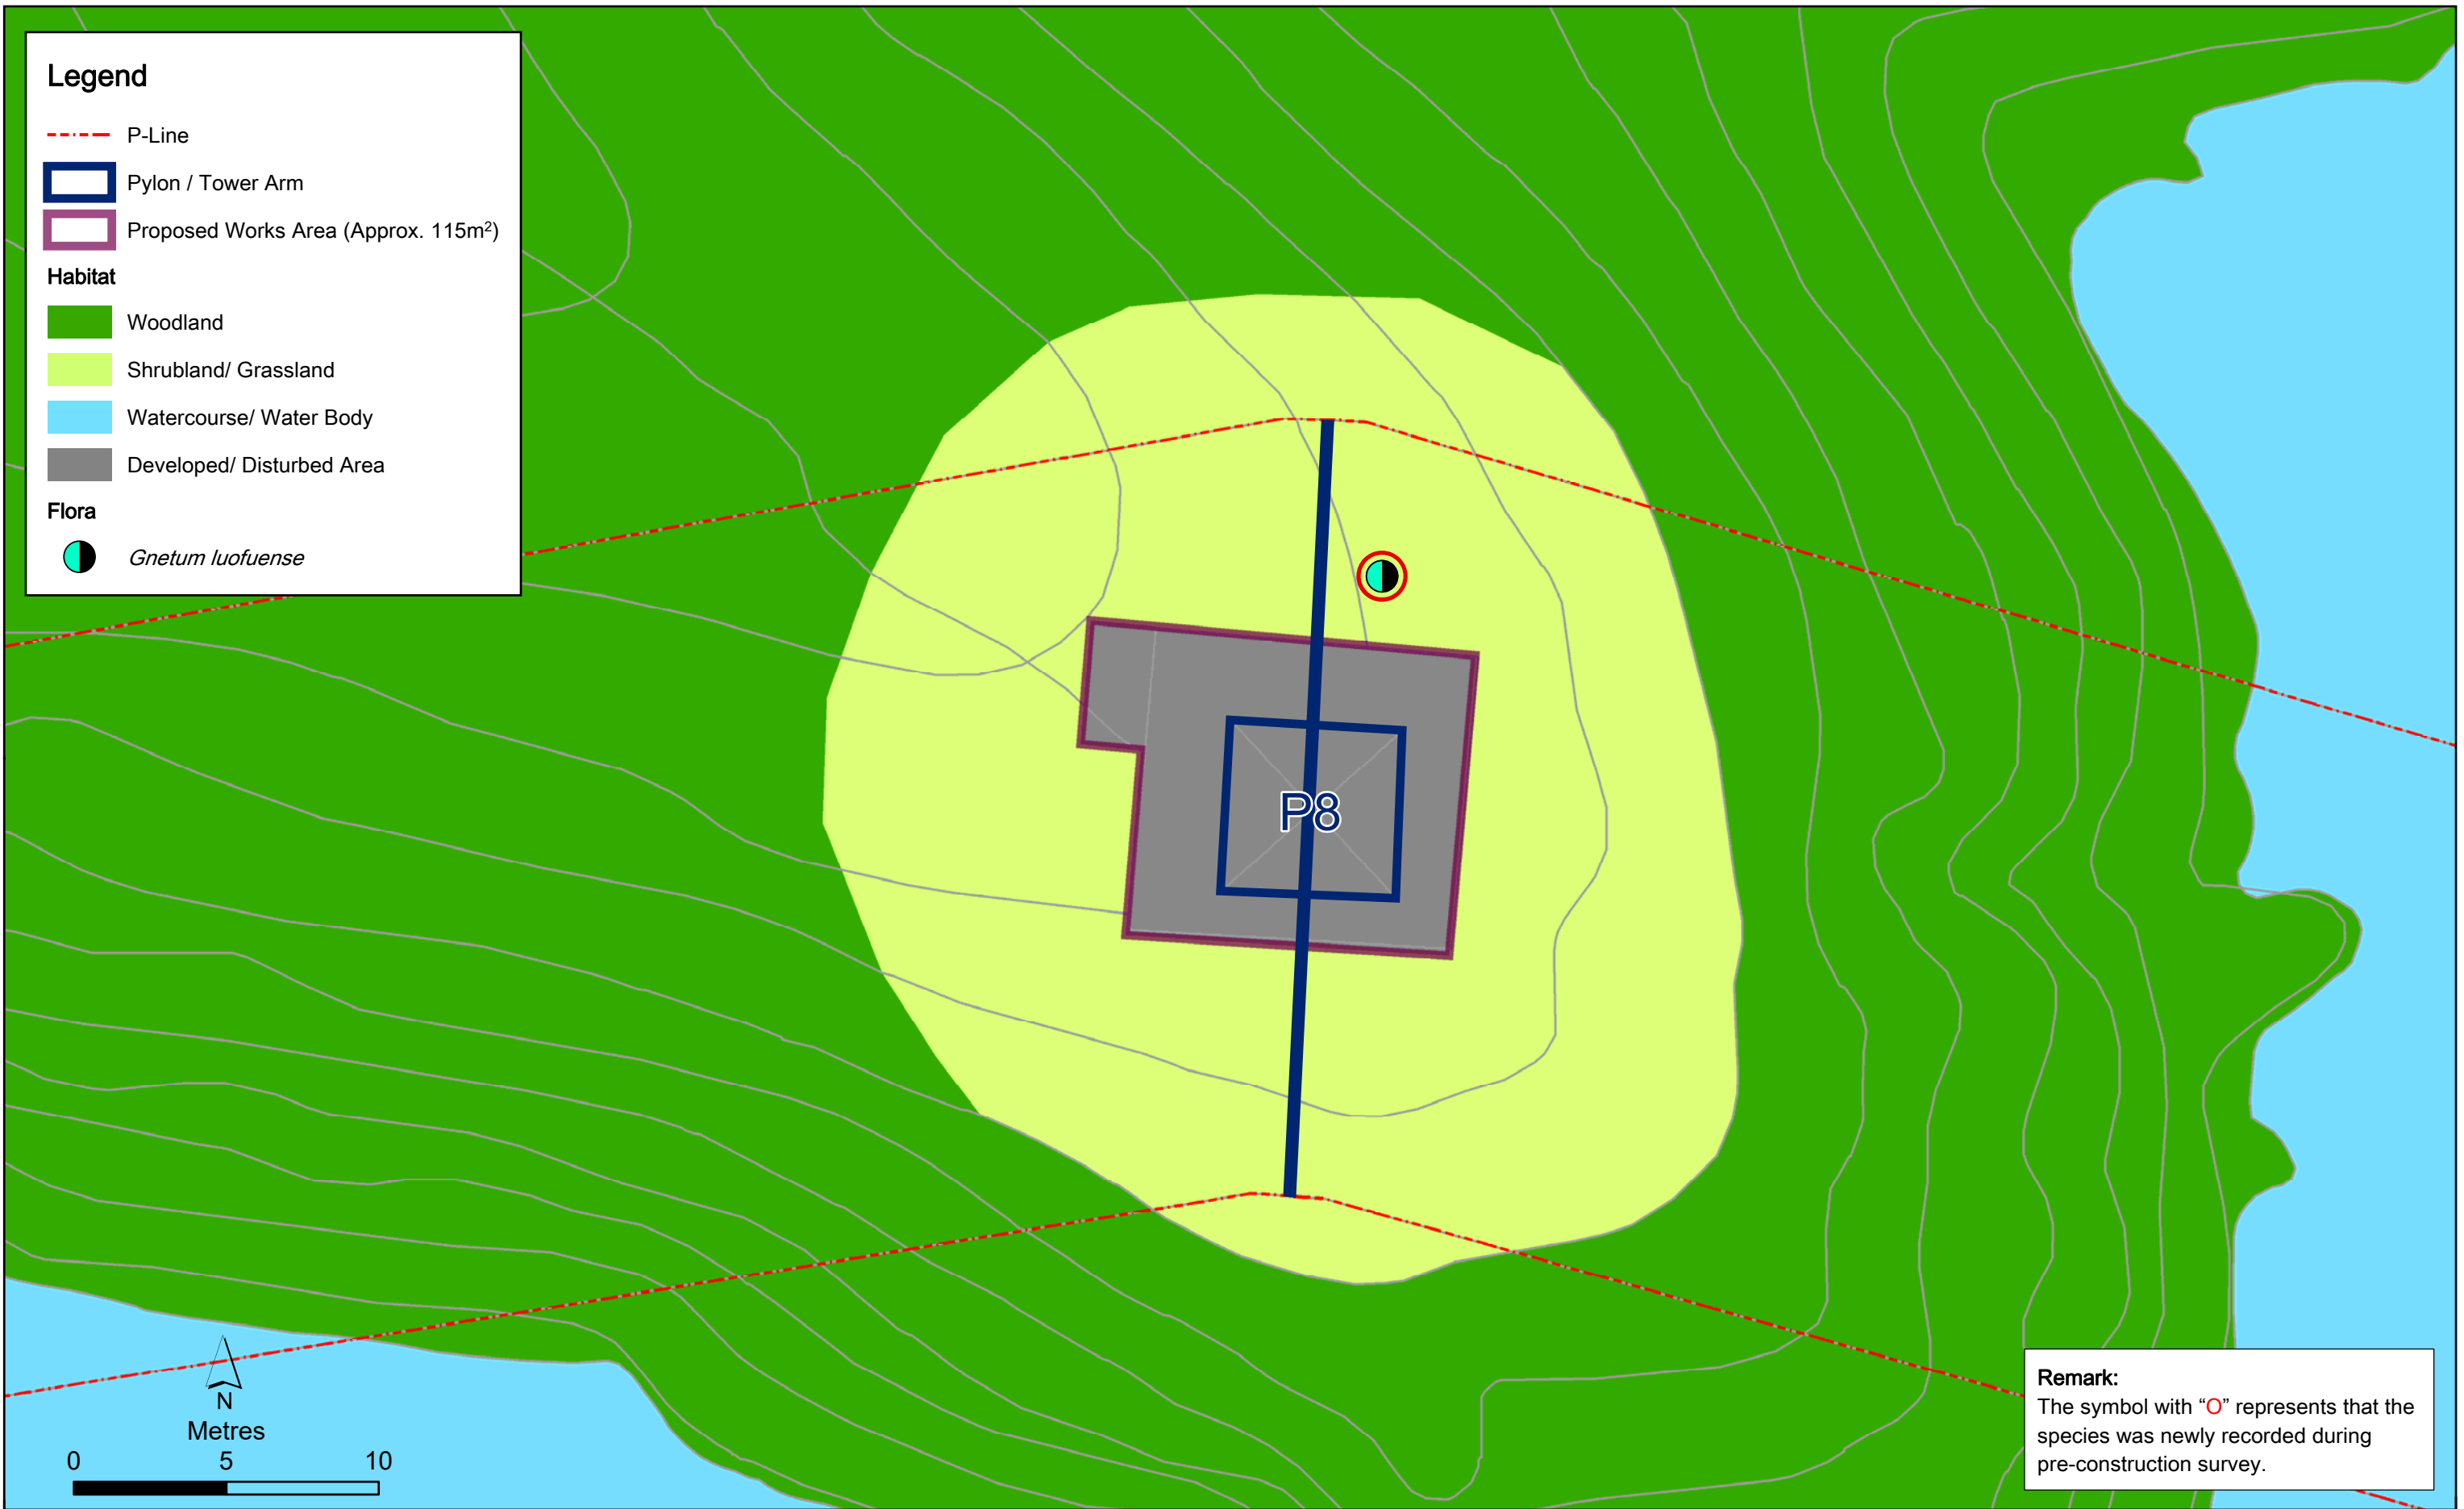
Figure 2.1.2

Zoom-in Habitat Map for Pylon P8

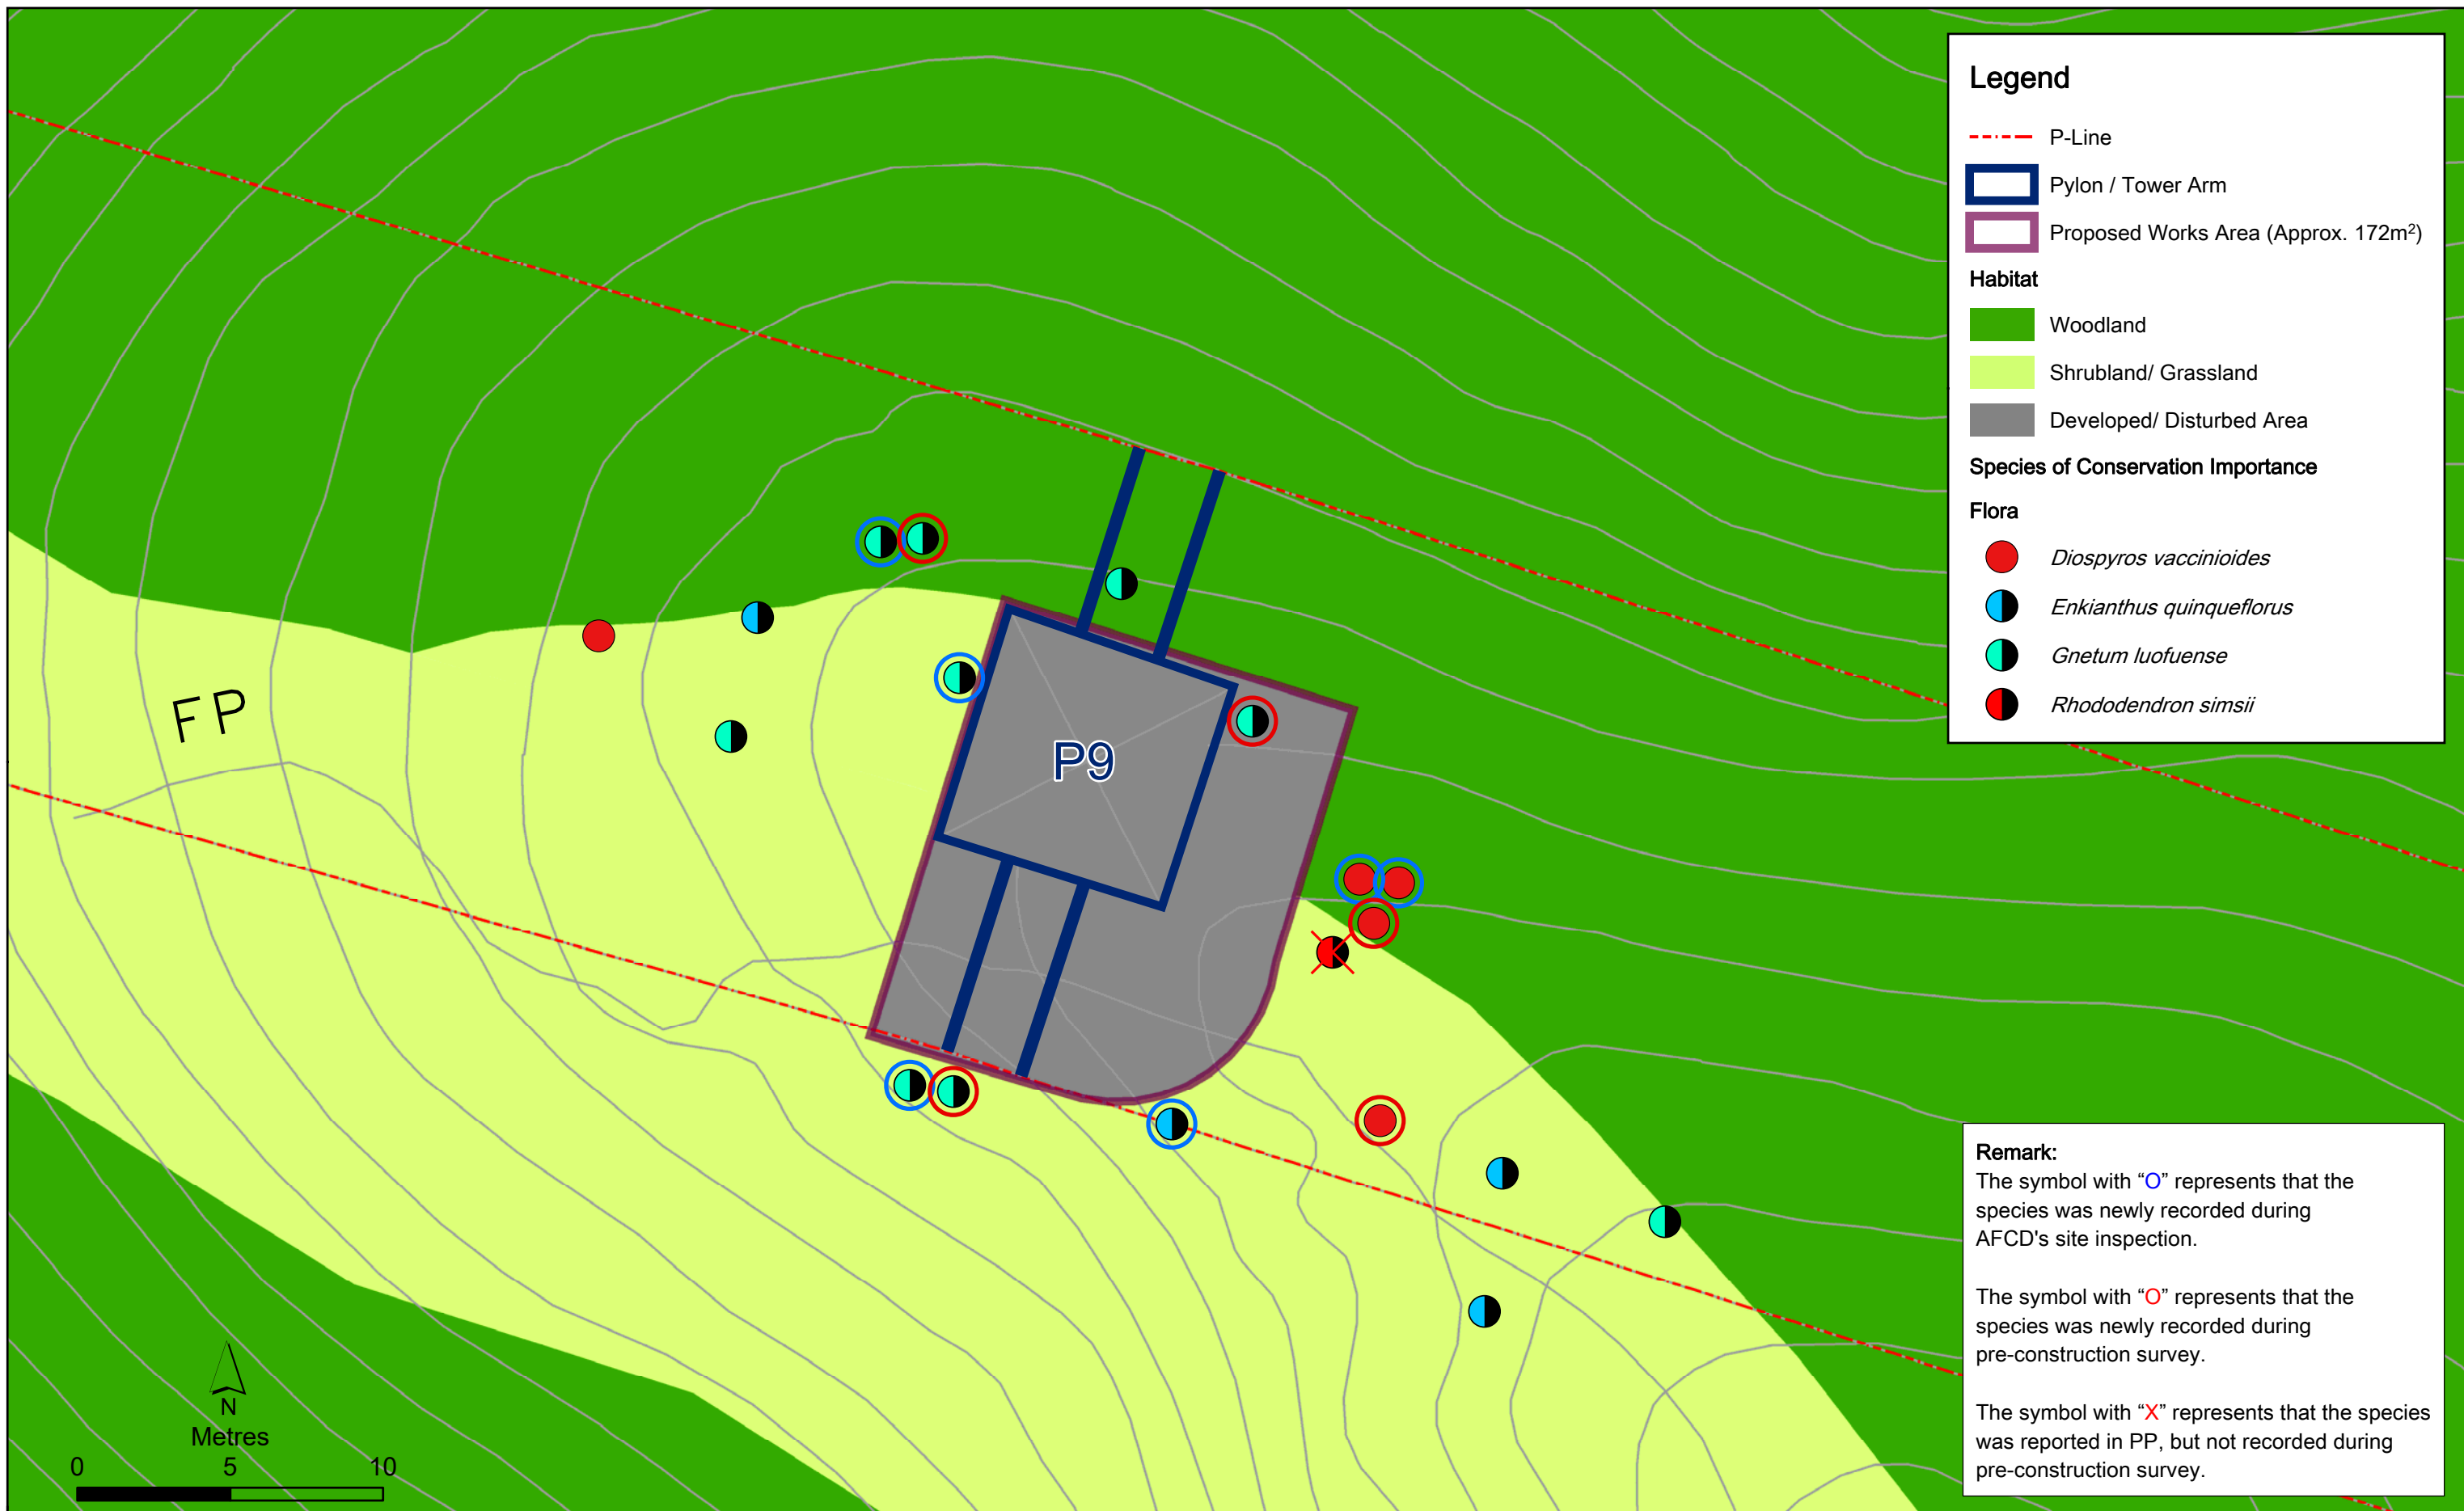
Figure 2.1.3

Zoom-in Habitat Map for Pylon P9

Three individuals of *Gnetum luofuense* and *Rhododendron simsii* reported in PP at P7, P9 and P13 were not recorded during the pre-construction surveys (**Figures 2.1.1, 2.1.3 and 2.1.7**).

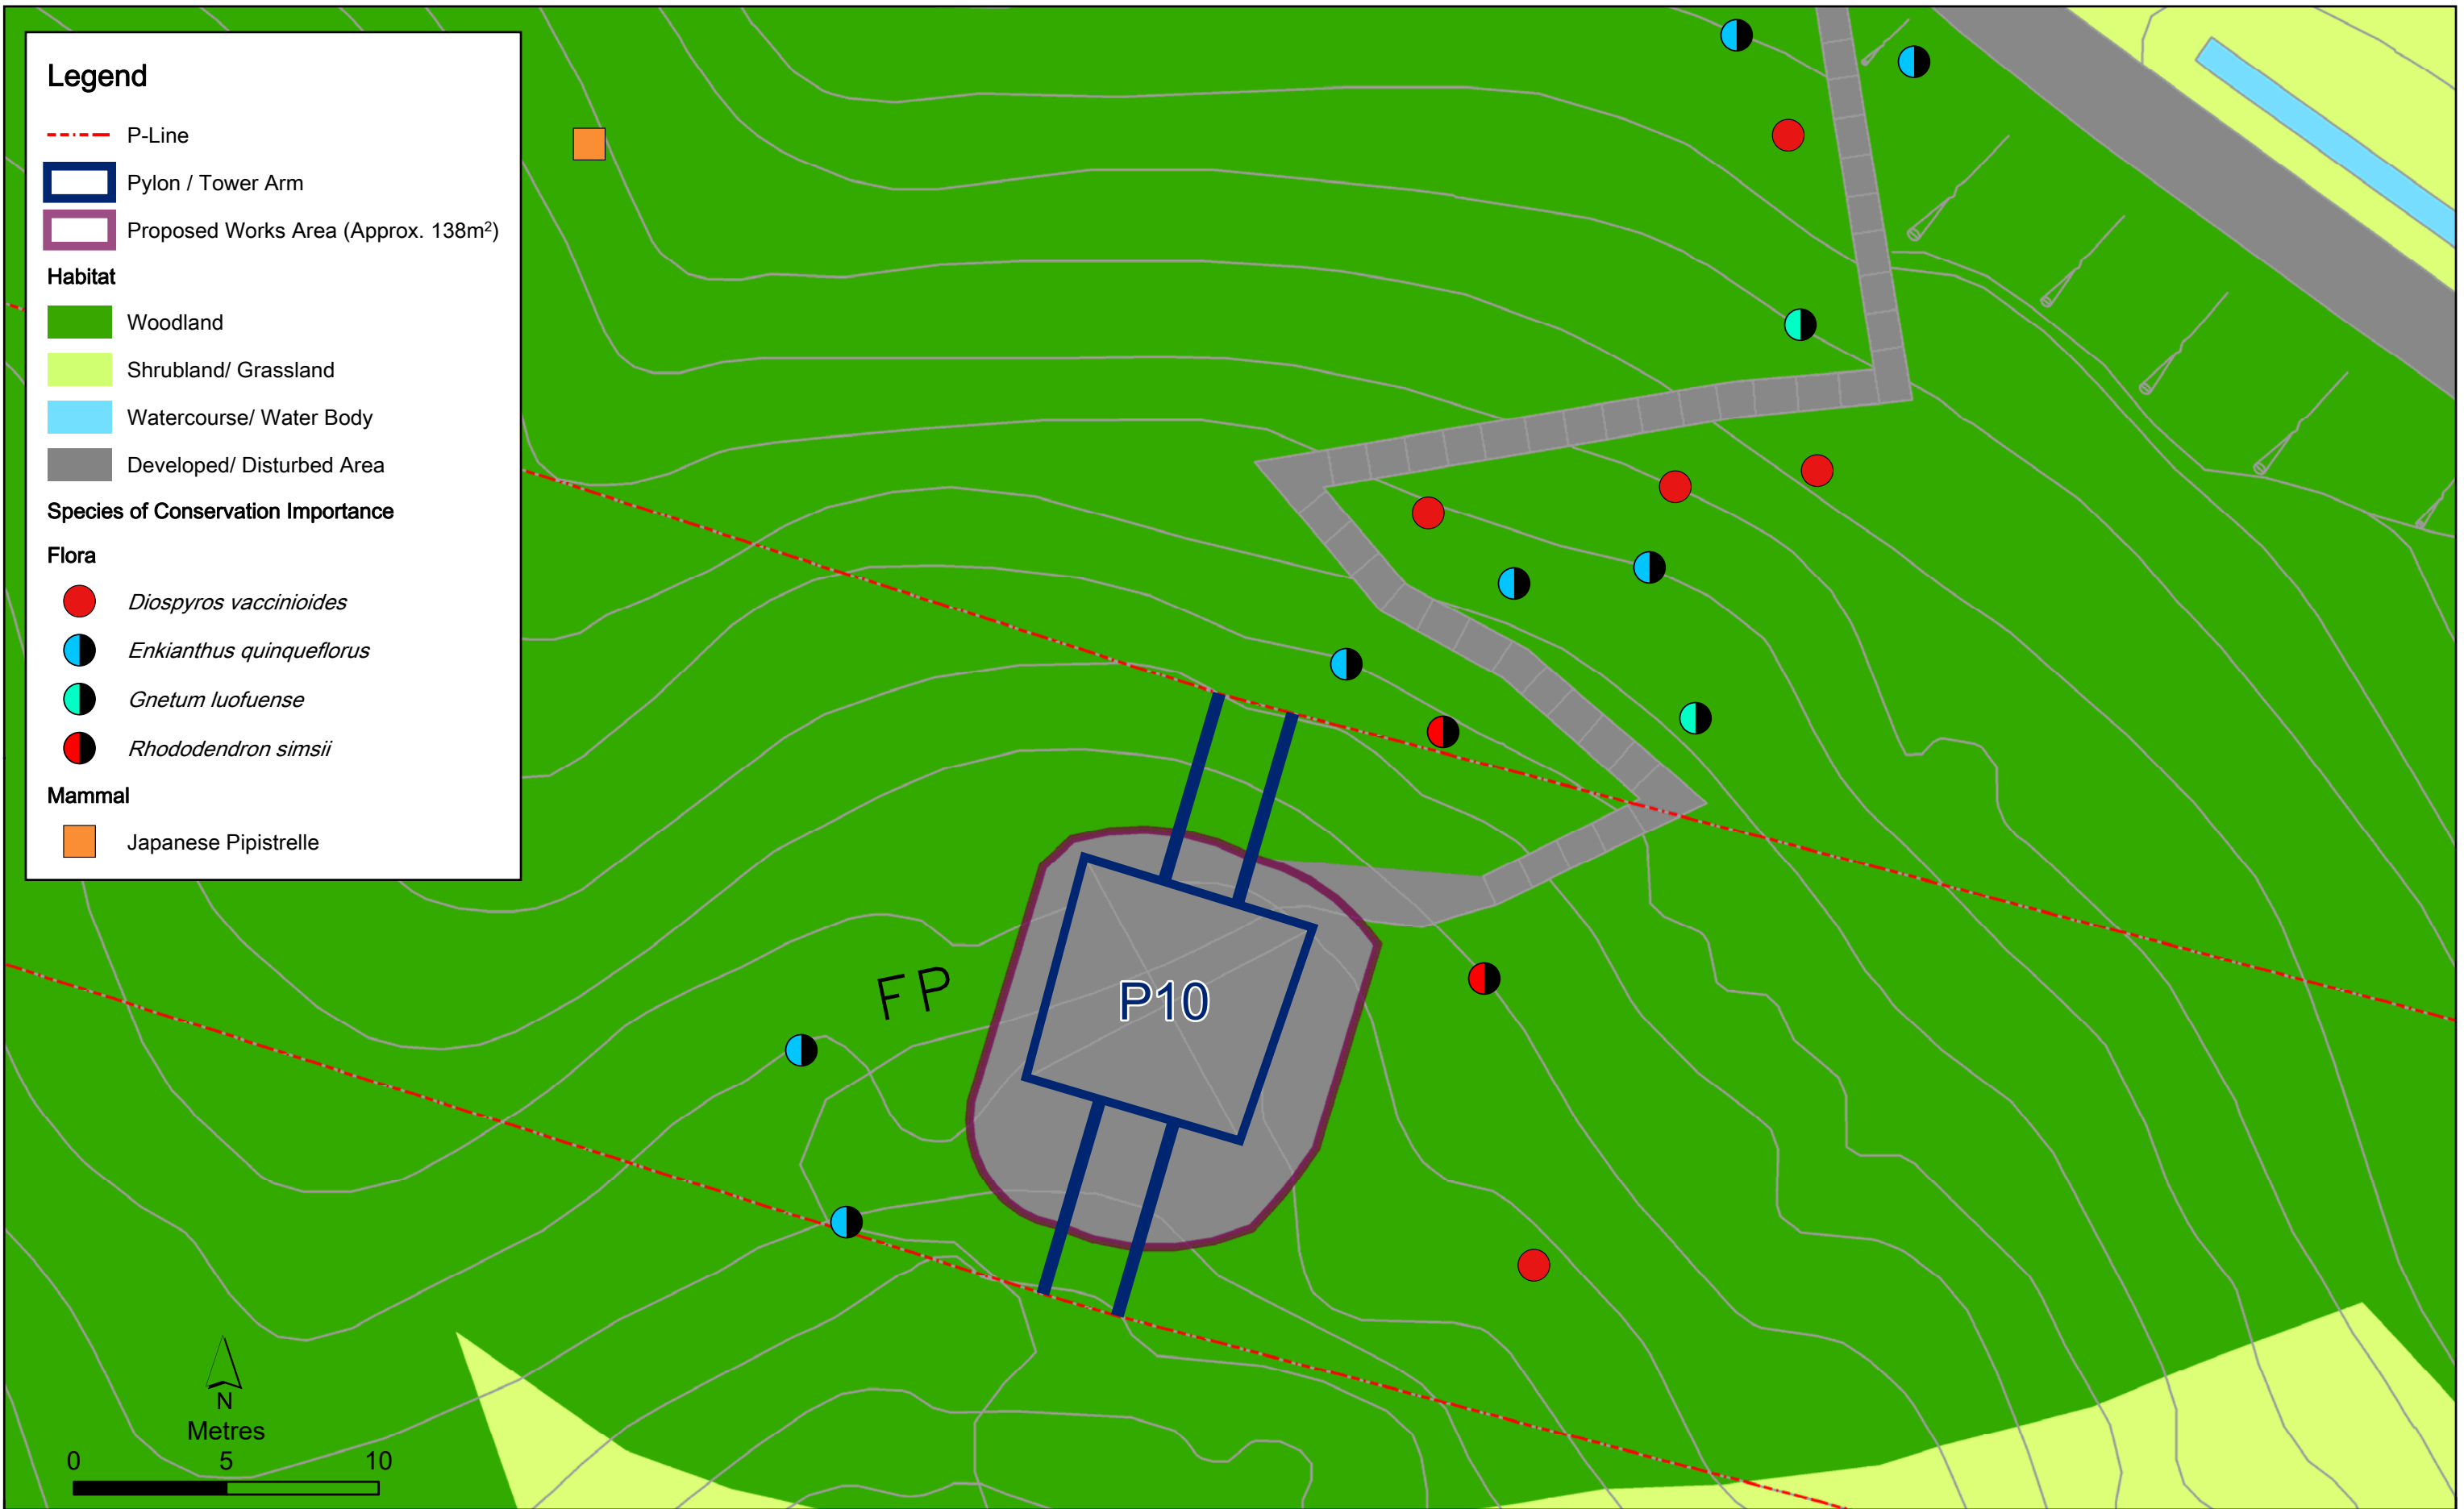
Figure 2.1.4

Zoom-in Habitat Map for Pylon P10

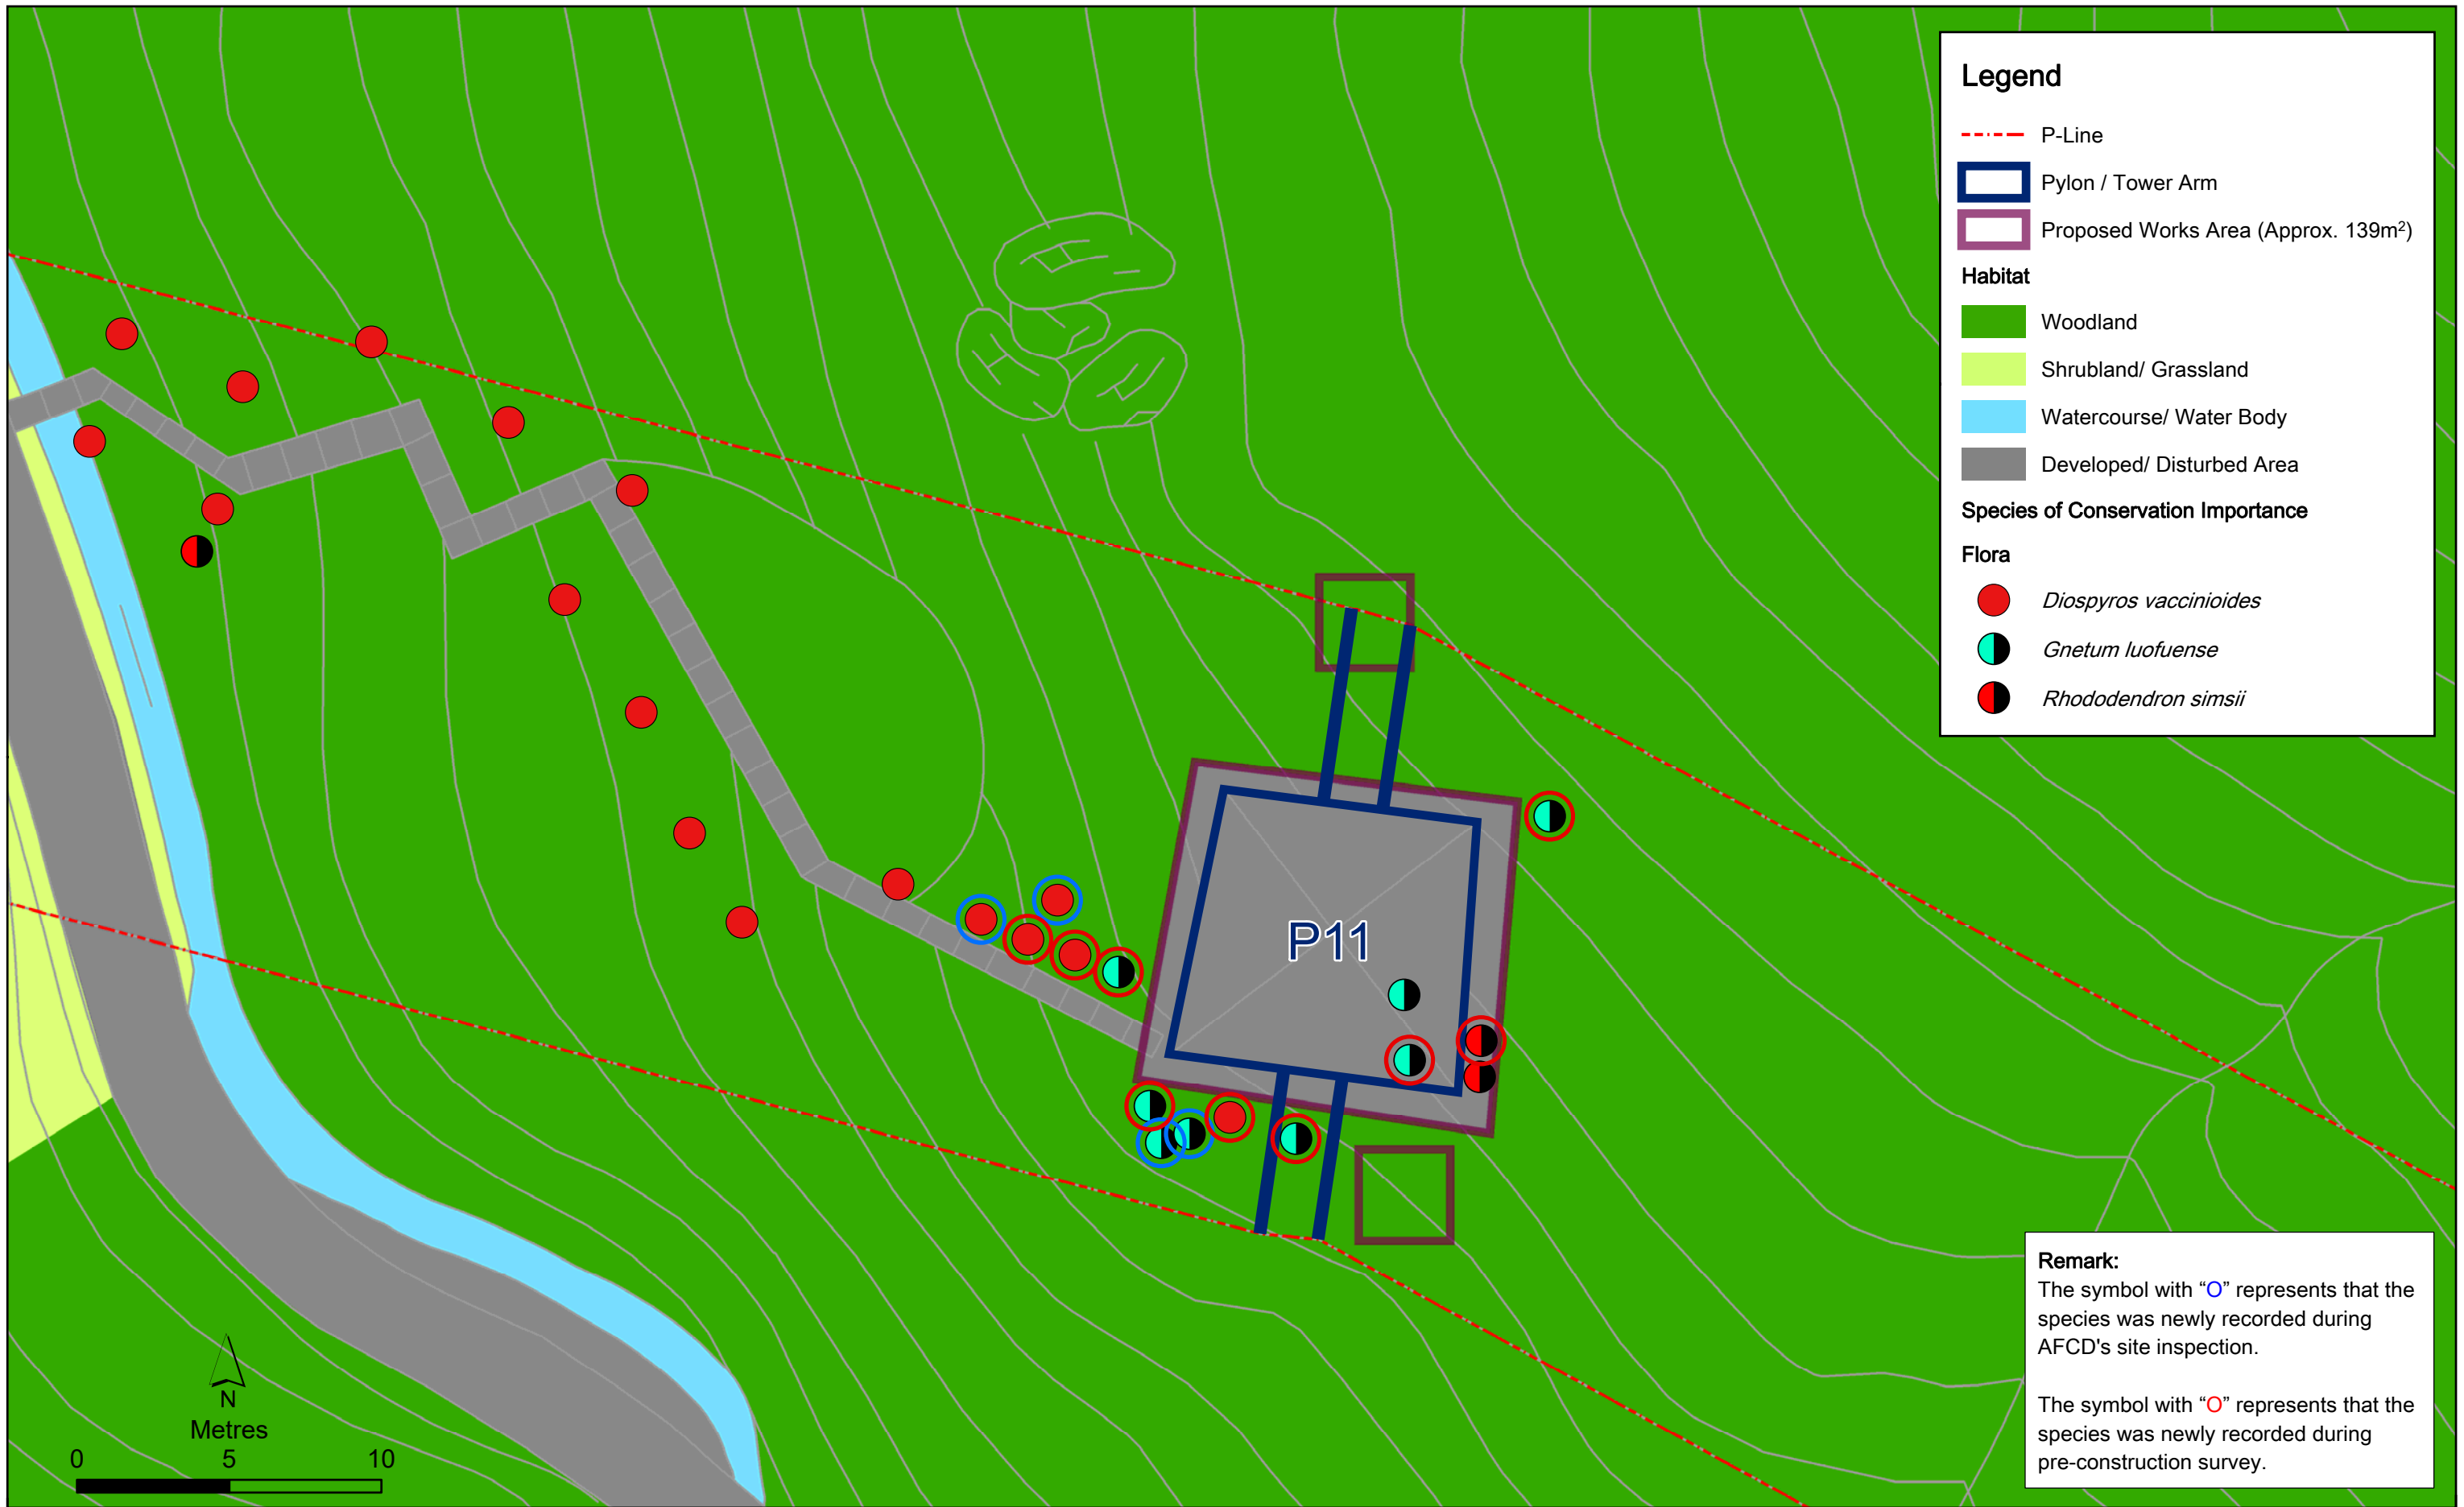
Figure 2.1.5

Zoom-in Habitat Map for Pylon P11

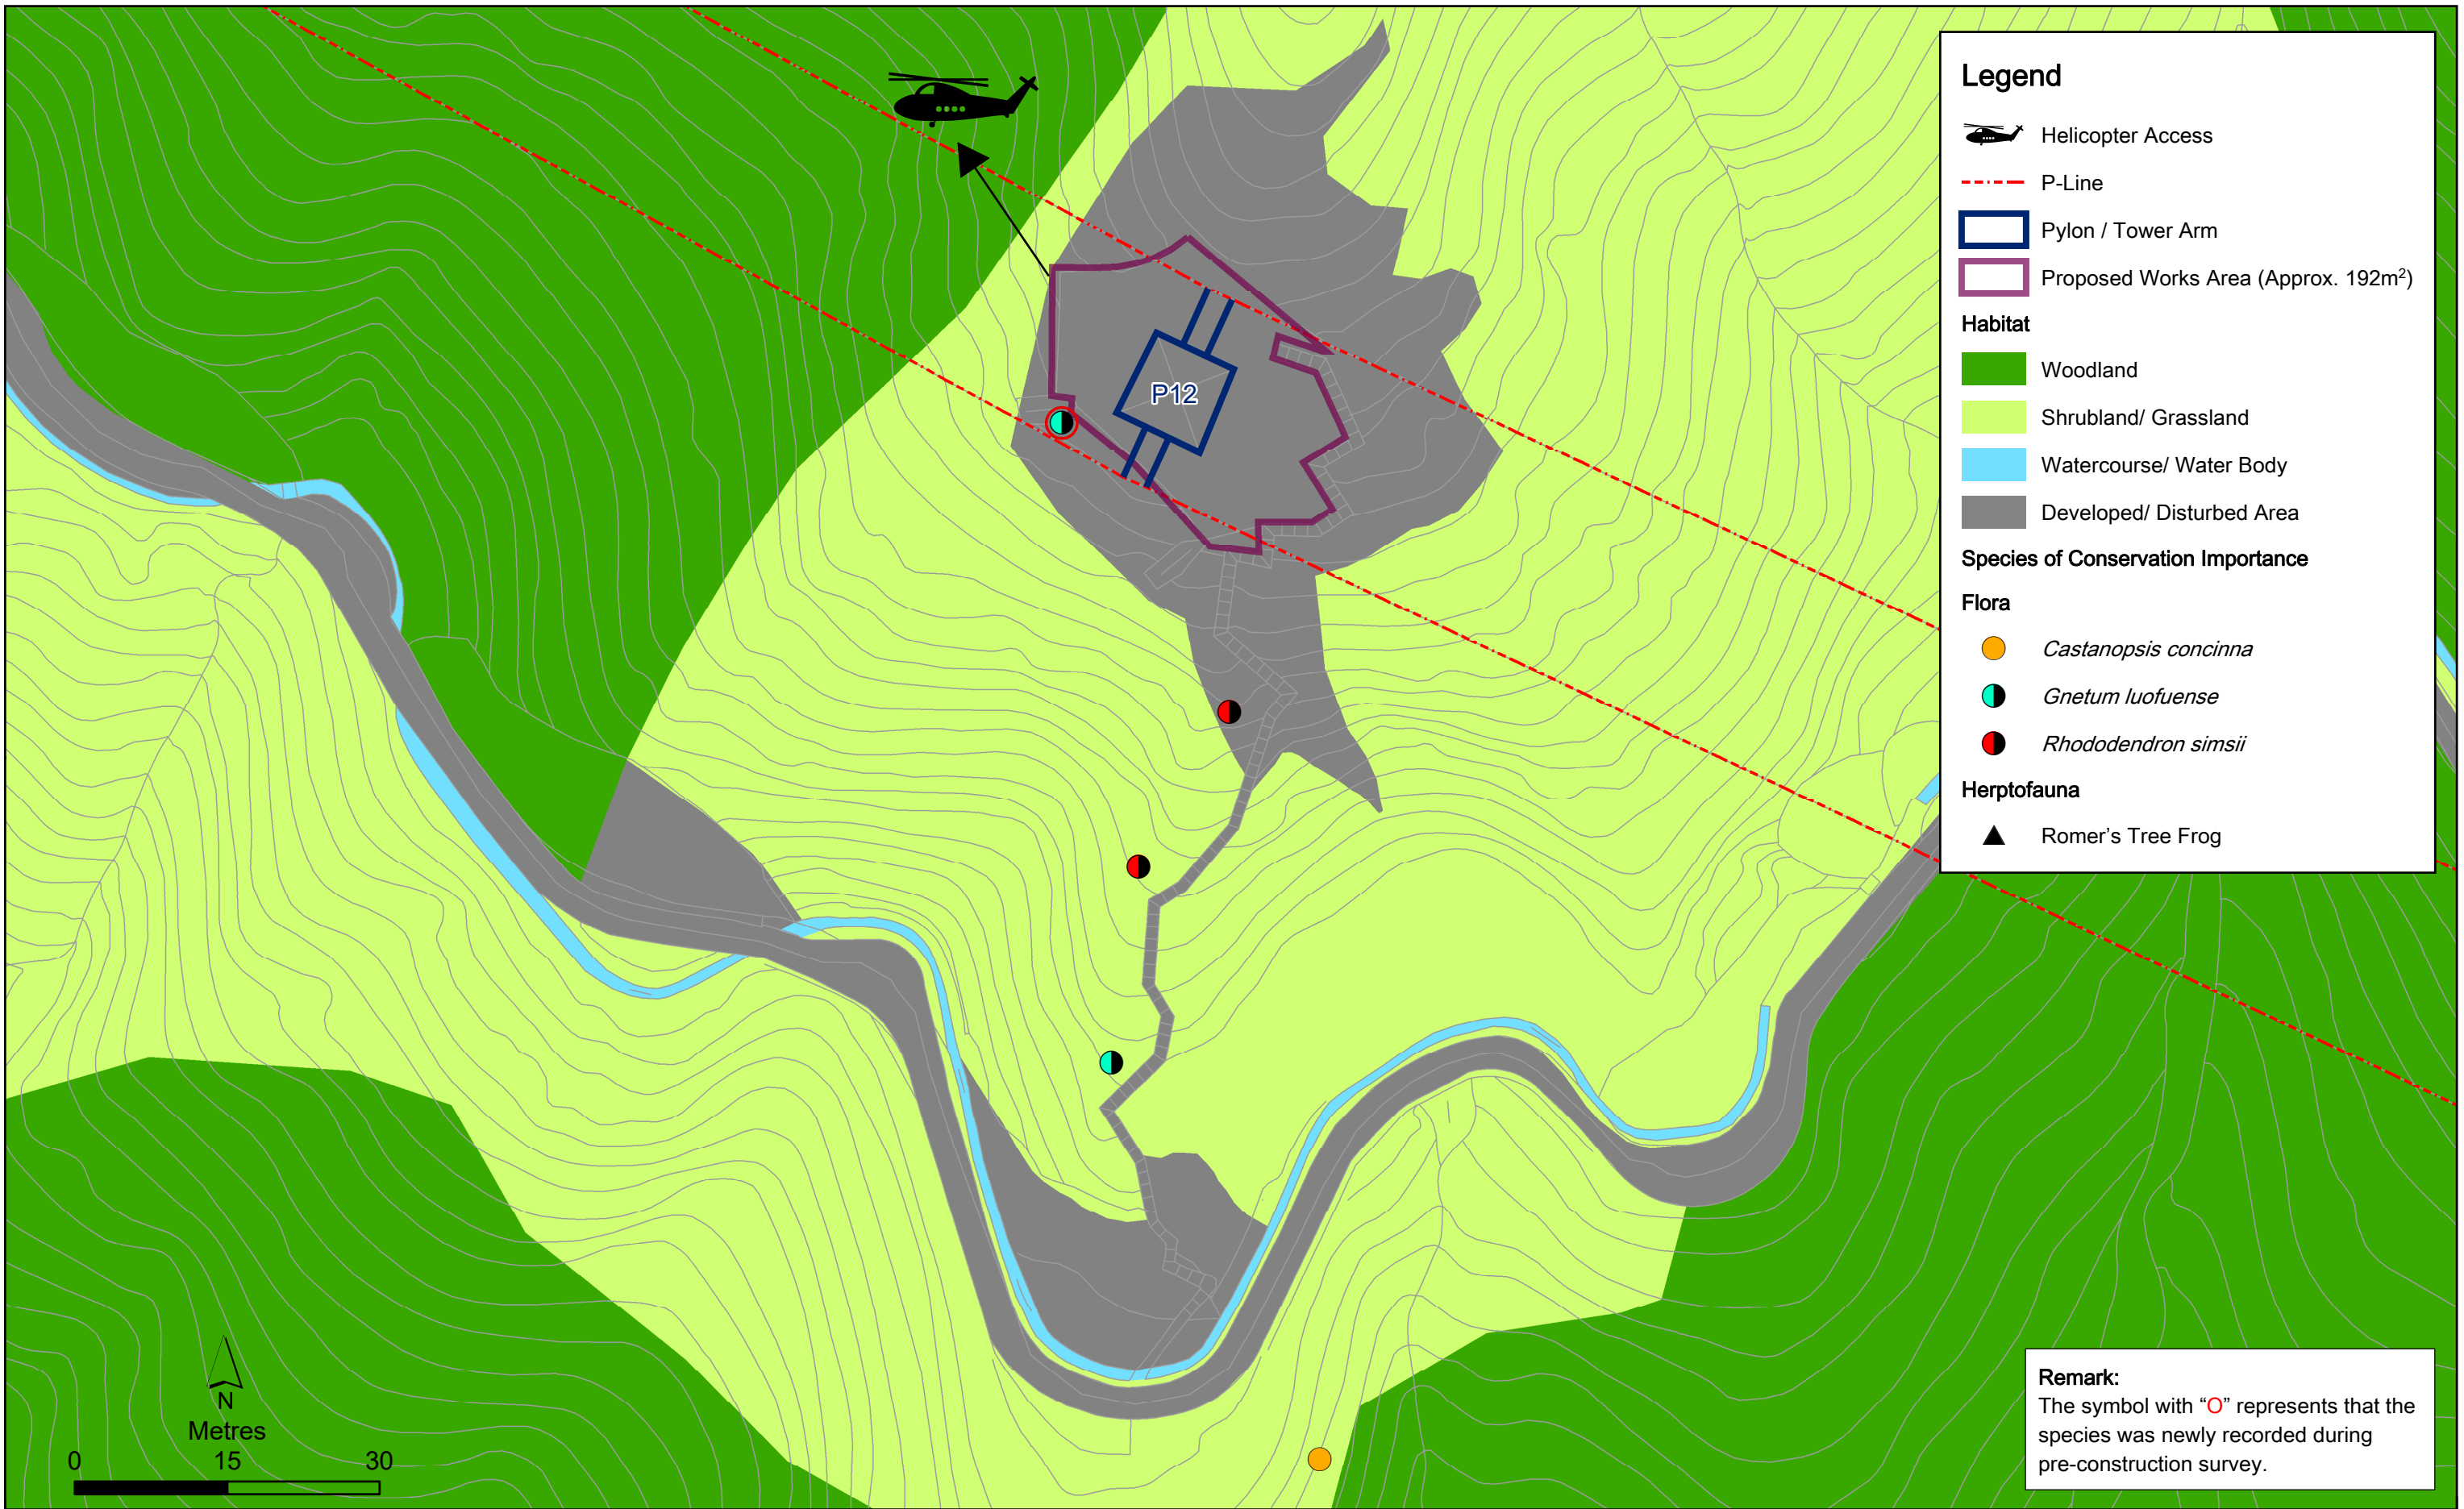
Figure 2.1.6a

Zoom-out Habitat Map for Pylon P12

One pylon (i.e. P13) would require use of vehicular roads/footpaths. 4 pylons (i.e. P7, P9, P10 and P14) would require use of both vehicular roads/footpaths and helicopter transportation for equipment and removal of materials. The vehicular roads/footpaths to be used are shown in **Figures 2.1.1a, 2.1.3a, 2.1.4a and 2.1.8a**. 3 pylons (i.e. P8, P11 and P12) would require use of helicopter transportation. The use of helicopter are shown in **Figure 2.1.1a - 2.1.6a and 2.1.8a**.

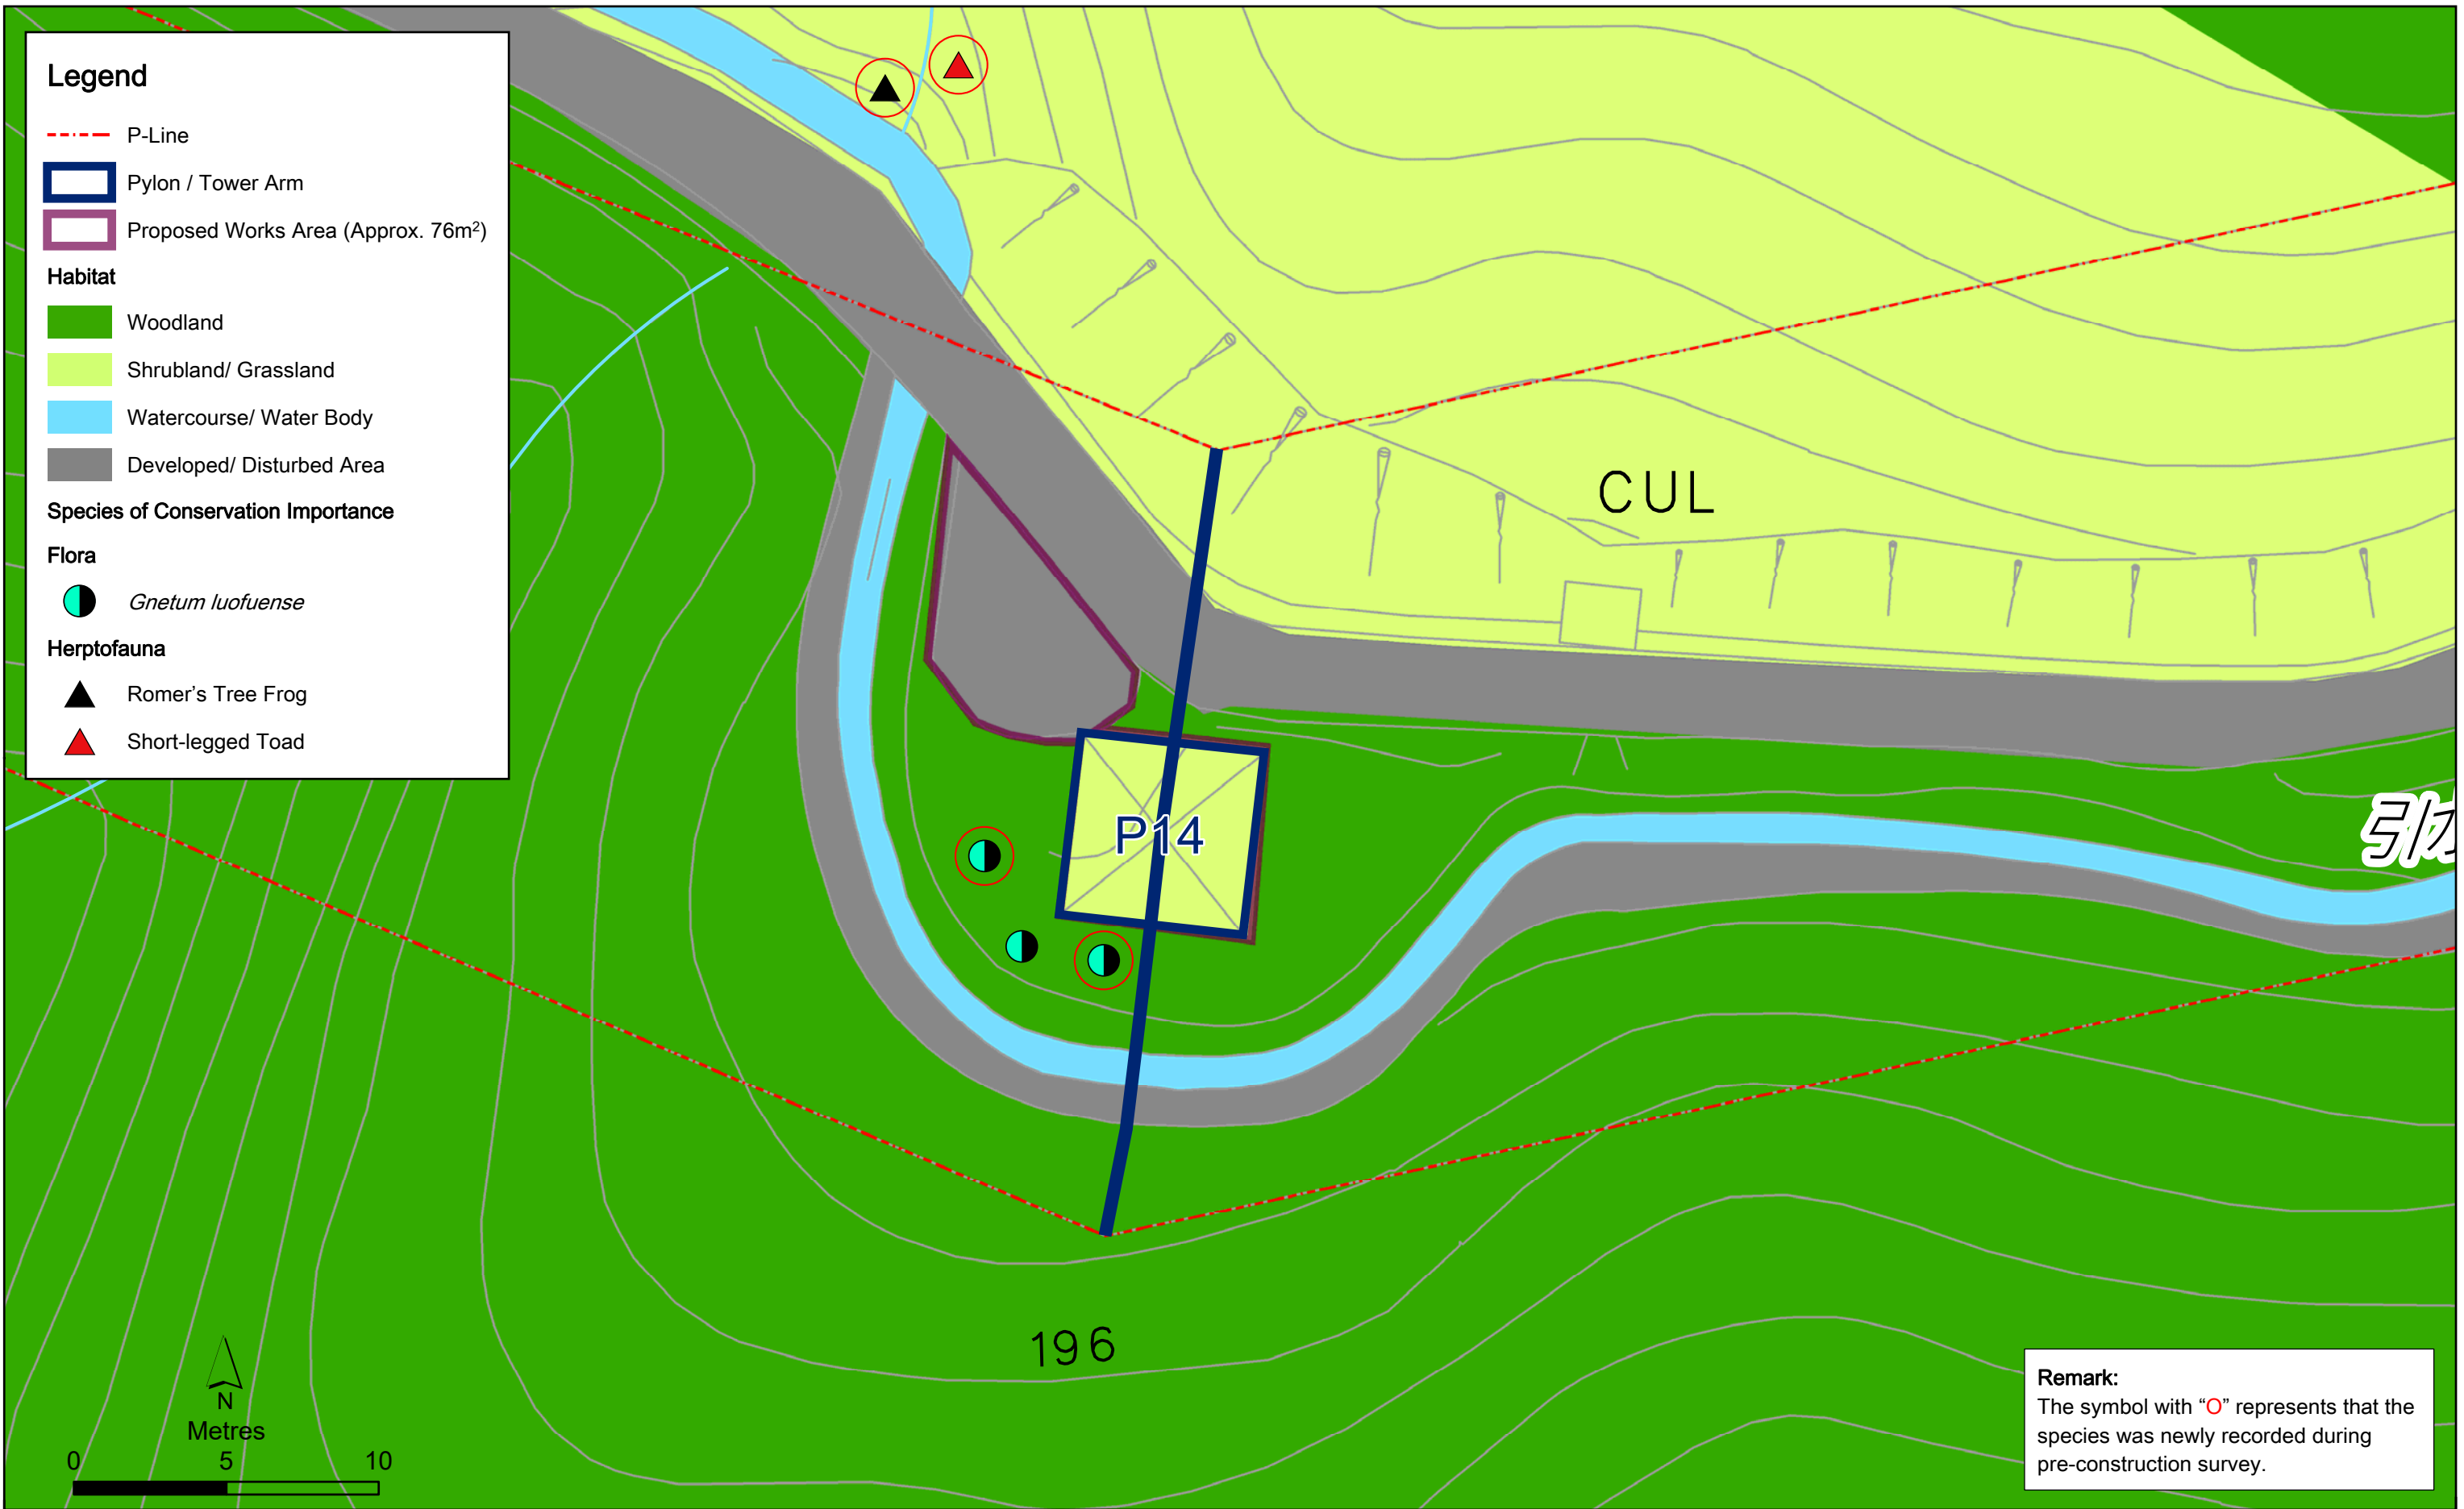
Figure 2.1.8

Zoom-in Habitat Map for Pylon P14
