# Removal of 132kV Overhead Line and Pylons for P-Line

Ecological Management  
Plan (P7 to P14)

22 September 2022

Project No.: 0585151

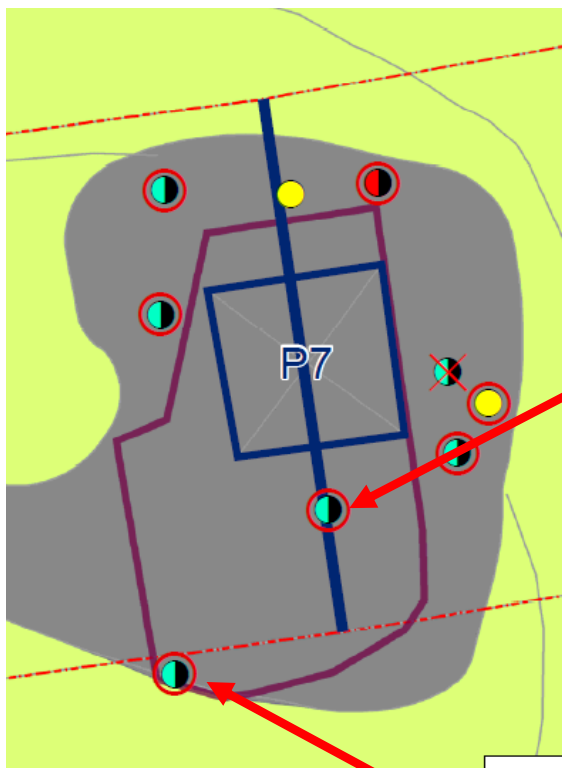
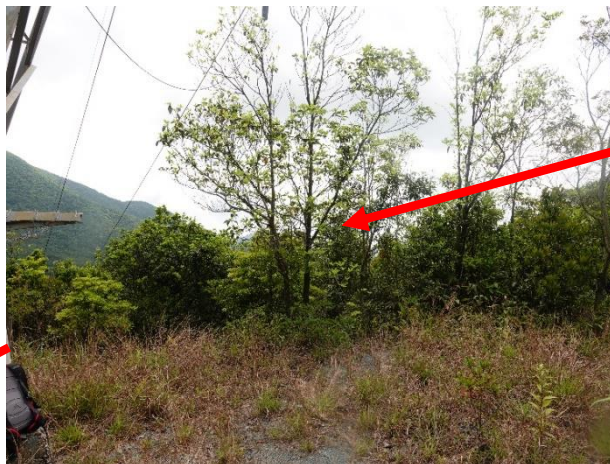
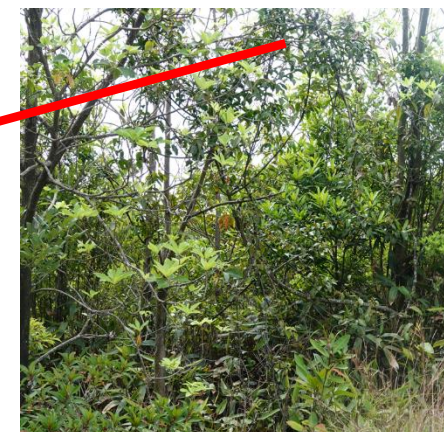
*Gnetum luofuense* recorded within the proposed work area at P7 (entangling on HKE-P7-003)

Metal cage (1.5m above ground) will be erected around the drip line of tree (HKE-P7-003) which entangled by *Gnetum luofuense*. The entangled branches above 1.5m of the ground will be covered by soft protective net.

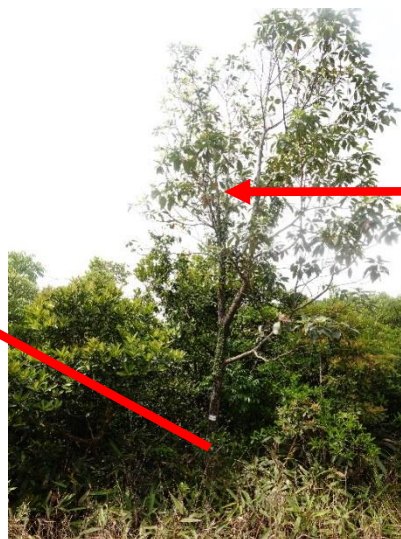
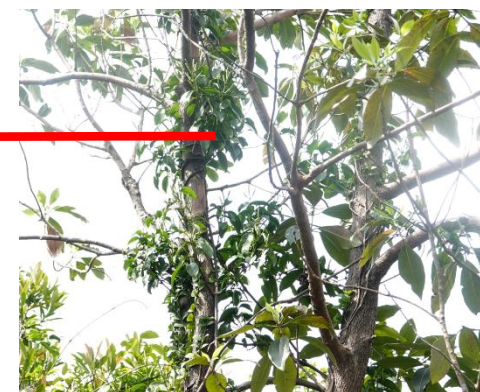
*Gnetum luofuense* recorded within the proposed work area at P7

*Gnetum luofuense* recorded within the proposed work area at P7 (entangling on HKE-P7-001)

As the species is located at edge of proposed work area, temporary protective fencing (1.5m above ground) will be erected around the drip line of tree which entangled by *Gnetum luofuense*. The entangled branches above 1.5m of the ground will be covered by soft protective net.

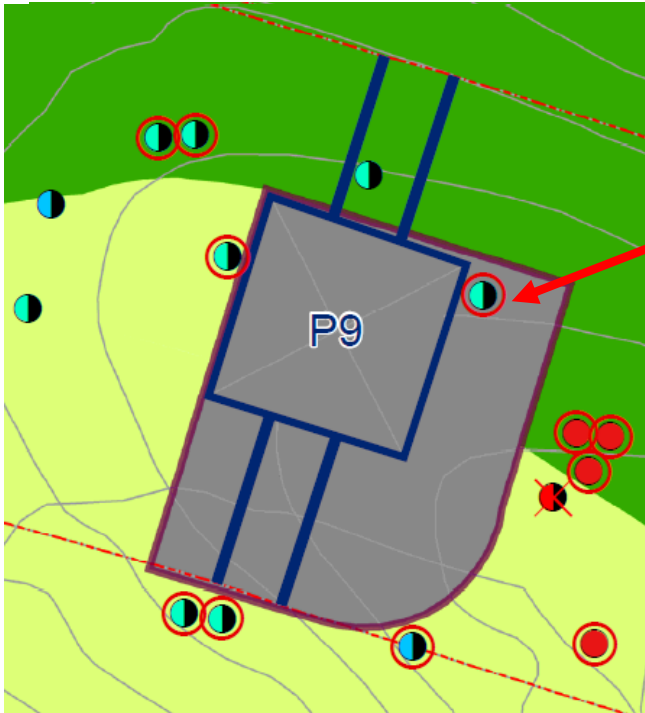
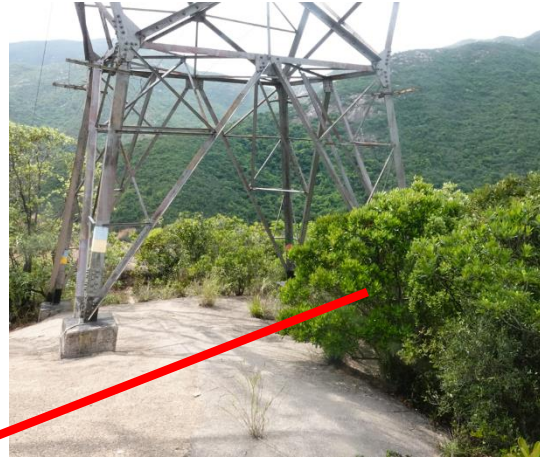
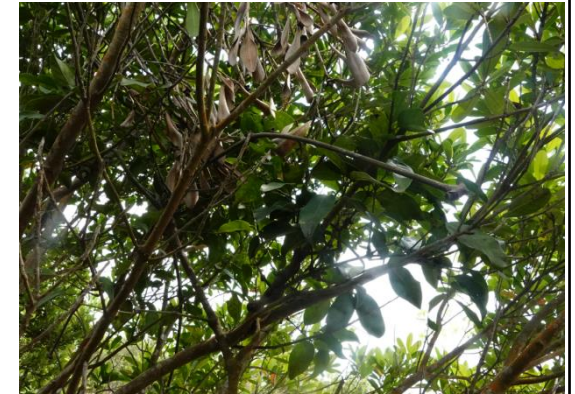
*Gnetum luofuense* recorded inside the tree crown of the shrub (*Polyspora axillaris*) at P9

Temporary protective fencing will be provided to the shrub (*Polyspora axillaris*) locating at edge of proposed work area of P9. As the *Gnetum luofuense* is only found inside the tree crown, soft protective net is considered unnecessary.

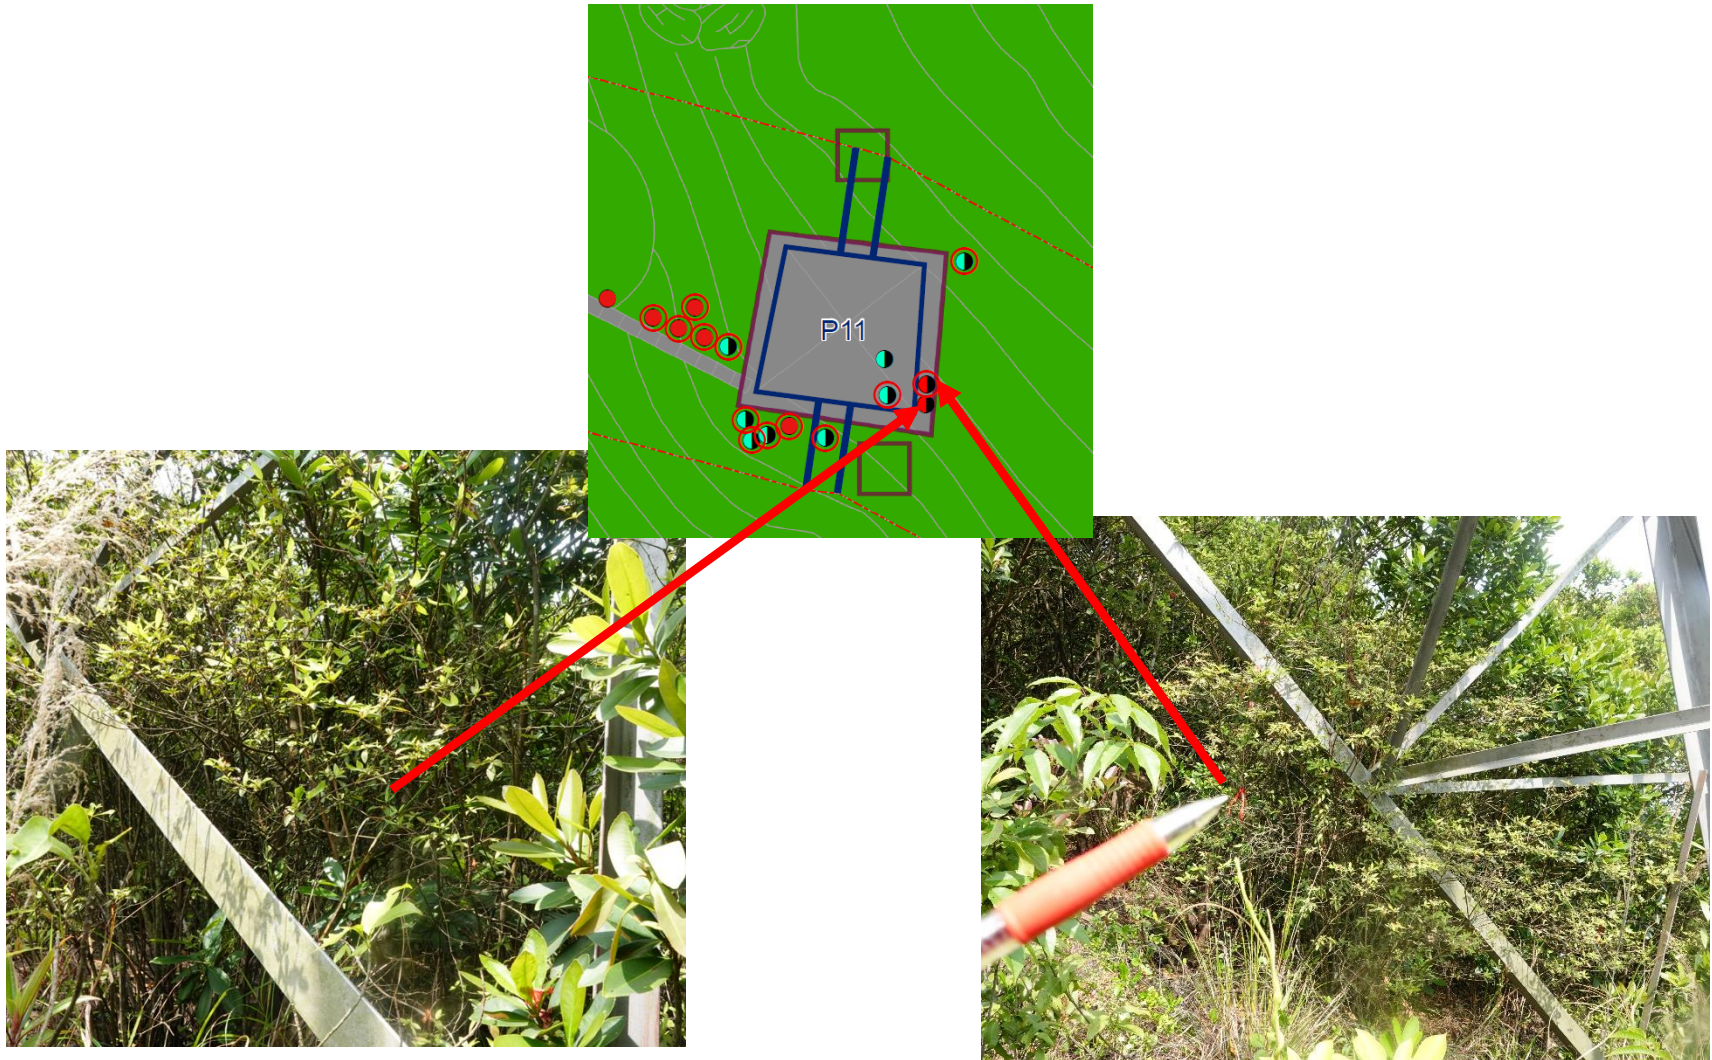
*Rhododendron simsii* recorded within the proposed work area at P11

The *Rhododendron simsii* was recorded at P11 located at the fringe of proposed works areas will be also provided with protective measure. Temporary metal cage will be erected around the dripline of the shrub to avoid potential impact under the Project (**Annex A10**). The temporary metal cage will be removed upon completion of works. The Contractor will ensure that the parts of pylon segments will not have direct contact with the identified *Rhododendron simsii*.

*Rhododendron simsii* (shaded area) will be well covered by metal cage at P11

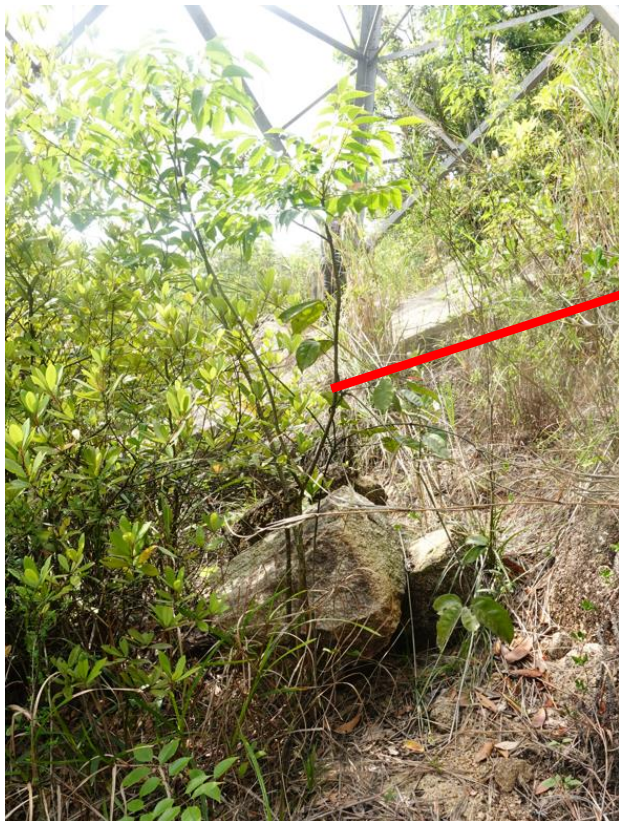
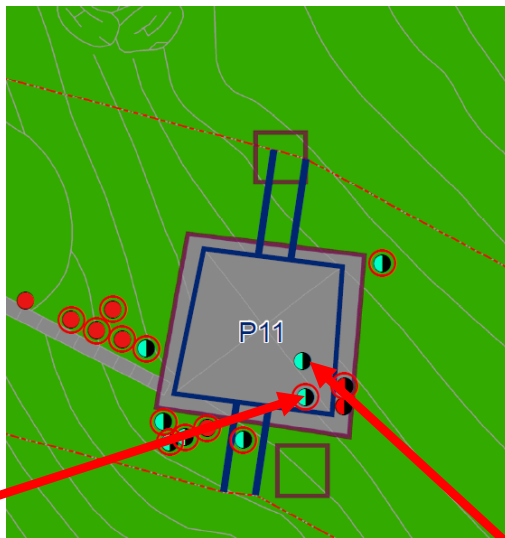
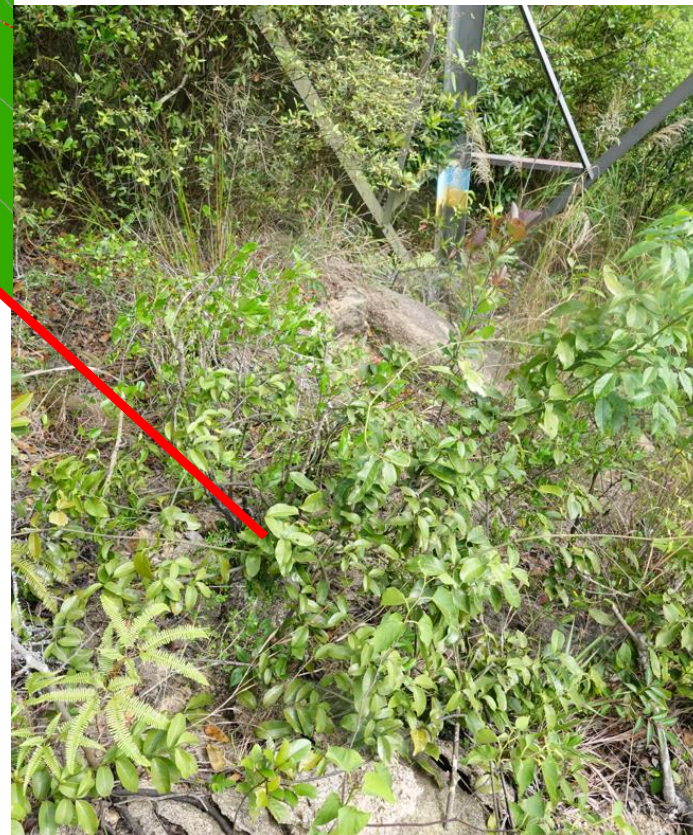
*Gnetum luofuense* recorded within the proposed work area at P11

*Gnetum luofuense* (shaded area) will be well covered by temporary metal cage considering the individual is small in size

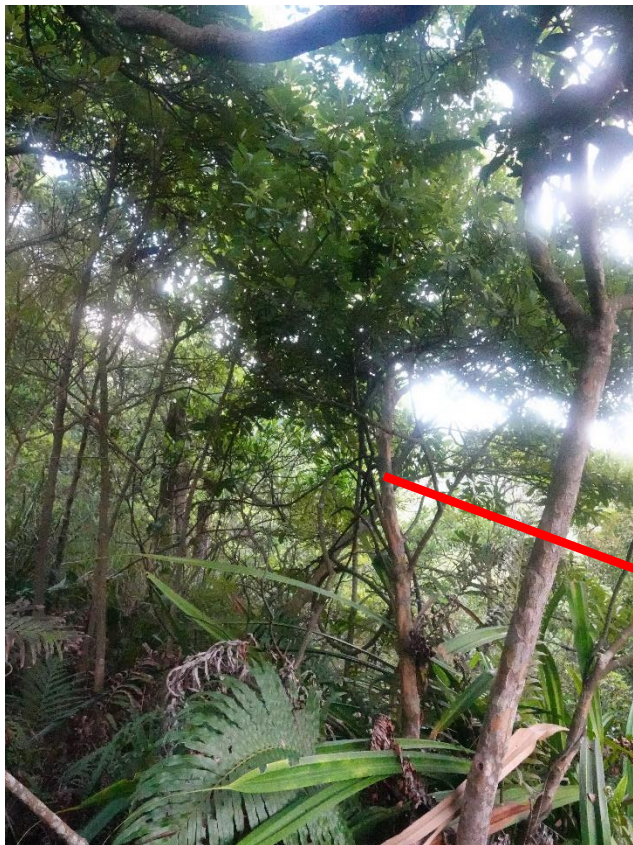
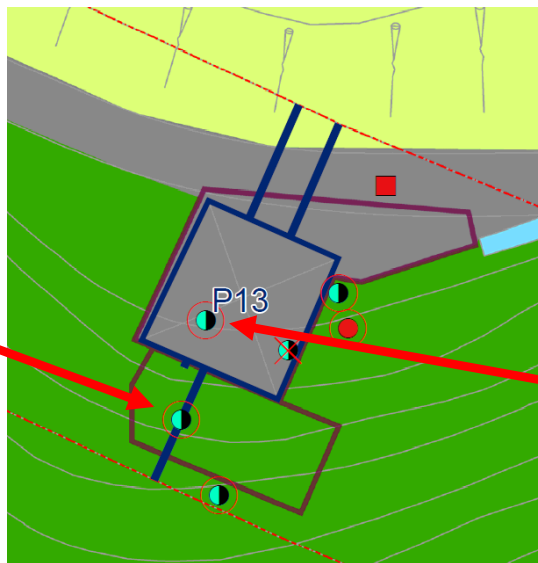
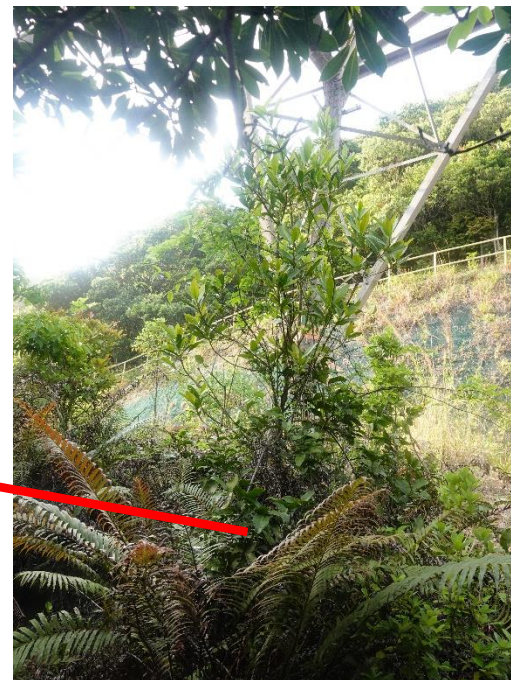
*Gnetum luofuense* recorded entangling on the *Litsea rotundifolia* var. *oblongifolia* within the proposed work area at P13

*Gnetum luofuense* recorded entangling on the shrub (*Polyspora axillaris*) at P13

Due to site constraints, *Gnetum luofuense* (shaded area) at the upper part of the shrub (*Litsea rotundifolia* var. *oblongifolia*) will be well covered by soft protective net

Temporary platform will be built for the *Polyspora axillaris* entangled by *Gnetum luofuense* to avoid trampling/ damage/ disturbance by works.

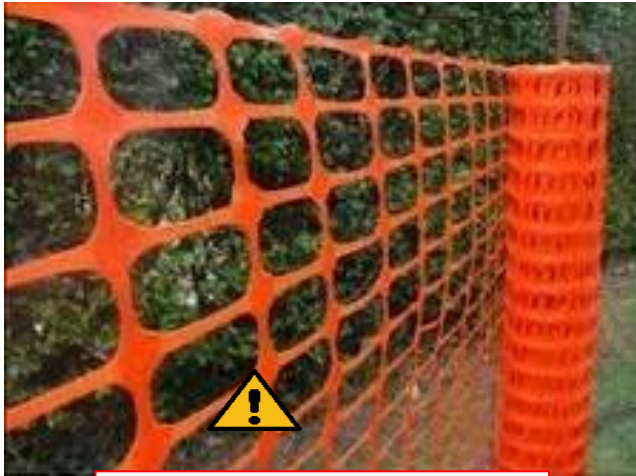
**Soft protective net**

The soft protective net with warning sign in sharp colour will be used to cover the species that may be potentially affected by the dismantle works. The soft net allows to cover irregular shape of flora species and species growing off the ground, in particular for the climber *Gnetum luofuense*. The net with warning sign aims to alert workers that the presence of the species.

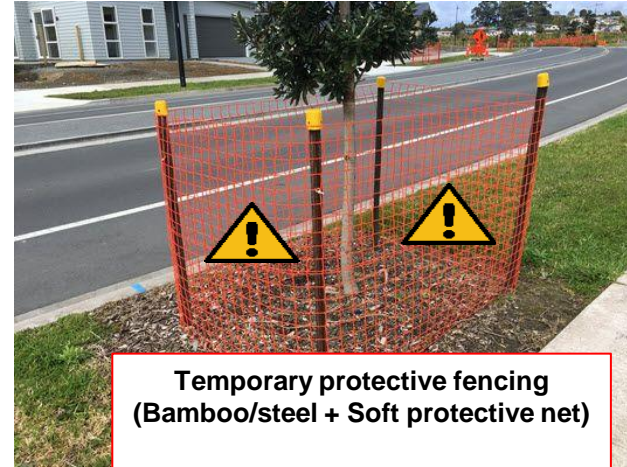
**Temporary protective fencing  
(Bamboo/steel + Soft protective net)**

Temporary protective fencing is made use of soft protective net with Bamboo/steel surrounded in order to provide a more robust structure for protection purpose. When area is available, it will be used for the shrubs/tree entangled by *Gnetum luofuense* at the **edge** of proposed work area .

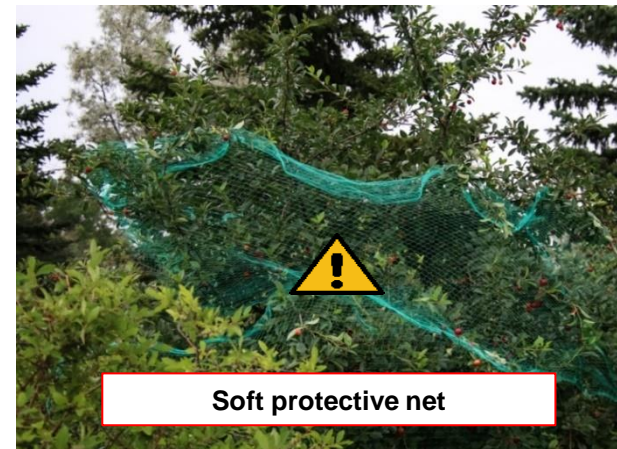
**Soft protective net**

As indicated, the shrubs/tree entangled by *Gnetum luofuense* will be covered with soft protective net.

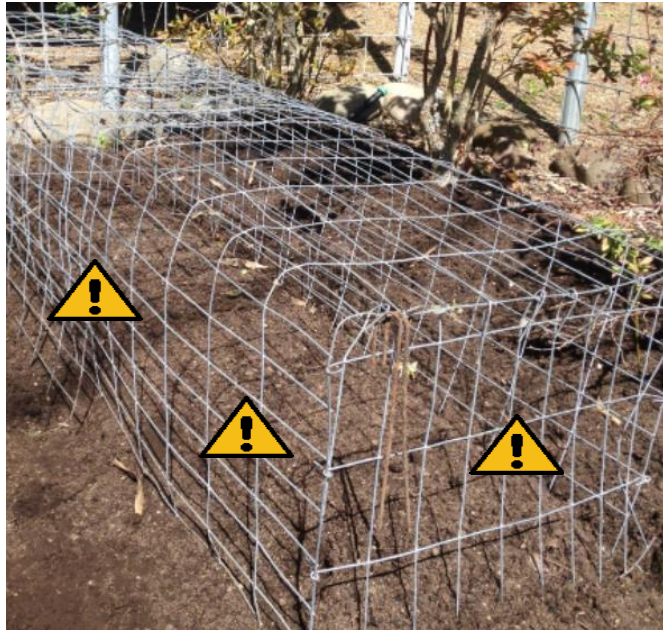
**Temporary Metal Cage**

When area is available, temporary metal cage will be built around the identified plant with the aim to avoid damage during the dismantling works.

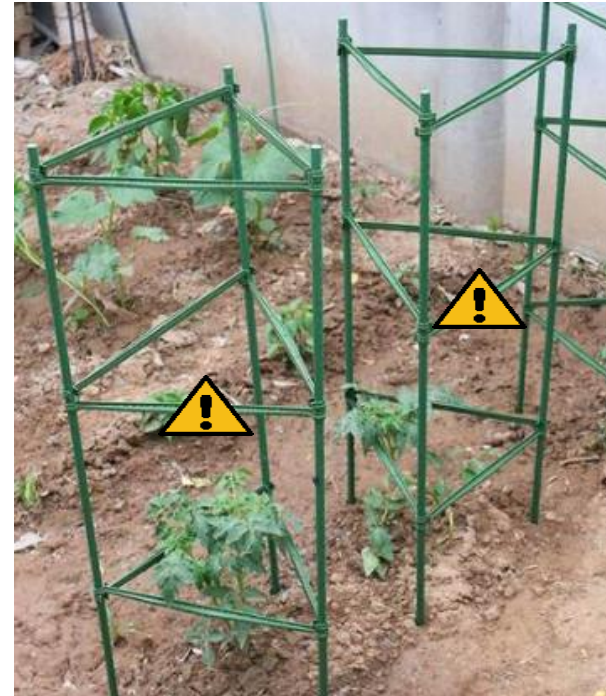
**Temporary Platform**

Temporary platform will be built to avoid trampling/ damage/ disturbance by works. It will be applied for the relatively tall shrub/tree underneath the pylons, which is entangled by *Gnetum luofuense*

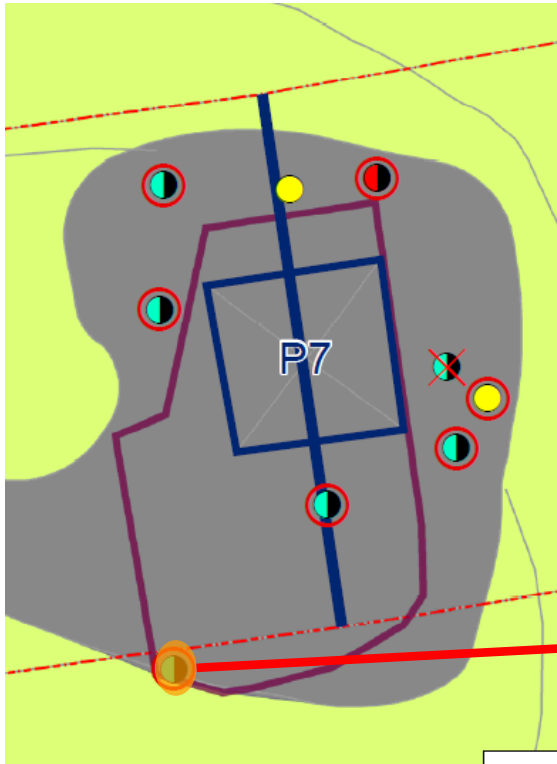
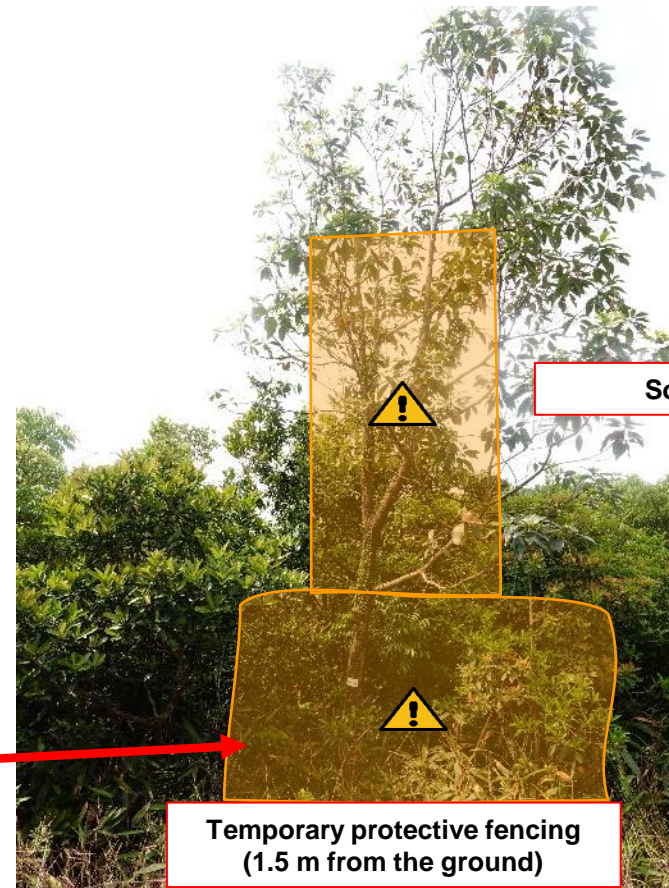
Soft protective net

Temporary protective fencing  
(1.5 m from the ground)

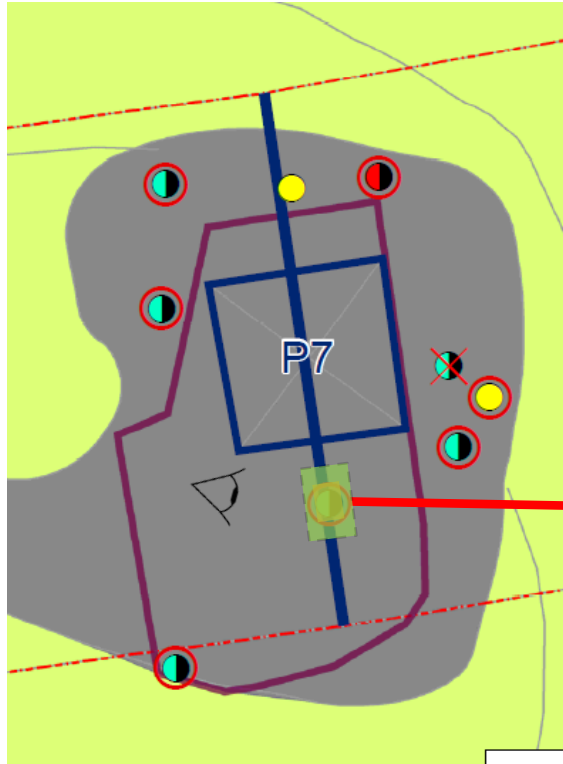
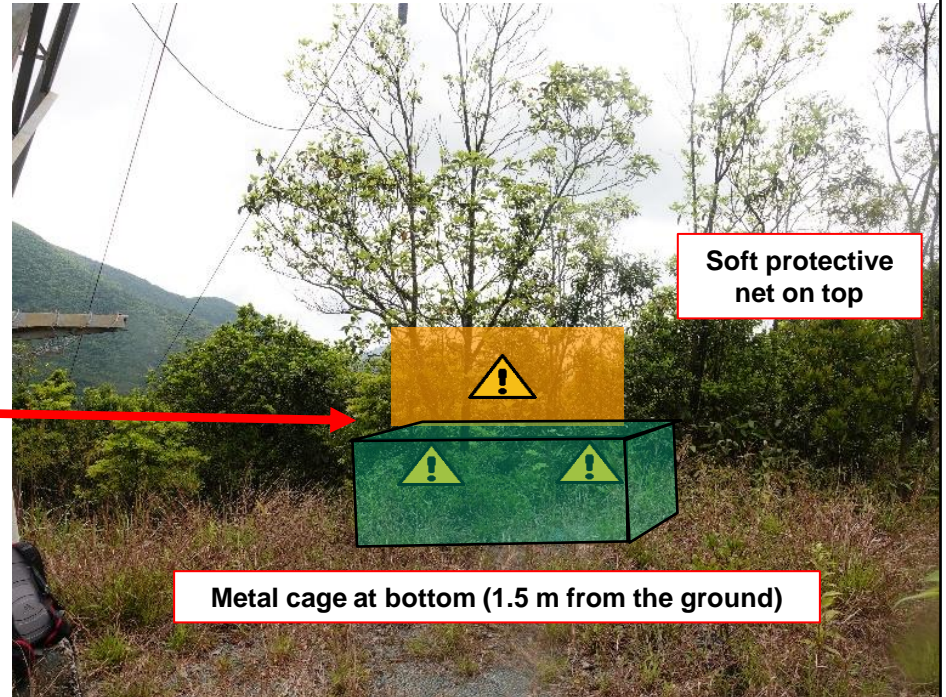
Soft protective net on top

Metal cage at bottom (1.5 m from the ground)

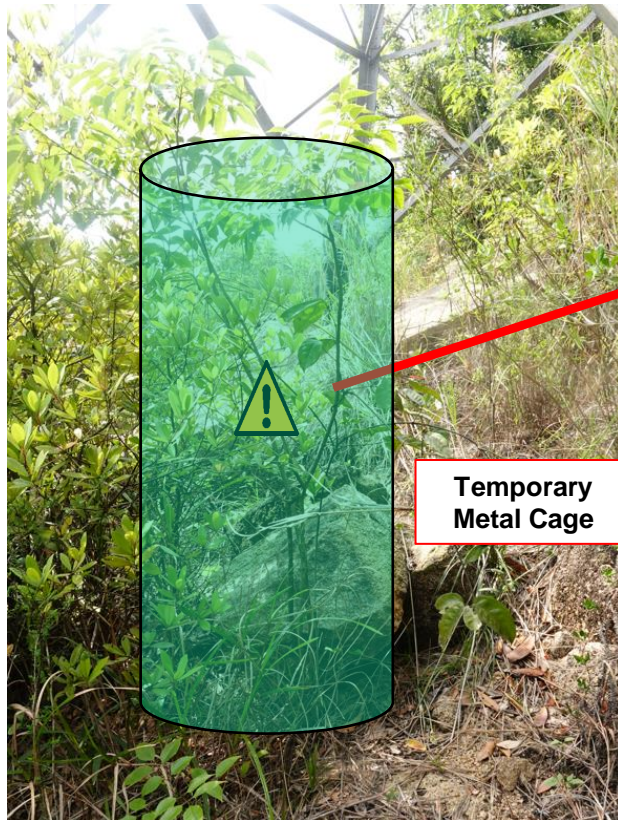
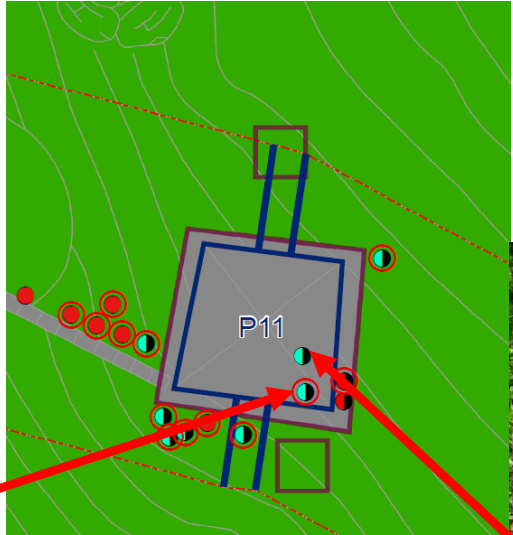
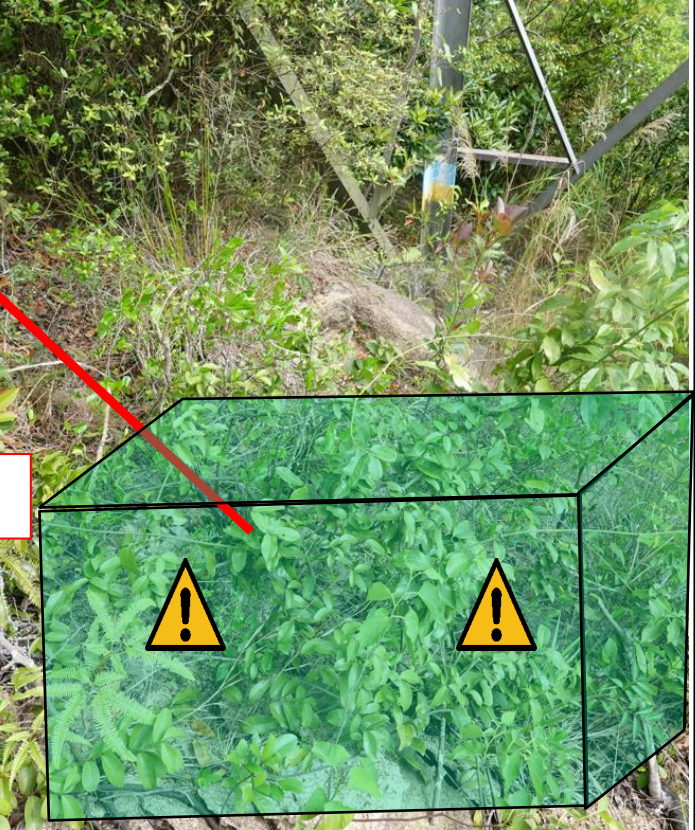
Temporary Metal Cage

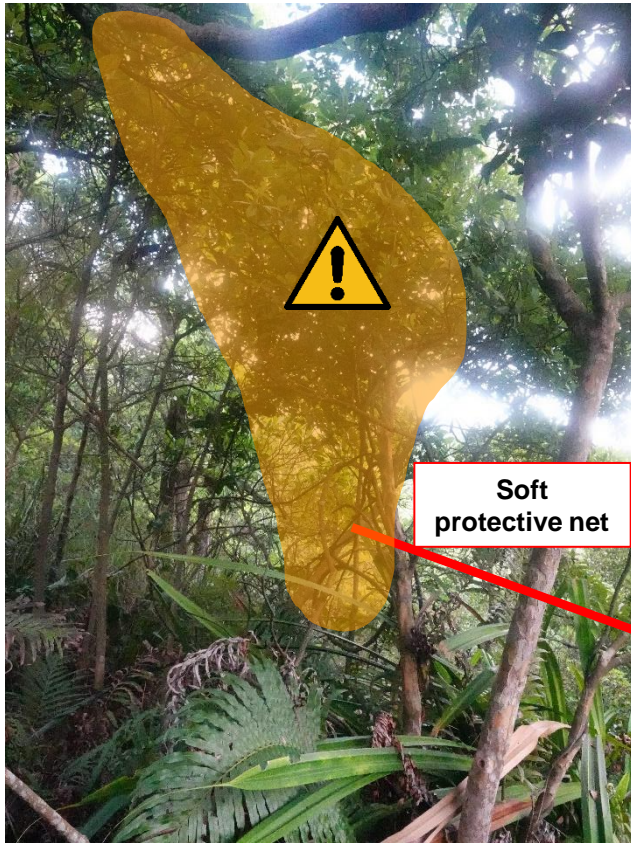
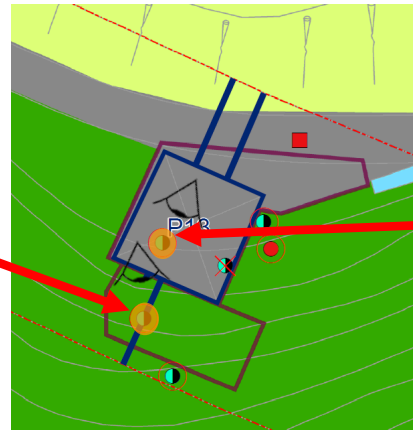
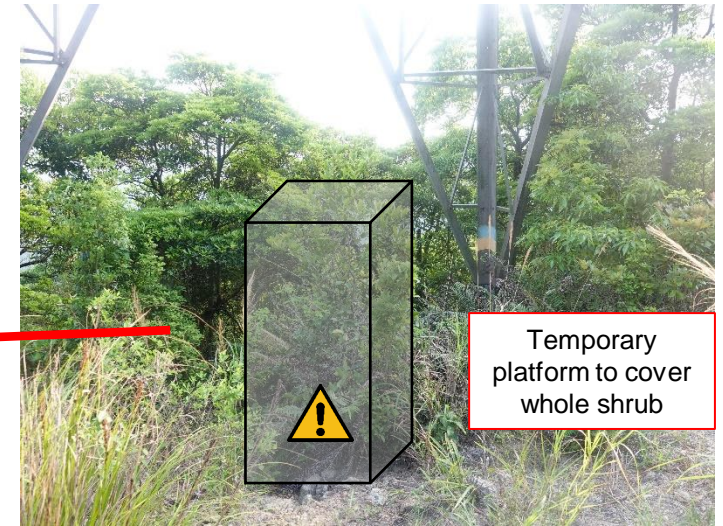
**Soft protective net**

**Temporary platform to cover whole shrub**

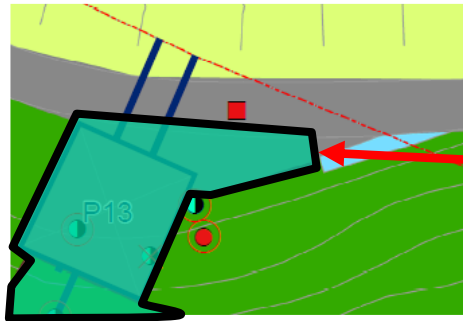
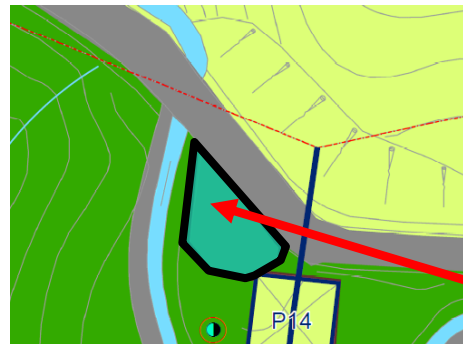
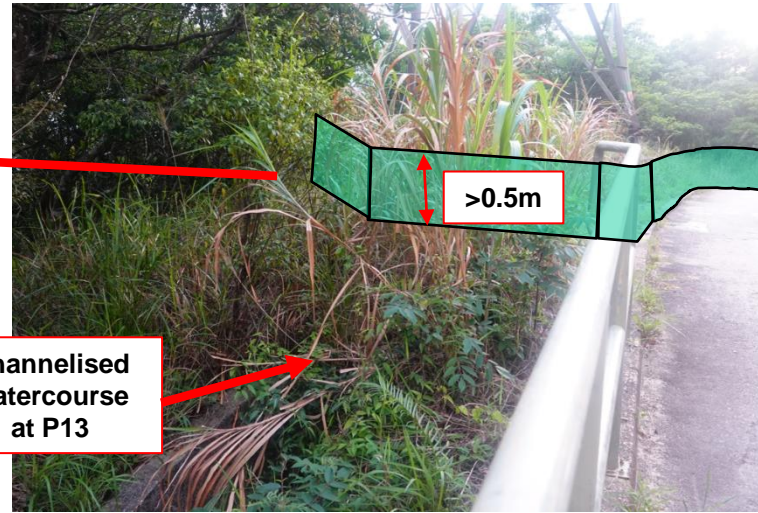
Channelised watercourse at P13

Calls of Romer's Tree Frog and Short-legged Toad were heard from the natural stream near P14. Given that the pylon dismantling works will be scheduled out of wet season (i.e. April - October) and the natural stream is separated by a concrete channel and walk trail from P14, as such indirect impact to these two species is considered to be insignificant. In order to further avoid the impact, temporary fence with a height of 0.5m will be erected around the proposed works area at P13 and P14 to prevent amphibian species of conservation importance (if any) from returning to the works areas (**Annex A14**).

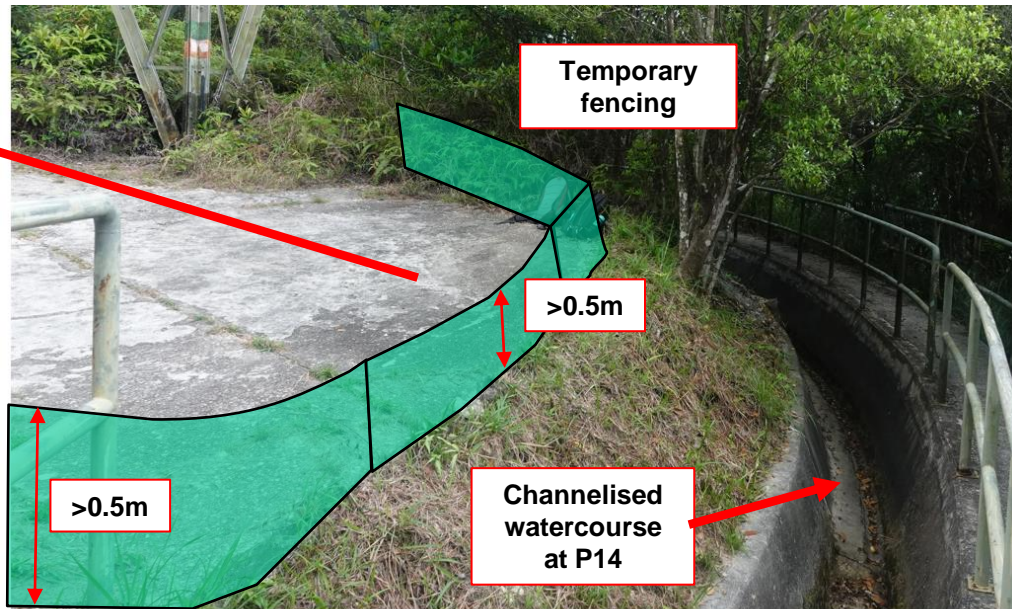
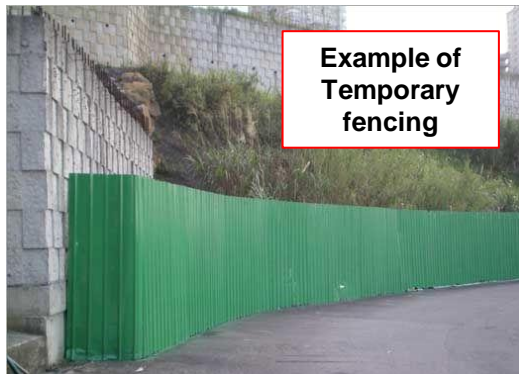
Example of Temporary fencing

The temporary fencing should have at least 0.5m in height and no hole for animal to pass.

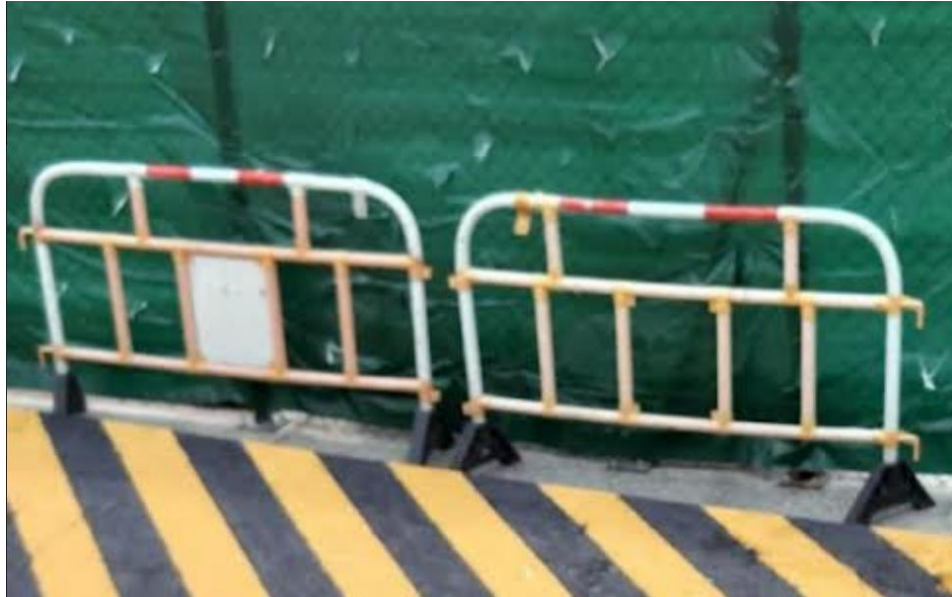
**Temporary Fence**

When area is available, temporary fence will be used to mark proposed works area.

The boundary of the works area will be clearly marked by temporary fence where possible, and soft PVC tape at area where space is limited, before and during the proposed works to avoid impacts on the flora and fauna species of conservation importance recorded nearby (**Annex A15**). The works area boundaries will be regularly checked to ensure that they are not breached and that no damage occurs to surrounding areas/ country parks.

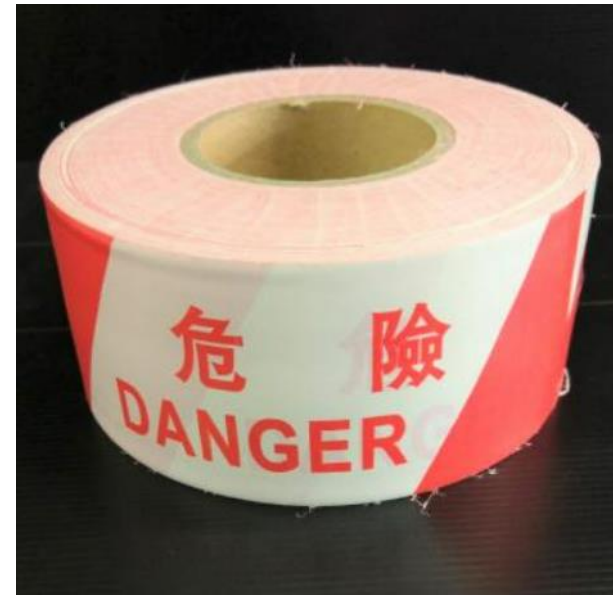
**PVC Tape**

When area is limited, PVC tape will be used to mark proposed works area.
