Cheung Chau Submarine Cable System

Pre-Installation Coral Survey Report

Oct 2022

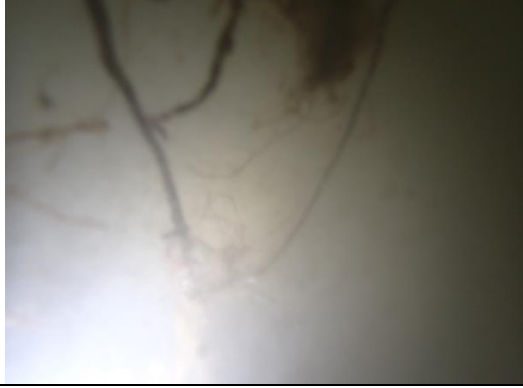
3.4 No soft coral or gorgonian coral was recorded during the spot check survey. However, dead gorgonian coral *Echinomuricea sp.* was recorded. Five hard coral colonies with two species were recorded (at least 15 m away from the cable alignment) during the spot dive survey (**Table 2**) including one colony of *Oulastrea crispata* and four colonies of *Favites acuticollis*. Their GPS coordinates, size and health condition were recorded in **Table 2**. Photos of each coral colony were shown in Photo **Plate A**. All corals recorded in the survey area are common species in Hong Kong water.

Dead <i>Echinomuricea</i> sp.	Coral #1 <i>Oulastrea crispata</i>

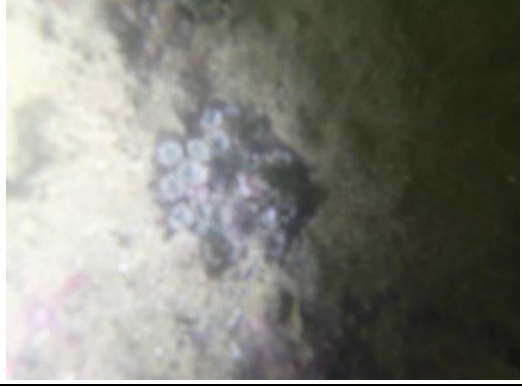
No.	Coral species	Size (cm)	% Bleaching	Partial Mortality	% Sediment	GPS Coordinates	
1	<i>Oulastrea crispata</i>	8	0	0	0	22°11'50.21N	114°01'17.43E
2	<i>Favites acuticollis</i>	15	0	0	0	22°11'50.00N	114°01'17.03E
3	<i>Favites acuticollis</i>	19	0	0	0	22°11'49.90N	114°01'16.88E
4	<i>Favites acuticollis</i>	16	0	0	0	22°11'49.78N	114°01'16.69E
5	<i>Favites acuticollis</i>	22	0	0	0	22°11'49.12N	114°01'16.02E

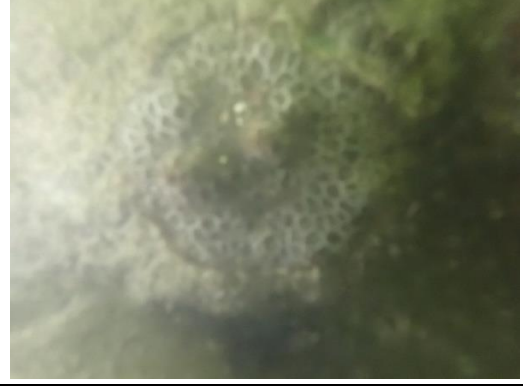
Coral #2 <i>Favites acuticollis</i>	Coral #3 <i>Favites acuticollis</i>

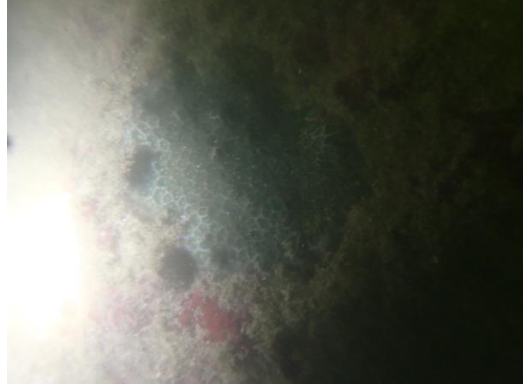
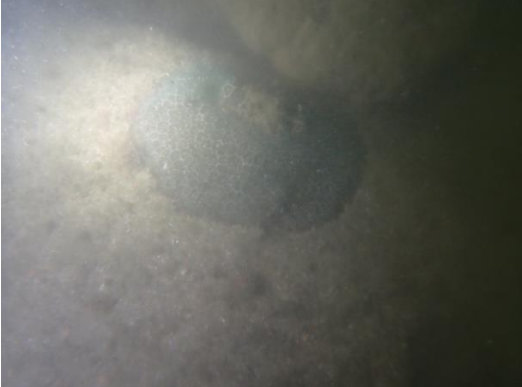
Coral #4 <i>Favites acuticollis</i>	Coral #5 <i>Favites acuticollis</i>
