# **Post-Installation Coral Survey Report**

**ECO-ENVIRO CONSULTANTS COMPANY**

**Dec 2023**

**Re: Cheung Chau Submarine Cable System  
Environmental Permit No. EP-612/2022  
Certification of Post-Installation Coral Survey Report**

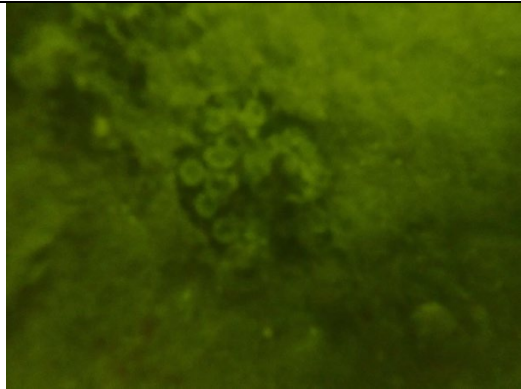
No.	Coral species	Size (cm)	% Bleaching	Partial Mortality	% Sediment	GPS Coordinates	
1	<i>Oulastrea crispata</i>	8	0	0	0	22°11'50.21N	114°01'17.43E
2	<i>Favites acuticollis</i>	15	0	0	0	22°11'50.00N	114°01'17.03E
3	<i>Favites acuticollis</i>	19	0	0	0	22°11'49.90N	114°01'16.88E
4	<i>Favites acuticollis</i>	16	0	0	0	22°11'49.78N	114°01'16.69E
5	<i>Favites acuticollis</i>	22	0	0	0	22°11'49.12N	114°01'16.02E

Coral #1 <i>Favites acuticollis</i>	Coral #2 <i>Favites acuticollis</i>

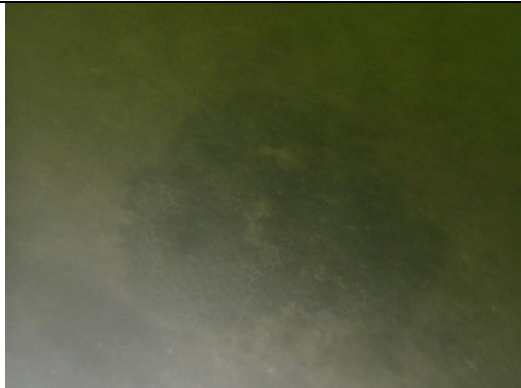
Coral #3 <i>Favites acuticollis</i>	Coral #4 <i>Favites acuticollis</i>

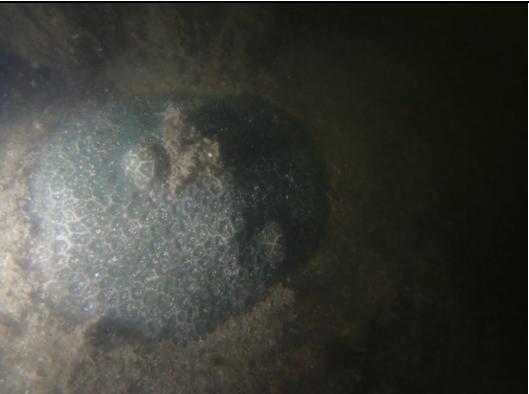
Coral #5 <i>Favites acuticollis</i>
