Reprovisioning and Upgrading of Salt
Water Service Reservoirs in Western
District for Water Supplies Department:
*Eighth Monthly Environmental
Monitoring and Audit Report*

April 2008

Environmental Resources Management

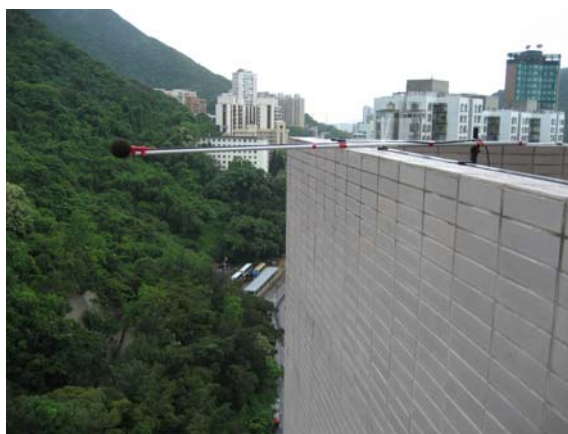
Baseline Noise Monitoring Station (NM2)
