Reprovisioning and Upgrading of Salt
Water Service Reservoirs in Western
District for Water Supplies Department:
*Thirteenth Monthly Environmental
Monitoring and Audit Report*

September 2008

Environmental Resources Management

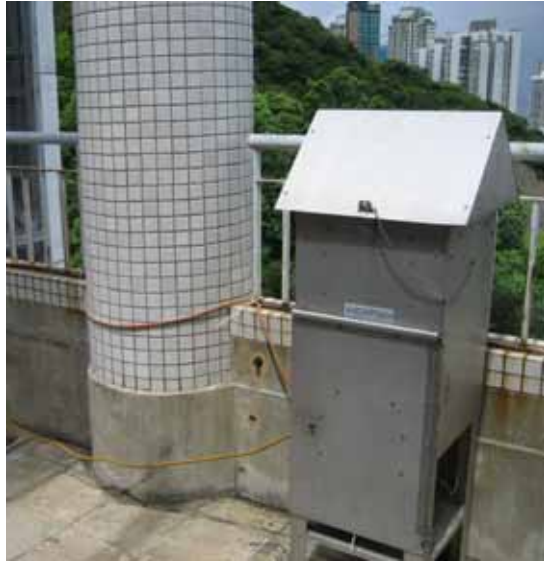
Air Quality Monitoring Station (AM1)

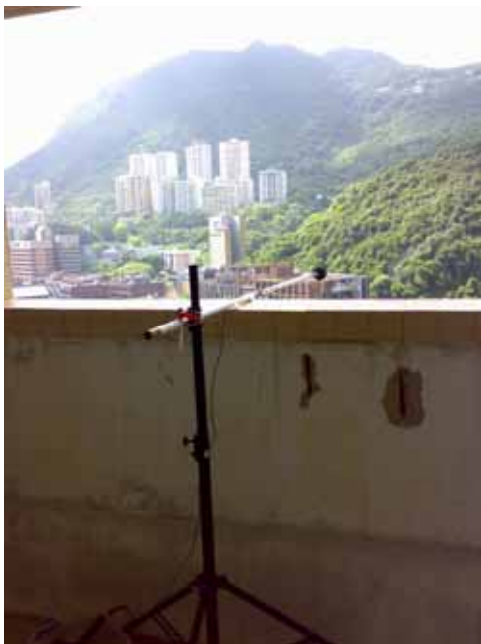
Noise Monitoring Station (NM1)

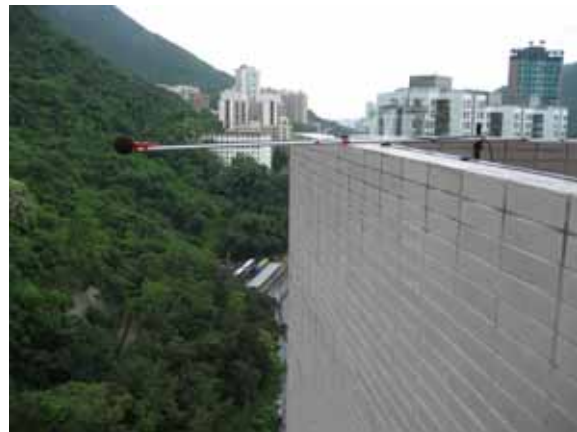
Baseline Noise Monitoring Station (NM2)

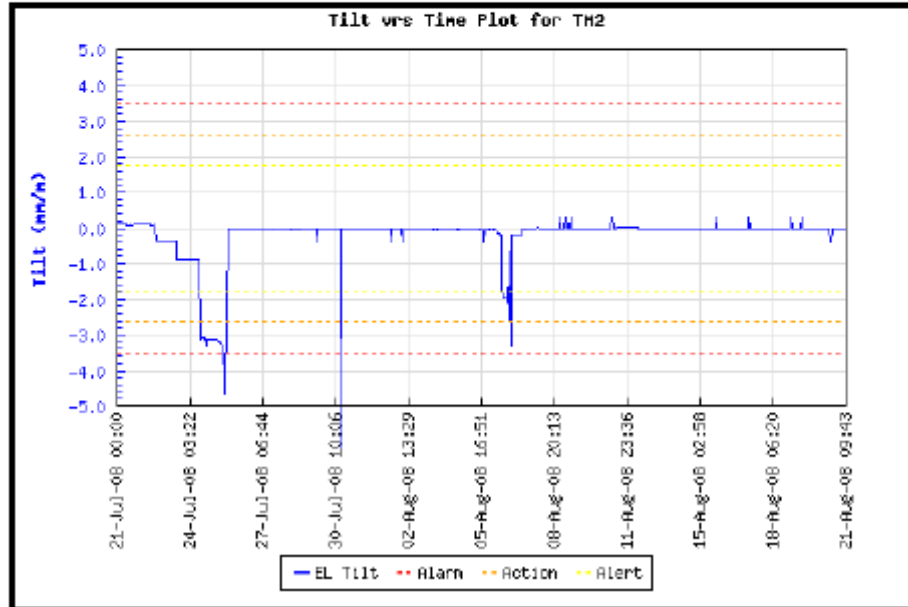
As reported by the Contractor, exceedances recorded at tiltmeter TM02 on 24 and 25 July 2008 were due to equipment malfunction caused by moisture inside the tiltmeter. The normal function of the tiltmeter resumed after removal of the moisture.

ELECTROLEVEL TILT SENSOR MONITORING RECORD SHEET

Instrument ID : TM2 Type : Electro Level
 Easting : 831797.083 Northing : 816014.766 Initial Level : 92.664 mPD
 Location : Valve House
 Remark : Radio Transmitter Serial No. 50348; +ve Reading => Rotation towards West South

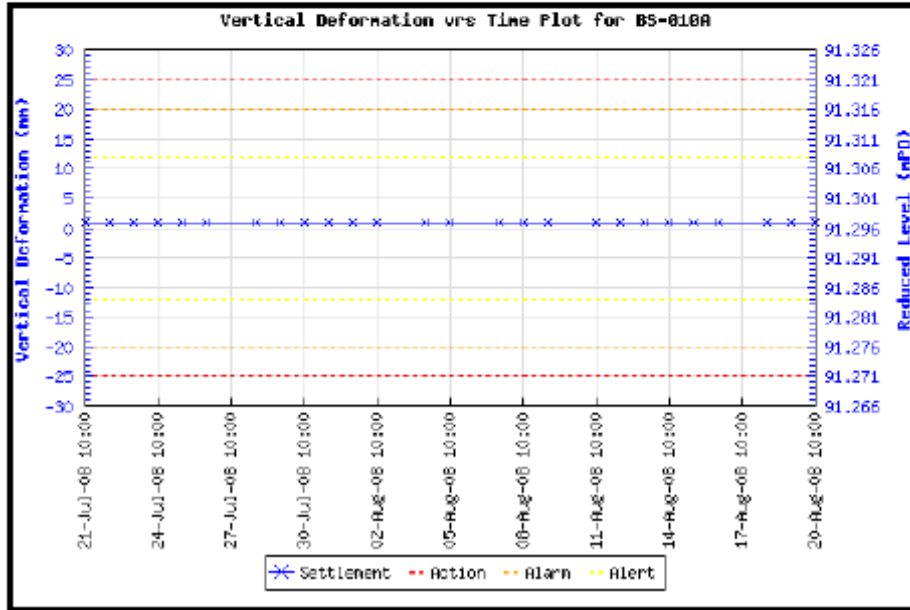
SETTLEMENT MONITORING RECORD SHEET

Instrument ID : BS-010A
 Easting : 831808.247
 Location : Valve House
 Remark :

Type : Building Settlement Marker Type DMP5
 Northing : 816016.001 Initial Level : 91.296 mPD
