Reprovisioning and Upgrading of Salt
Water Service Reservoirs in Western
District for Water Supplies Department:
*Fourteenth Monthly Environmental
Monitoring and Audit Report*

October 2008

MONTHLY ENVIRONMENTAL
MONITORING & AUDIT REPORT

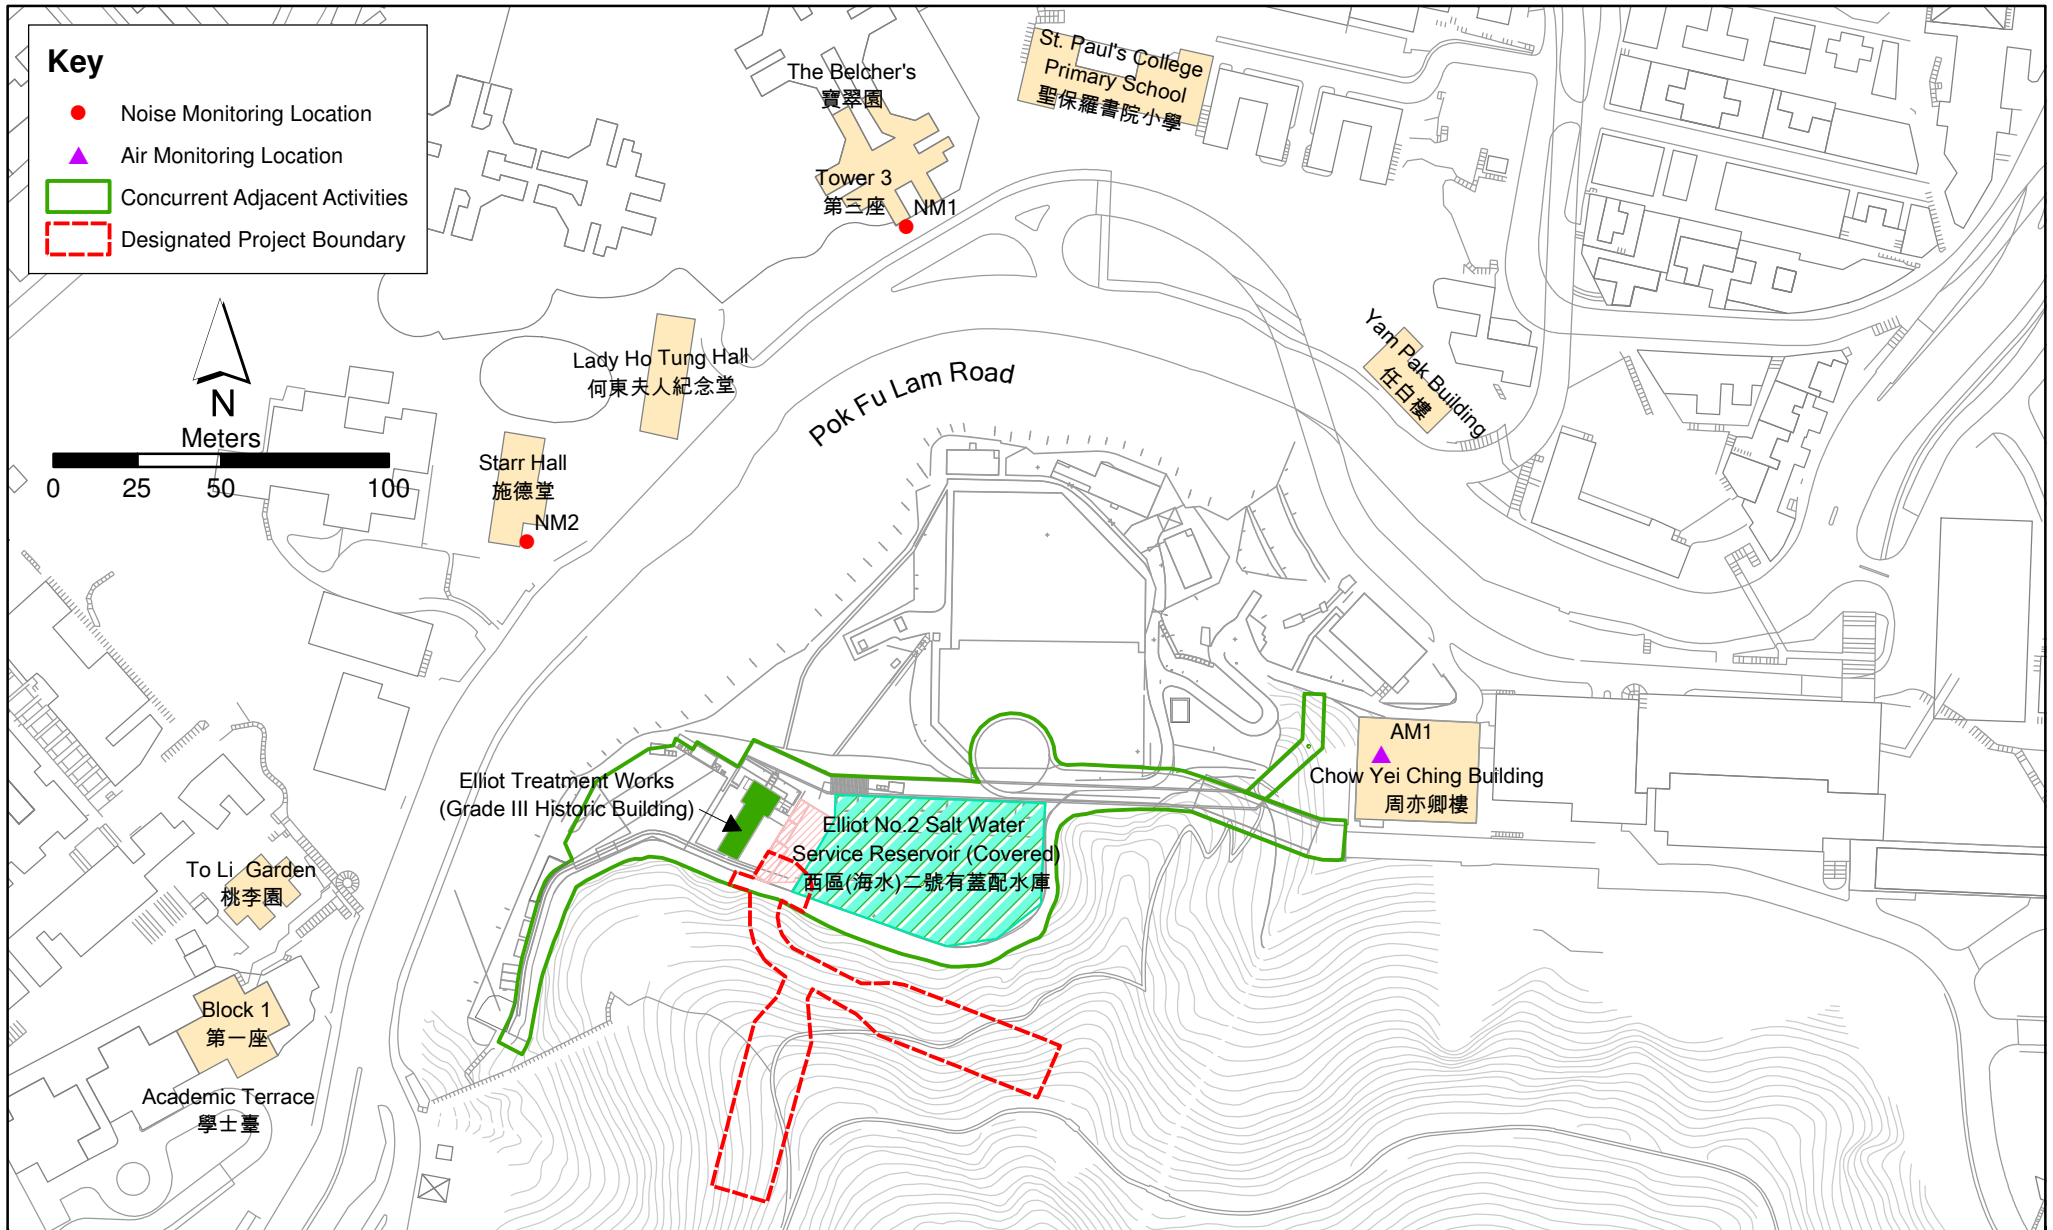
Figure B1

Air and Noise Monitoring Locations

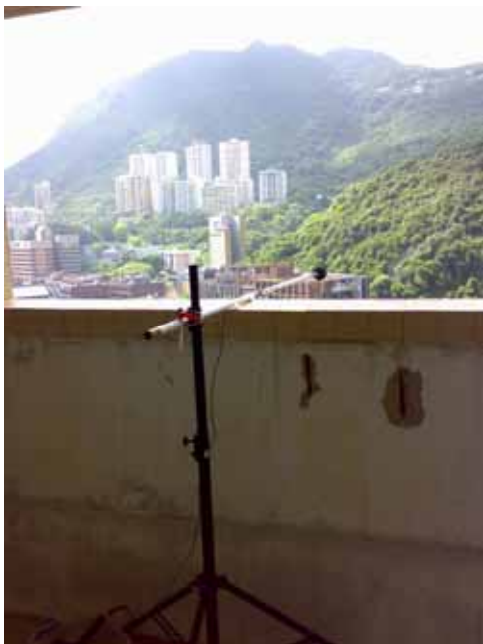
Noise Monitoring Station (NM1)

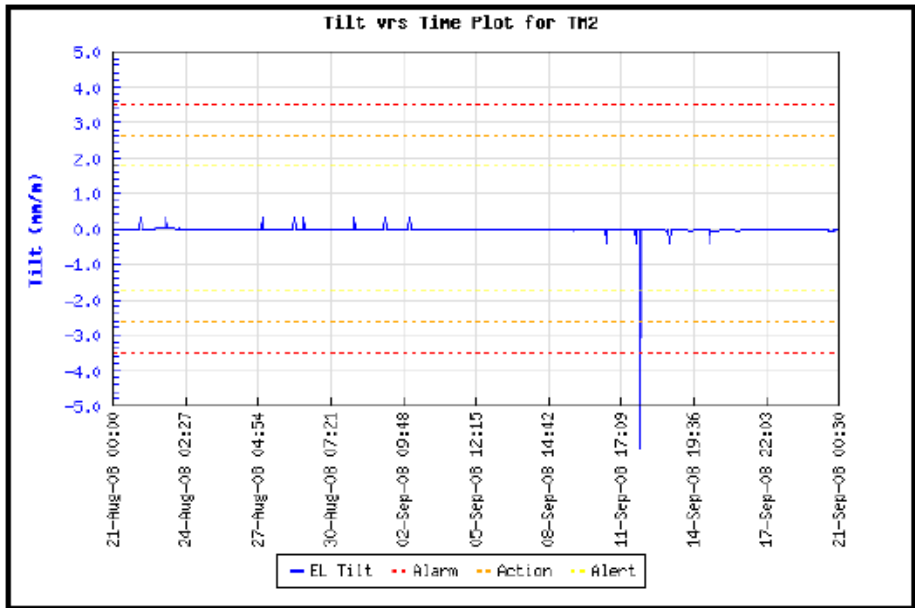
As reported by the Contractor, exceedances recorded at tiltmeters TM02 on 12 September 2008, TM05 on 4 September 2008 and TM10R on 28 August 2008 were due to equipment malfunction caused by moisture inside the tiltmeter. The normal function of the tiltmeters resumed after removal of the moisture.

ELECTROLEVEL TILT SENSOR MONITORING RECORD SHEET

Instrument ID : TM2 Type : Electro Level
 Easting : 831797.083 Northing : 816014.766 Initial Level : 92.664 mPD
 Location : Valve House
 Remark : Radio Transmitter Serial No. 50348; +ve Reading => Rotation towards West South

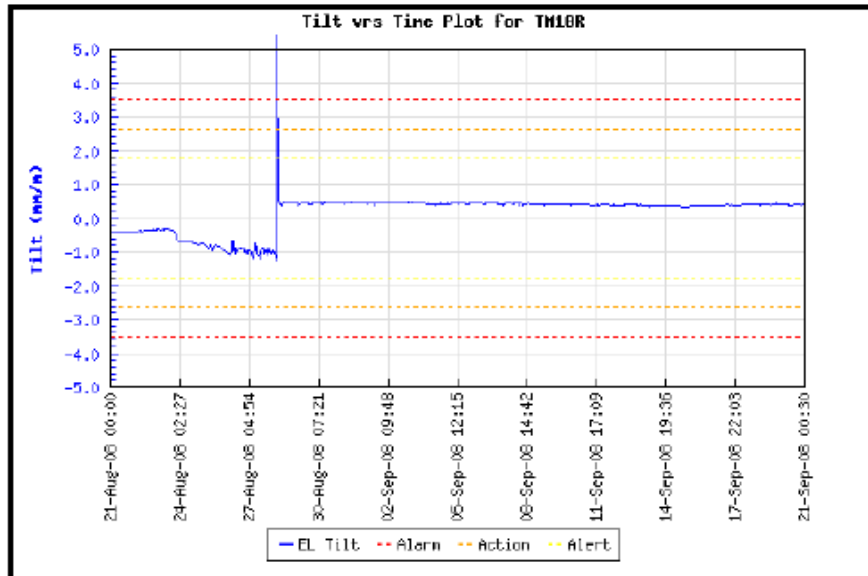
ELECTROLEVEL TILT SENSOR MONITORING RECORD SHEET

Instrument ID : TM10R Type : Electro Level
 Easting : 831805.802 Northing : 816017.577 Initial Level : 92.744 mPD
 Location : Valve House
 Remark : Radio Transmitter Serial No. 50270; +ve Reading => Rotation towards West North

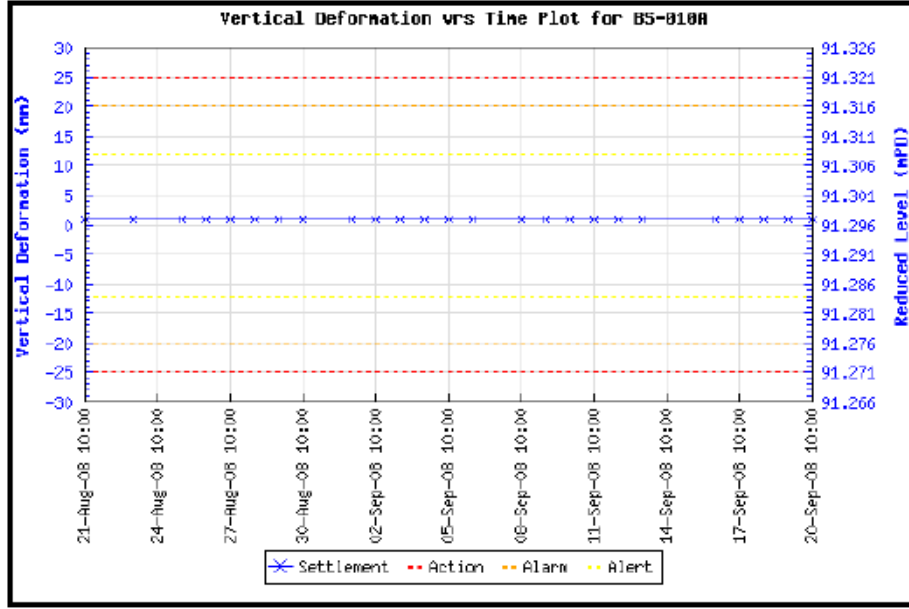
SETTLEMENT MONITORING RECORD SHEET

Instrument ID : BS-010A
 Easting : 831808.247
 Location : Valve House
 Remark :

Type : Building Settlement Marker Type DMP5
 Northing : 816016.001 Initial Level : 91.296 mPD

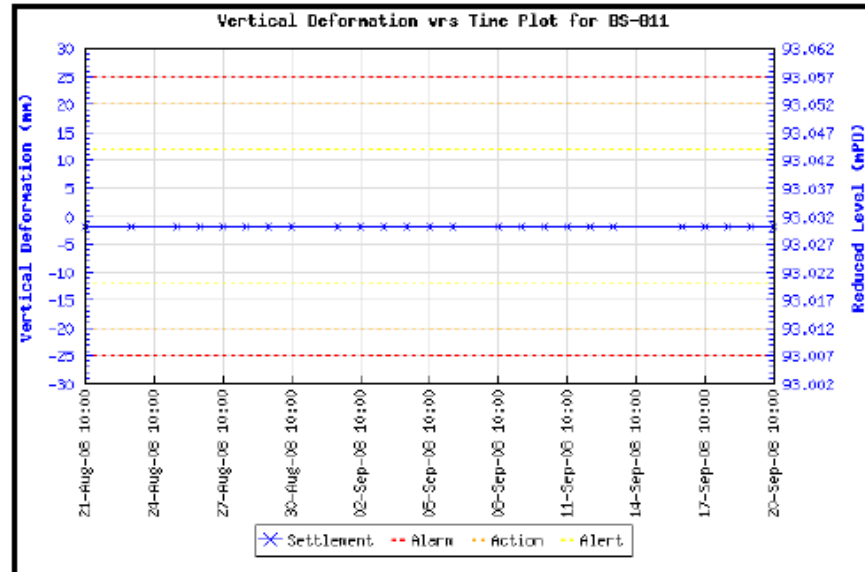
SETTLEMENT MONITORING RECORD SHEET

Instrument ID : BS-011
 Easting : 831795.830
 Location : Valve House
 Remark :

Type : Building Settlement Marker Type DMP5
 Northing : 815997.133 Initial Level : 93.032 mPD
