# MONTHLY ENVIRONMENTAL MONITORING & AUDIT REPORT

Reprovisioning and Upgrading of Salt Water Service Reservoirs in Western District for Water Supplies Department: *Fifteenth Monthly Environmental Monitoring and Audit Report*

November 2008

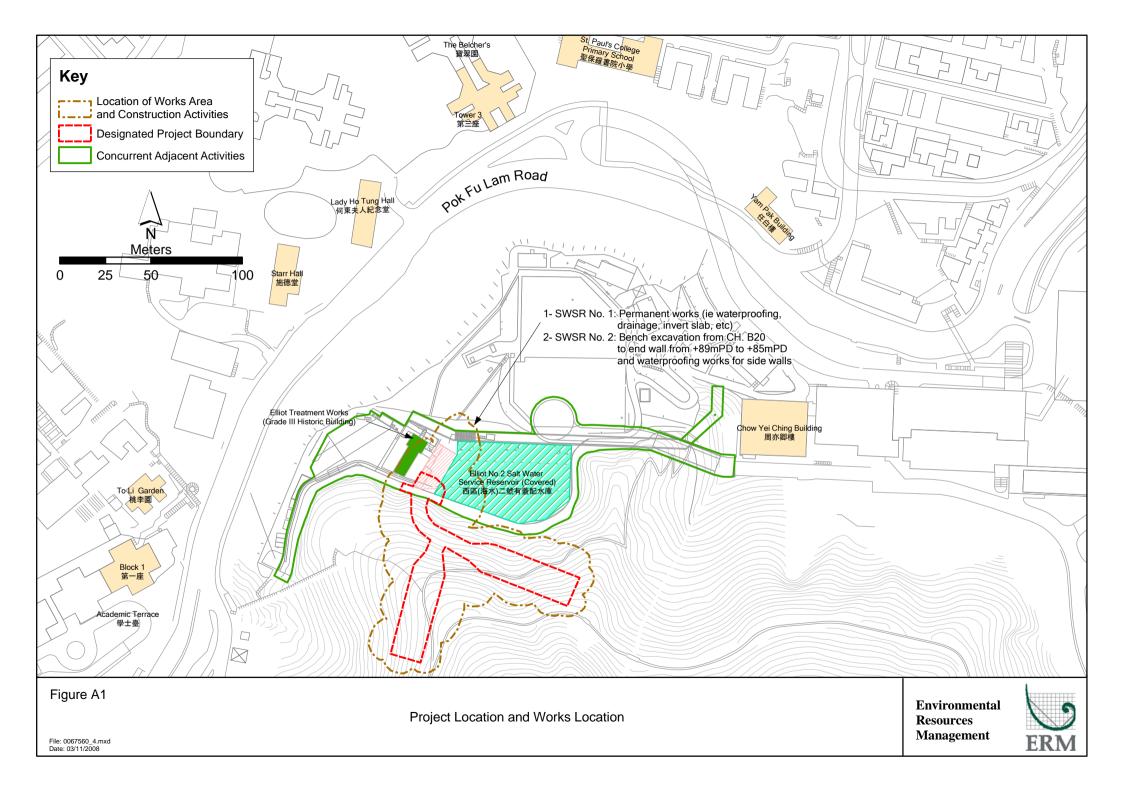
Locations of Works Areas and Construction Activities during the Reporting Period, and updated Construction Programme

A summary of the major construction activities undertaken in this reporting period is shown in *Table 2.1*. The locations of the construction activities are shown in *Annex A*.

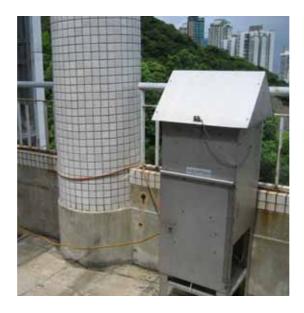
Air Quality Monitoring Station (AM1)

In accordance with the EM&A Manual, monitoring of ambient 24-hour Total Suspended Particulates (TSP) level was conducted at the monitoring station listed in *Table 3.1*. A map and a photograph showing the monitoring station are presented in *Annex B*.

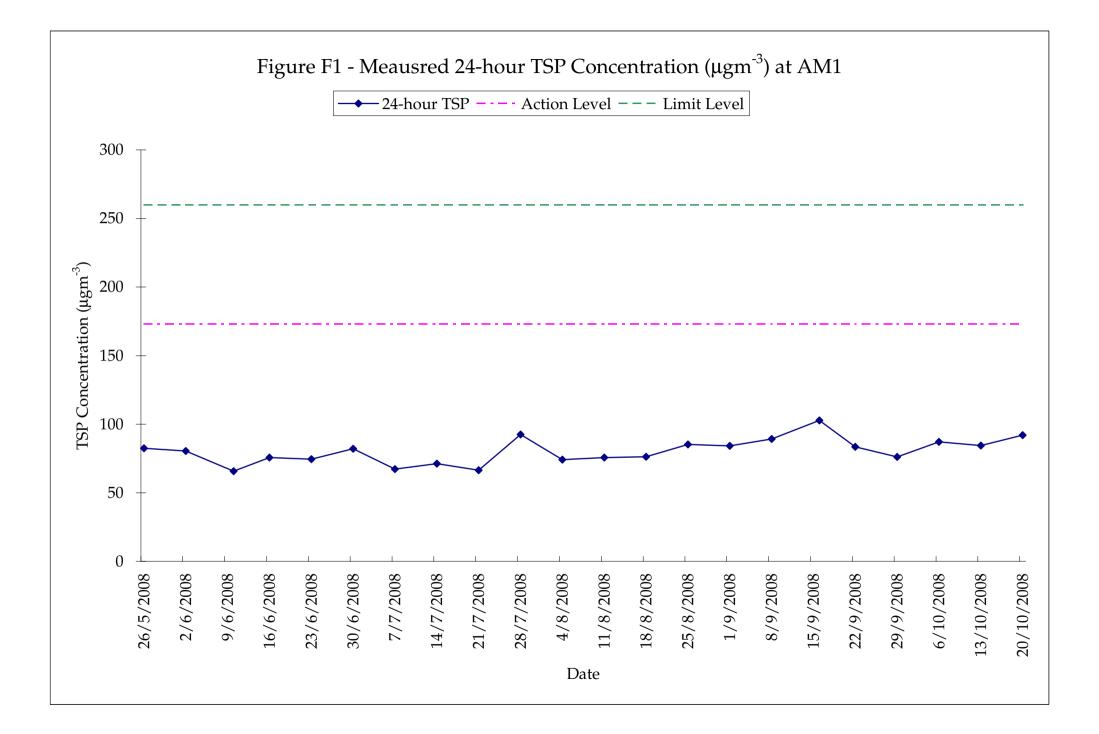
Five sets of 24-hour TSP measurements were carried out at the monitoring station AM1 during the reporting period. The monitoring data for 24-hour TSP together with wind data and graphical presentations are presented in *Annex F*. The weather condition during the monitoring period varied from sunny to fine. The local impacts near the monitoring station were mainly associated with vehicular emissions from the road traffic along Pok Fu Lam Road. No exceedance of the Action and Limit Levels for 24-hour TSP was recorded during the reporting period.

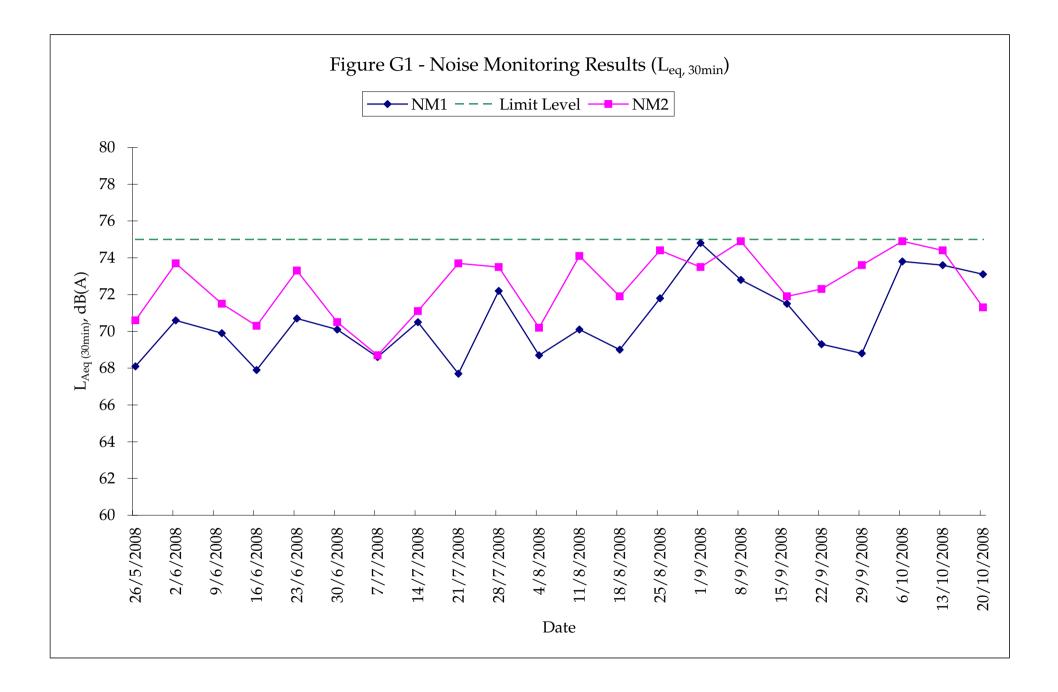
Monitoring Location: NM2 - Roof of Starr Hall

Five sets of 30-minute construction noise measurements were carried out at monitoring stations NM1 & NM2 during the reporting period. The monitoring results together with graphical presentations are presented in *Annex G*. The local impacts observed near the monitoring stations were mainly traffic noise from Pok Fu Lam Road and the concurrent projects undertaken in the vicinity. No exceedance of the Action and Limit Levels for construction noise was recorded during the reporting period.

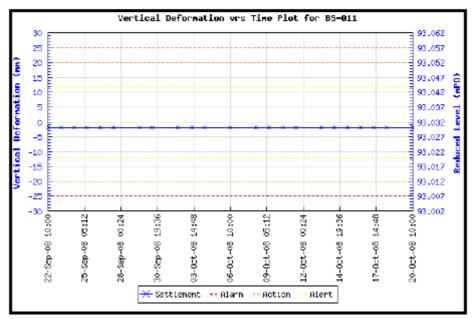
Instrument ID : BS-011 Easting : 831795.830 Location : Valve House Remark :

Type : Building Settlement Marker Type DMP5 Northing : 815997.133 Initial Level : 93.032 mPD
