Contract No. SSW327

***Reprovisioning of Cape Collinson
Crematorium***

**Monthly Environmental and Audit Report
October 2014
(Version 1.0)**

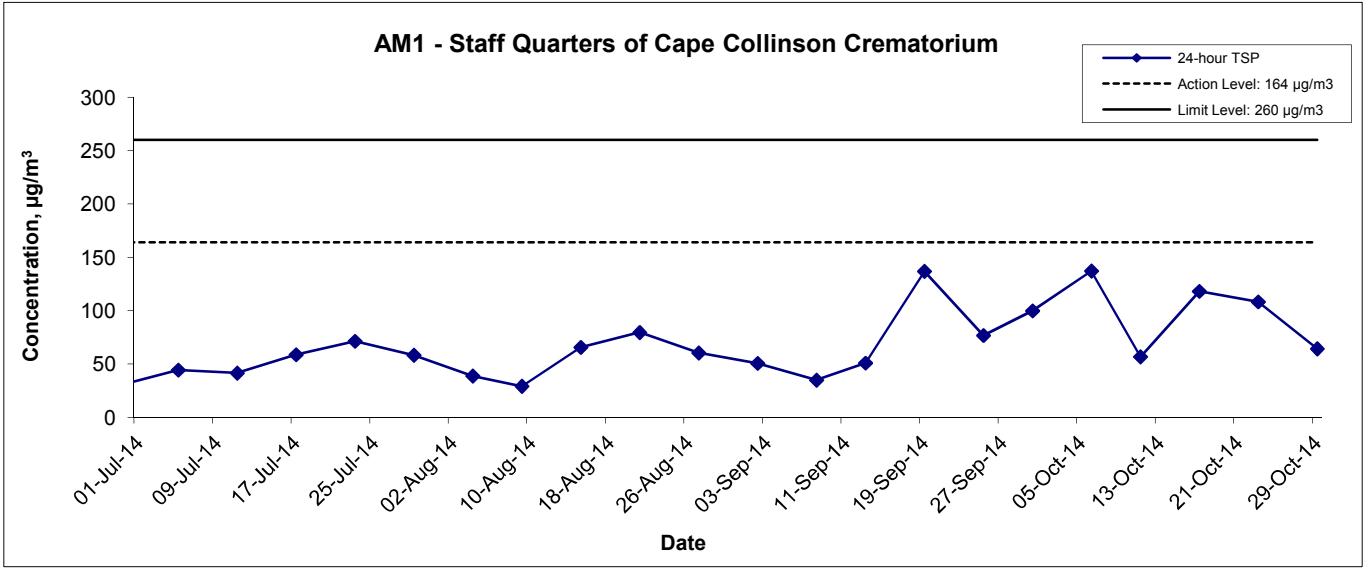
Title Contract No. SSW 327 Reprovisioning of Cape Collinson Crematorium Graphical Presentation of 24-hour TSP Monitoring Results	Scale N.T.S	Project No. MA0031	
	Date Oct 14	Appendix E

Start Date	Weather Condition	Air Temp. (K)	Atmospheric Pressure, Pa (mmHg)	Filter Weight (g)		Particulate weight (g)	Elapse Time		Sampling Time(hrs.)	Flow Rate (m ³ /min.)		Av. flow (m ³ /min)	Total vol. (m ³)	Conc. (µg/m ³)
				Initial	Final		Initial	Final		Initial	Final			
6-Oct-14	Sunny	300.0	765.1	3.2428	3.4927	0.2499	10982.5	11006.5	24.0	1.23	1.23	1.23	1772.1	141.0
11-Oct-14	Sunny	299.5	761.8	3.2880	3.4747	0.1867	11006.5	11030.5	24.0	1.23	1.23	1.23	1769.8	105.5
17-Oct-14	Cloudy	297.2	767.1	3.1600	3.4015	0.2415	11030.5	11054.5	24.0	1.24	1.24	1.24	1790.6	134.9
23-Oct-14	Sunny	295.8	765.5	3.2515	3.4679	0.2164	11054.5	11078.5	24.0	1.25	1.24	1.25	1792.8	120.7
29-Oct-14	Cloudy	297.4	766.7	3.2260	3.4012	0.1752	11078.5	11102.5	24.0	1.24	1.24	1.24	1789.6	97.9
													Min	97.9
													Max	141.0
													Average	120.0
