**Contract No. SSW 327**

**Reprovisioning of  
Cape Collinson Crematorium**

**Supplementary Contamination Assessment Plan  
(Version 3.0)**

July 2012

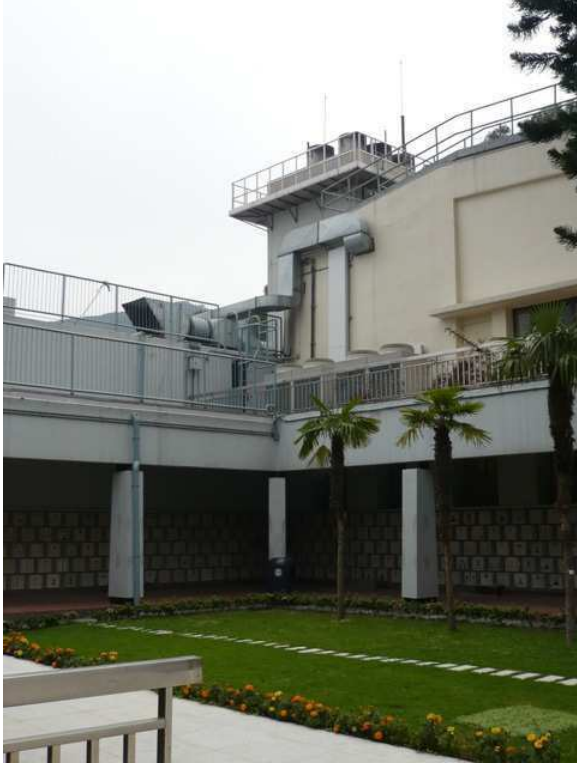
<b>Direction Photo Taken:</b> West of Chimneys			
<b>Description:</b> A total of 6 chimneys connected to 12 cremators were located at the roof of existing crematorium.

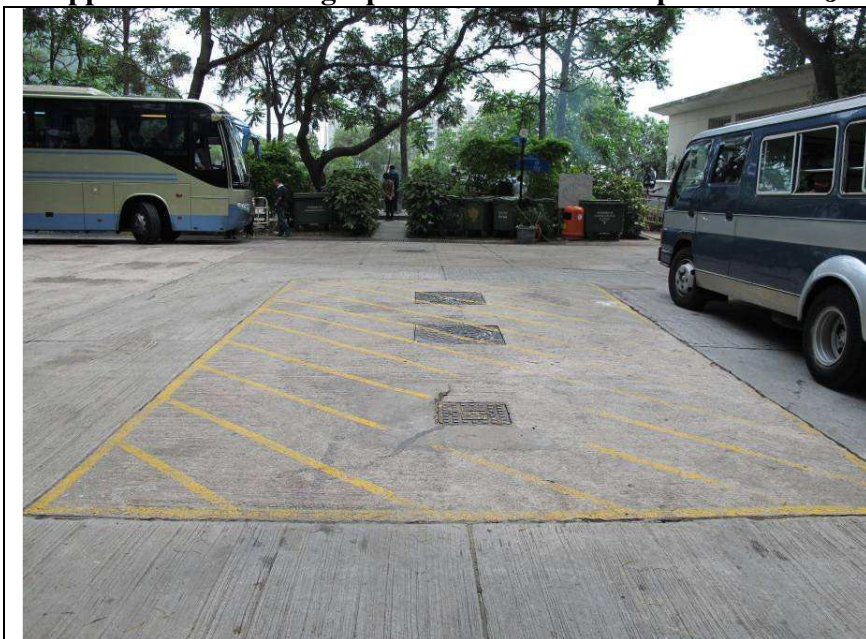
**Description: Location of Underground Storage Tank (UST)**

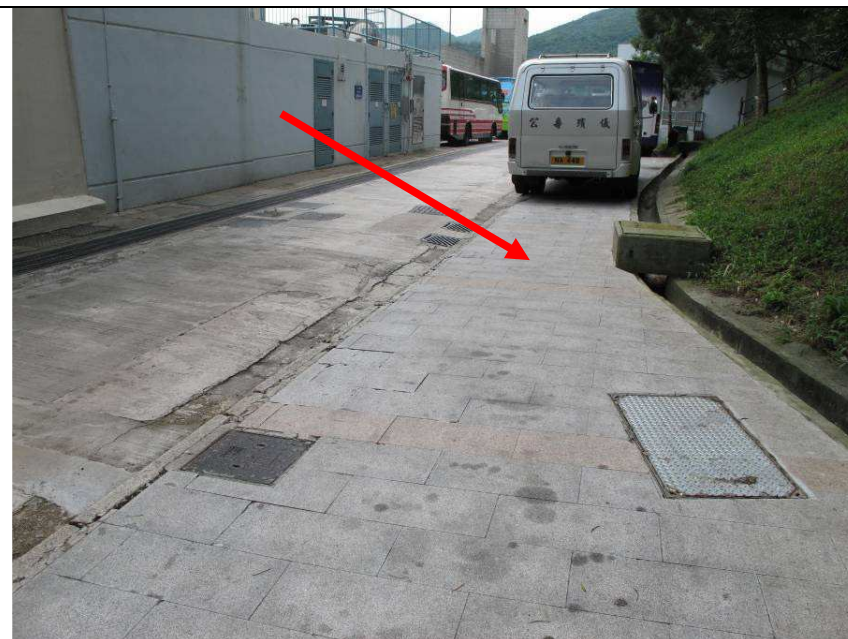
**Description: Location: Trial Pit 1(TP1)**

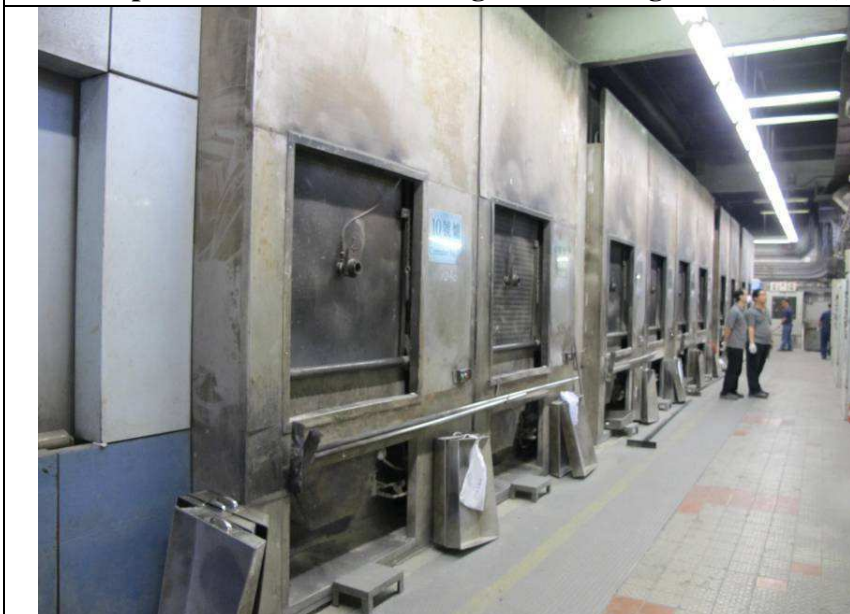
**Description: Cremator in Cremation Room 1 (CR1)**

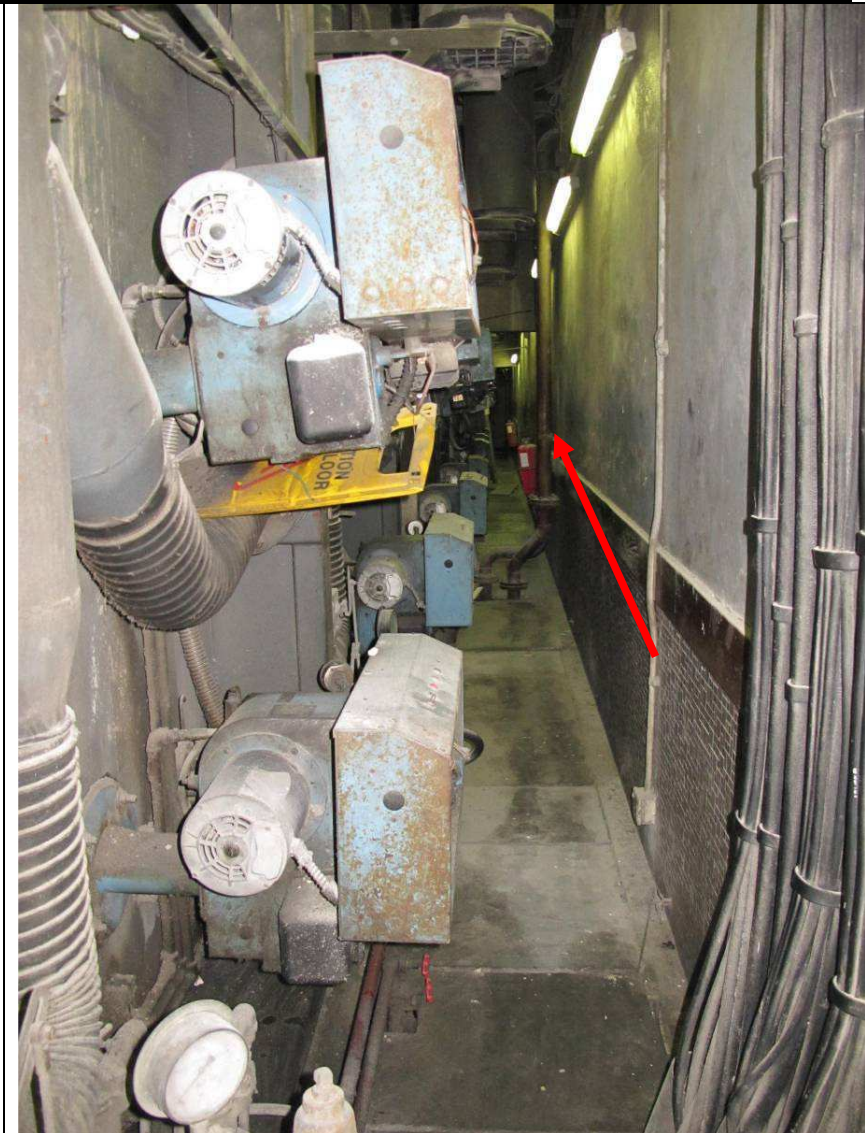
**Description: External Main Fuel Pipe to Cremator (CR1)**

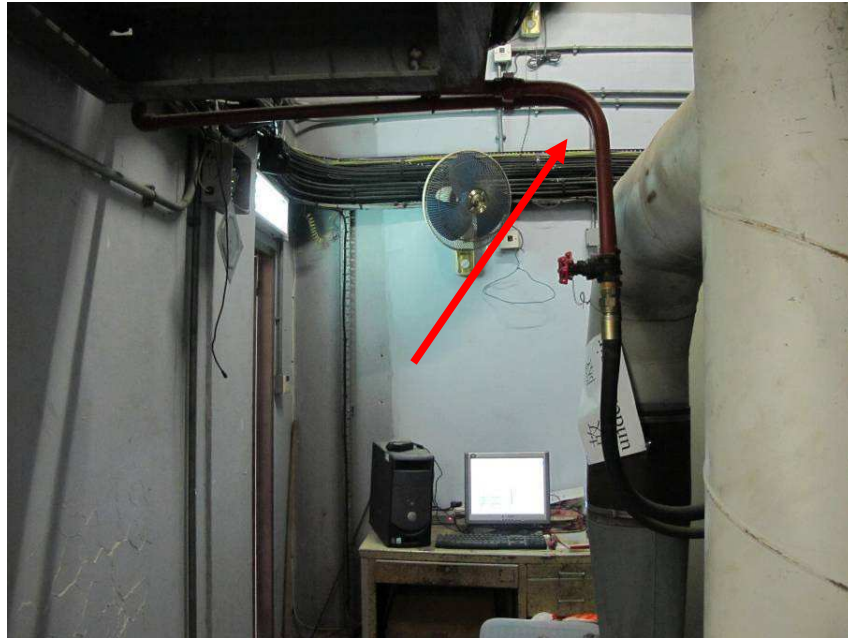
**Description: External Fuel Pipelines form  
Cremation Room 1 (CR1) to Cremation Room (CR2)**

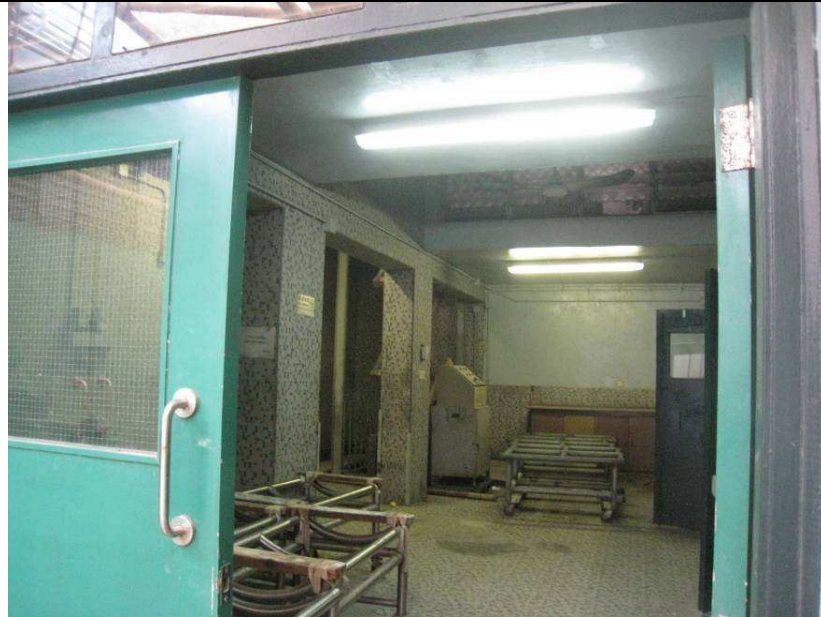
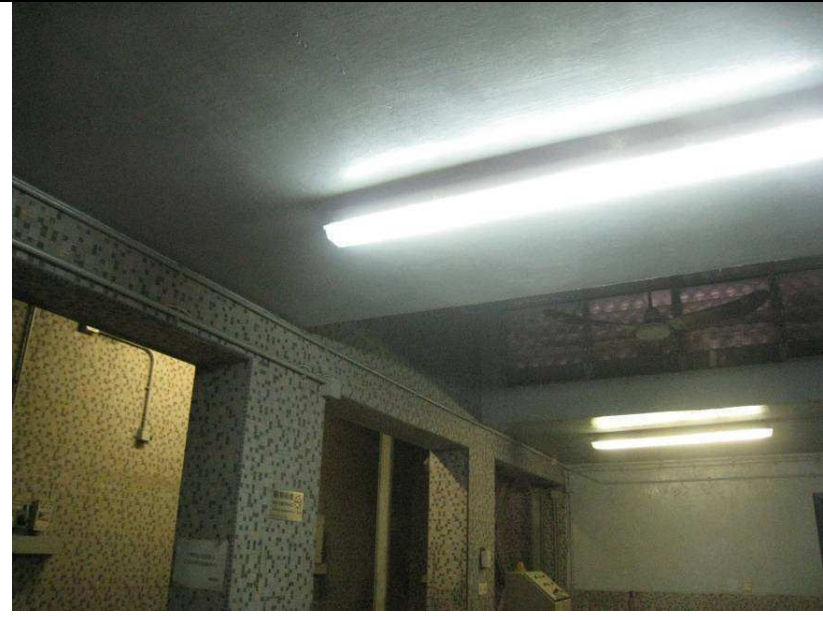
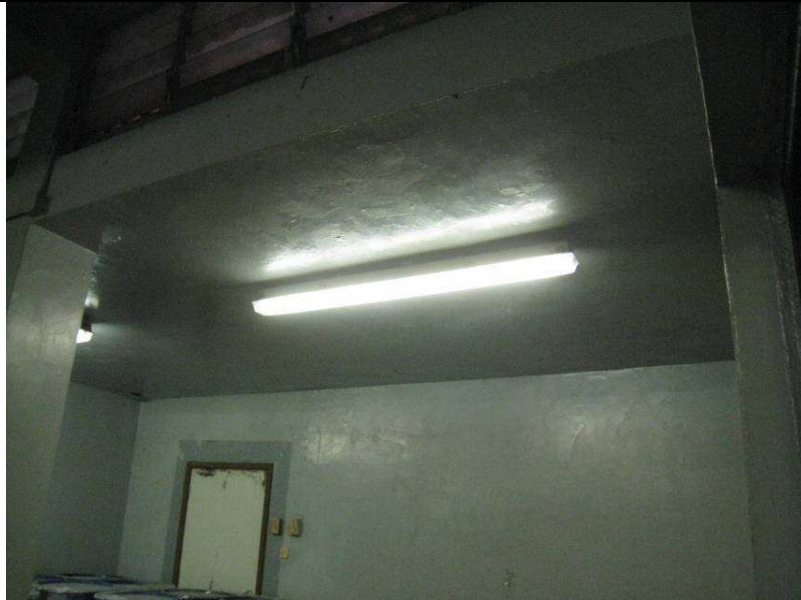
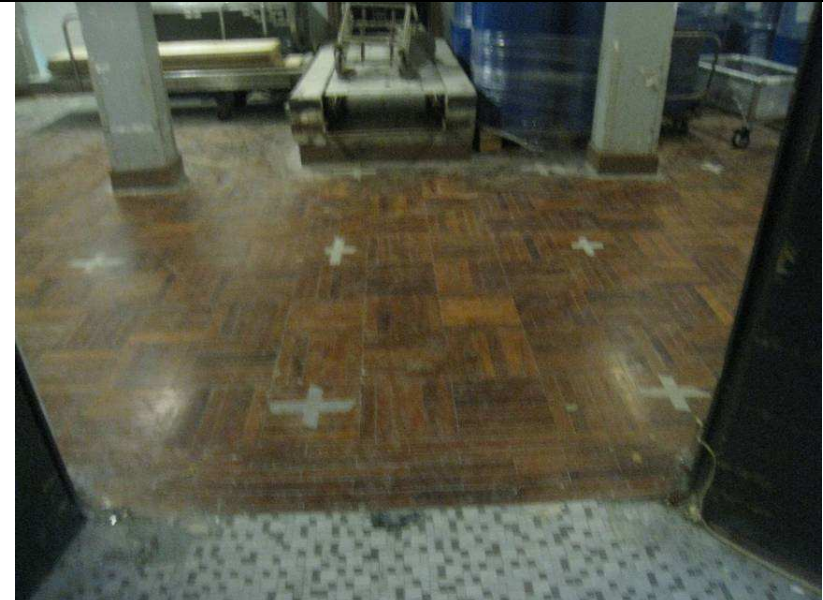
**Description: Existing Condition of the Storage Room under Cremation Room 1 (CR1)**

- The pipelines for diesel fuel delivery are exposed and not embedded in soil at CR1 and CR2 and the main pipe connecting the CR1 and AST are enclosed by concrete channel;
- The storage rooms underneath CR1 and CR2 are concreted. Fuel leakage in CR1 or CR2 will be contained by the storage rooms and is unlikely to reach the soil under the concrete floor.

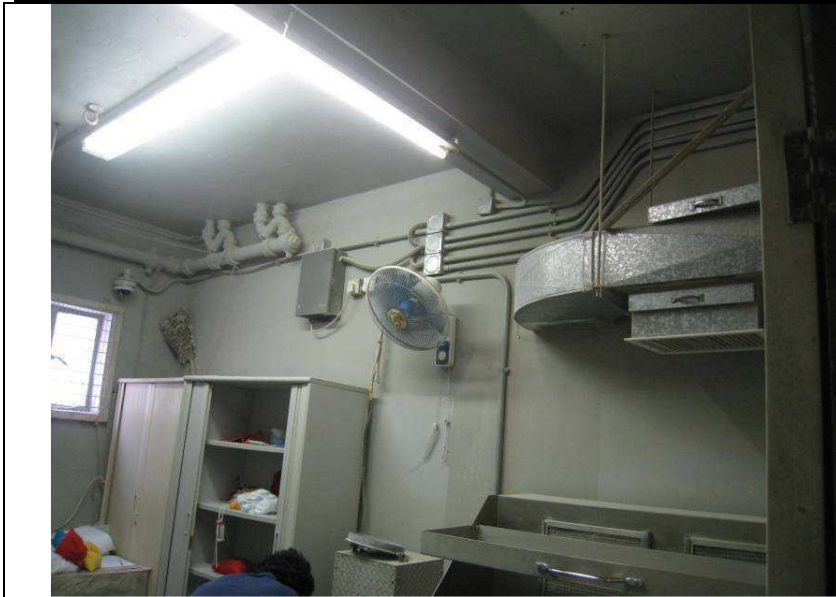
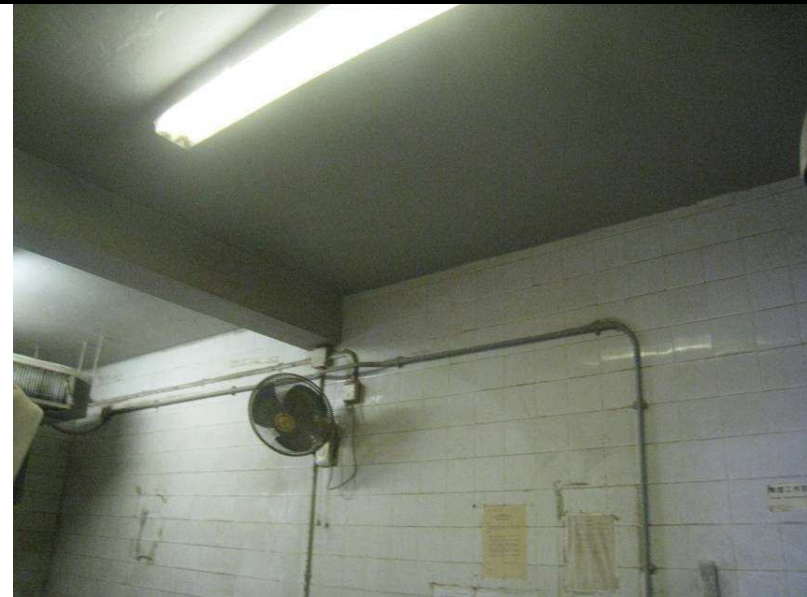
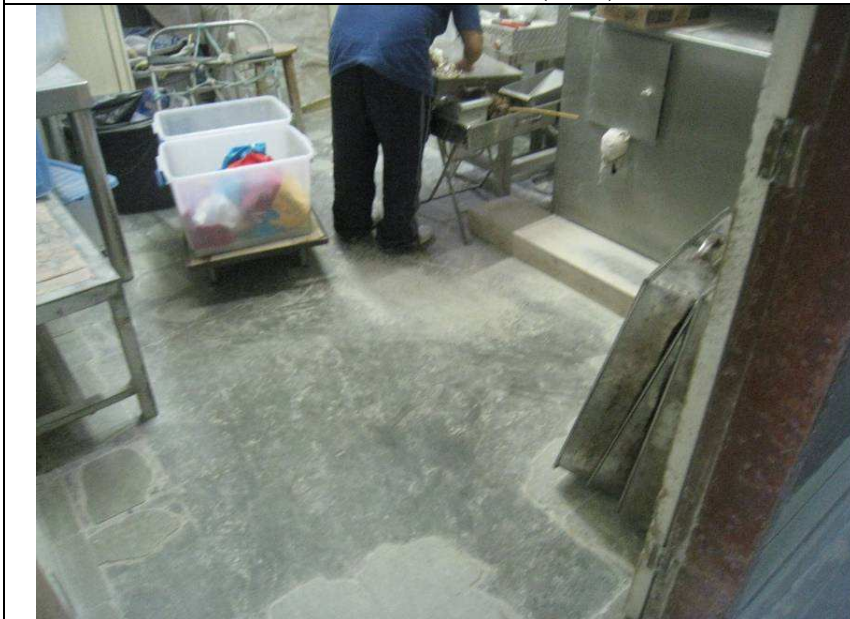
**Description: Existing Condition of the Storage Room under Cremation Room 2 (CR2)**
