**Contract No. EP/SP/58/08 – Sludge Treatment Facilities
Environmental Monitoring Results in Operation Phase – Monthly HCMP Reports
(July 2016)**

OPERATIONAL PHASE ECOLOGICAL MONITORING OF GREBE POND IN ACCORDANCE WITH THE APPROVED HABITAT CREATION AND MANAGEMENT PLAN

2016-07

CONTRACT EP/SP/58/08 SLUDGE TREATMENT FACILITIES

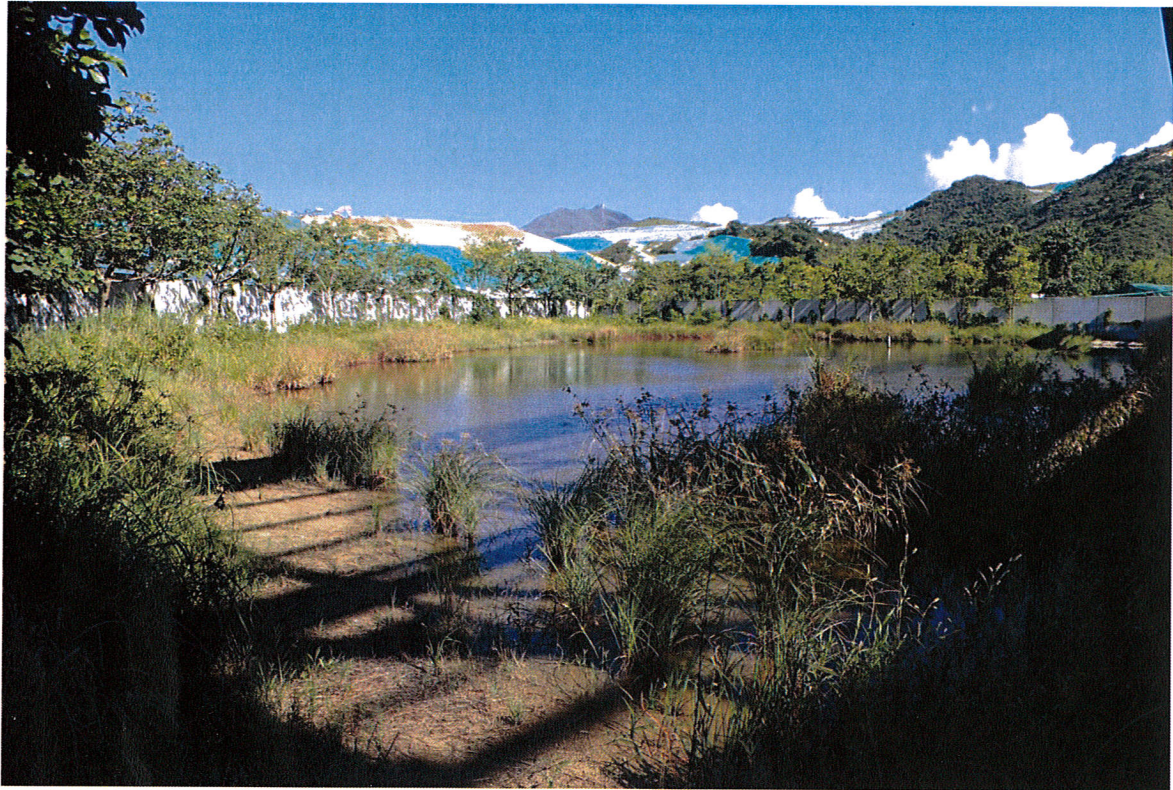
Plate 1

Management Activities Required	Action
Minor remedial work:	<ul style="list-style-type: none"> No fish or fry were observed in the Pond (Plate 1). The Landscape Contractor should remove all snails and destroy egg masses during their routine maintenance work in the Pond. At least weekly removal of Apple Snails is recommended. As a routine maintenance practice, the landscape contractor should remove the unwanted climbers (<i>Mikania micrantha</i> and <i>Acacia concinna</i>) and the self-seeded small tree <i>Tamarix chinensis</i>. All vegetation should be disposed away from the Grebe Pond. Grass cutting is needed around the pond (Plate 2). 	<ul style="list-style-type: none"> NA Contractor Contractor Contractor

The Grebe Pond.

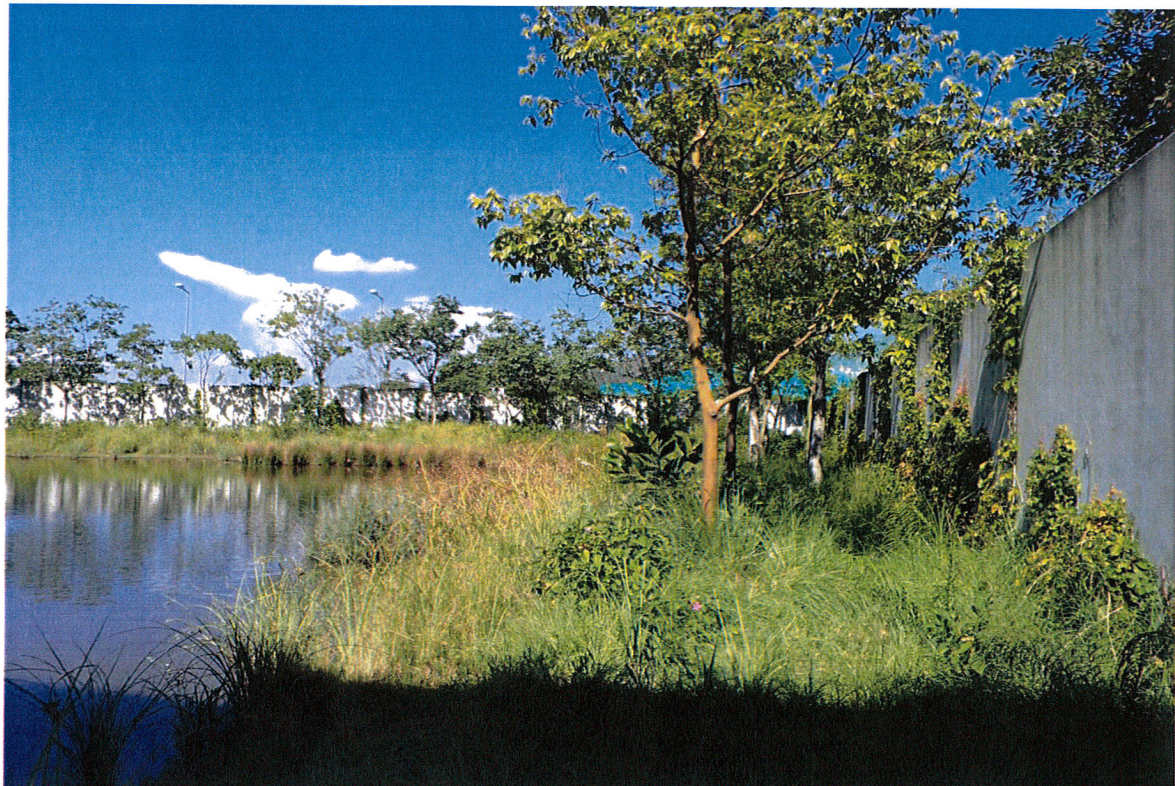
Plate 2

Minor Comments:	<ul style="list-style-type: none"> Less rubbish was noted in the Pond area. The Contractor should continue to remove the rubbish during the routine maintenance work. Grass cutting task from the May 2016 management plan has not been completed. 	<ul style="list-style-type: none"> Contractor Contractor
Water quality checks:	<ul style="list-style-type: none"> Water quality checks will normally form part of the Operational Phase monitoring of the Grebe Pond as per Section 8, Table 7 of the Habitat Creation and Management Plan. Summarised water quality results are shown in Table 2 below. The water temperature has reached the action level (30°C) due to hot weather. Monitoring will continue to check the health of aquatic species and the level of dissolved oxygen. No action is required from the Contractor. The water level of the pond is approximately at the +5.6mPD level, no water level adjustment is required. As a reminder, only freshwater can be pumped into the Grebe Pond. The contractor should regularly check the salinity level of the pumped water and avoid pumping water with high salinity level. 	<ul style="list-style-type: none"> NA NA Contractor Contractor

Grass around the Pond needs cutting.
