**Contract No. EP/SP/58/08 – Sludge Treatment Facilities
Environmental Monitoring Results in Operation Phase – Monthly HCMP Reports
(August 2016)**

Contract EP/SP/58/08 Sludge Treatment Facilities

OPERATIONAL PHASE ECOLOGICAL MONITORING OF GREBE POND IN ACCORDANCE WITH THE APPROVED HABITAT CREATION AND MANAGEMENT PLAN

2016-08

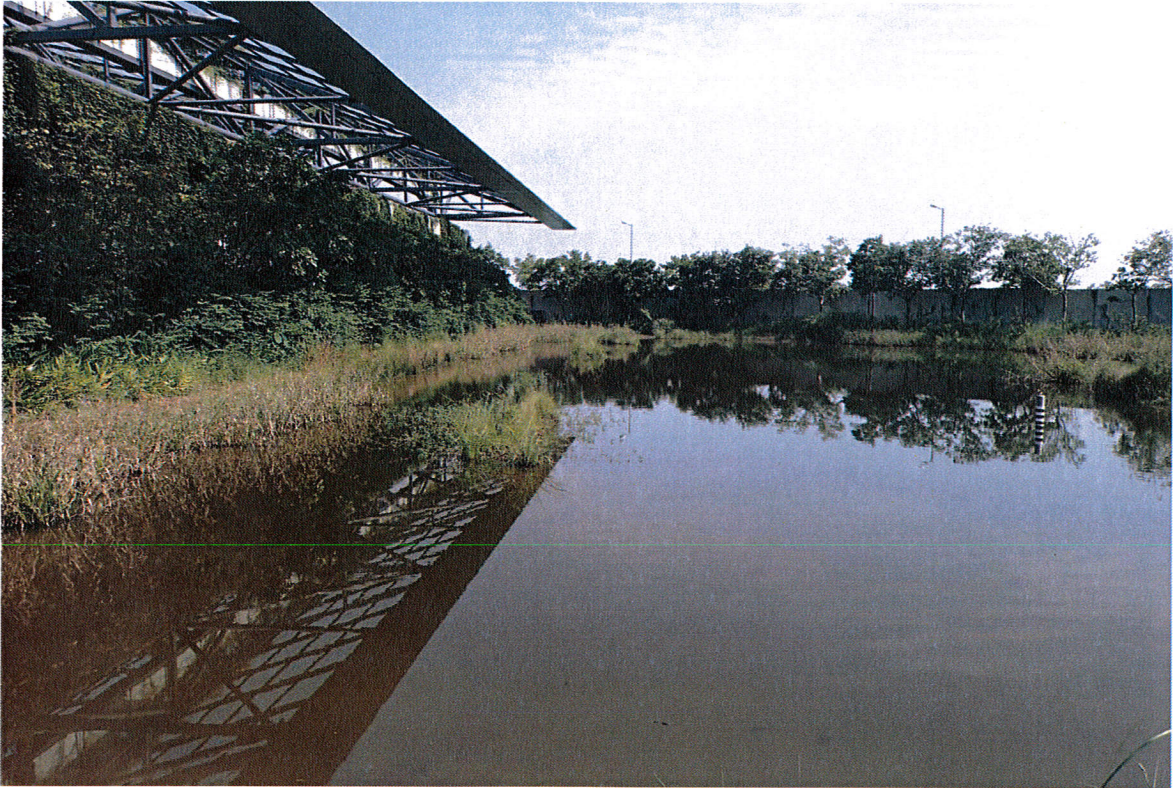
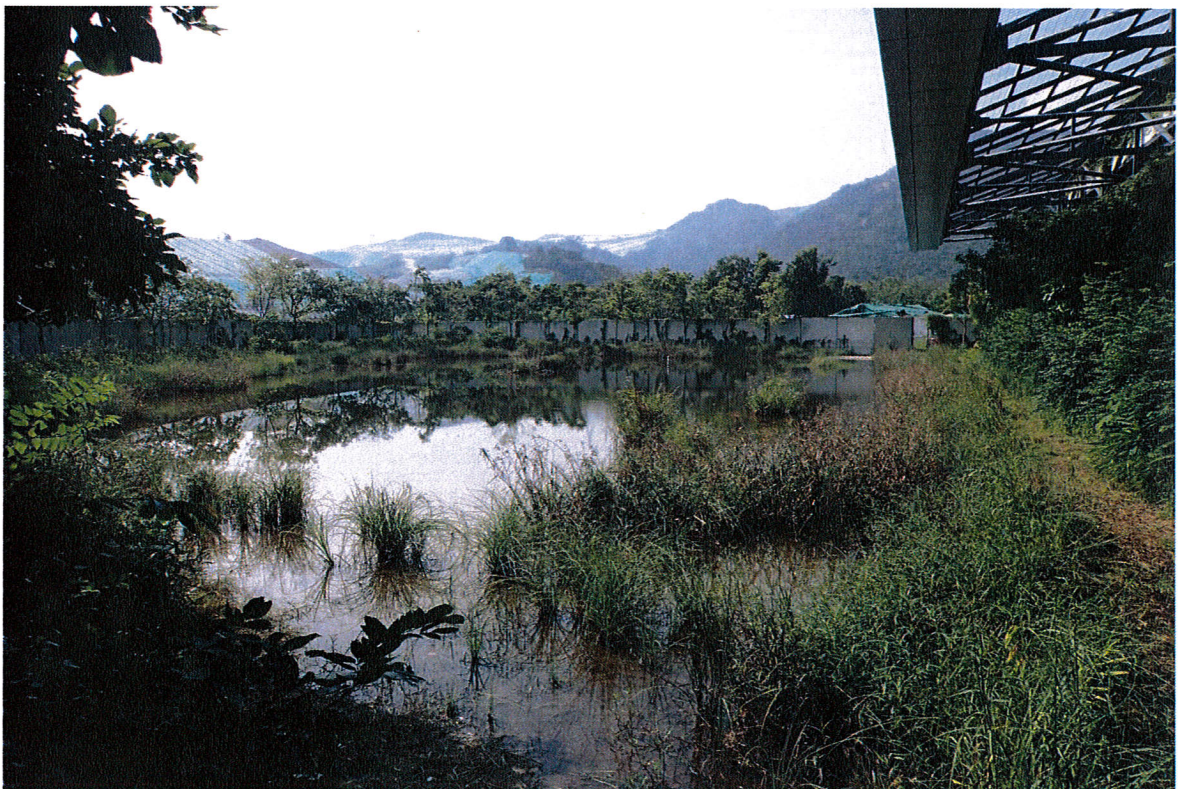
Plate 1

Management Activities Required	Action
Minor remedial work:	<ul style="list-style-type: none">No fish or fry were observed in the Pond (Plate 1).The Landscape Contractor should remove all snails and destroy egg masses during their routine maintenance work in the Pond. At least weekly removal of Apple Snails is recommended.As a routine maintenance practice, the landscape contractor should remove the unwanted climbers (<i>Mikania micrantha</i> and <i>Acacia concinna</i>) and the self-seeded small tree <i>Tamarix chinensis</i>. All vegetation should be disposed away from the Grebe Pond.	<ul style="list-style-type: none">NAContractor Contractor

The Grebe Pond.
