**Paul Y. Construction Company, Limited**

**MTR Works Contract 1117-  
Pat Heung Depot Modification Works**

**Monthly Noise Monitoring Report  
for  
June 2013**

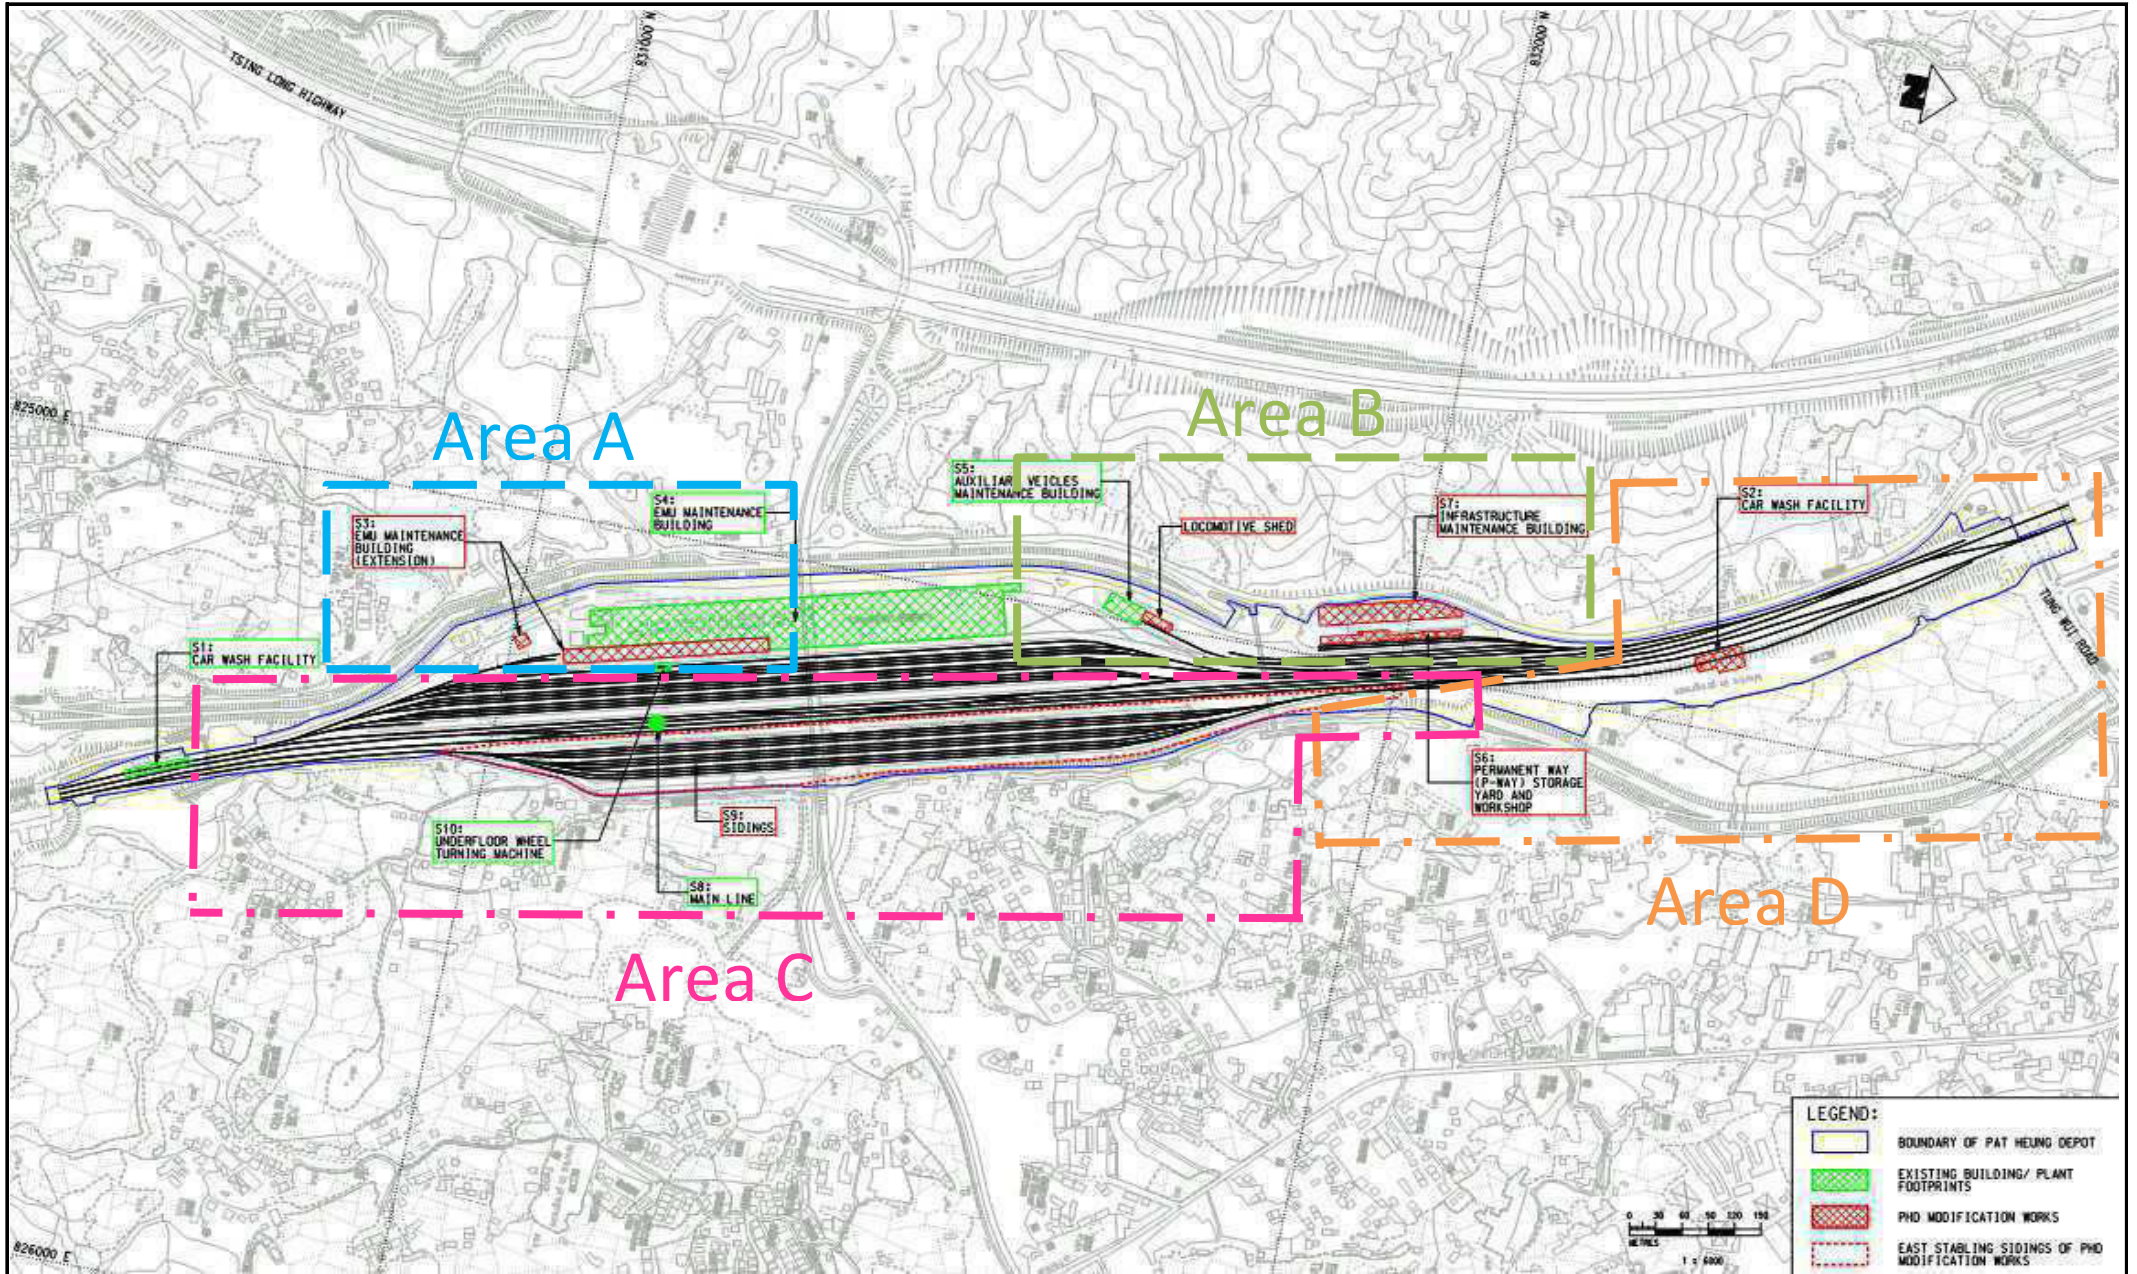
Scale	N.T.S	Proposal No.	MA13003
Date	Apr-13	Figure	1

- 2.5 The site layout and proposed modification works are illustrated in **Figure 1**.

Title  
 SCL Contract 1117  
 Shatin to Central Link -  
 Pat Heung Depot Modification Works  
 Site Layout Plan

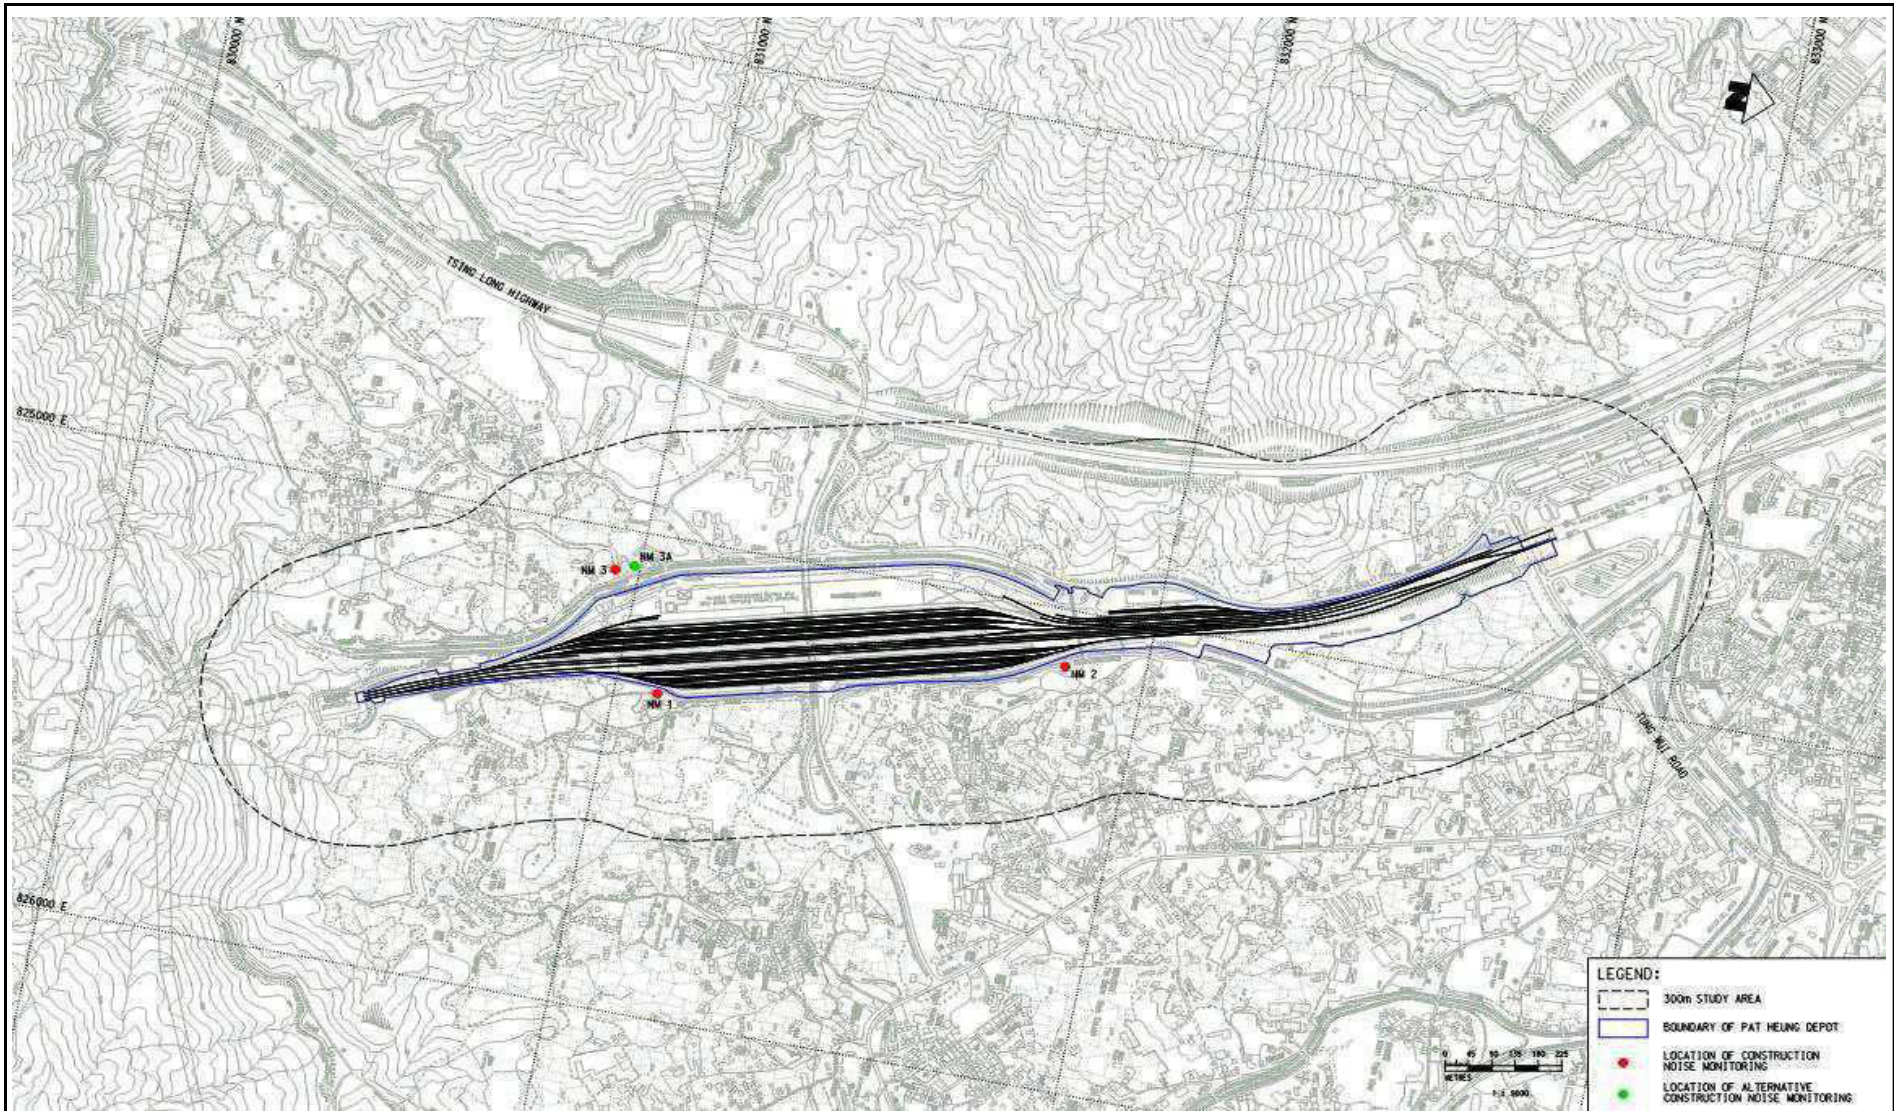
Title	MTR Works Contract 1117 Pat Heung Depot Modification Works		Scale	N.T.S	Proposal No.	MA13003	
	Location of Constrction Noise Monitoring Stations		Date	Apr-13	Figure	3

- 3.1 Noise monitoring was conducted in accordance with the approved EM&A Programme for PHD Modification Works.
- 3.2 With reference to the baseline monitoring report for the Project, **Table 3.1** and **Table 3.2** summarises the location of noise monitoring stations and shows the established Action and Limit Levels for construction noise monitoring works respectively. Location of the monitoring stations is shown on **Figure 3**.

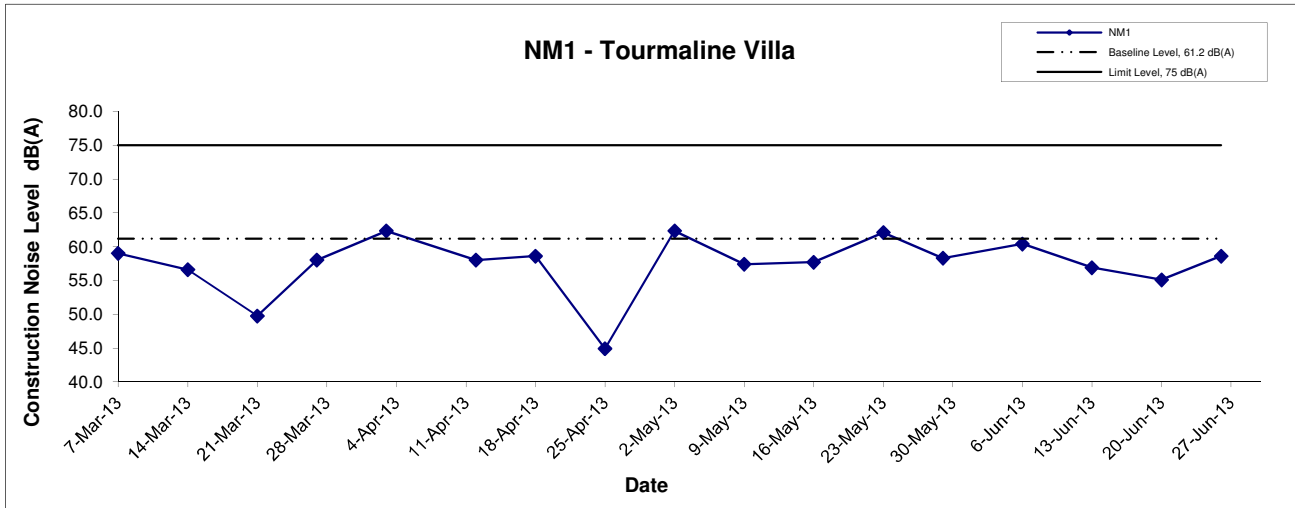
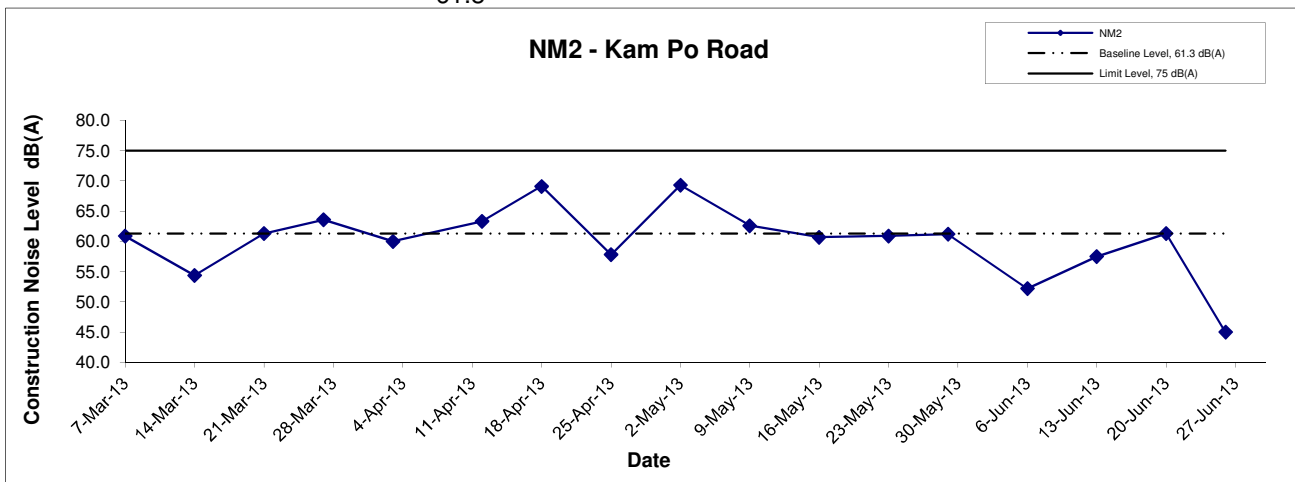
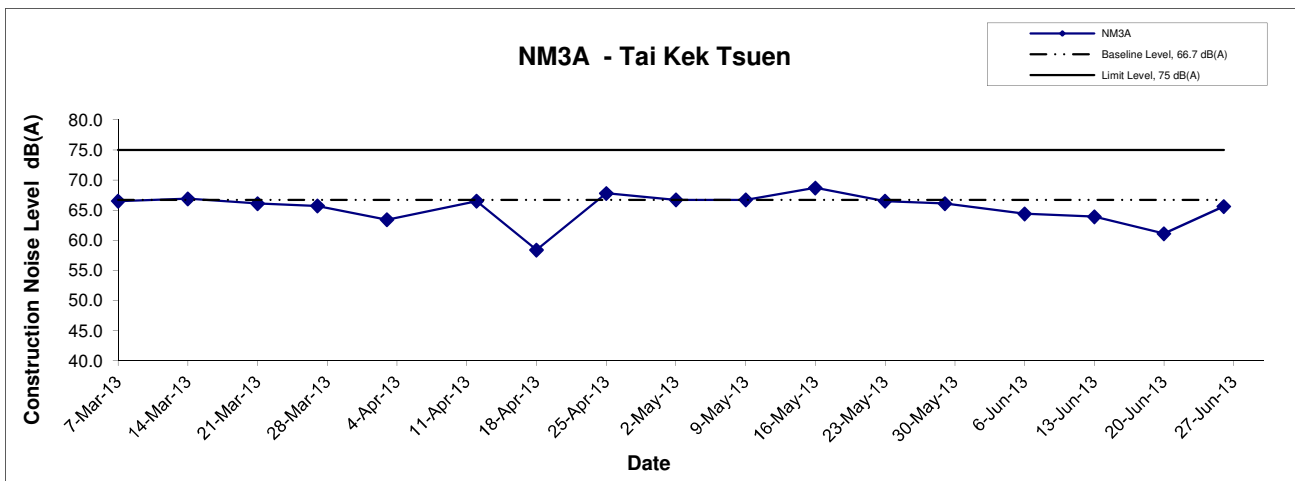
Title MTR Works Contract 1117 Pat Heung Depot Modification Works  Graphical Presentation of Construction Noise Monitoring Results	Scale N.T.S	Project No. MA13003	
	Date June 13	Appendix F

## Noise Levels
