**Paul Y. Construction Company, Limited**

**MTR Works Contract 1117-  
Pat Heung Depot Modification Works**

**Monthly Noise Monitoring Report  
for  
July 2013**

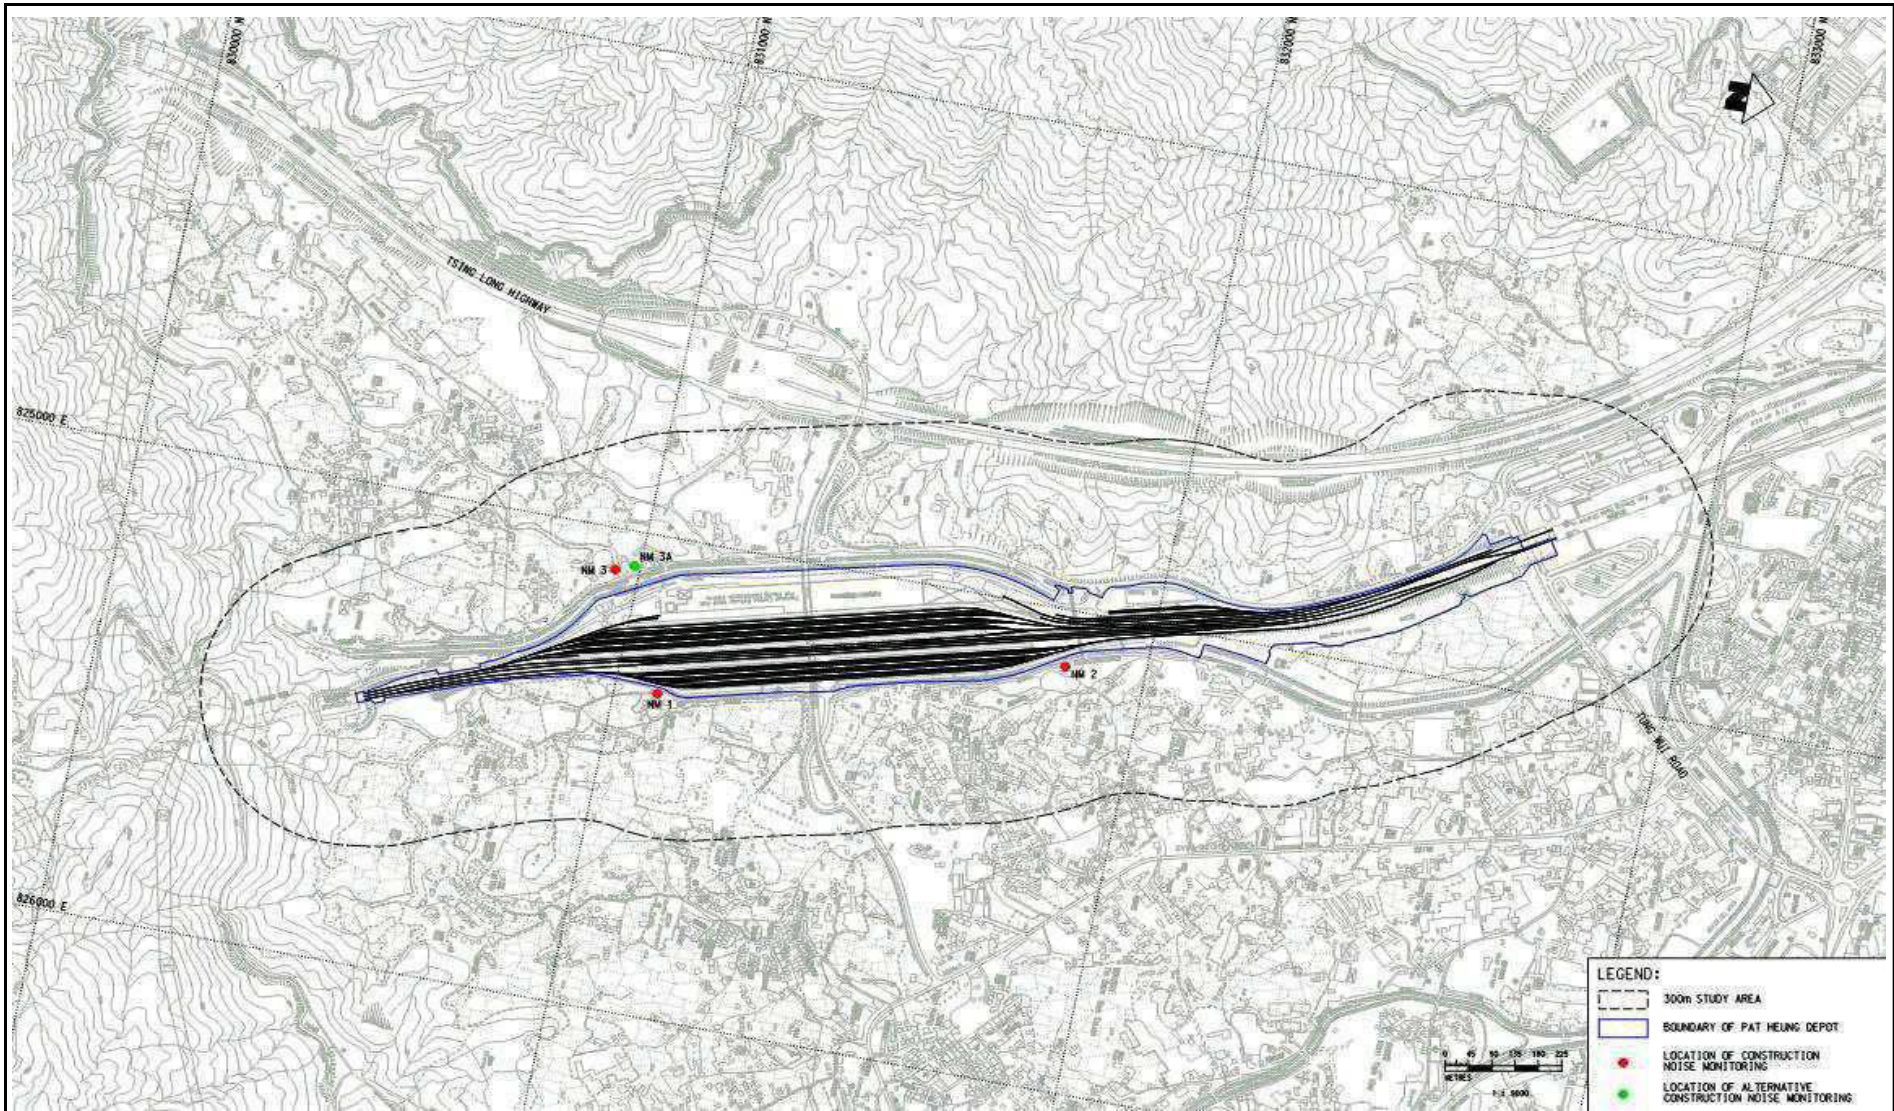
Title	MTR Works Contract 1117 Pat Heung Depot Modification Works		Scale	N.T.S	Proposal No.	MA13003	
	Location of Constrction Noise Monitoring Stations		Date	Apr-13	Figure	3

- 3.1 Noise monitoring was conducted in accordance with the approved EM&A Programme for PHD Modification Works.
- 3.2 With reference to the baseline monitoring report for the Project, **Table 3.1** and **Table 3.2** summarises the location of noise monitoring stations and shows the established Action and Limit Levels for construction noise monitoring works respectively. Location of the monitoring stations is shown on **Figure 3**.

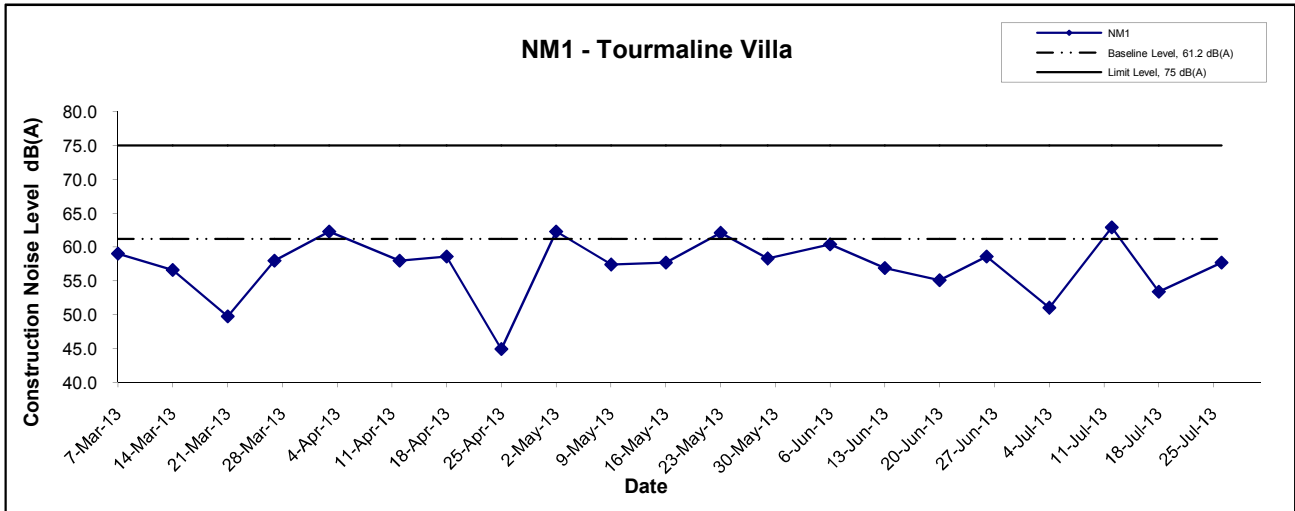
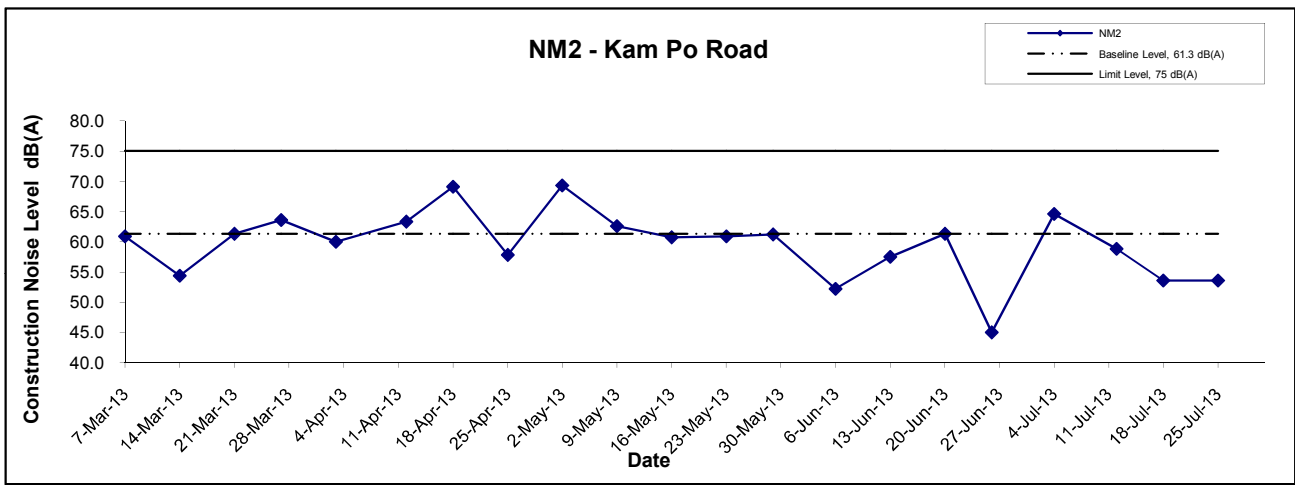
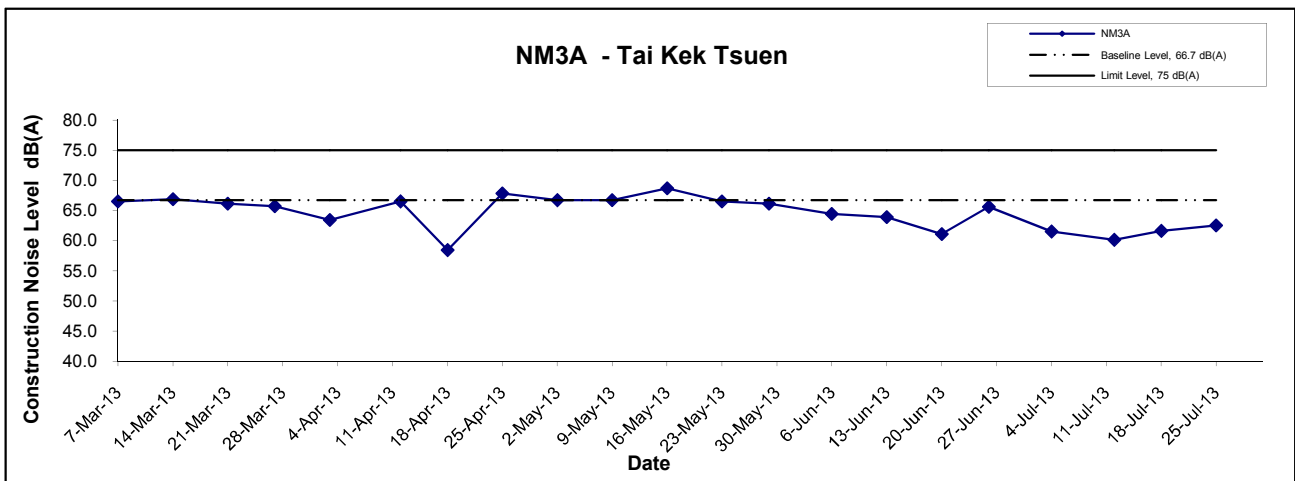
Title MTR Works Contract 1117 Pat Heung Depot Modification Works  Graphical Presentation of Construction Noise Monitoring Results	Scale N.T.S	Project No. MA13003	
	Date July 13	Appendix F

5. 4 sets of 30-minute construction noise measurements were carried out at each of the monitoring stations during normal weekdays of the reporting period. No exceedance was recorded during the reporting period.
