**MTR Works Contract 1117-
Pat Heung Depot Modification Works**

**Monthly Noise Monitoring Report
for
February 2014**

Pat Heung Modification Works
Monthly Noise Monitoring Report No. 12
[Period from 1 to 28 February 2014]

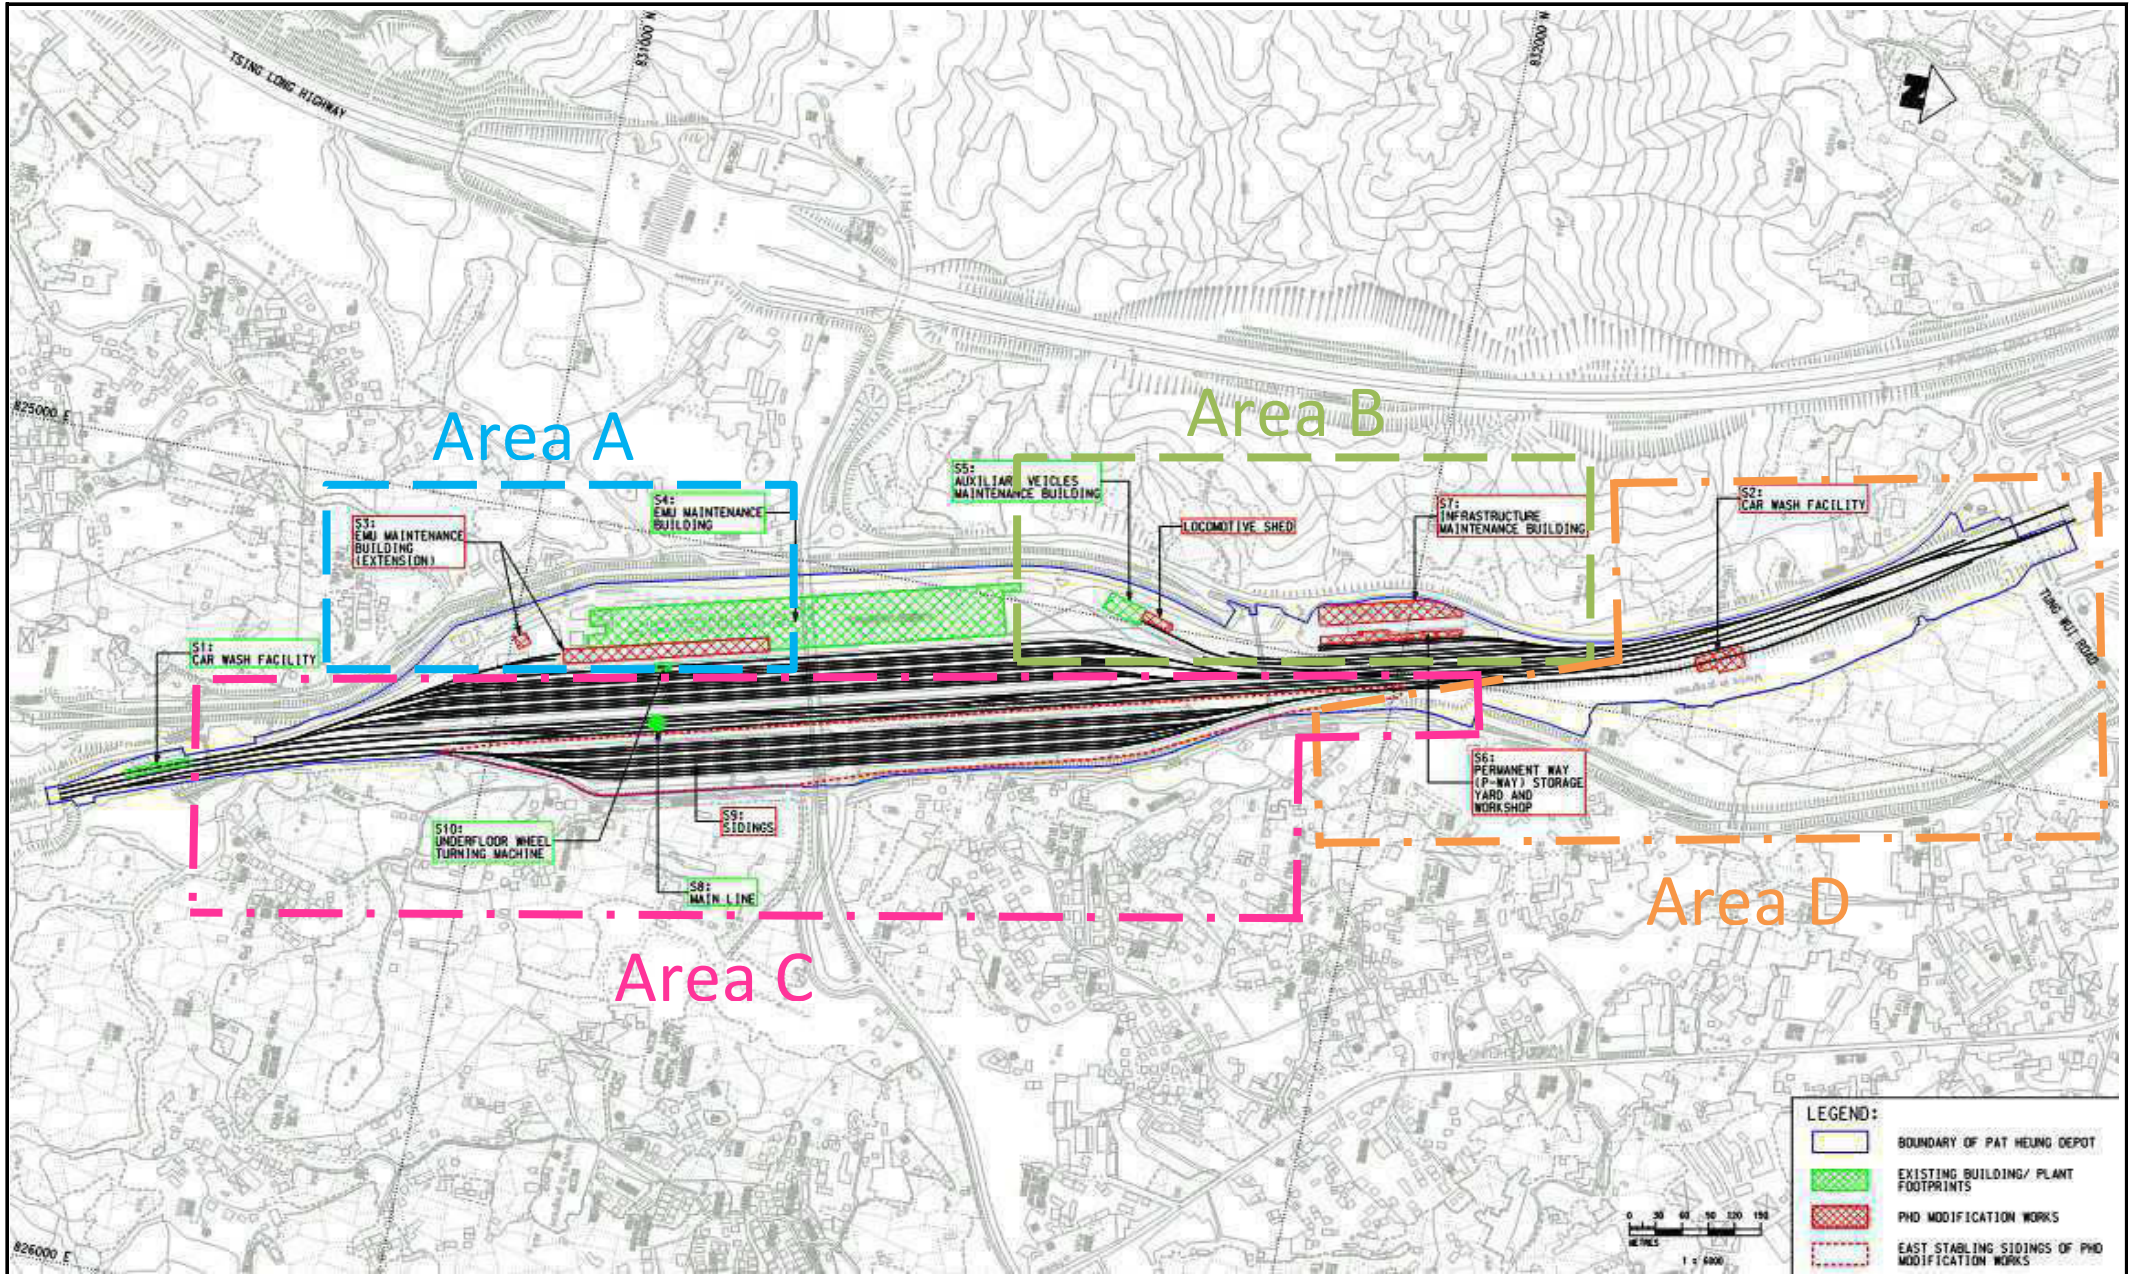
Title	SCL Contract 1117 Shatin to Central Link - Pat Heung Depot Modification Works Site Layout Plan	Scale	N.T.S	Proposal No.	MA13003	
		Date	Apr-13	Figure	1

- 2.5 The site layout and proposed modification works are illustrated in **Figure 1**.

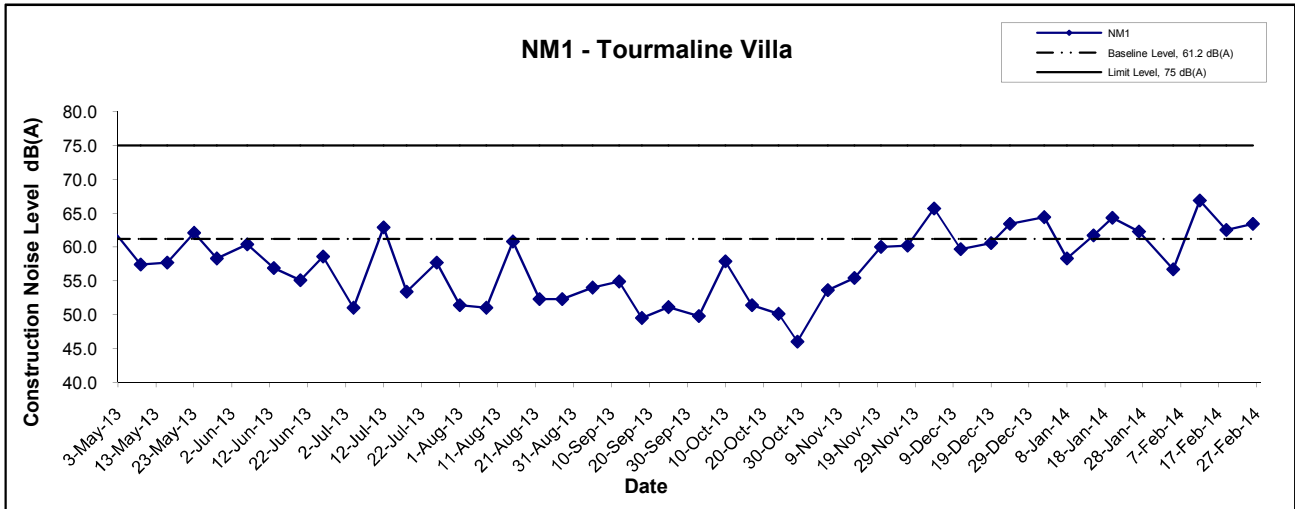
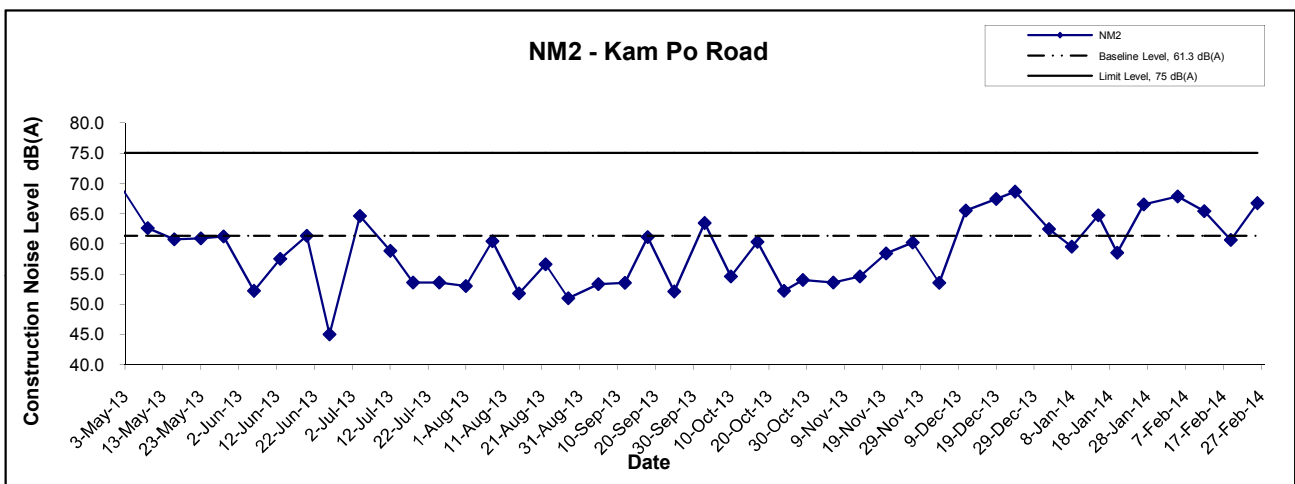
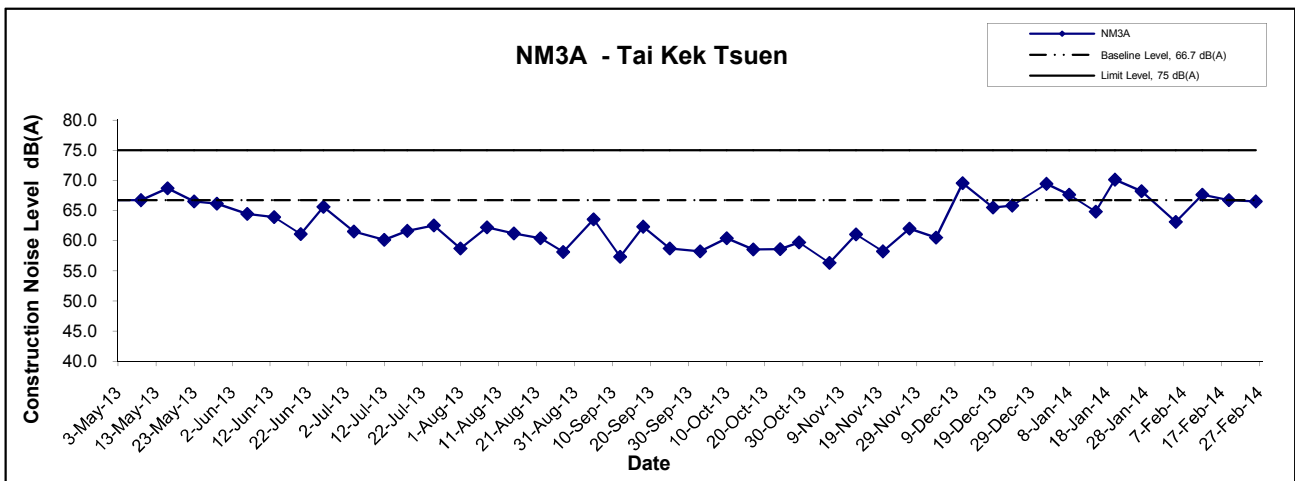
Title MTR Works Contract 1117 Pat Heung Depot Modification Works Graphical Presentation of Construction Noise Monitoring Results	Scale N.T.S	Project No. MA13003	
	Date Feb-14	Appendix F

Noise Levels
