**Paul Y. Construction Company, Limited**

**MTR Works Contract 1117-  
Pat Heung Depot Modification Works**

**Monthly Noise Monitoring Report  
for  
May 2013**

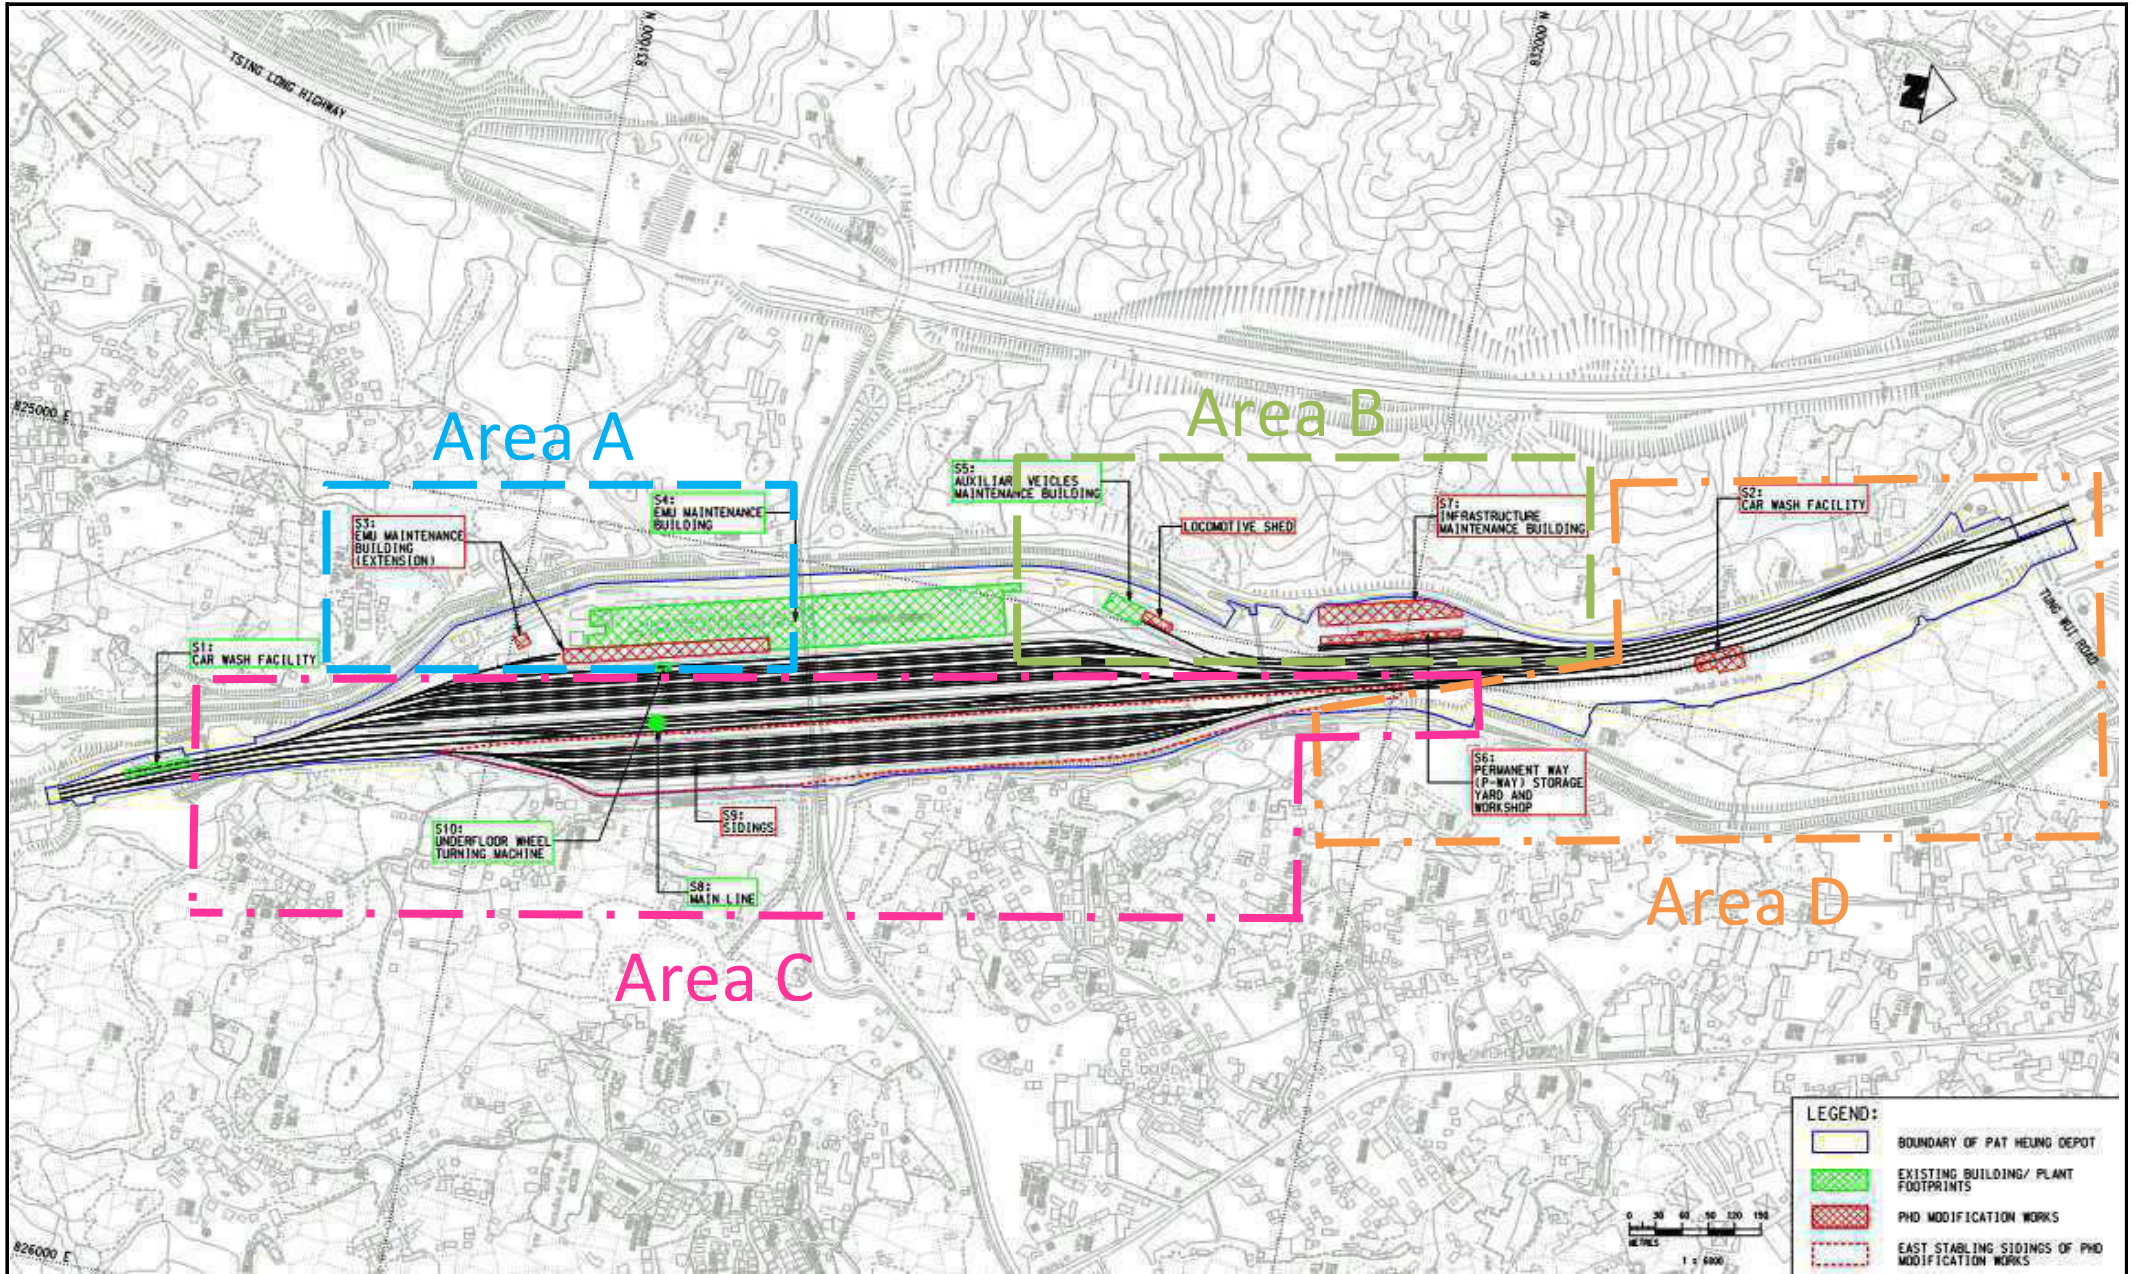
Title	SCL Contract 1117 Shatin to Central Link - Pat Heung Depot Modification Works		Scale	N.T.S	Proposal No.	MA13003	
	Site Layout Plan		Date	Apr-13	Figure	1

- 2.5 The site layout and proposed modification works are illustrated in **Figure 1**.

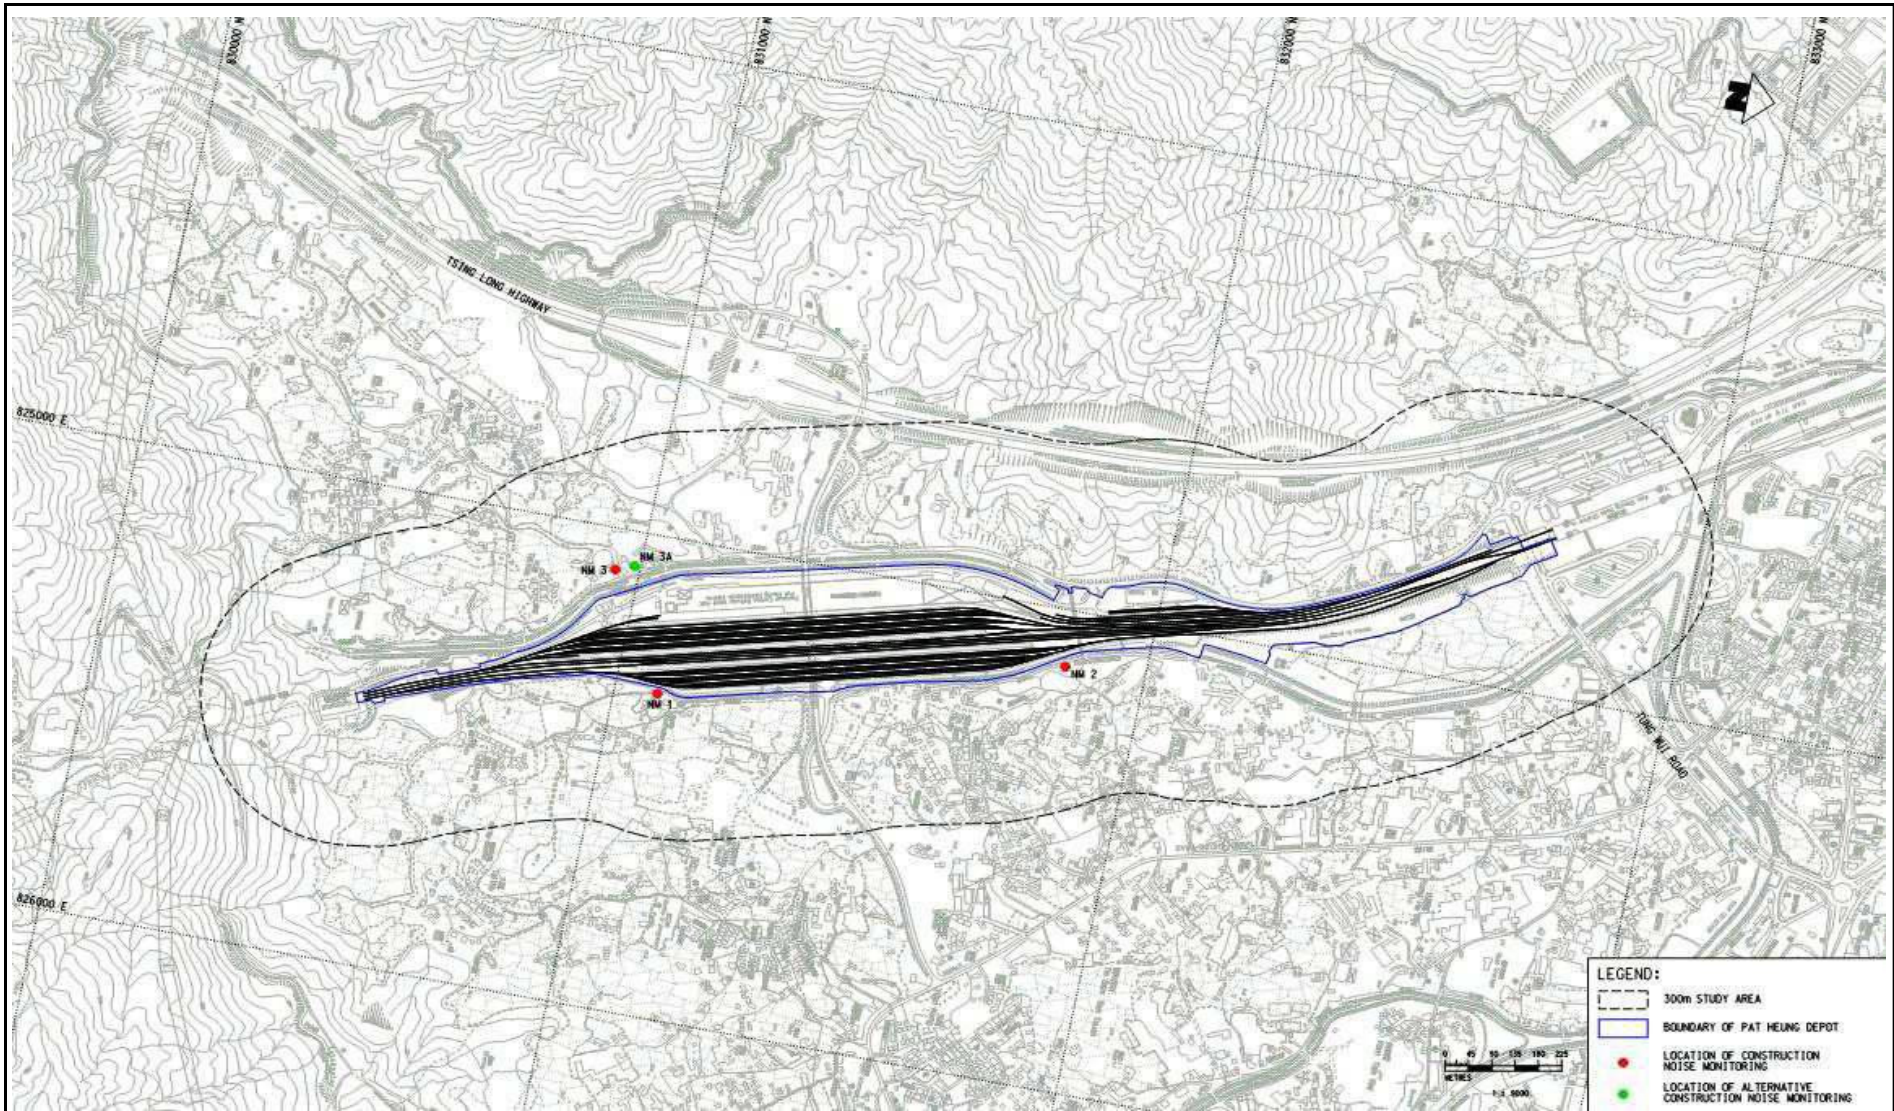
Title	MTR Works Contract 1117 Pat Heung Depot Modification Works		Scale	N.T.S	Proposal No.	MA13003	
	Location of Constrction Noise Monitoring Stations		Date	Apr-13	Figure	3

- 3.1 Noise monitoring was conducted in accordance with the approved EM&A Programme for PHD Modification Works.
- 3.2 With reference to the baseline monitoring report for the Project, **Table 3.1** and **Table 3.2** summarises the location of noise monitoring stations and shows the established Action and Limit Levels for construction noise monitoring works respectively. Location of the monitoring stations is shown on **Figure 3**.

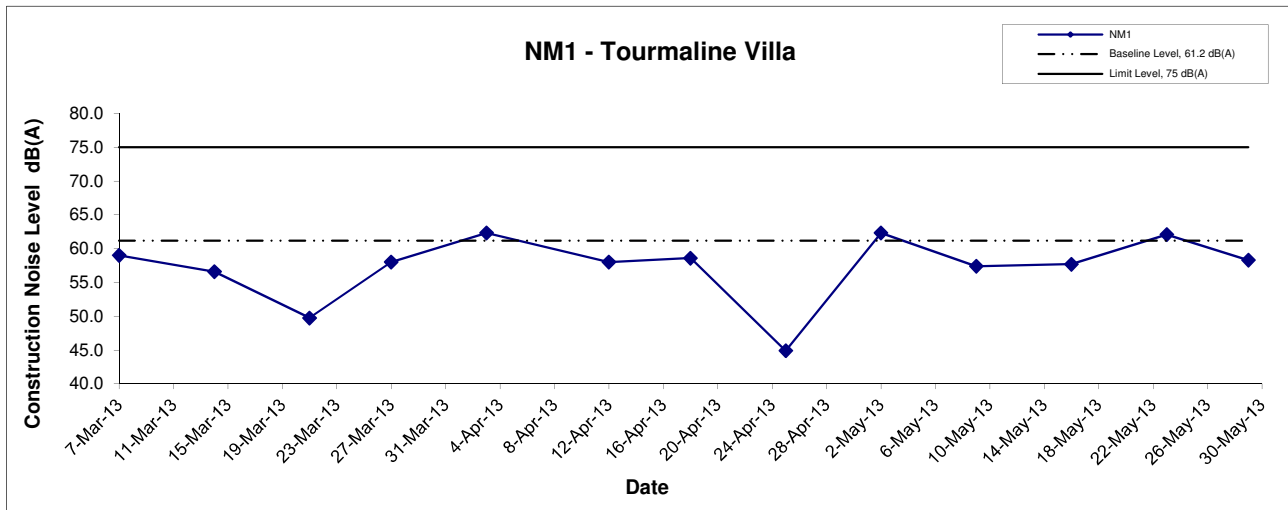
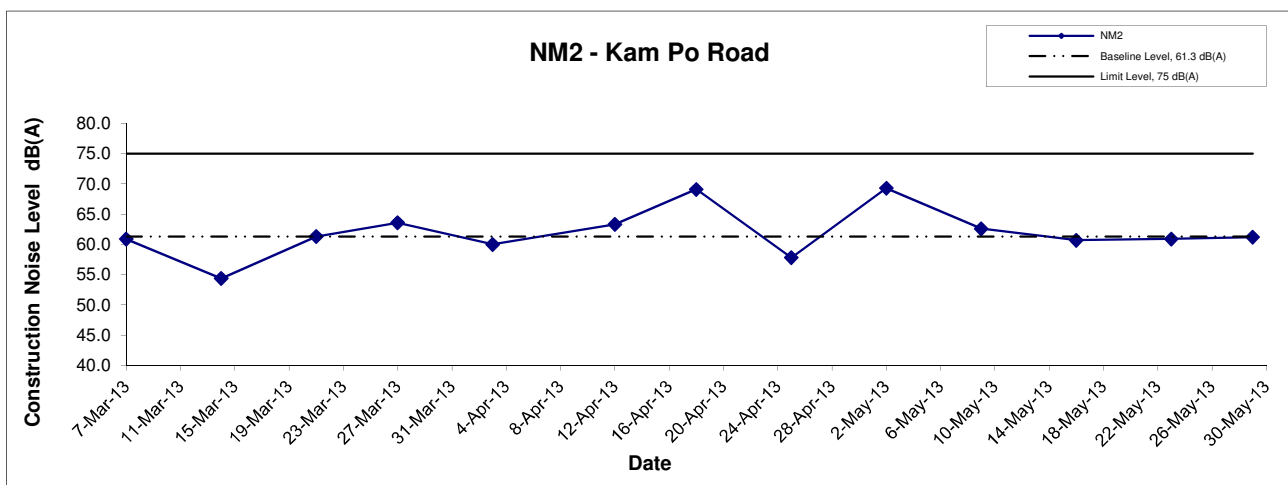
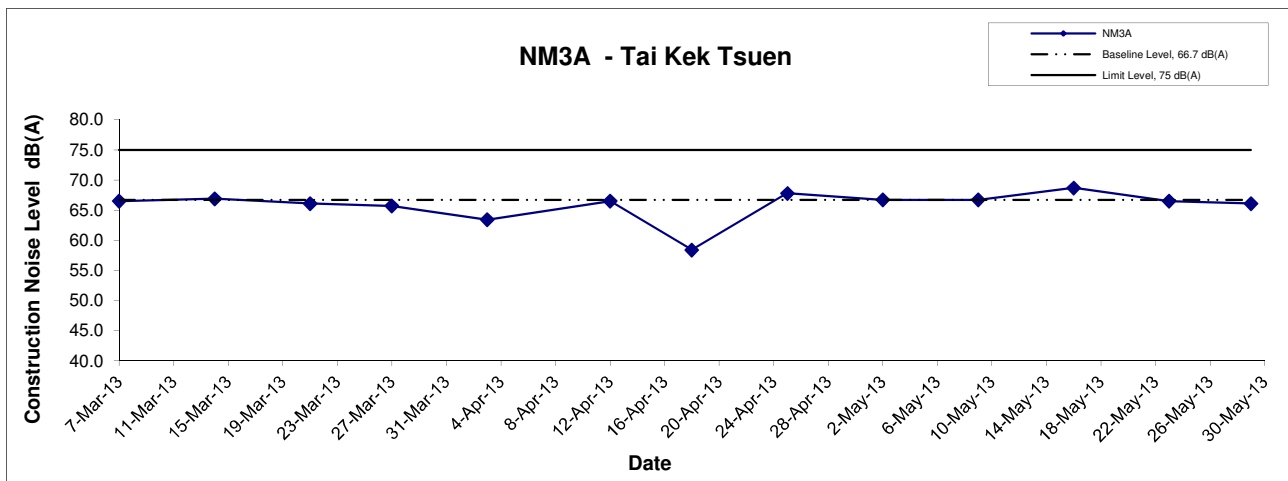
Title MTR Works Contract 1117 Pat Heung Depot Modification Works  Graphical Presentation of Construction Noise Monitoring Results	Scale N.T.S	Project No. MA13003	
	Date May 13	Appendix F

## Noise Levels
